Report on the investigation
of a hazardous diving incident
involving

MV Norma

in the Dover Strait

Report No 3/2009
January 2009

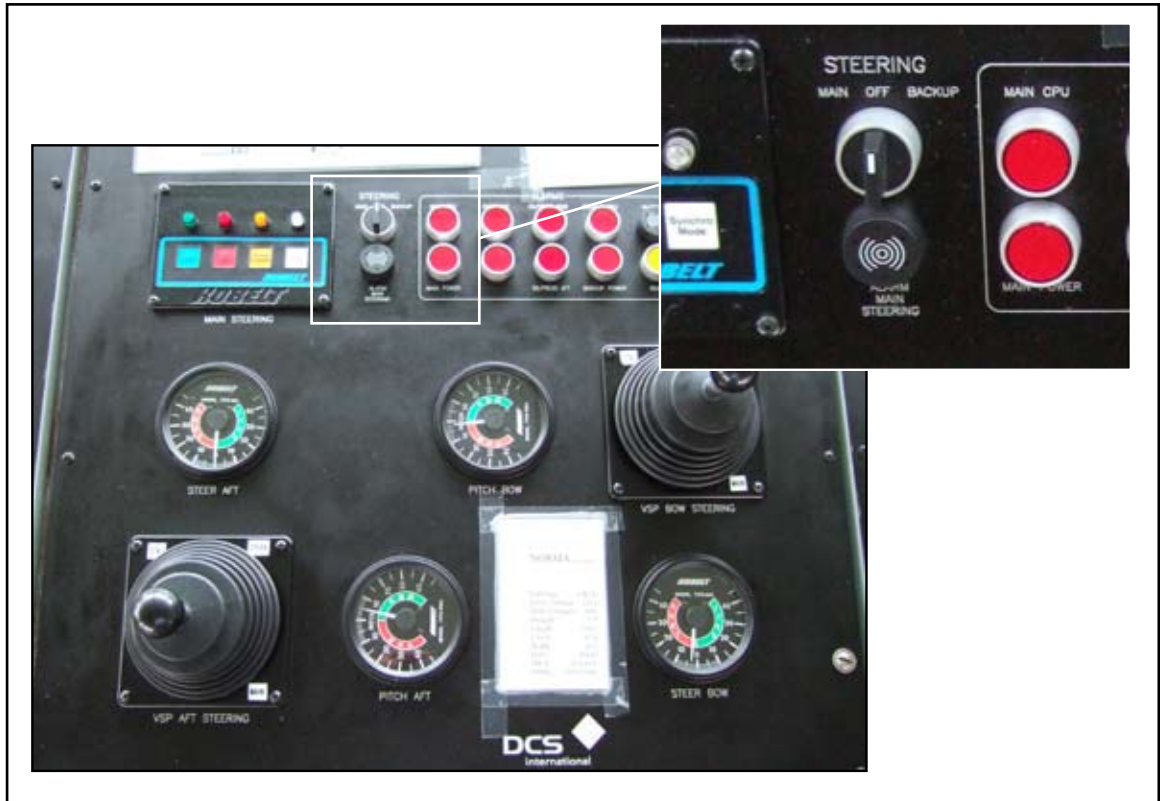
Figure 2

sited on the Voith Schneider propeller (VSP) control panel (**Figure 2**), to the off position. He then called the master using VHF radio and informed him that the motors had been switched off. The second officer did not inform the engine room that the electric motors were no longer required.

Propulsion and steering control panel

The incident would not have occurred if the aft VSP had been stopped as intended. Although the OOW turned the steering control switch to the off position (**Figure 2**), this only disengaged the control of the propeller pitch; the propellers continued to rotate. It is evident that the OOW was unaware that the VSPs

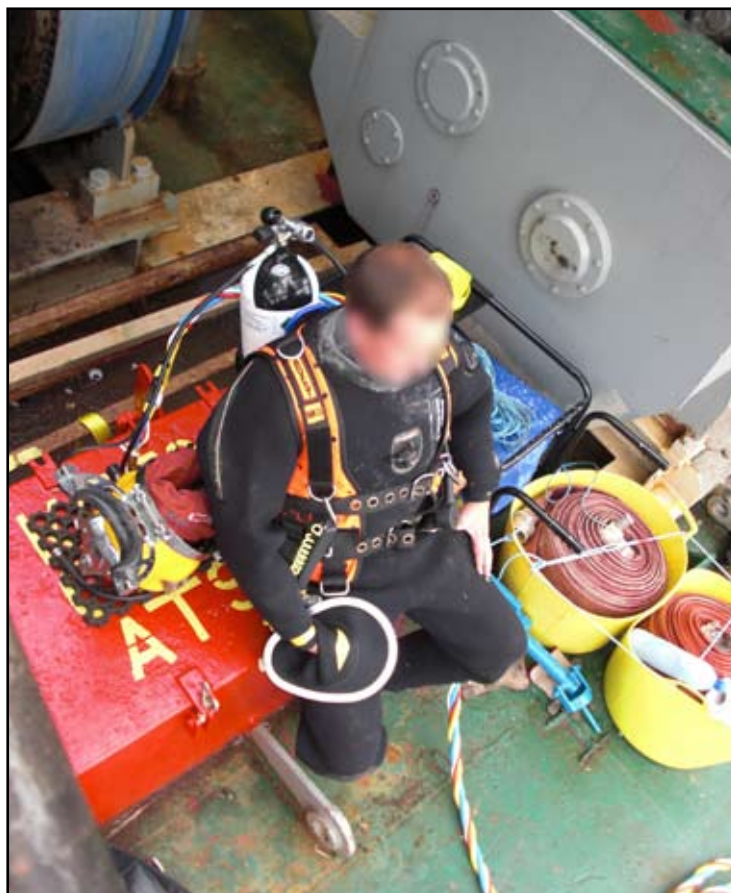
Figure 3

The purpose of the dive was to replace the light shot line with a 32mm polypropylene rope. The diver entered the water at 1125 using a full diving suit (**Figure 3**) and was attached to an umbilical cord which provided him with air, communications and a video link. The diver reported to his diving supervisor that the tide was slightly stronger than expected, but that he was happy to descend. About 3 minutes after leaving the surface he informed the diving supervisor that he was having difficulty because of tension on the umbilical cord. When he reached a depth of 20 metres, he reported that he could hardly move, and asked the diving supervisor if the surface crew were pulling on his umbilical cord. In response, the diving supervisor replied that they were not and, when the diver remarked that he wanted to come up, the supervisor told him to let go of the shot line and surface.

Diving suit

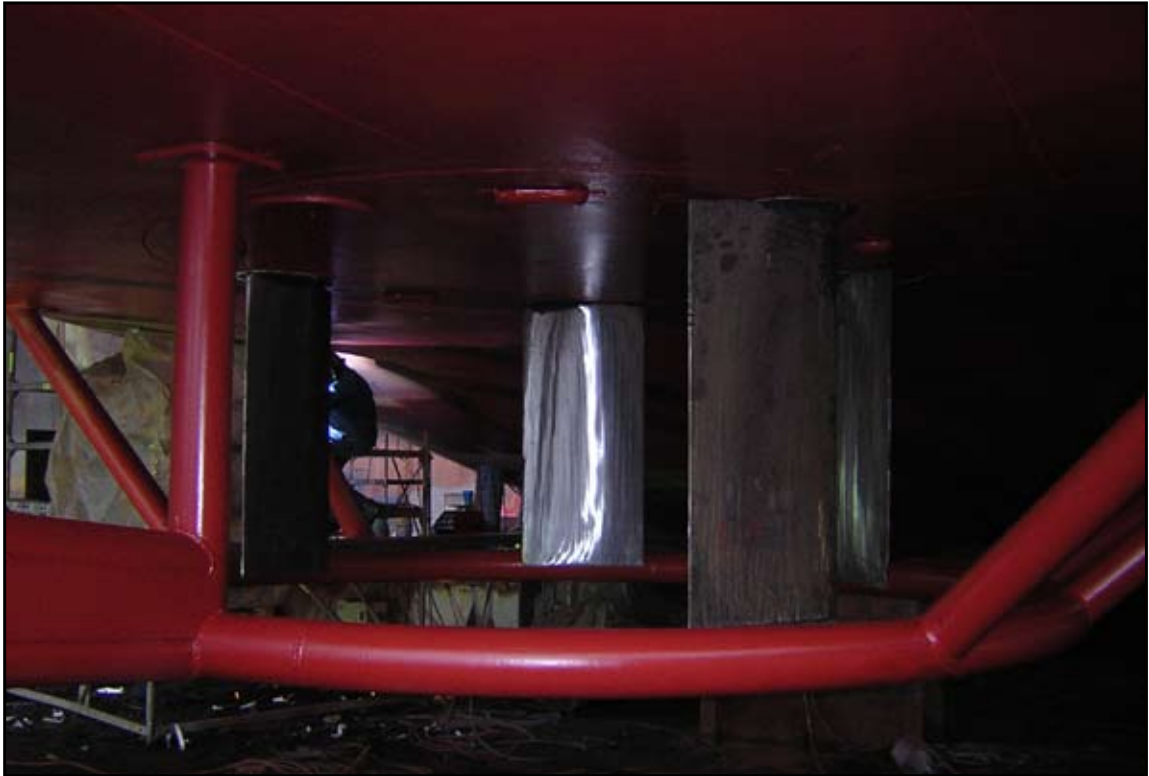
Meanwhile, the diver had been rotating violently and had realised that he was being dragged towards the aft VSP (**Figure 4**). He was unable to cut his umbilical cord but managed to turn on the air supply from his bail out bottle³. When the VSP finally stopped, he was about 3 metres away. He was then able

Voith Schneider propeller

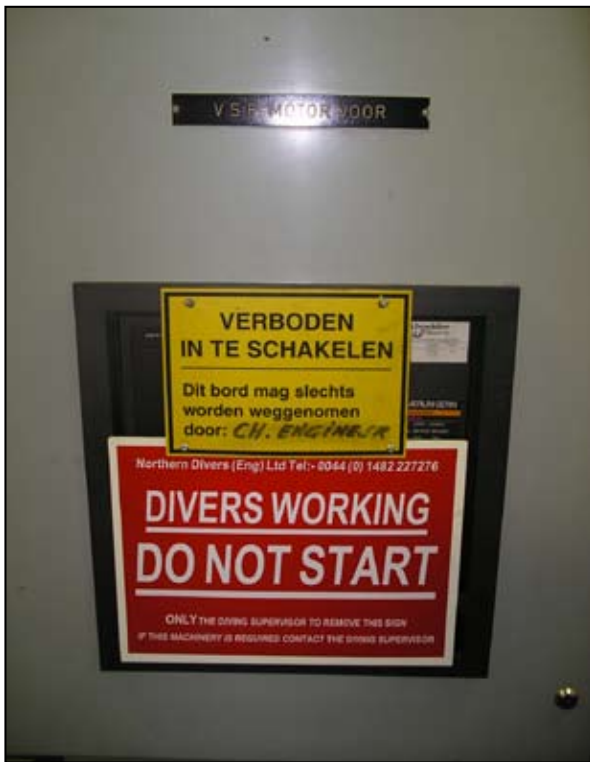
Figure 5

Warning sign on VSP switchboard

The following morning, the project team and the vessel's senior management agreed measures to isolate the vessel's propulsion. These included the placement of warning signs on the VSP switchboard in the engine room (**Figure 5**) and the use of 'emergency stop' switches, which disabled the VSP's starting circuit from the bridge (**Figure 6**). A 'permit to work' system covering diving operations was also implemented (**Annex B**).

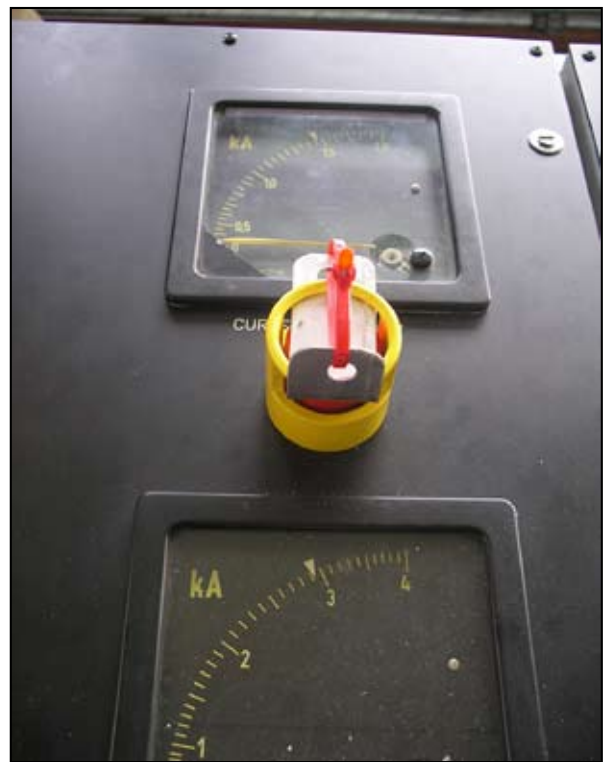
Figure 6

Emergency stops on bridge - measures to isolate motors from activation

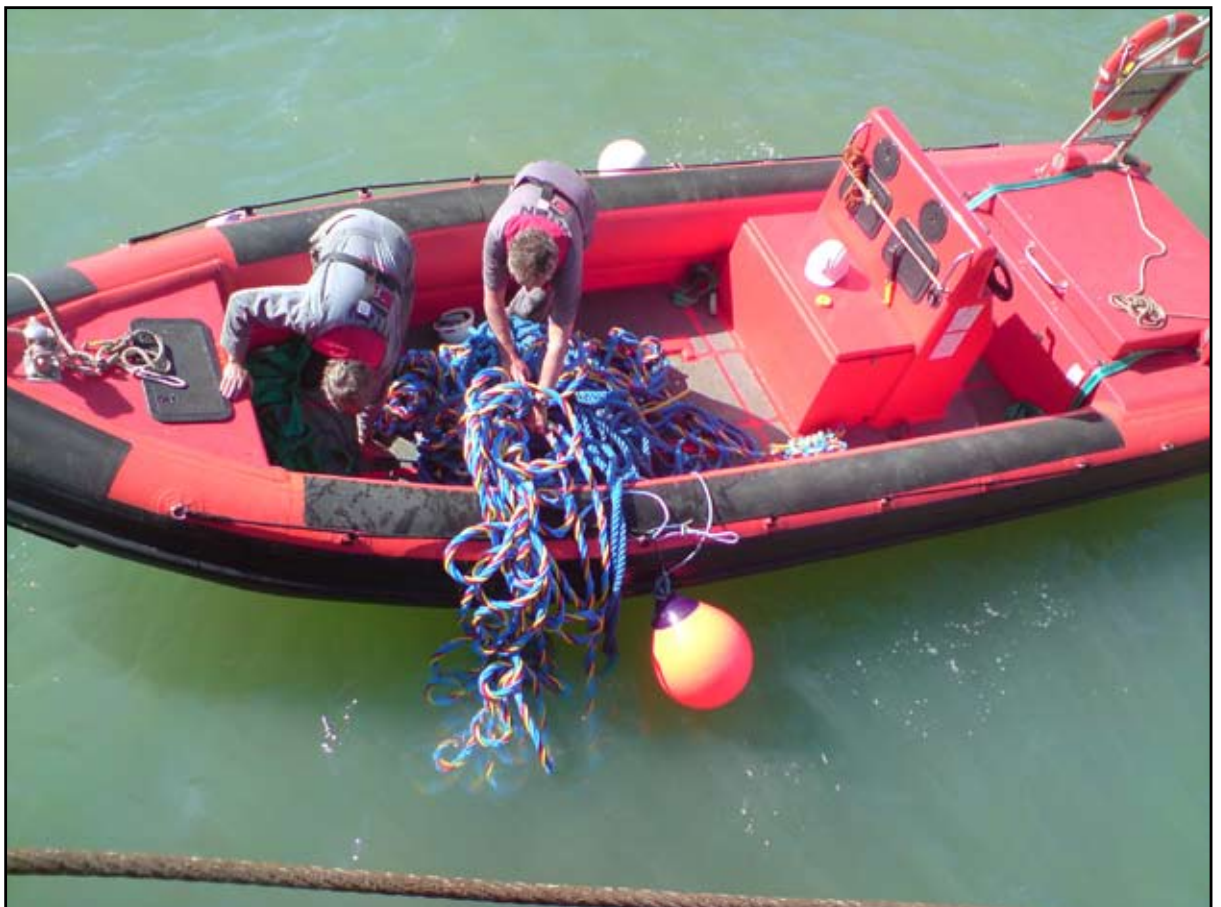
Figure 7

With the aft VSP cleared of the remnants of the umbilical cord and polypropylene rope (**Figure 7**) *Norma* departed Dover at 1545 on 24 June to return to the dive site. The relocation of *UB38* was successfully completed on 14 July despite several delays due to bad weather.

Recovery of umbilical cord and shot line in Dover

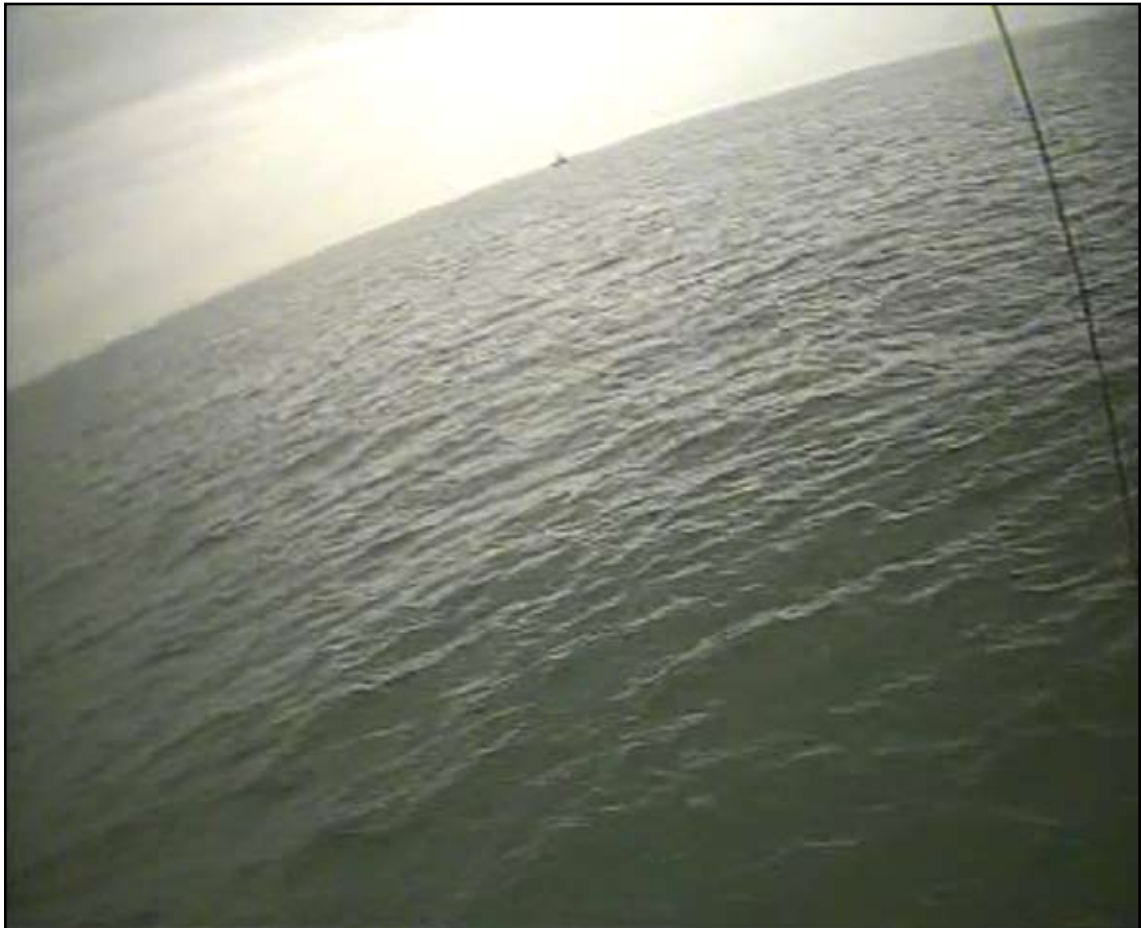
Figure 8

At the time of the incident, the weather was good. The wind was from a west-south-west direction, force 2 and the sea was slight with a low swell (**Figure 8**). High water at Dover was at 1339 and the predicted tidal stream at 1139 was 0.4 knot in a south-westerly direction.

Weather-view of diver before entering the water

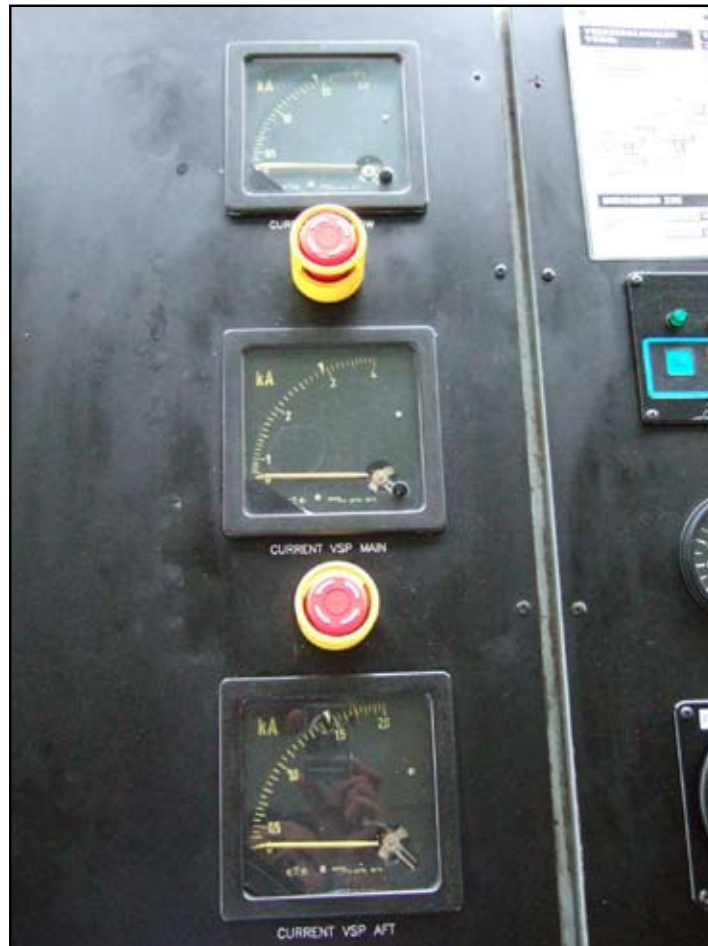
The electric motors were started from the VSP switchboard sited in the engine control room. Once running, the VSP units idled at 650 RPM in neutral pitch and each drew about 500A of electrical current. Control of the pitch was via the steering control system, which was switched on and off at the VSP control panel on the bridge (**Figure 2**). The control panel was also fitted with ammeters to indicate the power drawn by the units (**Figure 10**) along with emergency stops, which had to be depressed in a locked position. When activated, the emergency stops broke an electrical circuit, and the engines could not be restarted unless the bridge stops were reset.

Ammeters on bridge control panel

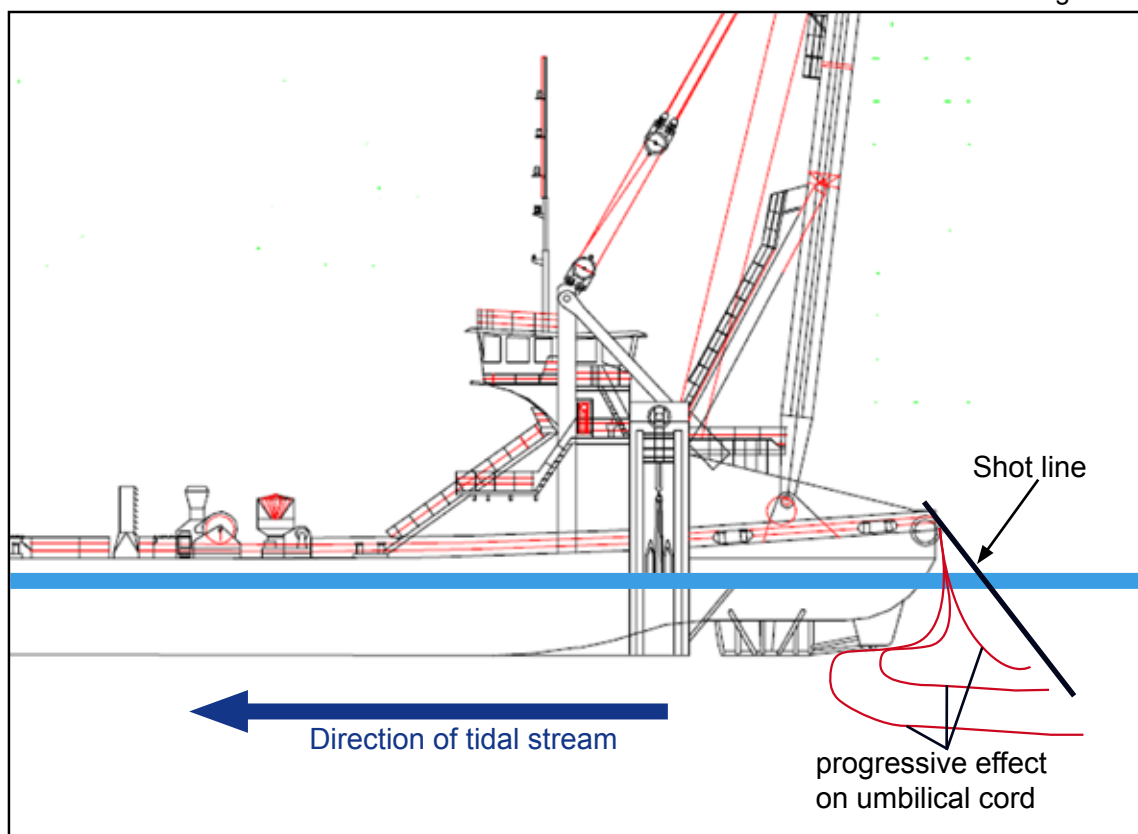
Figure 11

As soon as the diver started his descent, it is evident that his umbilical cord and the polypropylene line he was carrying were swept under the vessel's stern by the prevailing tidal stream (**Figure 11**). The cord and rope then became entangled in the vessel's aft VSP, which was idling on zero pitch, and the diver was reeled in to within 3m of its rotating blades. Loss of life or serious injury was only prevented by the rapid actions taken to stop the propulsion motors and the quick thinking of the diver to switch to his bail out bottle in what must have been an extremely harrowing situation.

Effect of tide on umbilical cord and shot line
