Report on the investigation of
the grounding of
Ovit
in the Dover Strait
on 18 September 2013

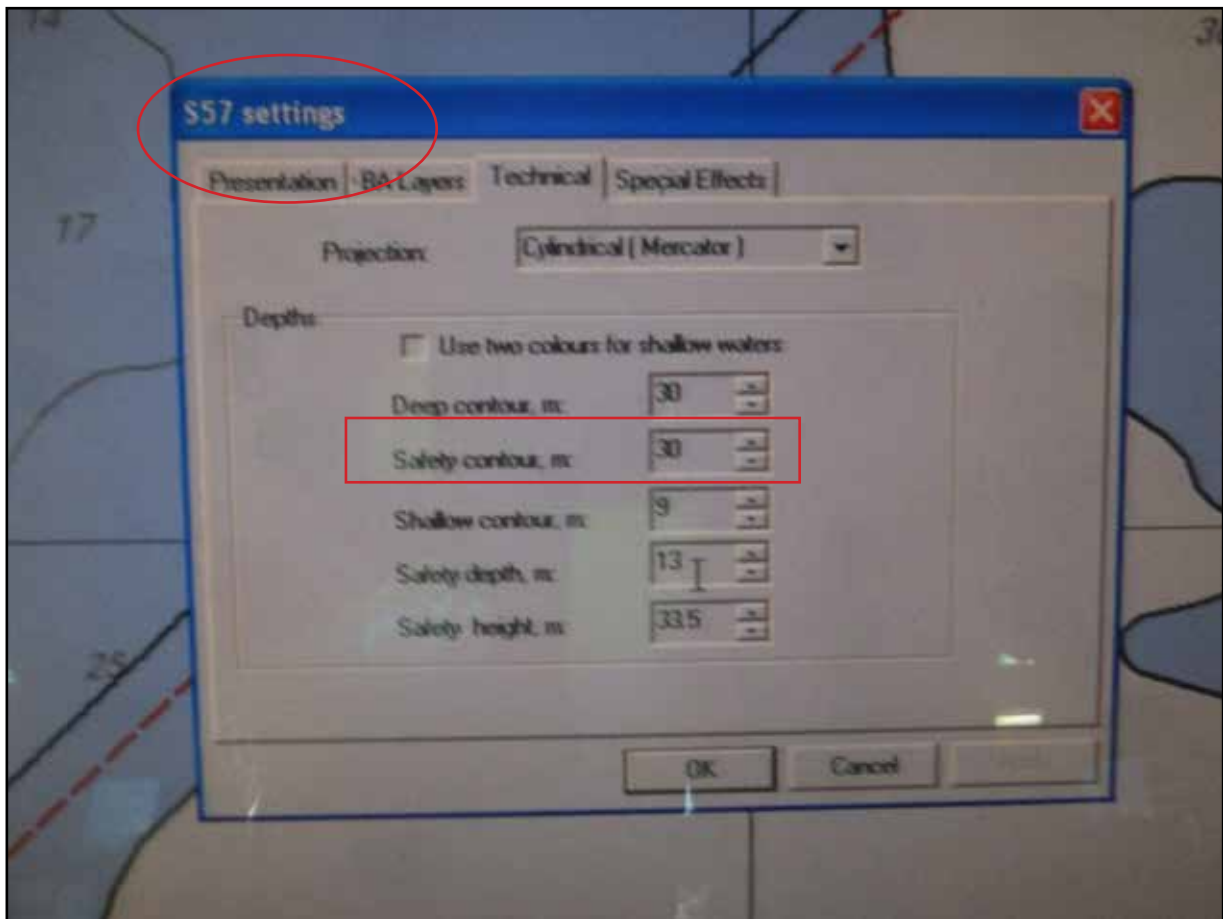
Figure 9: Maris 900 ECDIS 'S57' input page

These values were selected on the S57 settings page (**Figure 9**). The deep and shallow contour values only control colour shading. The safety contour and safety depth settings require values which are appropriate to the local navigational conditions and take into account; the ship's draught, the effect of squat and, where necessary, height of tide⁵.

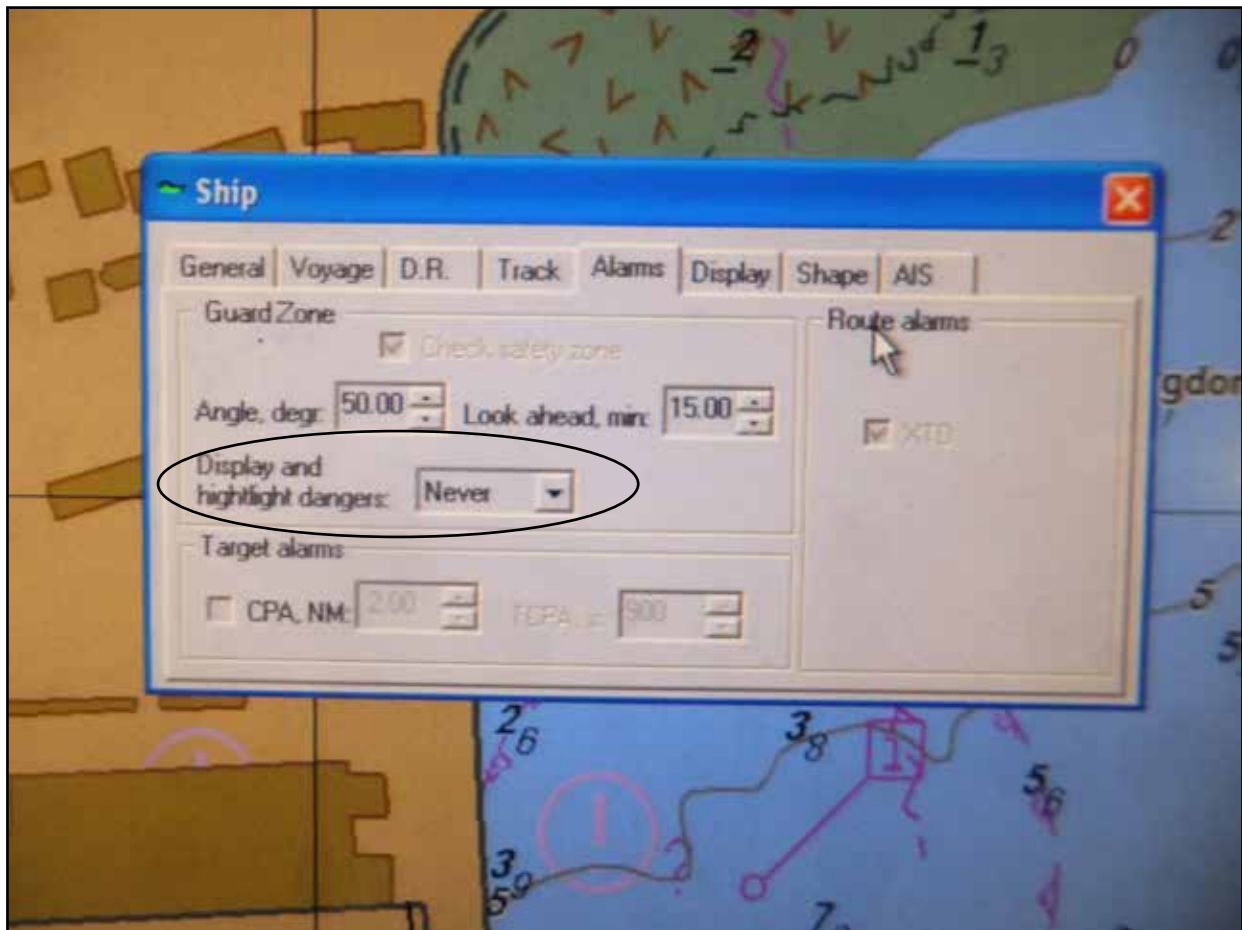
Figure 10: Maris 900 ECDIS guard-zone settings page

- The safety contour alarm should have activated shortly before *Ovit* crossed the 30m contour at 0417. However, the ECDIS display during the grounding (**Figure 6**) shows that only the XTD and grounding alarms were active. As the safety contour alarm is intended to activate when a vessel is about to cross the designated contour, it is almost certain that it did not function because the 'display and highlight dangers' option on the guard zone page was set to 'never' (**Figure 10**). Effectively, this disabled a mandatory alarm.

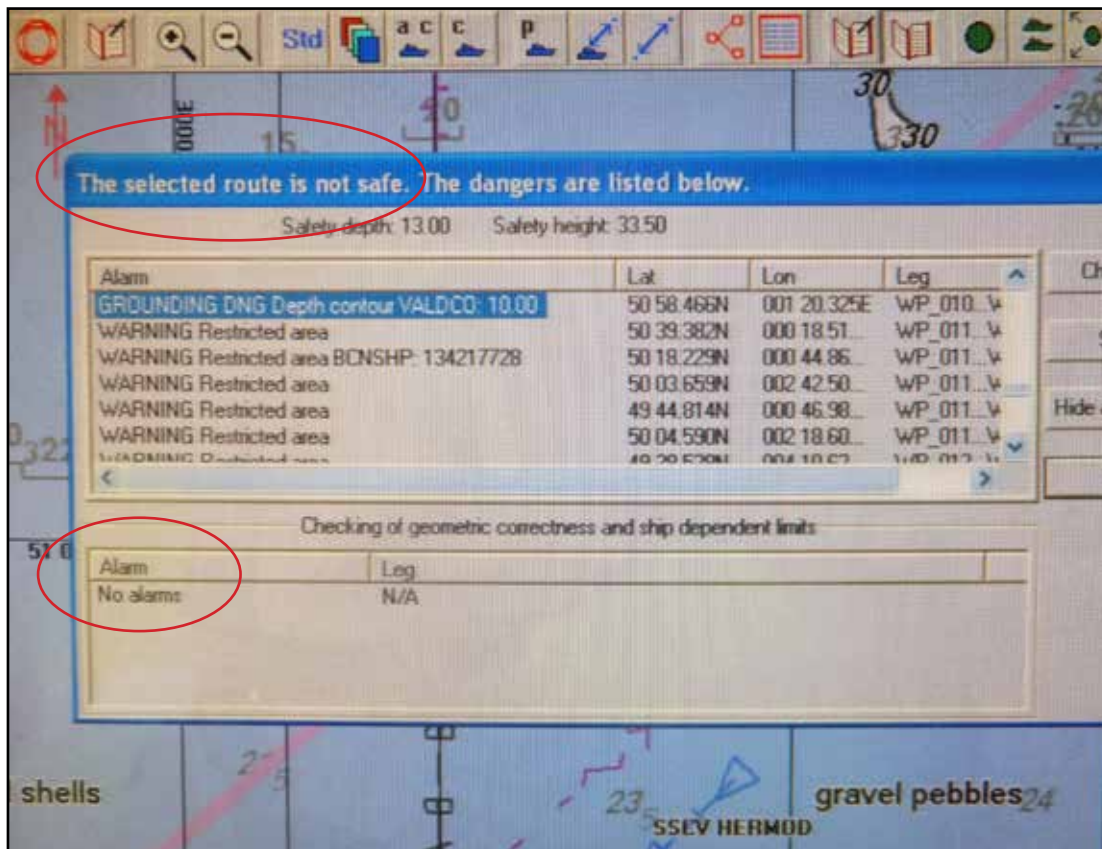
Figure 11: Maris 900 ECDIS check-route page

- The cross track distance (XTD) was set to 0.00nm. The safety guard zone was set to 50° and 15 minutes. The 'display and highlight dangers' sub menu was selected to 'never' (Figure 10).
- With the *Rotterdam - Vasto* route selected, the 'check-route' page highlighted a significant list of potential hazards including the risk of grounding on the Varne Bank (Figure 11). The page was shown to *Ovit's* deck officers who interpreted the 'no alarms' notation on the lower half of the page to mean that there were no hazards along the route.

- At the top of the check-route page, it clearly stated that the selected route was unsafe (**Figure 11**). However, it was unhelpful that the words 'no alarms' could be seen in the bottom left of the same page. The 'no alarms' information refers to system input data but, as shown by *Ovit's* deck officers' understanding of the system, it can be inadvertently linked with the navigational safety data above it.

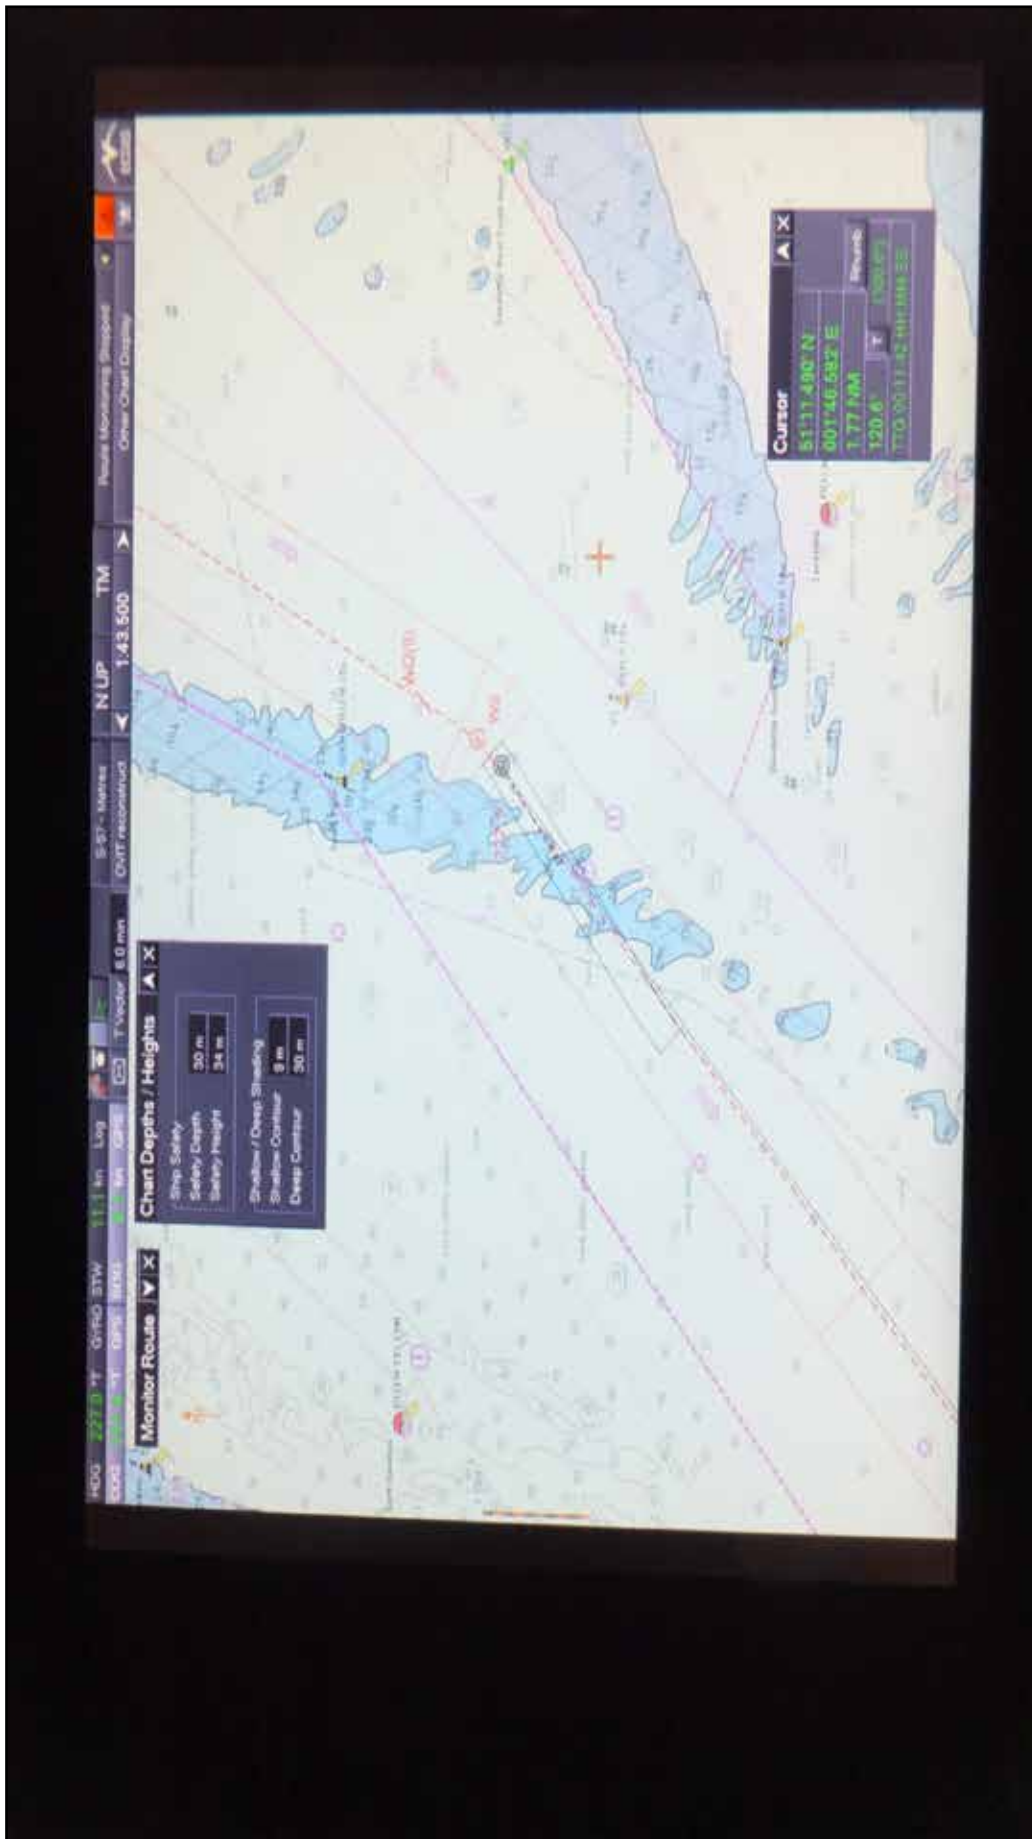
Figure 12: Reconstruction showing Ovi's earlier 30m contour crossing

- *Ovit* crossed the 30m safety contour at 0251 (**Figure 12**) and 0417.
- *Ovit* passed over a charted depth of 13m at 0427 which initiated the 'grounding alarm'.
- The Varne Light Float was sighted at a range of just over 10nm.
- The lights on the cardinal buoys marking the east and west sides of the Varne Bank were sighted at 5nm.

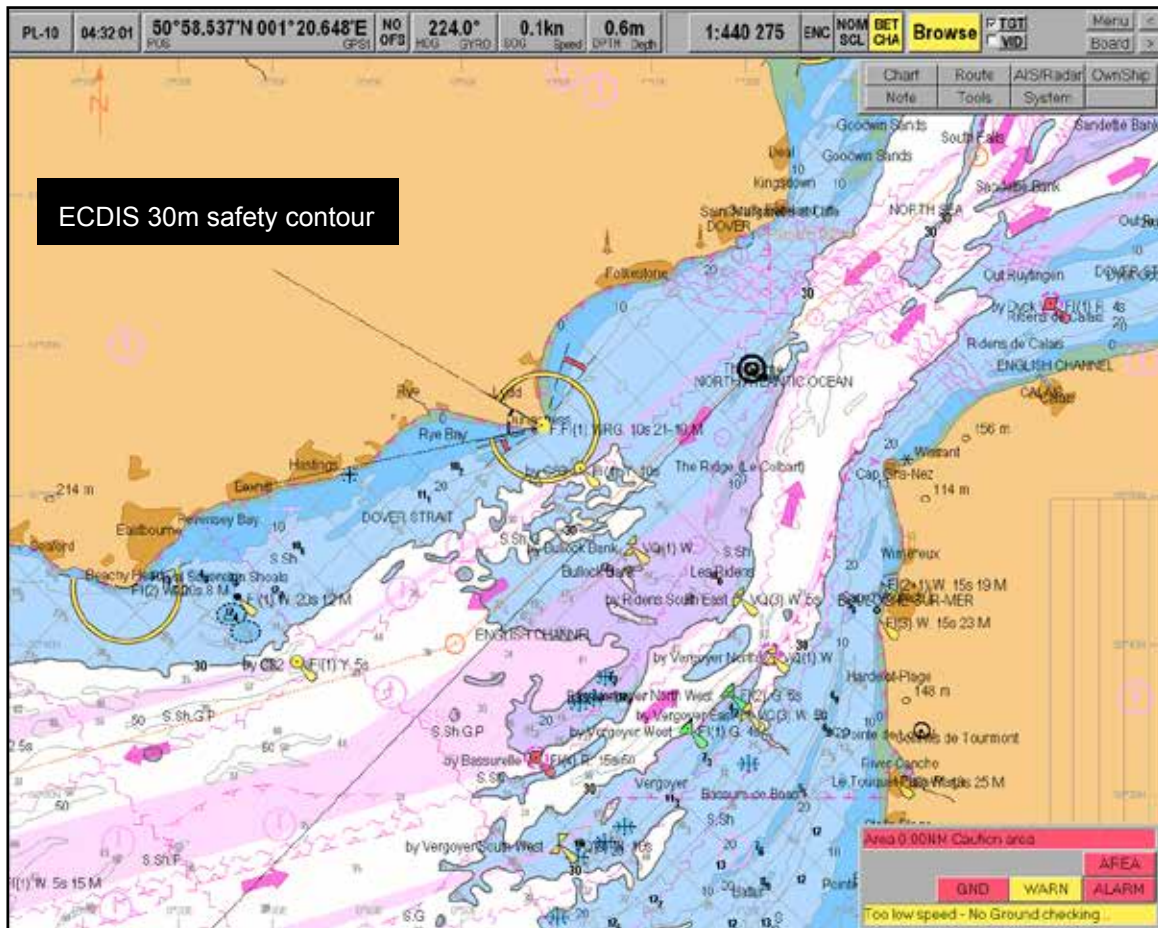
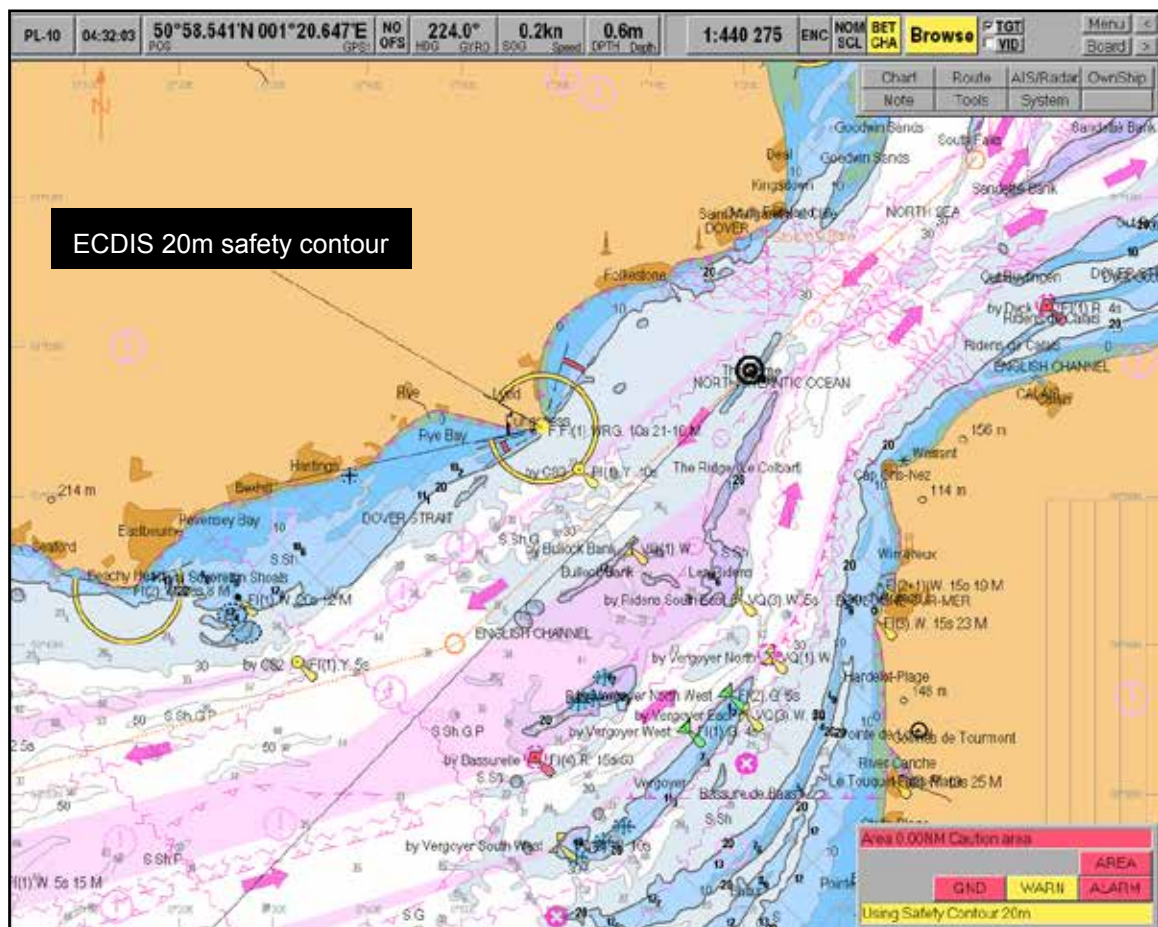
Figure 13: ECDIS display comparison of 30m and 20m safety contours

- There was a considerable difference between the ECDIS display with a safety contour set at 20m, and the display with the safety contour set at 30m (**Figure 13**).
