Report on the investigation into
the grounding of
Pride of Canterbury
“The Downs” – off Deal, Kent
31 January 2008

Marine Accident Investigation Branch
Carlton House
Carlton Place
Southampton
United Kingdom
SO15 2DZ

**Report No 2/2009
January 2009**

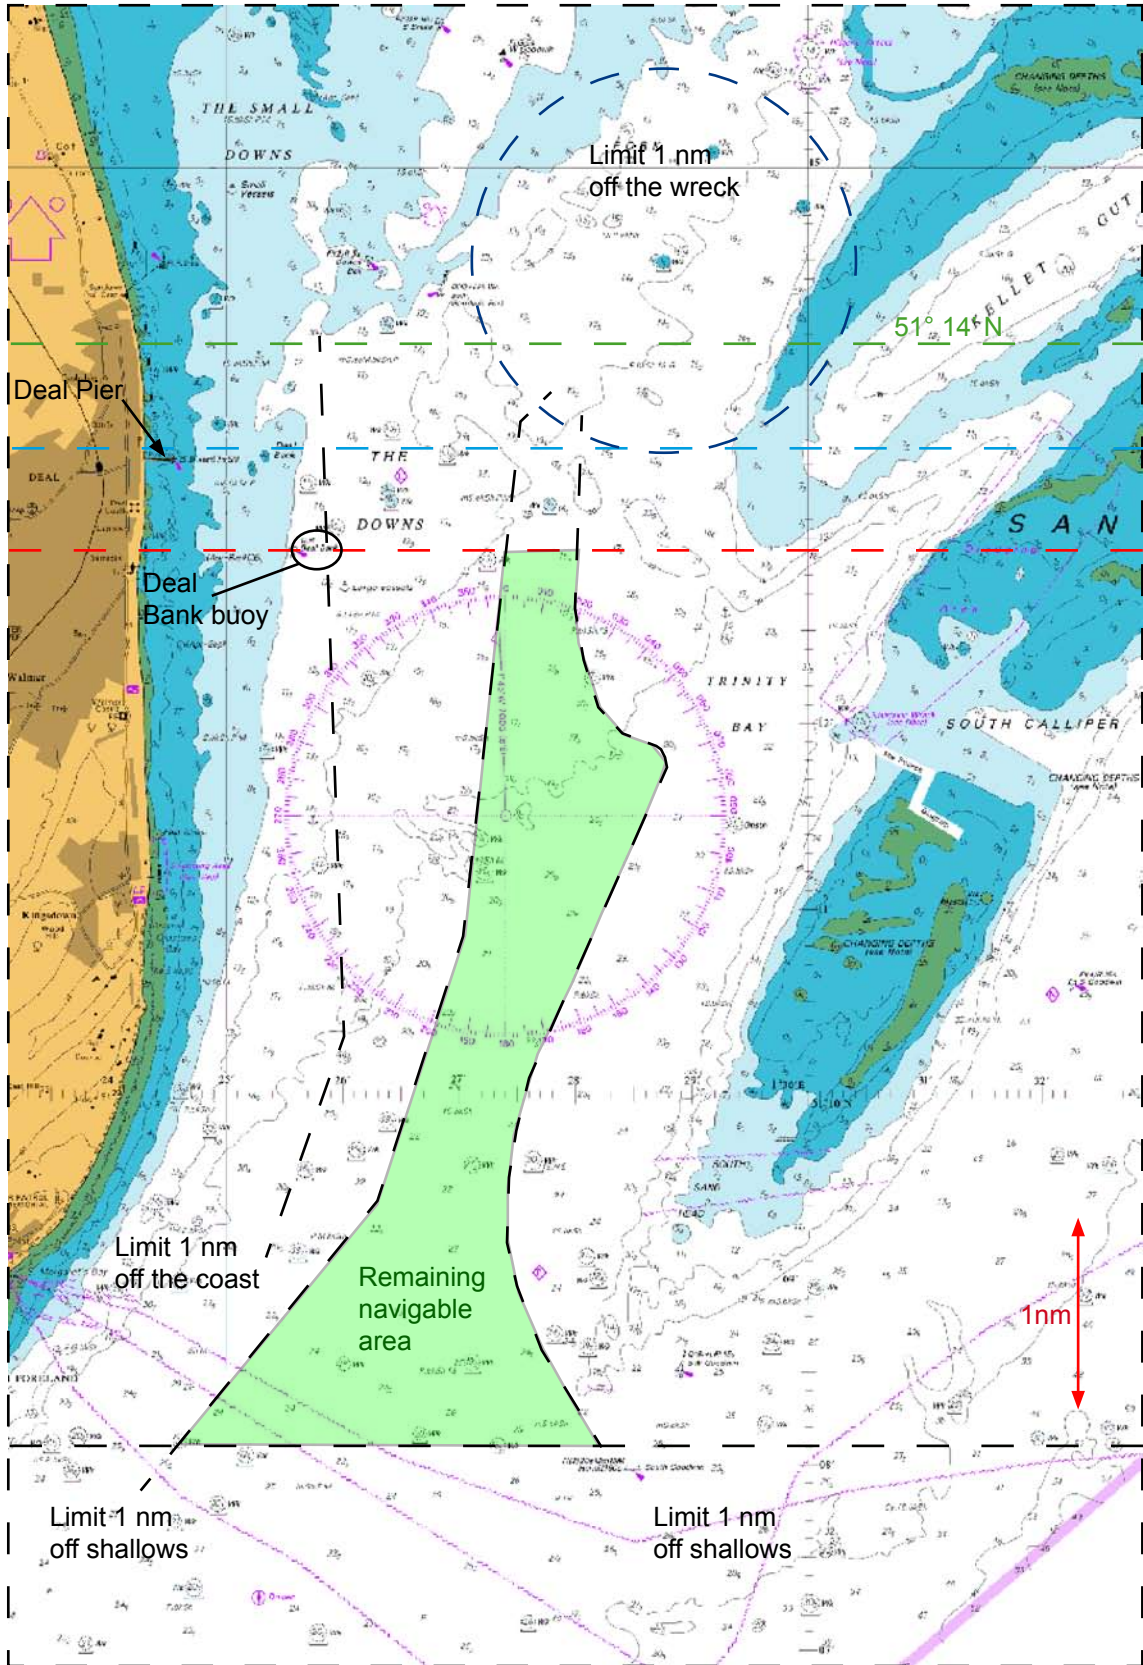
- Navigable area taking account of master's restrictions
- Northern limit on the final run
- Northern limit on the 2nd run
- Northern limit on the 1st run

Without specific instructions, especially clearly defined no-go areas and a northern limit, being available and marked on the chart, it was not easy for the OOW to ensure that the master's wishes were complied with. Had the paper chart been marked with all limitations required by the master, including subsequent modifications, it would have been clear that the plan could not have been easily complied with (**Figure 4**).

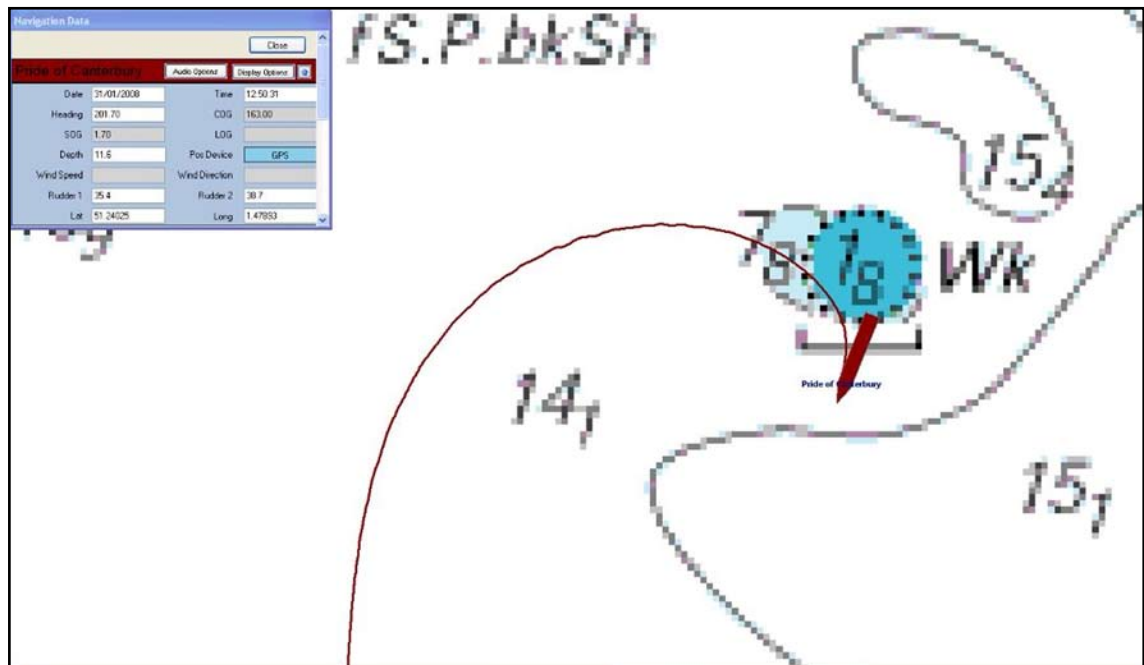
At 1239 the helmsman reported that the vessel had lost steerage, and speed was increased. The speed had increased to 9.5 kts by the time Deal Pier was abeam to port, but this was not appreciated by the bridge team due to the various distractions.

The master then took four further telephone calls and, at 1244, *Pride of Canterbury* passed 51° 14 N making a speed of 7.3 knots. At this time, the car deck fire alarm activated again, and the whole bridge team became involved in discussions about finding a way to operate extra ventilation on the car deck to prevent the fire alarms being activated by the lorry's exhaust. At 1245, the bridge team's focus returned to the navigation of the vessel when the master commented that the chief officer should not take the vessel any further north. In reply, the chief officer stated his intention to make a turn to starboard and

Detail of track record of *Pride of Canterbury* approaching the wreck of *Mahratta*

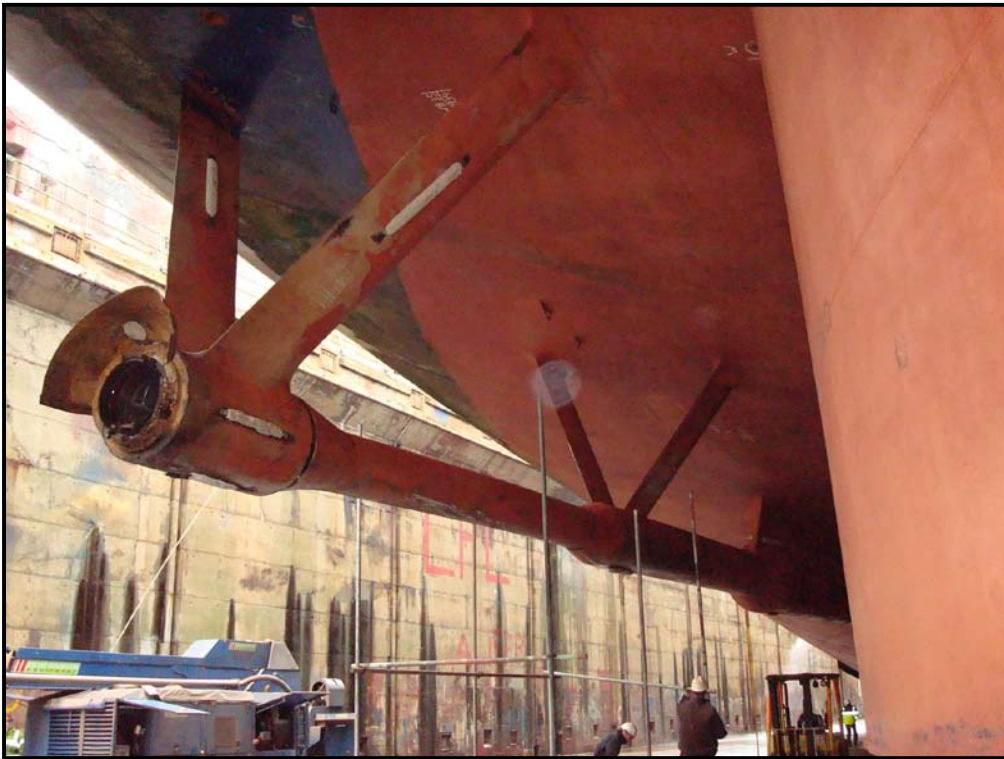
Figure 6

- Loss of the port CPP hub.
- Loss of about 1m of the port tail shaft.
- Port after stern tube, centre stern tube, stern tube bearings - all damaged and misaligned.
- Two sections of the port intermediate tail shaft bent.
- Misalignment of associated framing, extending to gearbox and main engines.
- The port rudder stock bent.

Port side missing CP propeller and hub

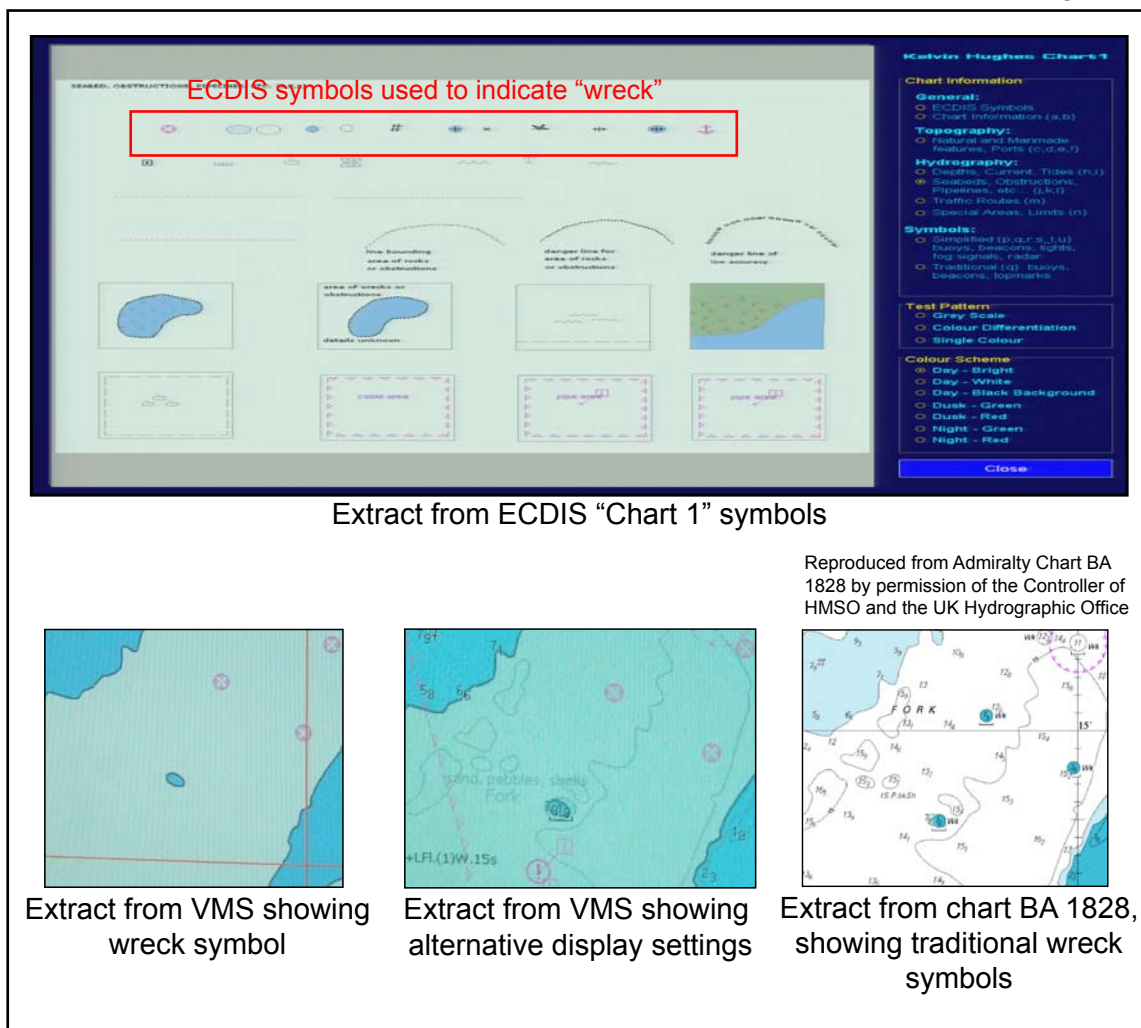
The lack of proper training in the use of ECDIS possibly led to the wreck being undetected. It is possible that the wreck on the shallow patch was displayed, but that the ECDIS symbol was misunderstood. Display options permit differences between the symbols displayed on paper charts and on ENCs (**Figure 11**). Another explanation, which is also linked to a lack of proper training, is that the “misapplication” of certain user settings may result in a dangerous underwater obstruction not being displayed on the screen. If the initial value for the safety contour is selected without understanding the constraints, and the option for display of obstructions is set inappropriately, an ECDIS may not display the underwater hazards with sufficient clarity to alert the navigator. If a passage plan had been drawn using the VMS, and the VMS safety check function had been used, the presence of dangers on the route would have been automatically highlighted. However, no passage plan for the area of The Downs was formulated.

The wreck was clearly displayed on chart BA 1828, but because the bridge team were not systematically fixing the vessel's position on the chart, it did not assist them in detecting the obstruction.
