FLYER TO THE SHIPPING INDUSTRY

Pride of Canterbury

Grounding of a passenger ferry on a chartered wreck while awaiting Dover port to reopen

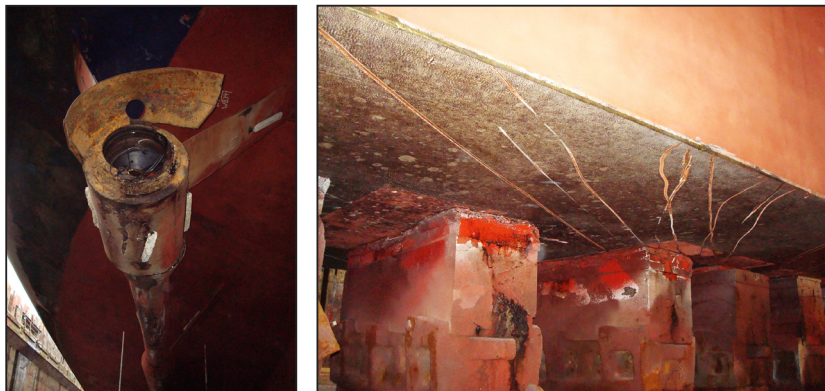
On the afternoon of 31 January 2008, while sheltering off the port of Dover in bad weather conditions, the passenger ferry *Pride of Canterbury*, with 275 passengers and 101 crew on board, grounded on a chartered wreck. She sustained major damage, including the total loss of her port controllable pitch propeller hub and a section of tail shaft.

Damage sustained by *Pride of Canterbury*
