Report on the investigation of the heavy weather  
damage to the passenger cruise ship

***Pacific Star***

10 July 2007

**Report No 5/2008**  
**February 2008**

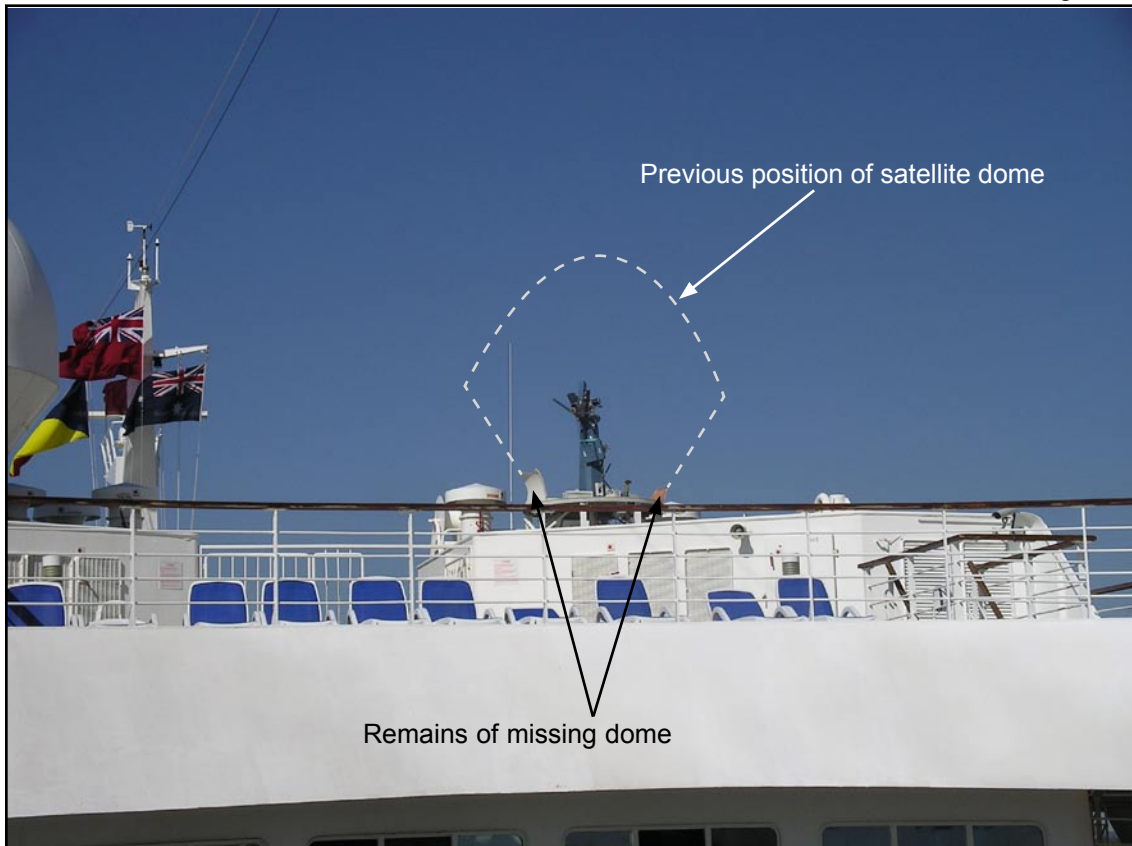
Figure 3

Satellite dome position

The satellite communications dome was designed to withstand a wind speed of 100 knots, which is rarely encountered. The maximum relative wind speed observed during the incident was 95 knots, but it is not known at what stage the dome failed. The satellite dish was then exposed to the elements until it, too, failed. If it is accepted that the dome failed at or near the peak of the wind speed, not accounting for any shock loading on the mounting due to ship movement, then the dome failed within 5% of its designed maximum wind speed parameter.

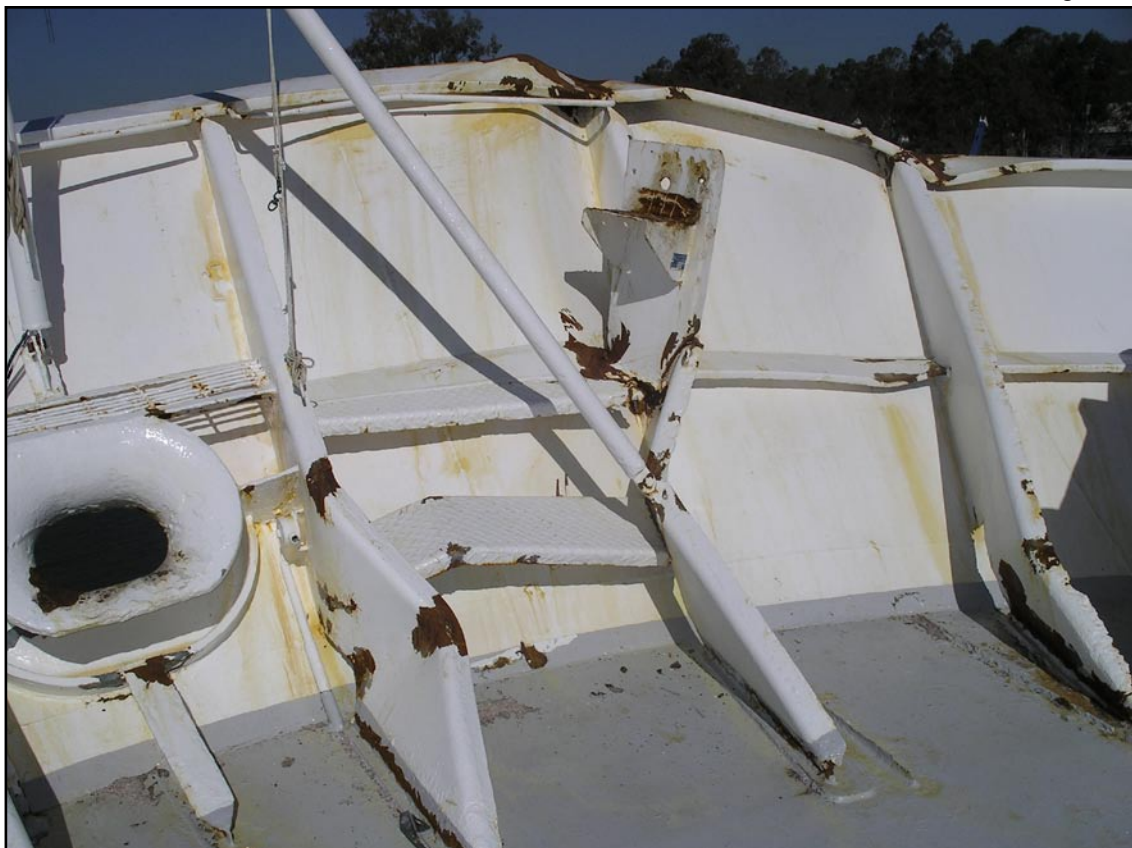
Figure 4

Damage to forecabin bulwark

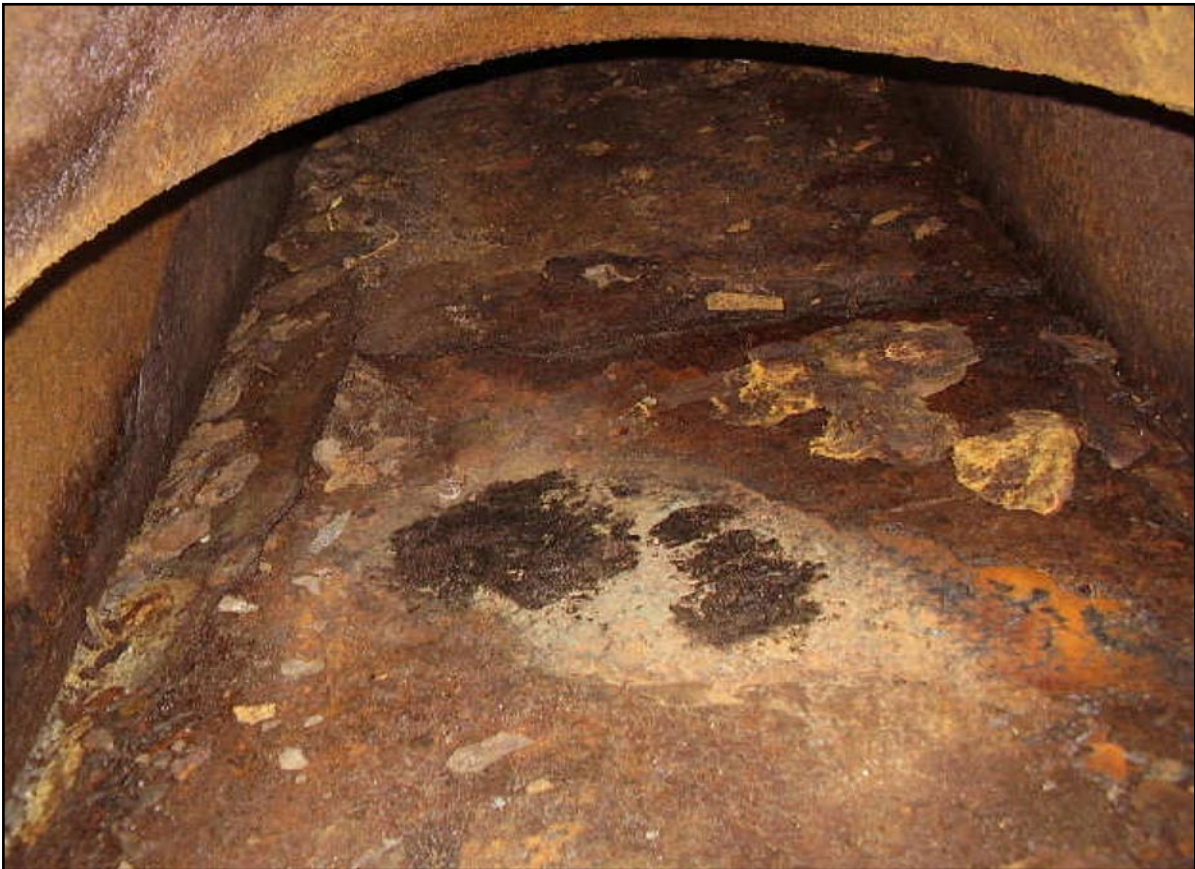
Figure 5

therefore concluded that the most likely cause was a leak in the hull. He instructed the ventilation engineer to remove the fan from the ducting. The ducting was of rectangular construction, and used two adjacent transverse frames and the ship's side plating to form three sides, with the duct completed by fitting a plate over the two frames. With the fan removed, it was clear that the ducting to the level of the fan was full of water. With no obvious sign of water ingress visible, the ducting was pumped dry using a portable salvage pump. Water could be seen seeping into the ship, apparently from under a large rust flake at the ship's side (**Figure 5**). Assessing that disturbing the rust flake might cause the plate to fail, the CTO looked at alternative methods of maintaining the watertight integrity of the hull. In discussion with the staff captain and staff engineer, and aware that the classification society surveyor would be attending at the next port, it was decided to keep the ducting dry with the salvage pump, and to fabricate a blanking piece to fit where the fan had been sited. The blanking piece was loosely attached to the trunking, and a man was stationed in the area to monitor the situation. In the event that the ship's side plate failed, he was to inform the engineer on watch in the Machinery Control Room (MCR) by UHF radio, withdraw the salvage pump, swing the blank plate into position and secure it with more bolts. In this way, water would be kept within the ventilation duct.

Damage to ventilation duct

Ventilation duct at frame 31 Starboard – A cement box was fitted to the inside of the ducting. There were concerns that the ship's side would not be able to support the weight of the cement box due to the size required. A reinforcing structure was therefore constructed of 6mm bar passed through holes drilled in the frames, and welded into position to bind the cement structure and prevent it from cracking. A layer of steel mesh was placed over this framework to provide reinforcement for the cement (**Figure 9**). Shuttering was placed inside the duct to reduce the thickness of the cement box. The blanking plate was refitted, with a drain spill and valve arrangement, so that any water ingress to the ducting could be monitored (**Figure 10**).

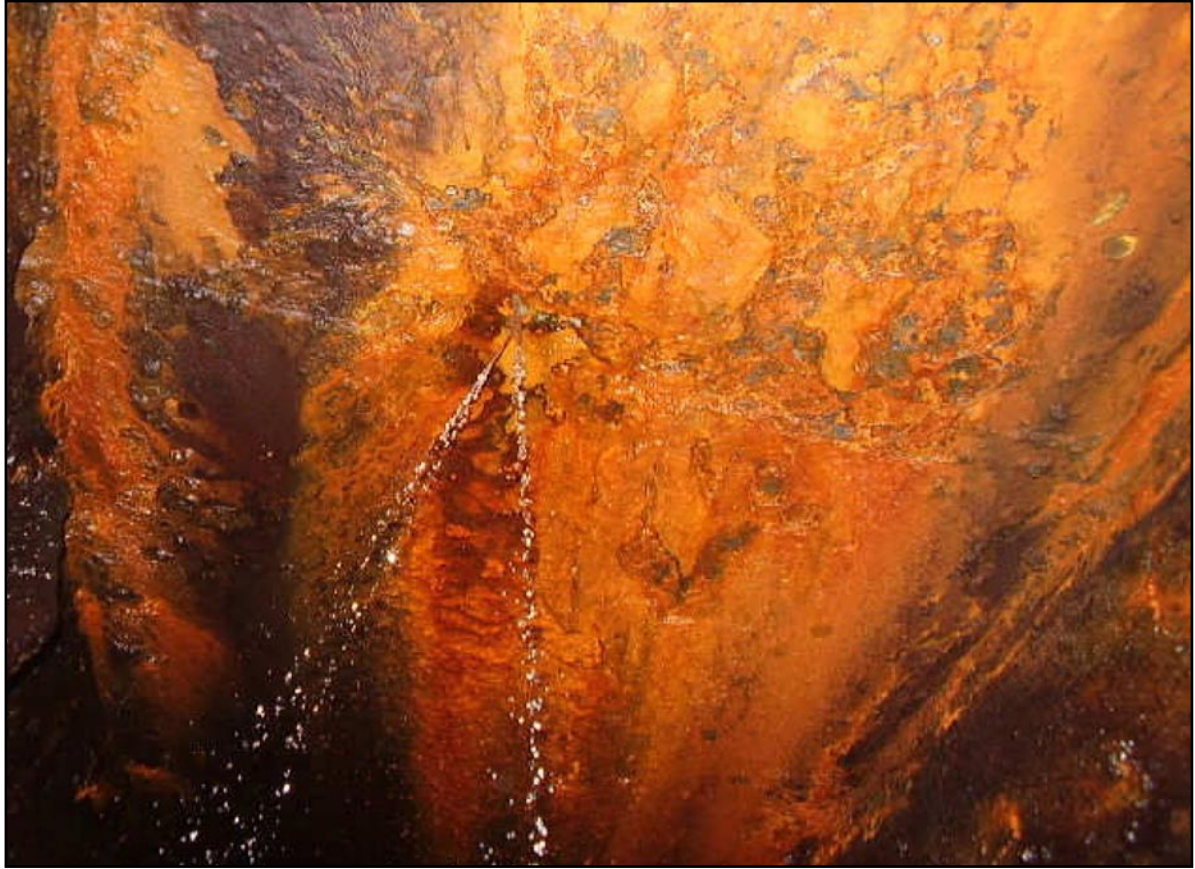
Figure 6

On arrival at Port Vila, on Friday 13 July 2007, an underwater survey of the known areas of damage was carried out by divers. The source of water ingress to the forepeak was found to be three small holes in close proximity, and the shell plate in the vicinity of the holes was so badly corroded that it was possible for the diver to push a finger through the ship's side. Ultrasound measurements were taken in way of the leaking ventilation trunking. This measured the thickness of the side plating as 3mm, and further scraping of the corrosion on the ship's side around the area of leakage increased the rate of flow of water through the ship's side both above and below the original site. Additional damage to the hull was also found by the divers in way of No 2 deep ballast tank where a crack was discovered in a previous repair, but it was established that it had not penetrated the hull.

Damage to the forepeak tank

The forepeak tank of *Pacific Star* had originally been coated with epoxy paint, and reportedly re-coated in 2001, but this had degraded. As the ship's loading did not vary very much throughout her life, and in an effort to keep the ship on an even keel, a constant level of sea water was kept in the forepeak tank. In addition to general corrosion due to the continually damp atmosphere above the water level within the tank, and the poor state of the tank coating, the structure would have suffered increased localised corrosion in the area of the constant water line as a consequence of its regular wetting due to surface movement. When the storm damage highlighted the problem on the starboard side of the tank, a similar patch of localised corrosion was discovered in the corresponding position on the port side of the tank although this corrosion was found to be within the limits of acceptable diminution. Both patches were approximately 30cm<sup>2</sup>. These areas were not identified during previous surveys of the tank, possibly because they did not stand out against the poor visual condition of the tank. No rules or guidance are provided for class surveyors to focus on the internal water line area of a tank for inspection and NDT survey.

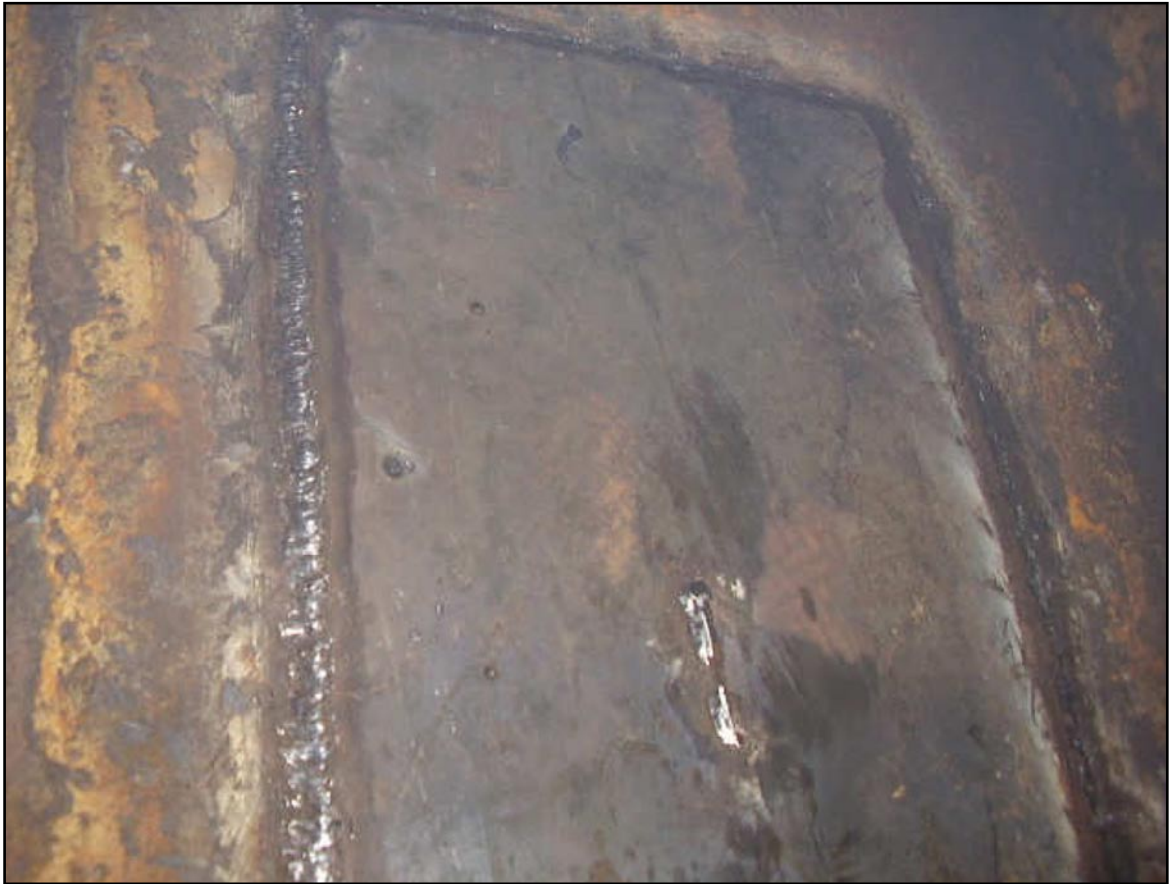
Figure 7

Temporary repair to the forepeak

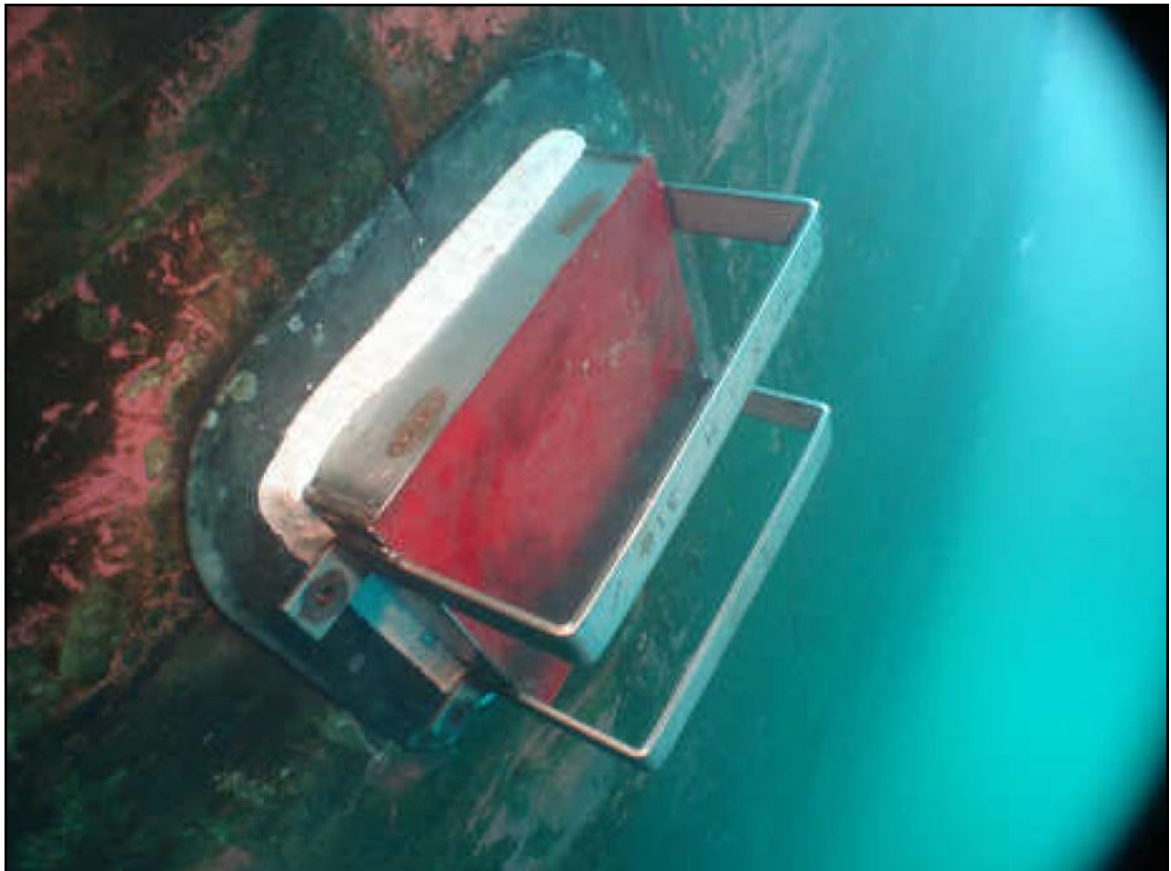
Figure 8

Temporary repair to No.2 deep ballast tank

No 2 deep ballast tank – Magnetic plate positioned over the crack, and the plate sealed around with epoxy cement (**Figure 8**).

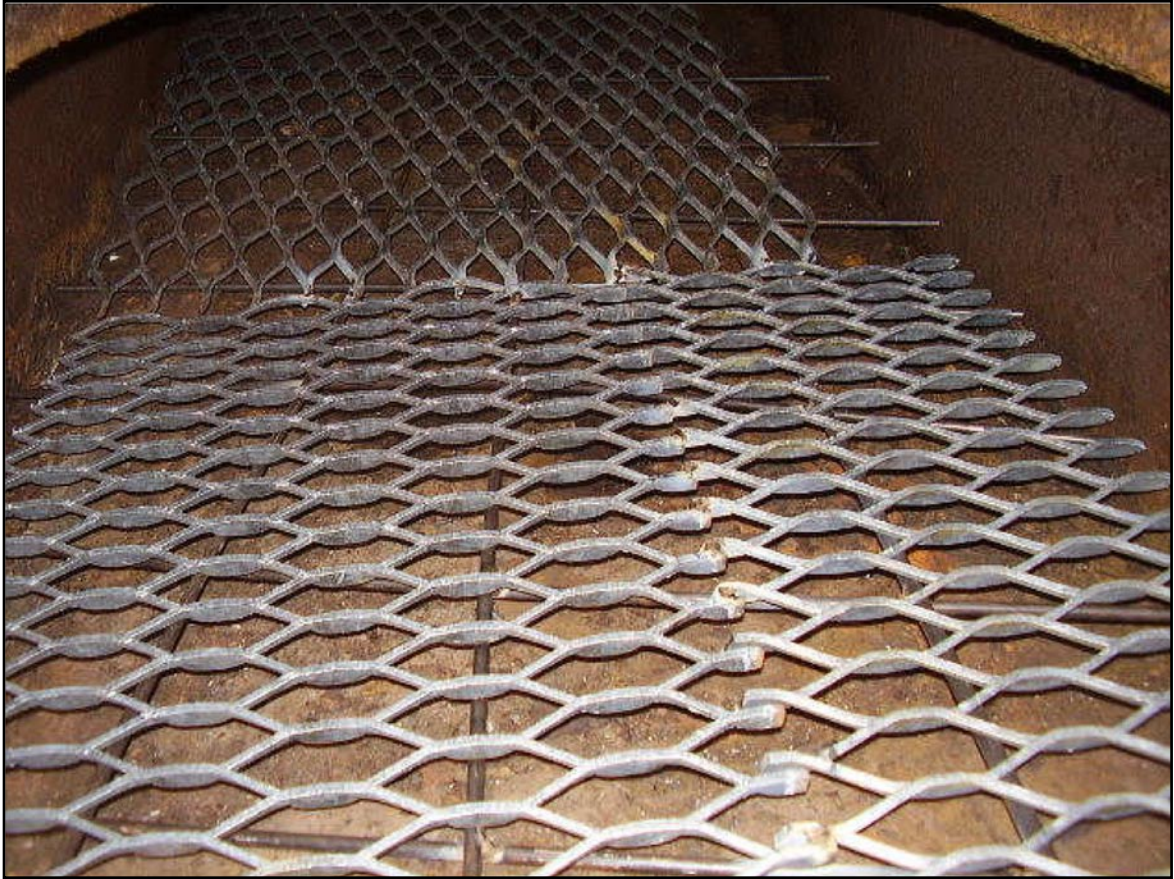
Figure 9

Reinforcement to cement box in ventilation duct

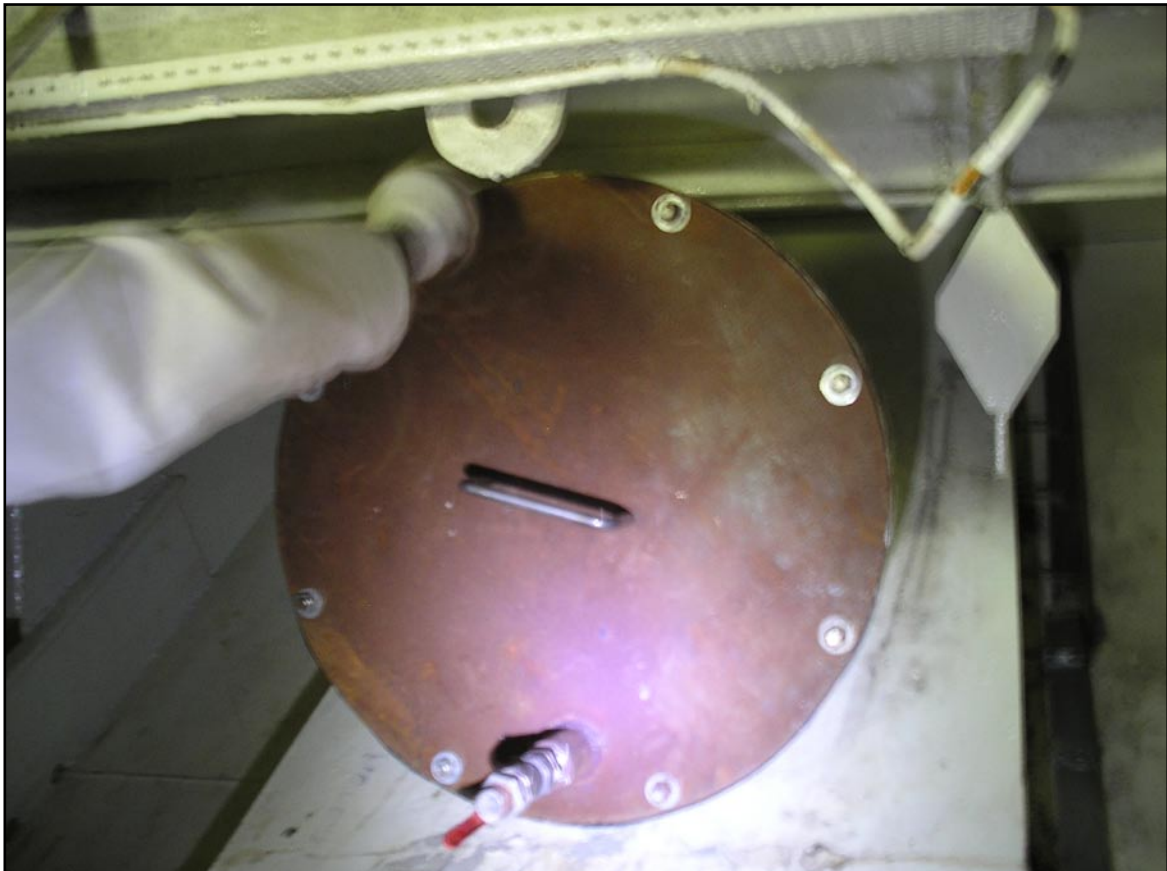
Figure 10

Closing of ventilation duct

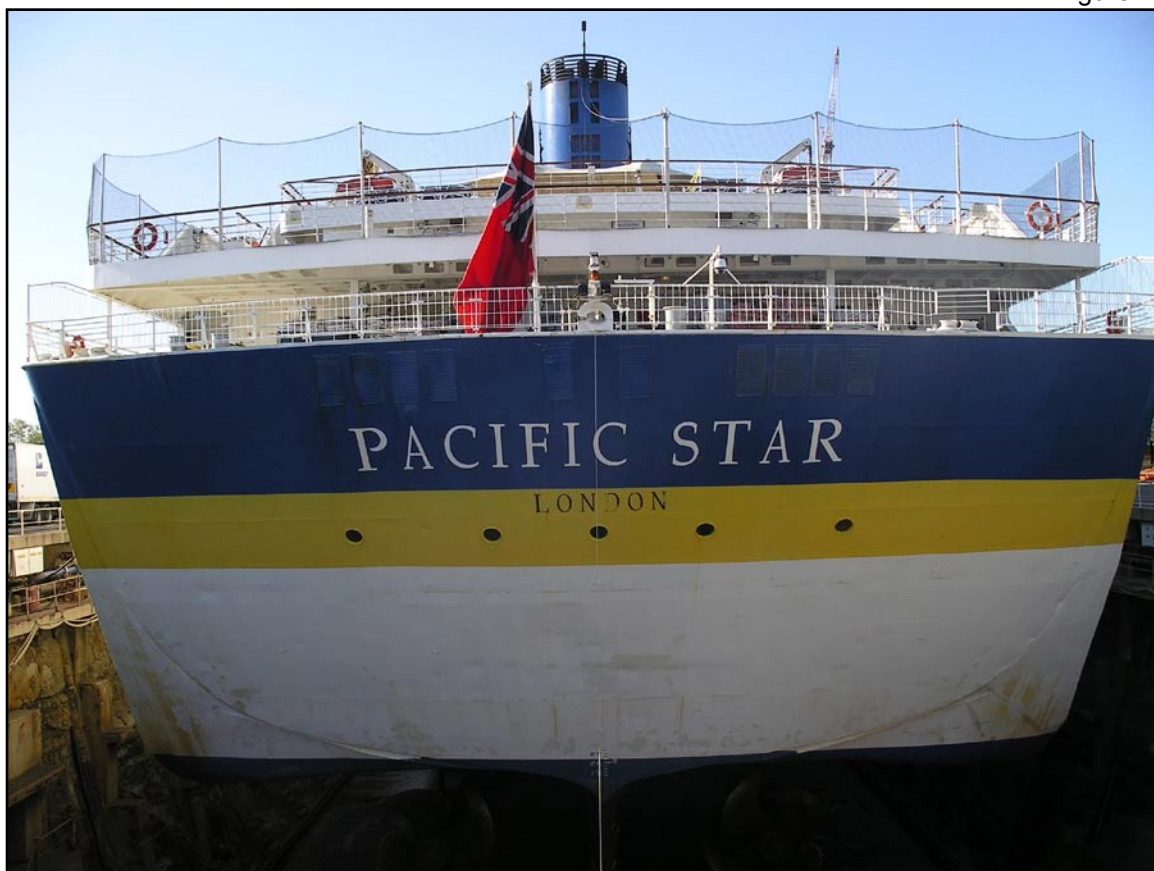
*Pacific Star* in dry dock in Brisbane

Repairs to *Pacific Star* were effected in dry dock in Brisbane between 20 and 27 July (**Figure 11**). Details of the repairs are listed at **Annex 1**.
