MARINE ACCIDENT INVESTIGATION BRANCH

FISHING ACCIDENT FLYER

COLLISION AND SINKING WHILE PAIR TRAWLING

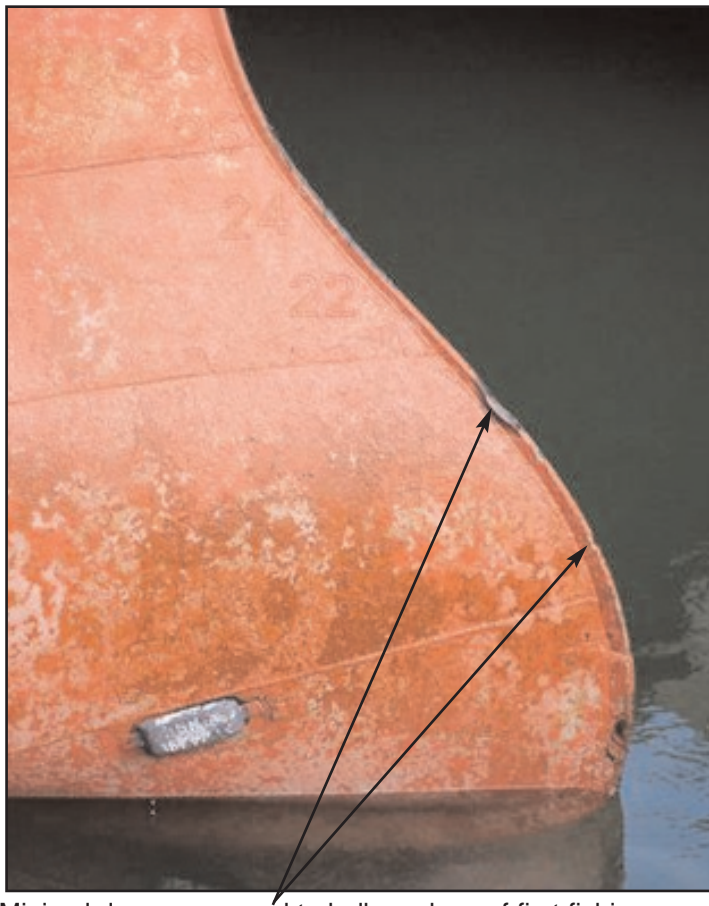
Minimal damage caused to bulbous bow of first fishing vessel
