Part 2 – Fishing Vessels

Watch Where You're Going

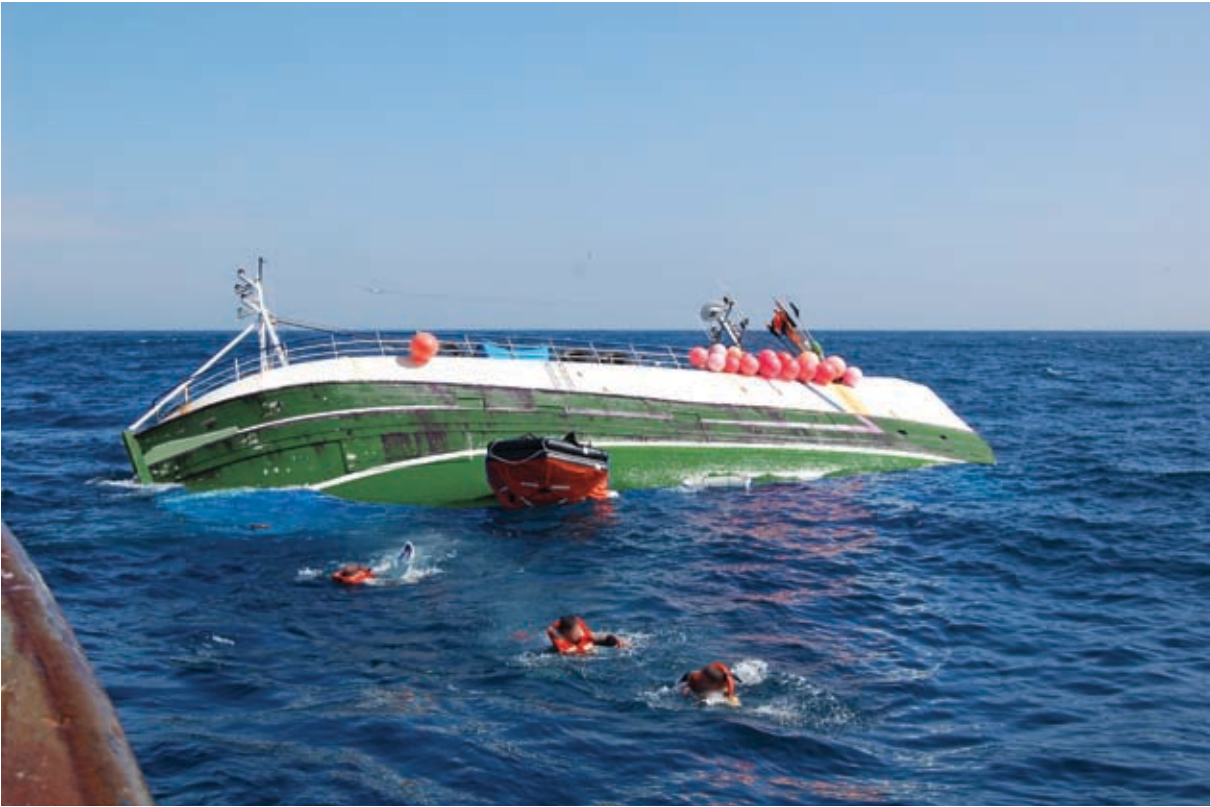
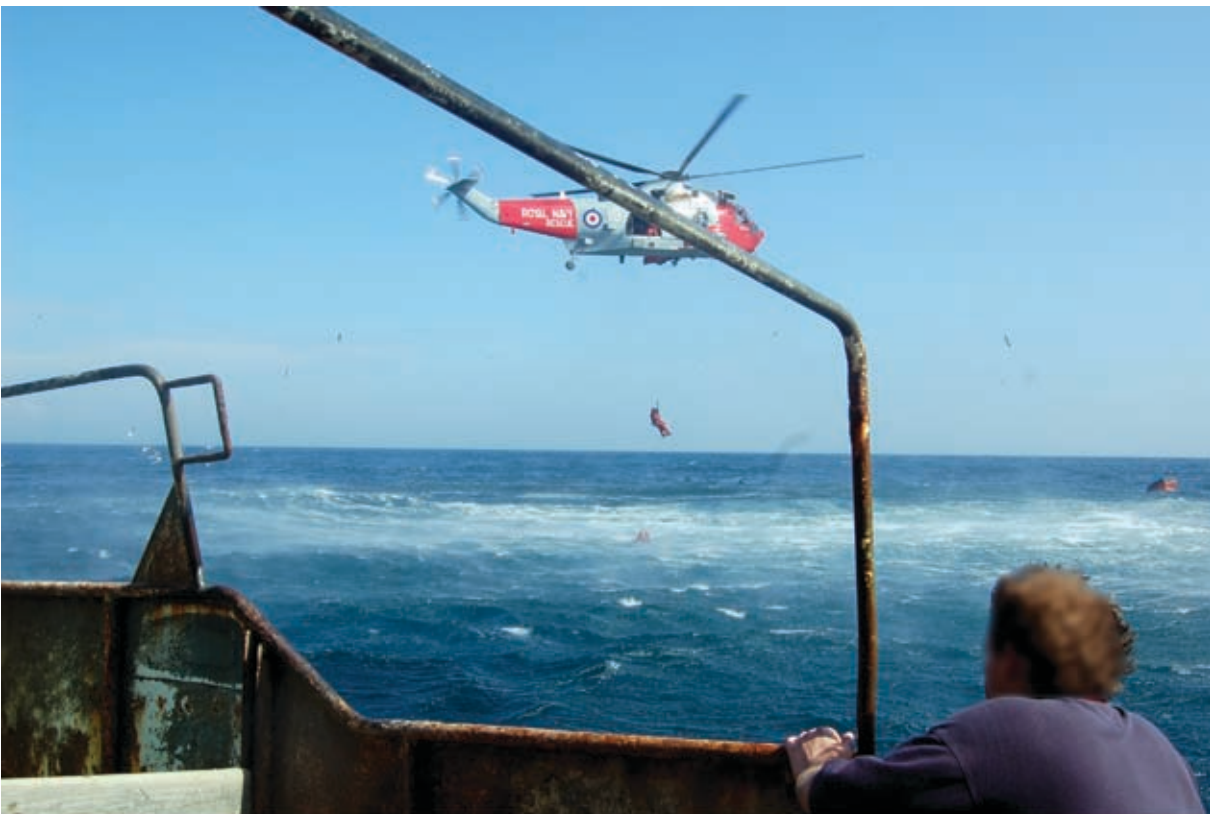
Figure 1

At 1509, the vessel sank. Fortunately, the rescue helicopter was overhead at about 1510 and winched the crew members to safety (Figures 1 and 2).

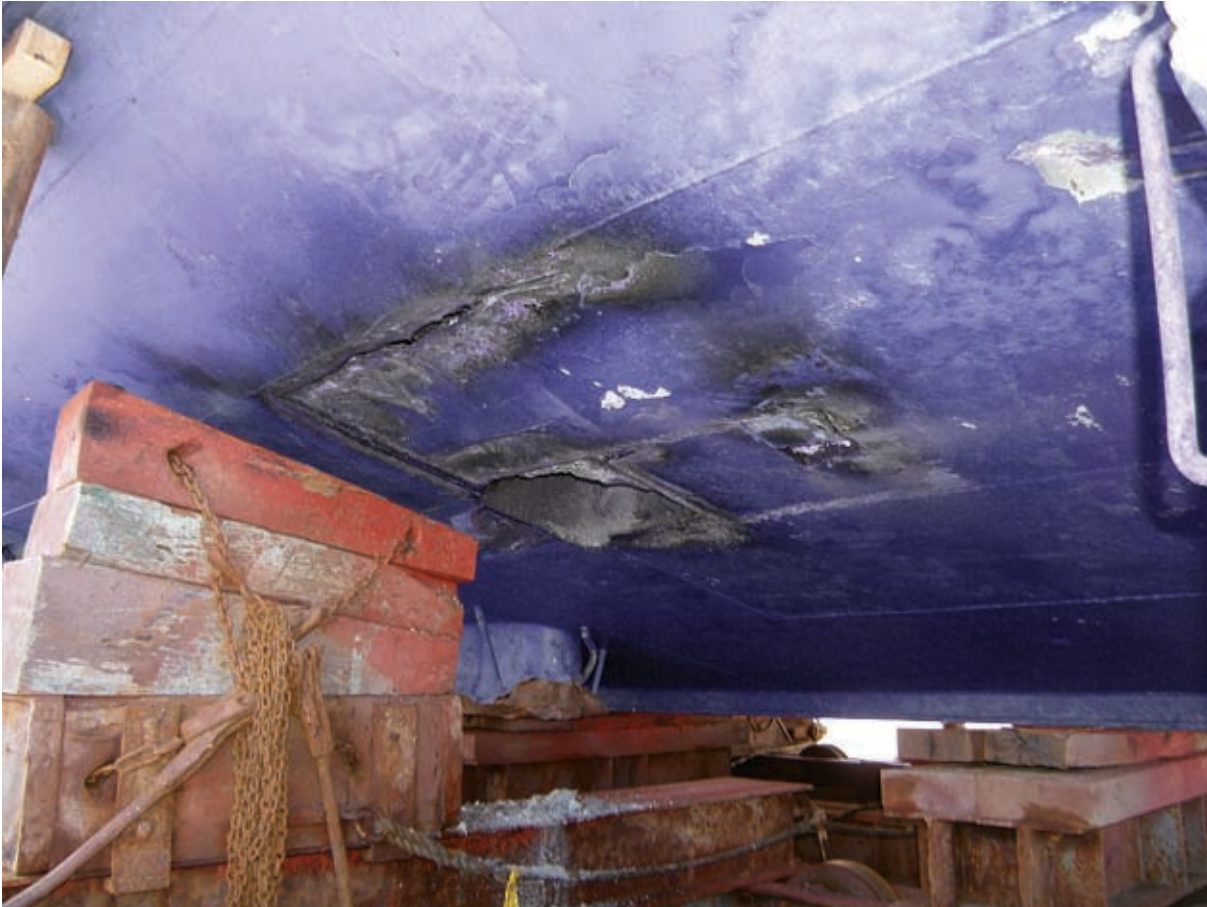
Some of the damage caused by the grounding

Port control contacted the vessel when it was no longer held on radar, and the skipper advised them that he had grounded. The crew checked for water ingress; none was found. The skipper decided to wait for a rise in tide before attempting to refloat, and 12 minutes later the vessel was afloat. The skipper and mate carefully made their way back into the harbour, this time making use of the chart plotter. On their arrival, the coastguard noticed a considerable amount of pollution in the vicinity of the propeller, and the decision was taken to remove the vessel to a nearby slipway.

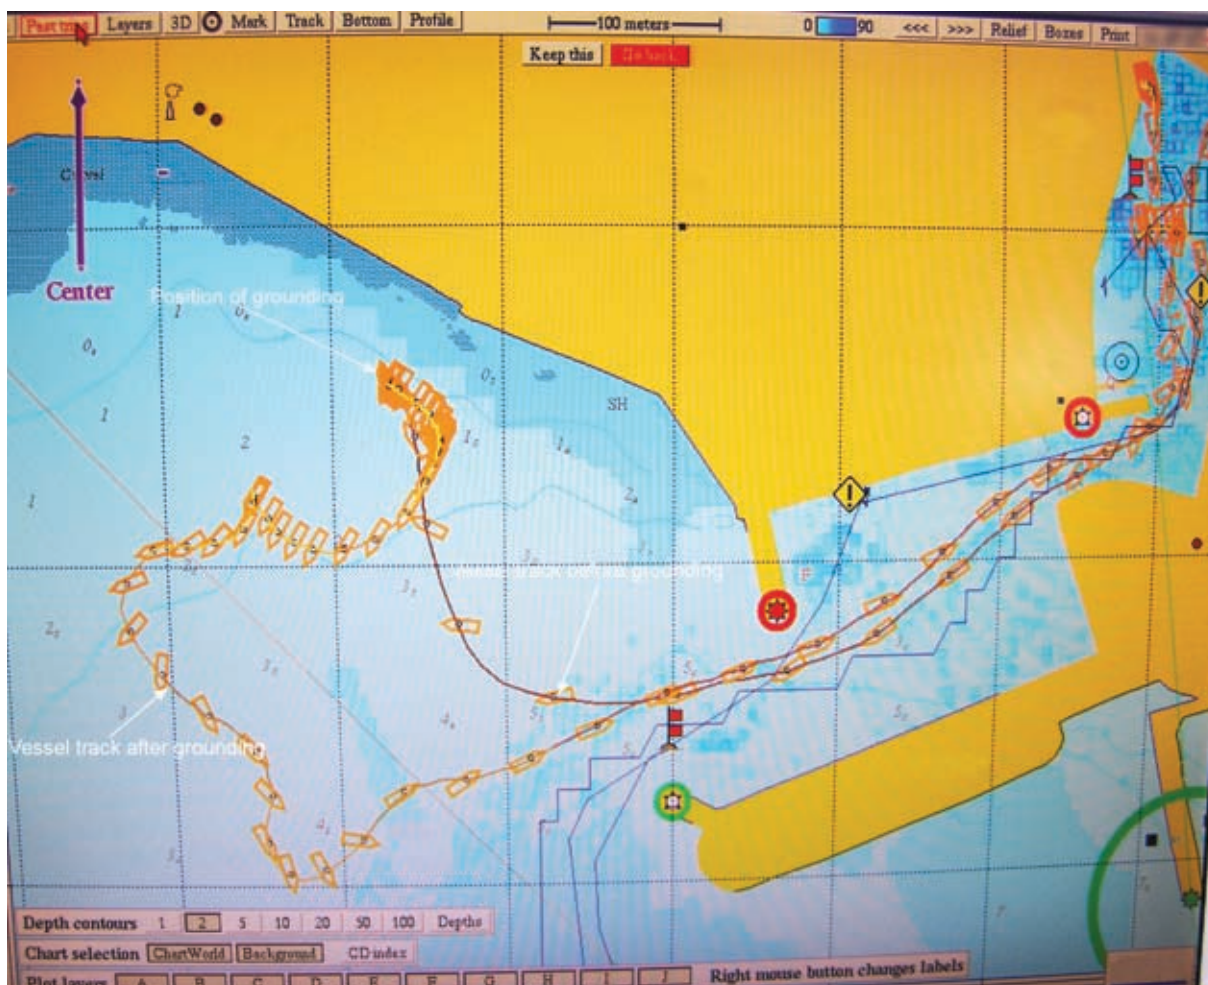
Vessel's track – recorded from electronic chart plotter

By chance, the mate glanced at the rudder indicator and saw that the rudder was set hard to starboard. He immediately alerted the skipper, who started to bring the helm back to port. As the rudder returned to amidships, the noise of the vessel grounding could be heard. The mate de-clutched the main engine and then reduced the pitch and revolutions to zero.

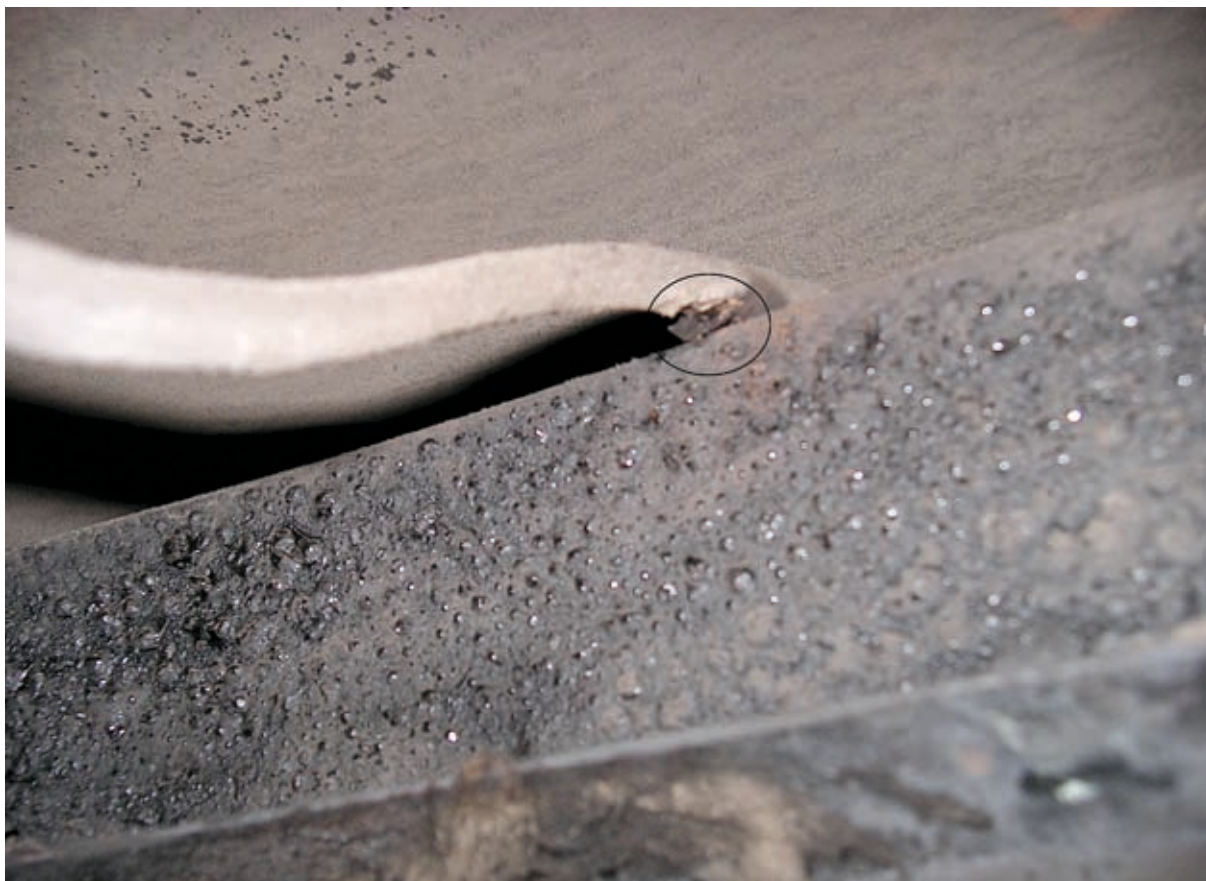
What the skipper did not know was that the cabin dividing bulkheads stopped short of the deckhead, and that cabin power supply cables were draped over the sharp edges, and consequently the insulation had been badly chafed (Figure 1). The crew also connected numerous electrical devices to untested electrical extension leads.

Figure 1: Cable chafing

The fire was caused either by a short circuit where the electrical cables were draped over the non-continuous bulkheads, or by an overheating electrical device belonging to one of the crew. It caused widespread damage throughout the accommodation area, alleyways, galley and mess room. The 220 volt electrical distribution panel outside the engine room access was totally destroyed (Figures 3, 4 and 5).

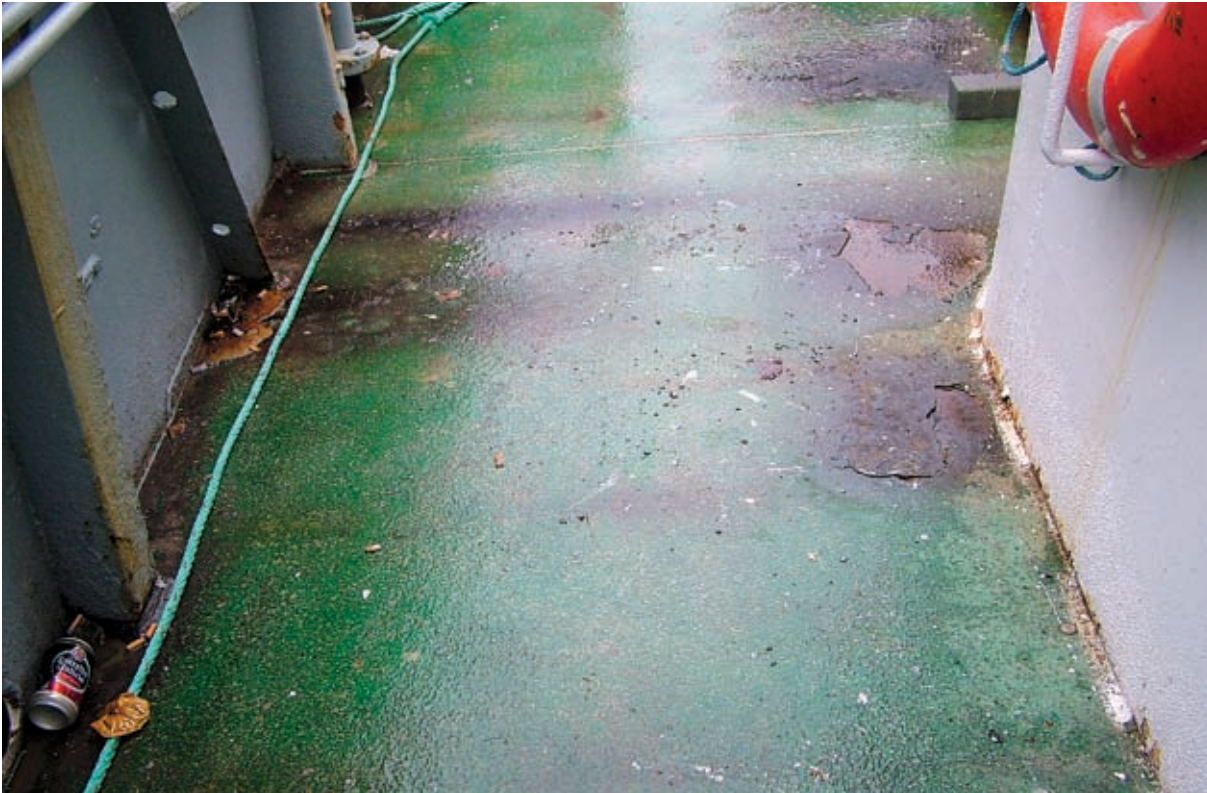
Figure 2: Blistering of the paint on the main deck

The situation worsened as the paint on the starboard side of the main deck started to blister (Figure 2). The skipper decided to

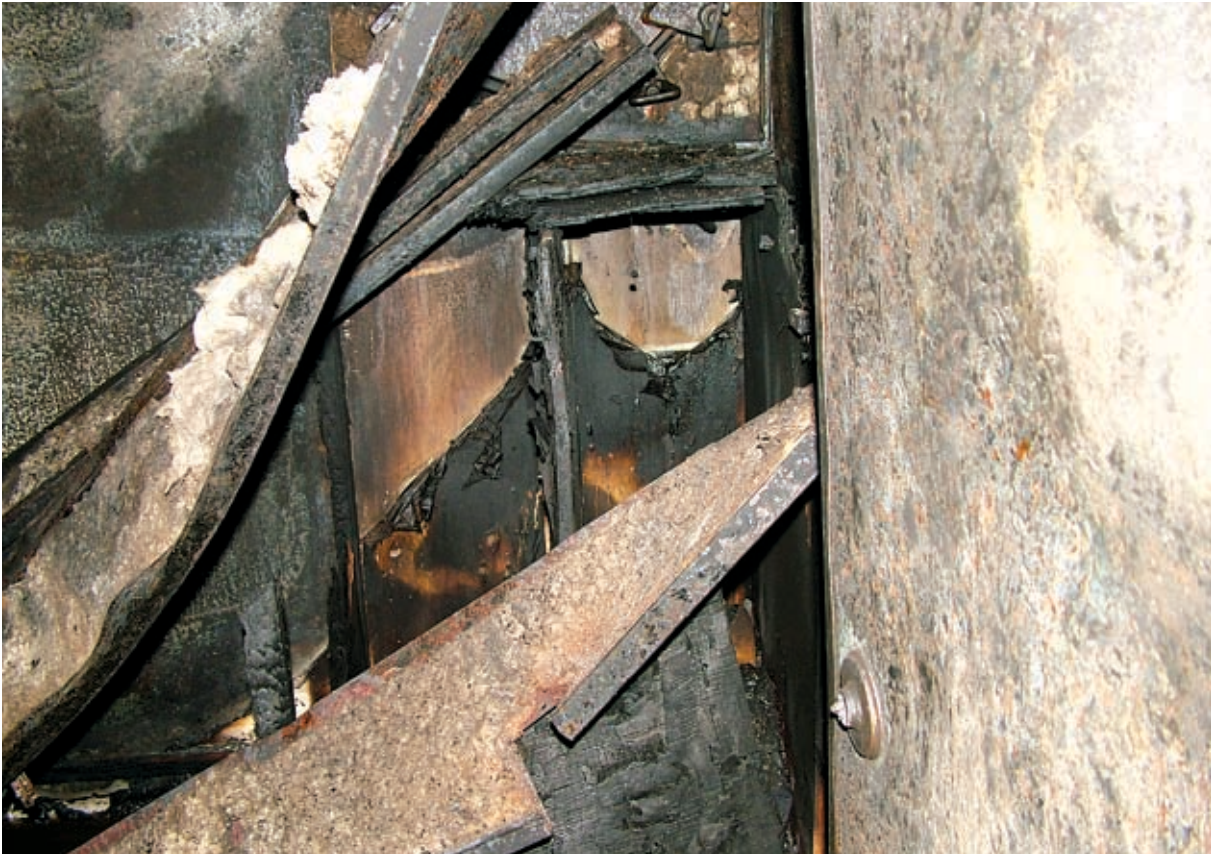
Figure 3: Cabin damage

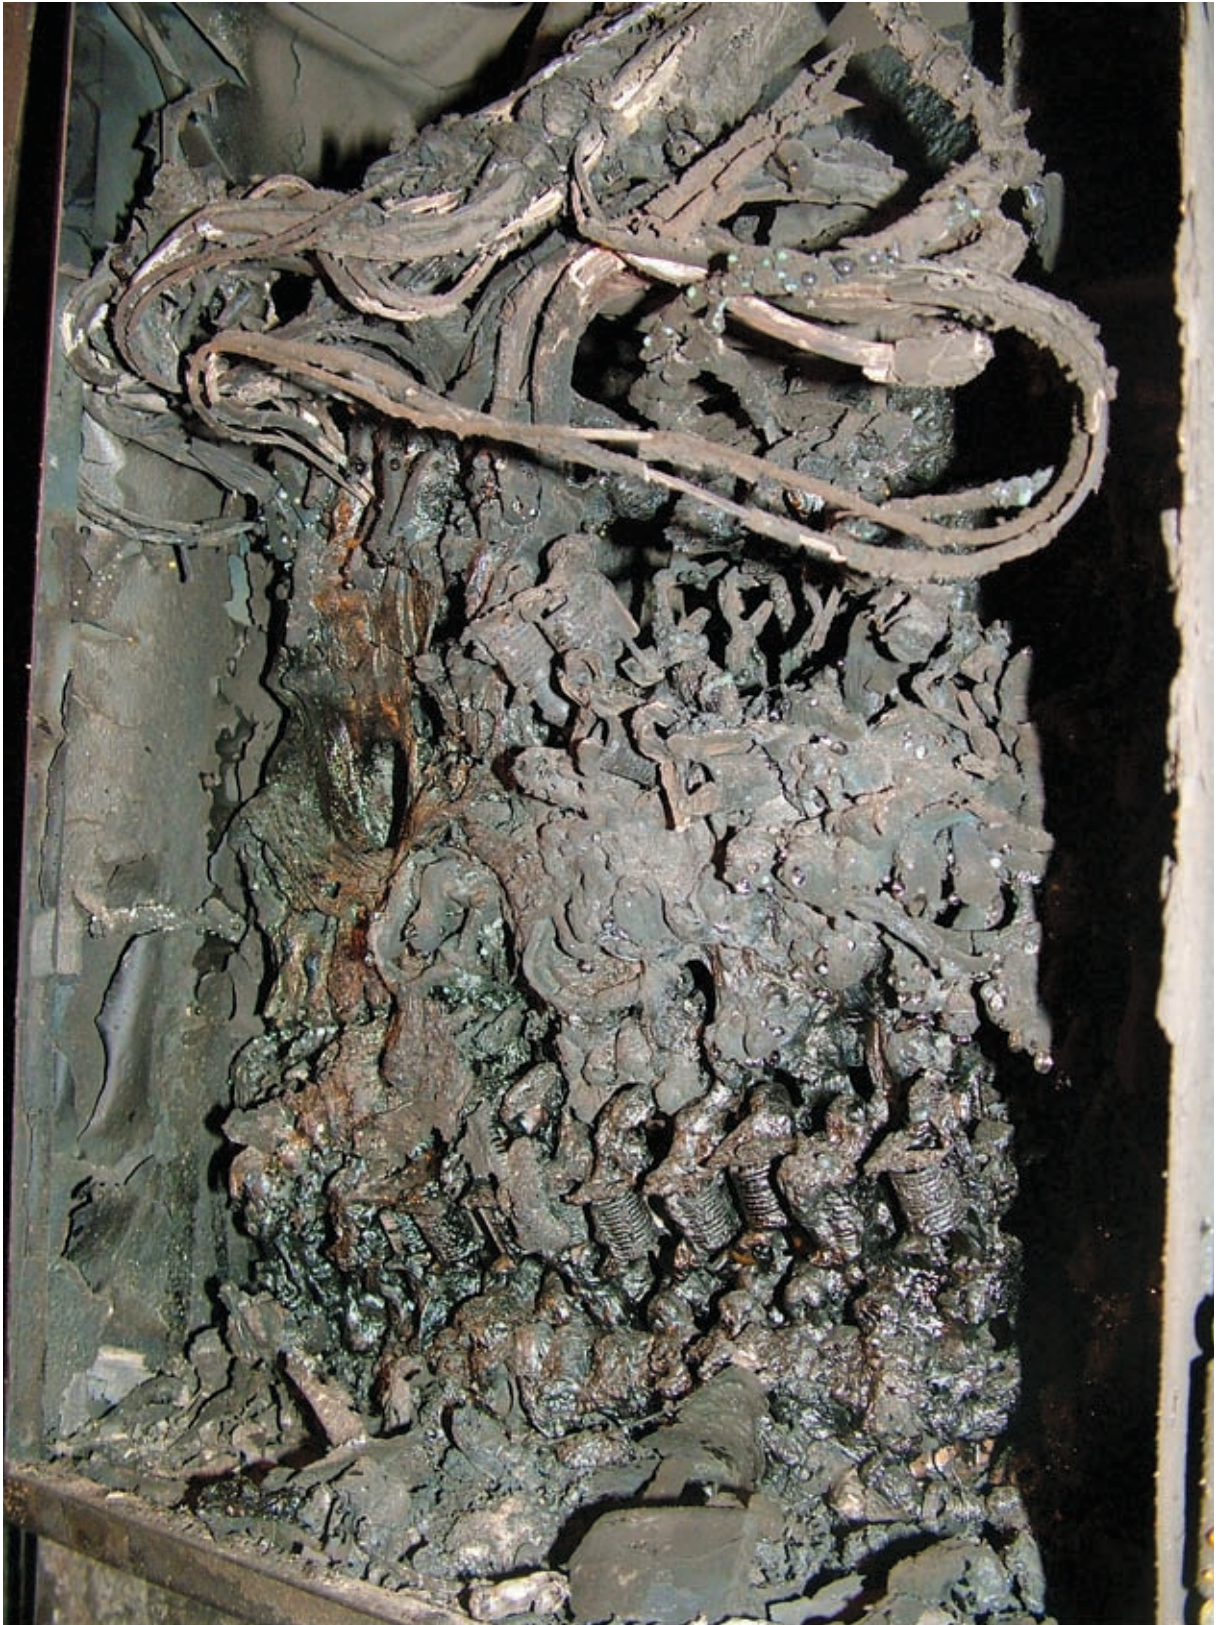
Figure 5: Damage to the 220v distribution panel
