Part 2 – Fishing Vessels

What Did We Hit?

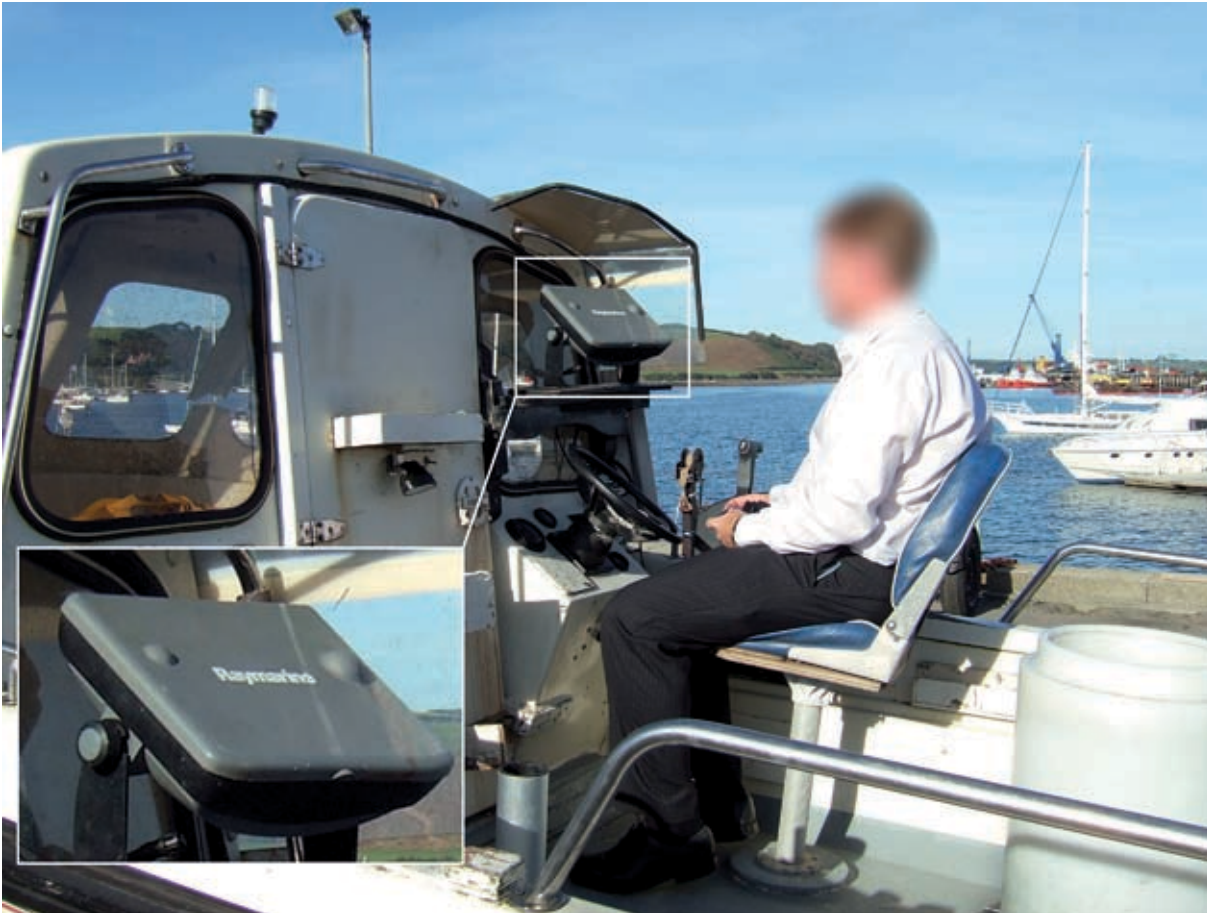
At approximately 0615 on a still autumn morning, a single-handed 5m dory left port and headed south towards her fishing grounds at a speed of between 18 and 26 knots. Soon afterwards, her skipper saw a cluster of lights ahead and adjusted course by several degrees to port to avoid them. Once steady on the new course, he sat down to rest in a position from where he could not see ahead (Figure 1).

When the vessels collided, the skipper of the dory, who was not wearing a lifejacket, hit his head on a chart plotter (Figure 1) and fell to the deck. He then possibly lost consciousness for a short period as the boat's engine continued to run. The skipper managed to drive the dory back to port, and from there was taken to hospital for treatment.

Figure 1: View from the seated position on the dory

1. When in familiar waters, in good conditions, and when few other vessels are around, it can sometimes be easy to assign the keeping of a lookout a low priority. When this occurs, although more often than not no harm is done, there will always be a danger of being caught out. This is an unnecessary risk to lives and livelihoods; the effort required to keep an effective lookout is not onerous. It might take only a couple of minutes to make a cup of tea, but a boat moving at 25 knots will travel almost 1 mile in that time.

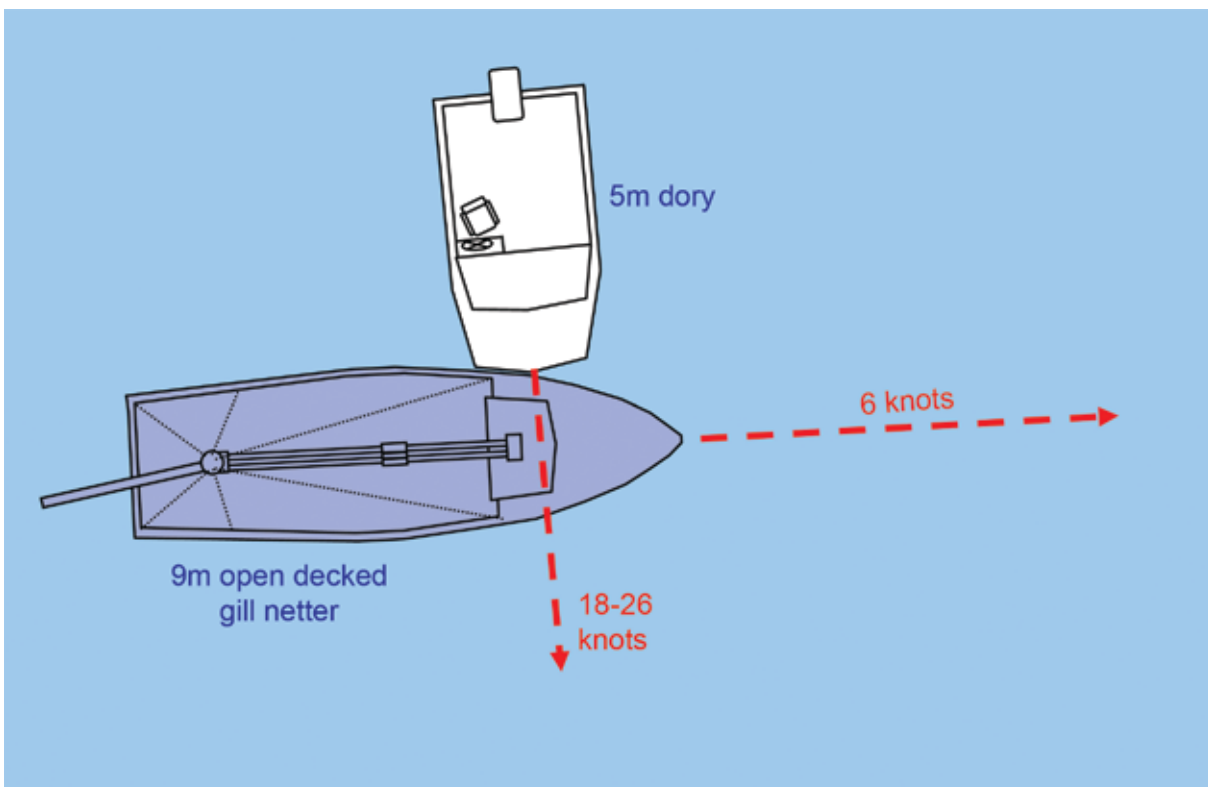
At about 0622, 1 hour before sunrise, the dory collided with a 9m open-decked gill-netter which was on an easterly course at 6 knots. The dory impacted almost head on with the port side of the gill netter (Figure 2).

Figure 2: Relative positions on impact

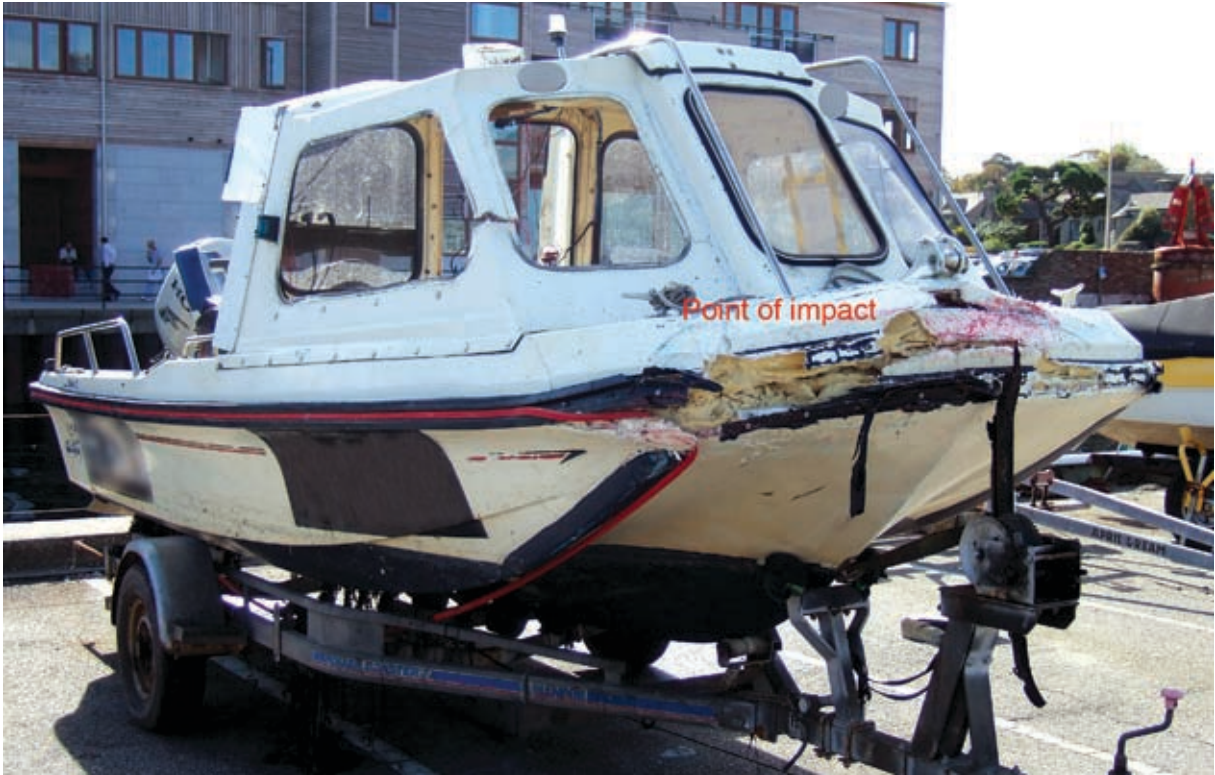
The gill netter's skipper, who was on watch in the wheelhouse, and two deckhands, who were sleeping, were all thrown to the deck. The vessel was holed above and below the waterline and her wheelhouse was displaced to starboard (Figure 3). With the vessel taking on water, the skipper used a mobile phone to inform the coastguard while the deckhands

Figure 3: Damage to bow of the dory

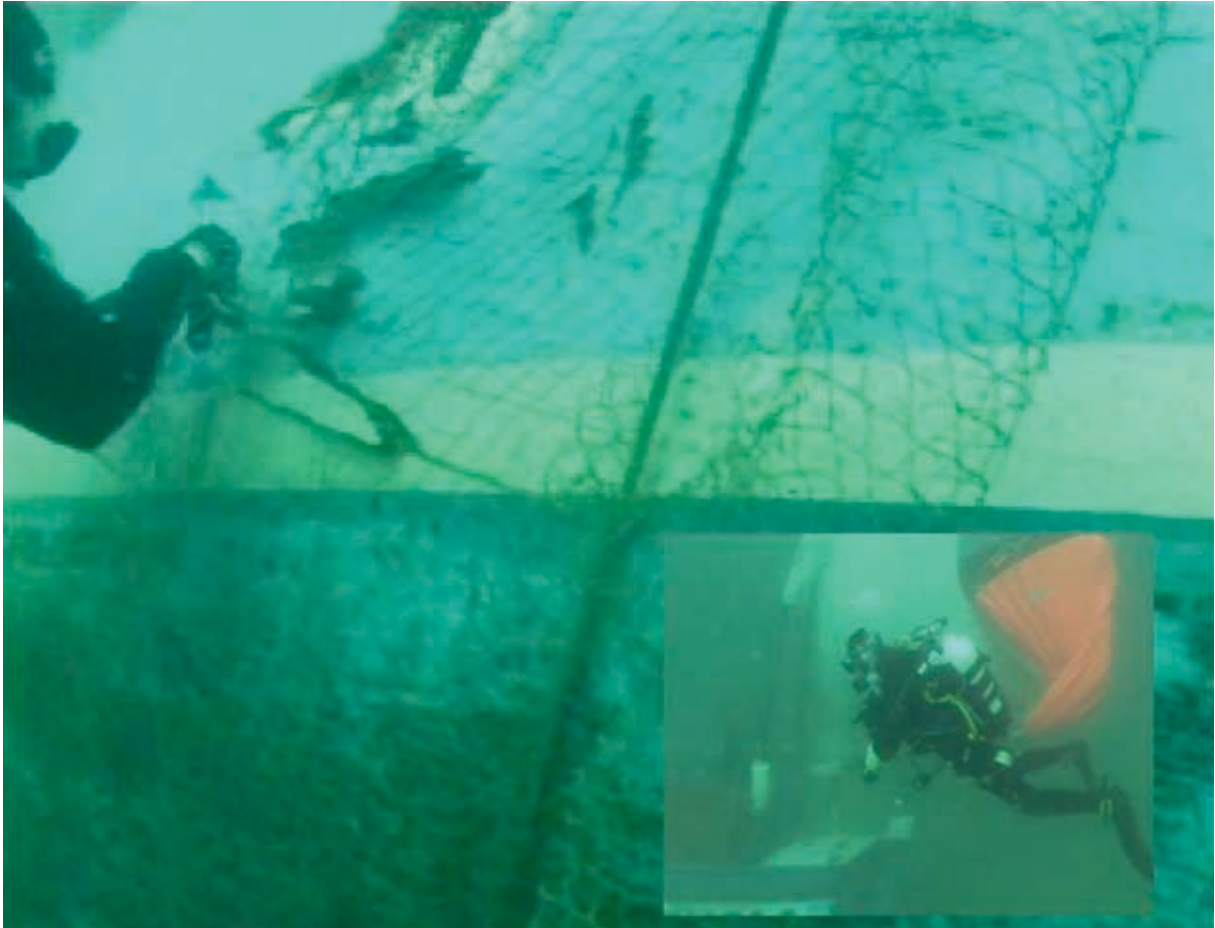
launched a liferaft over the stern. However, the liferaft did not fully inflate due to there being insufficient gas in its cylinder; it had not been serviced in accordance with its manufacturer's instructions. Fortunately, a local pilot boat quickly arrived on the scene and recovered the skipper and his crew. Although the damaged fishing vessel was taken in tow, she sank at 0646.

Figure 4: Gill netter diving survey

2. Unfortunately, liferafts occasionally do not operate as intended or expected due to poor design or maintenance. This can be prevented by ensuring that all liferafts carried meet a recognised standard and are serviced by approved technicians at intervals recommended by their manufacturers. Liferafts can and do save lives, so don't leave it to chance that yours will work when you need it.

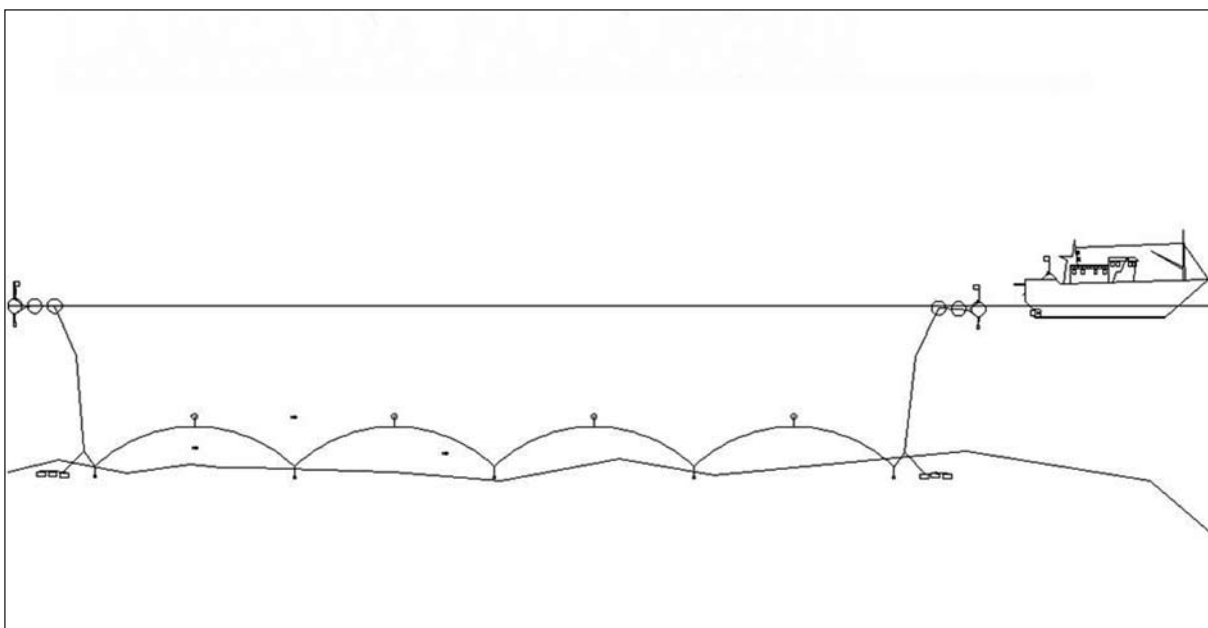
A long-liner fishing vessel was in the process of paying out her baited hooks onto the sea bed to a depth of 200m through a stern shooting hatch. At the end of the line there were three heavy weights to which was attached a 300m riser line. The other end of the line was to be attached to two dhan buoys, which were, in turn, connected by a 15m rope to a 3.3m tall marker buoy weighing 27kg. The buoys were stored on the aft deck, which was above the shelter deck shooting area.

It is likely that the deckhand had stood in a bight of the connecting rope and was thrown overboard when weight came onto the rope between the dhan buoys and the marker buoy.

Figure 1: Diagram showing the long-line on the seabed

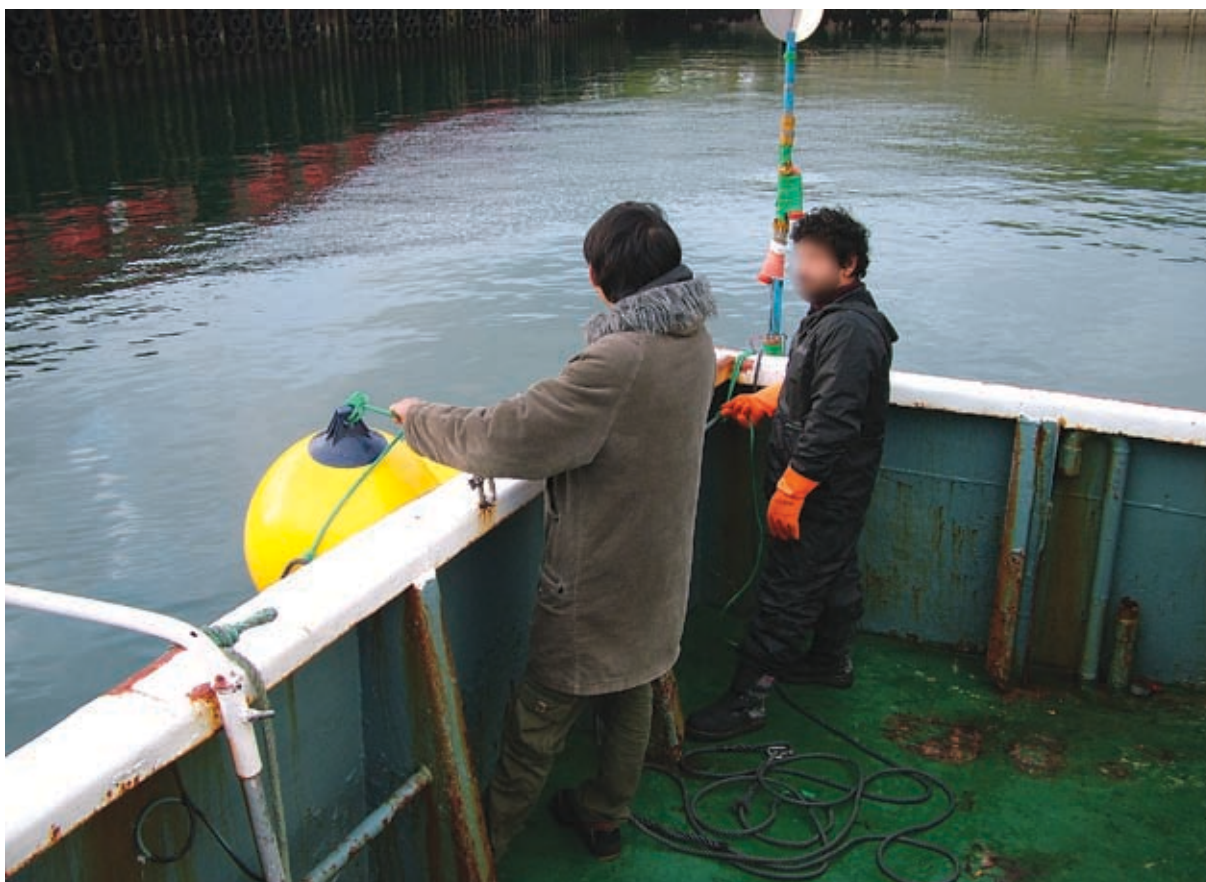
ahead. When the riser line was nearly all out, the first deckhand threw the dhan buoys over the side and, shortly afterwards, the second deckhand released the marker buoy. Suddenly, the second deckhand was lifted up and thrown over the metre-high bulwark. The first deckhand shouted to the shelter deck crew who saw the second deckhand land in the sea, face upwards, and threw two lifebuoys towards him. He made no attempt to swim to the lit marker buoy or to the lifebuoys, and he was quickly lost from sight.

Figure 2: Two fishermen showing the point of letting go of the dhan buoy

1. The activity of letting go two dhan buoys and a heavy marker buoy, at night, and with weight on the connecting rope, rendered the two deckhands particularly vulnerable to accidents. The connecting rope was black and lying on the deck between the two deckhands. The deck lights were behind them and they would have cast a shadow over the line. Furthermore, the deckhands were visually concentrating on releasing the buoys rather than keeping their feet clear of the connecting rope. In this case, the connecting rope should not have been attached to the riser line until such a check had been made. The dangers of standing in a bight of rope are well publicised. It is, therefore, essential that a positive check is made to ensure that the rope is clear before allowing weight to be taken.

2. A documented risk assessment on board covered the activity of launching the buoys and listed a number of control measures, including the need to keep away from the lines. It is necessary for skippers to ensure that safety-critical control measures are emphasised to the crew, and that they are adhered to. It is also important that all the crew embrace the safety culture promoted by risk assessments and their resulting safe systems of work.

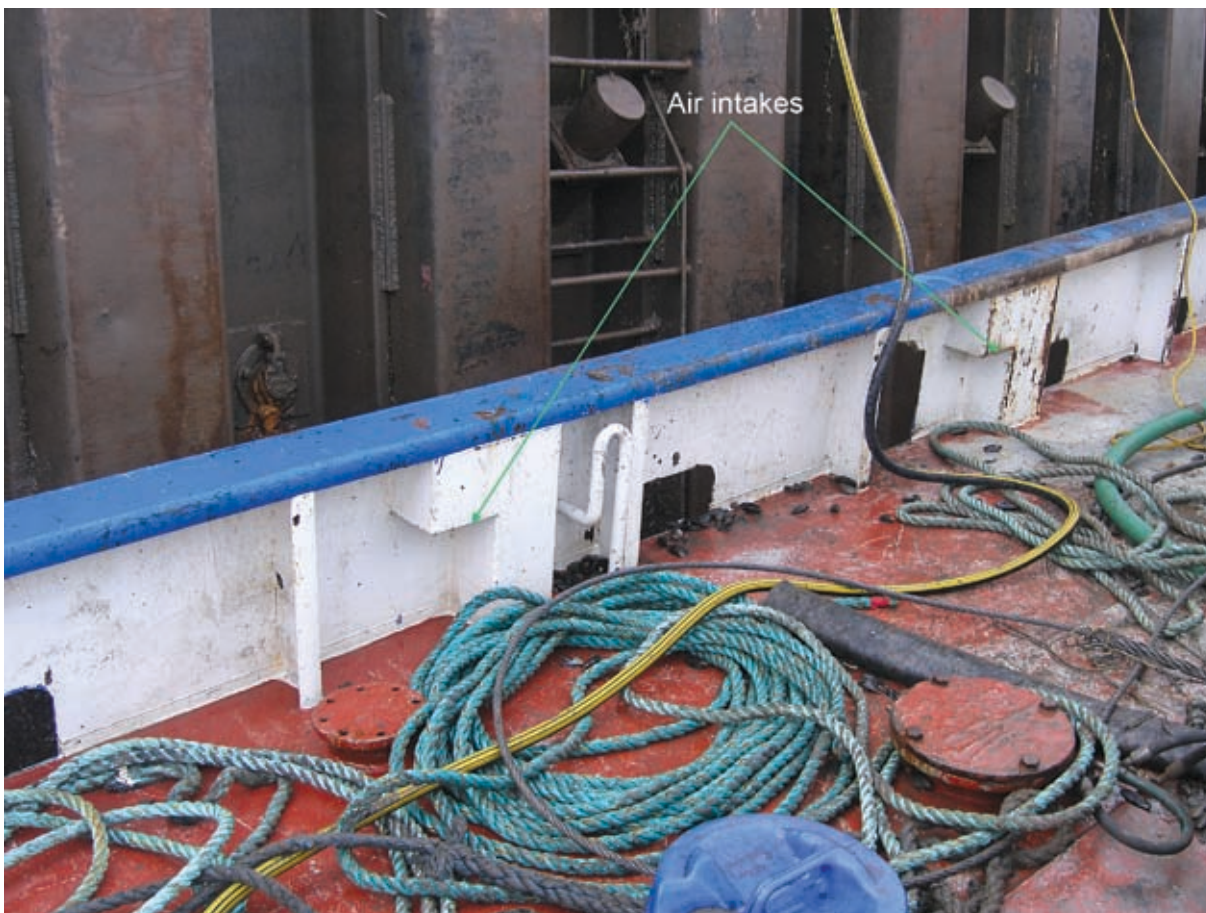
Despite the skipper's efforts, he was unable to free the dredge or correct the heel before downflooding occurred into the engine room via the vents sited under the bulwark. As the vessel capsized to starboard, the two crewmen on deck managed to scramble on to the port side of the wheelhouse. As a result, none of the crew entered the water. The skipper, who was in the wheelhouse, called the coastguard and the accompanying fishing vessel.

Figure 1: Deck, showing engine room air intakes

1. The fishing vessel had been built by the owners from a proven hull design. However, the four air intakes for the engine room had been positioned inside the bulwark only 0.3m off the deck. It has been estimated that these intakes would have been immersed at only 17 degrees of heel. Although your vessel may appear to have good initial stability, ensure that downflooding does not occur before 40 degrees of heel so as to maintain an adequate righting moment at greater angles of heel.

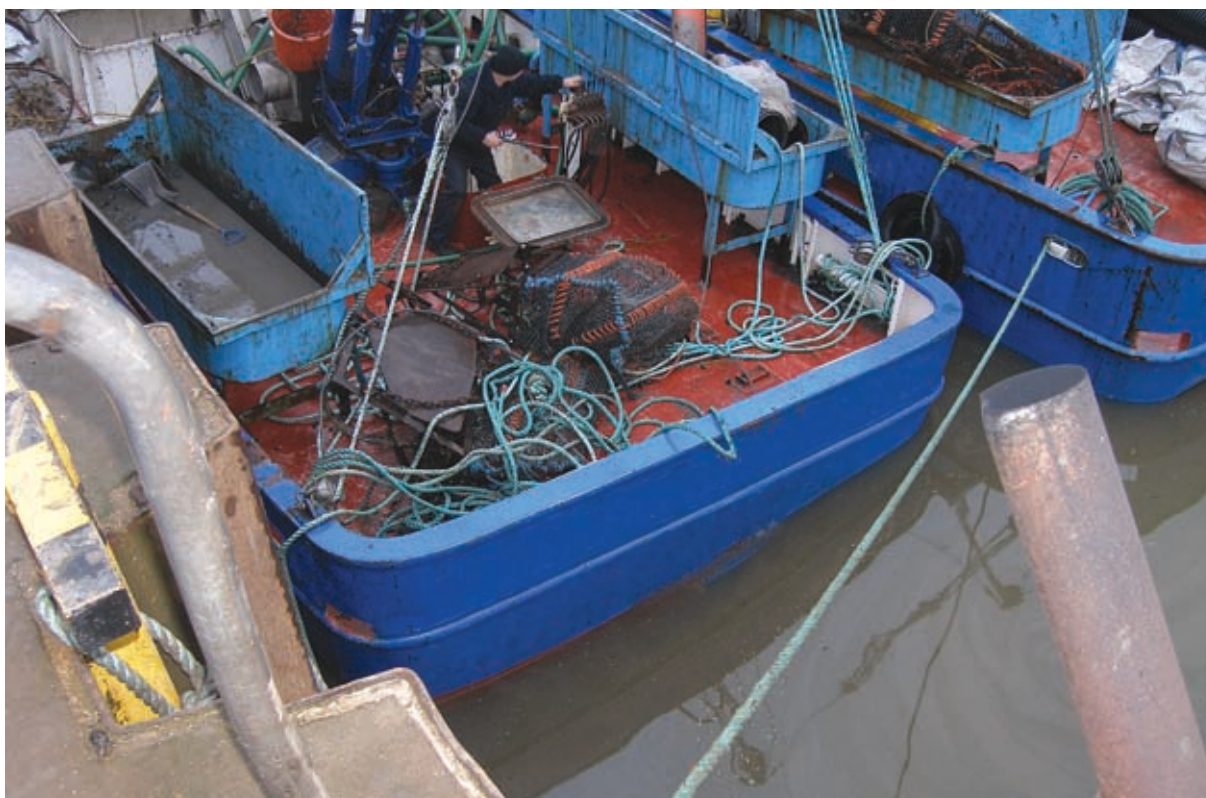
Figure 2: View of stern showing limited freeboard

2. To improve a bow down trim when fully loaded, roughly 2 tonnes of concrete ballast was added in the engine room 6 months before the accident. Although this ballast would have improved initial stability, the effect of the decreased freeboard would have also reduced the vessel's righting lever. It would also have resulted in the air intakes being immersed earlier. Before modifying your vessel, make sure you get an expert to assess the possible effect on your vessel's stability.

3. The loading limit for this fishing vessel was based on approximate calculations, since vessels of 'under 12m' registered length require no formal stability assessment. The stability performance of your fishing vessel is fundamental to you and your crew staying safe. Act on Seafish's recommendation and ensure your 'under 12m' fishing vessel has a stability assessment. At least then you will be able to operate knowing your vessel's loading limits.

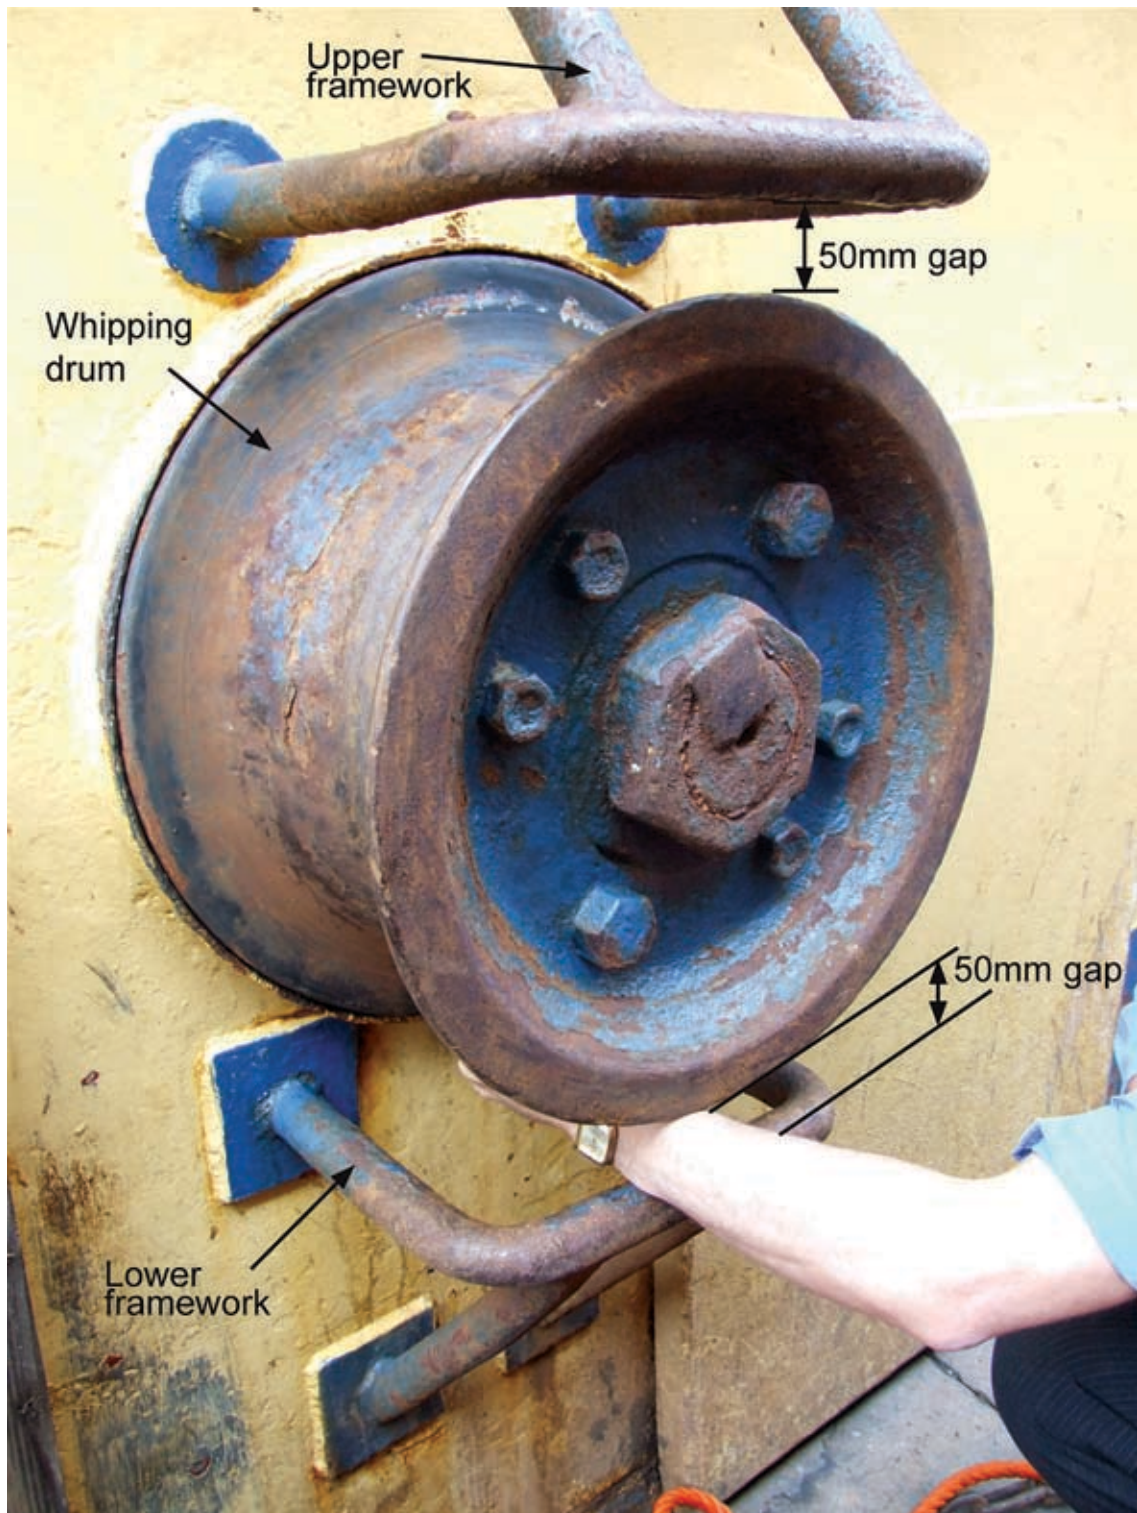
As he approached the winch, he slipped on the recovered dredging gear lying on the deck and, as he fell, his left hand became caught in the rope between the winch head and the lower framework. He was subsequently dragged twice round the whipping drum and framework, effectively performing two backwards somersaults, and on both occasions was unable to reach the stop button due to the framework. It was only once his arm had broken and shoulder dislocated that the deckhand was able to stop the winch and avoid being dragged round a third time, probably to his death.

Figure 1: Port whipping drum with demonstration of an arm in the gap between winch head and lower framework

- The frameworks above and below the whipping drum had been fitted when the vessel changed from a beam trawler to a scalloper. They created an additional entrapment hazard and undoubtedly contributed to the very serious injuries sustained by the deckhand.

- The frameworks also meant the emergency stop button could no longer be easily reached, and clearly delayed the deckhand in stopping the winch once he was trapped around it.

3. A new “tipping” arrangement has now been fitted to this vessel, which should remove the dangers evident from the initial working arrangement. Various alternative “tipping” configurations are available, such as automatic systems, or the use of a dedicated “tipping” winch, with a remote control. Not only will such systems offer safety benefits, but they will also lead to more efficient operations, thus saving time and money.

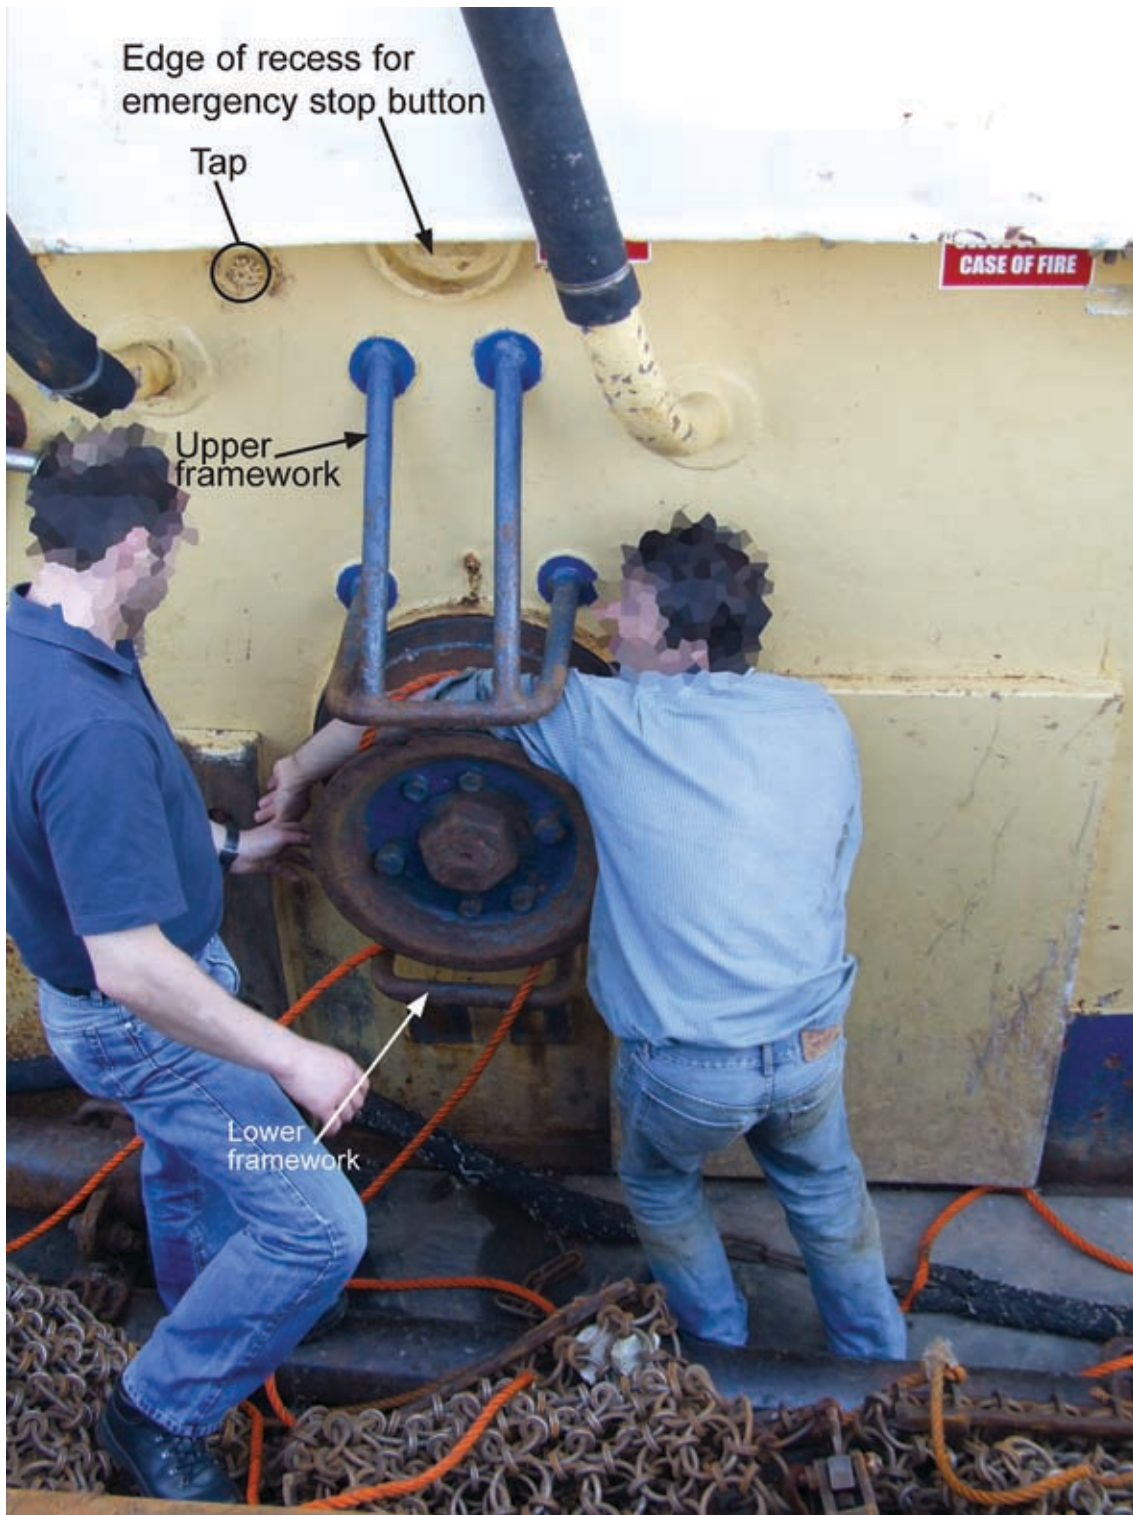
As soon as the winch stopped, the skipper and other deckhand hurried over to the port side to investigate. There they found the deckhand wrapped around the whipping drum and framework. They freed their colleague and then helped him into the galley. He had lost several fingers, fractured and severed his upper left arm and fractured nine of his left ribs. He had also punctured his left lung. With his condition deteriorating, the deckhand was evacuated by lifeboat and ambulance to hospital, where he was stabilised, but his arm subsequently had to be amputated.

Figure 2: Demonstration of “as-found” position of deckhand, trapped in whipping drum
