# Part 3 – Small Craft

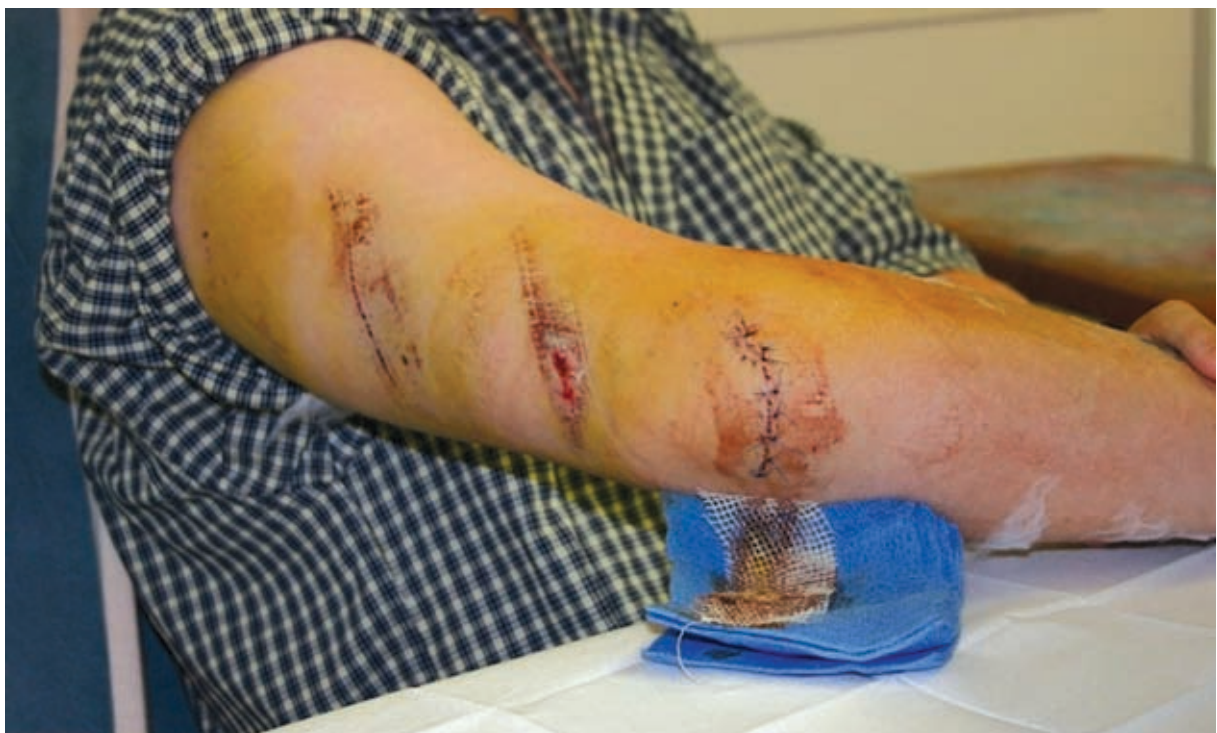
Figure 1

The instructor immediately took over the helm and manoeuvred the RIB to recover the trainees from the water. He quickly realised that the teenage boy was injured and headed back to the training base at best speed, calling the emergency services en route. The injured trainee was landed and taken to hospital by ambulance where he was found to have suffered a fracture, lacerations and bruising to his right arm (Figure 1).

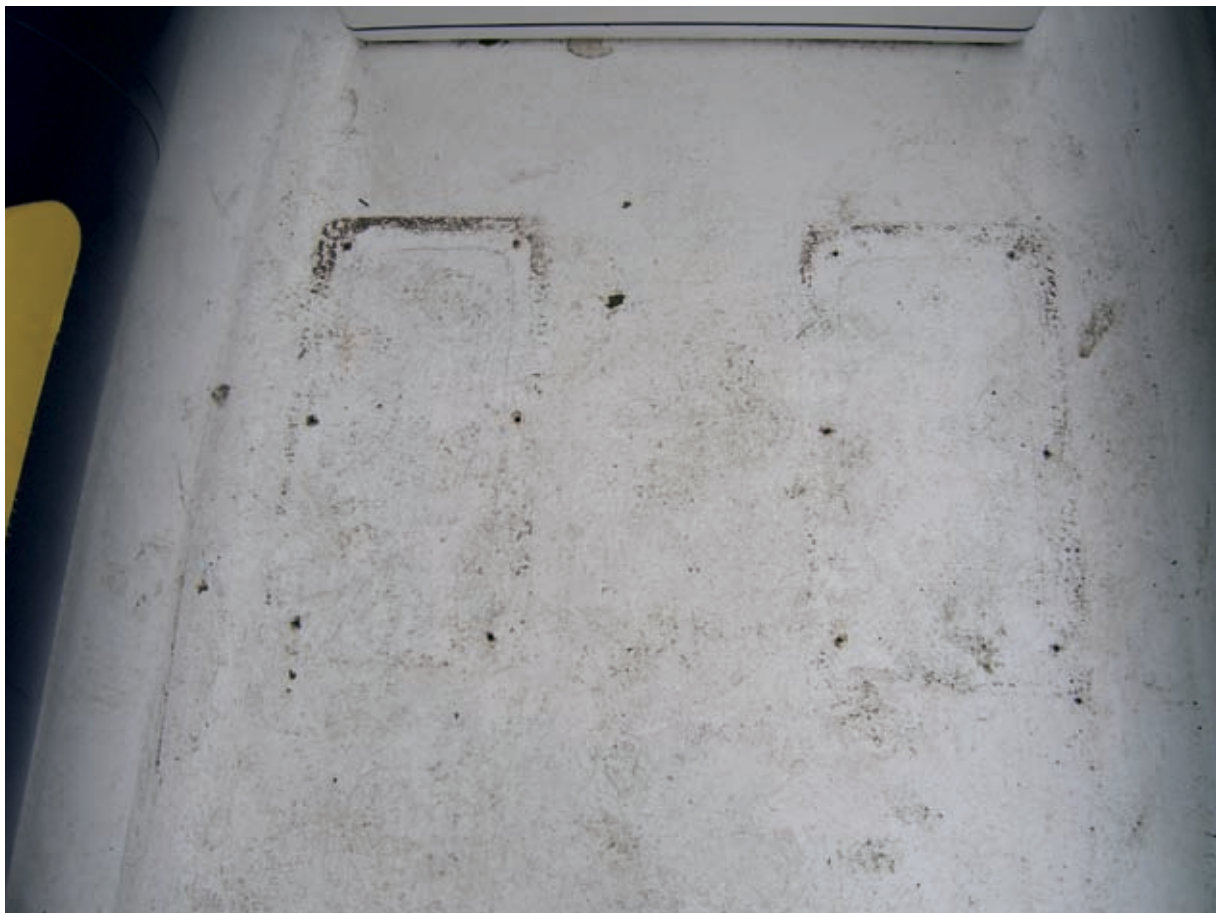
With no one at the helm, the boat careered on out of control because the kill-cord had fallen off the helmsman's wrist, and not operated. The RIB then collided with another vessel during which the console top was broken free

Vessel's deck showing outline of consoles – note lack of deck preparation and adhesive

1. The RIB's three occupants were very fortunate not to have been more seriously injured during this accident. The potential consequences of RIB seat pods or consoles coming adrift, especially at speed, can be very serious indeed. Owners and operators should regularly check that their RIB seats and consoles remain secure, particularly if adhesive sealant and screws are the method of attachment. Do not take your seat fixings for granted.

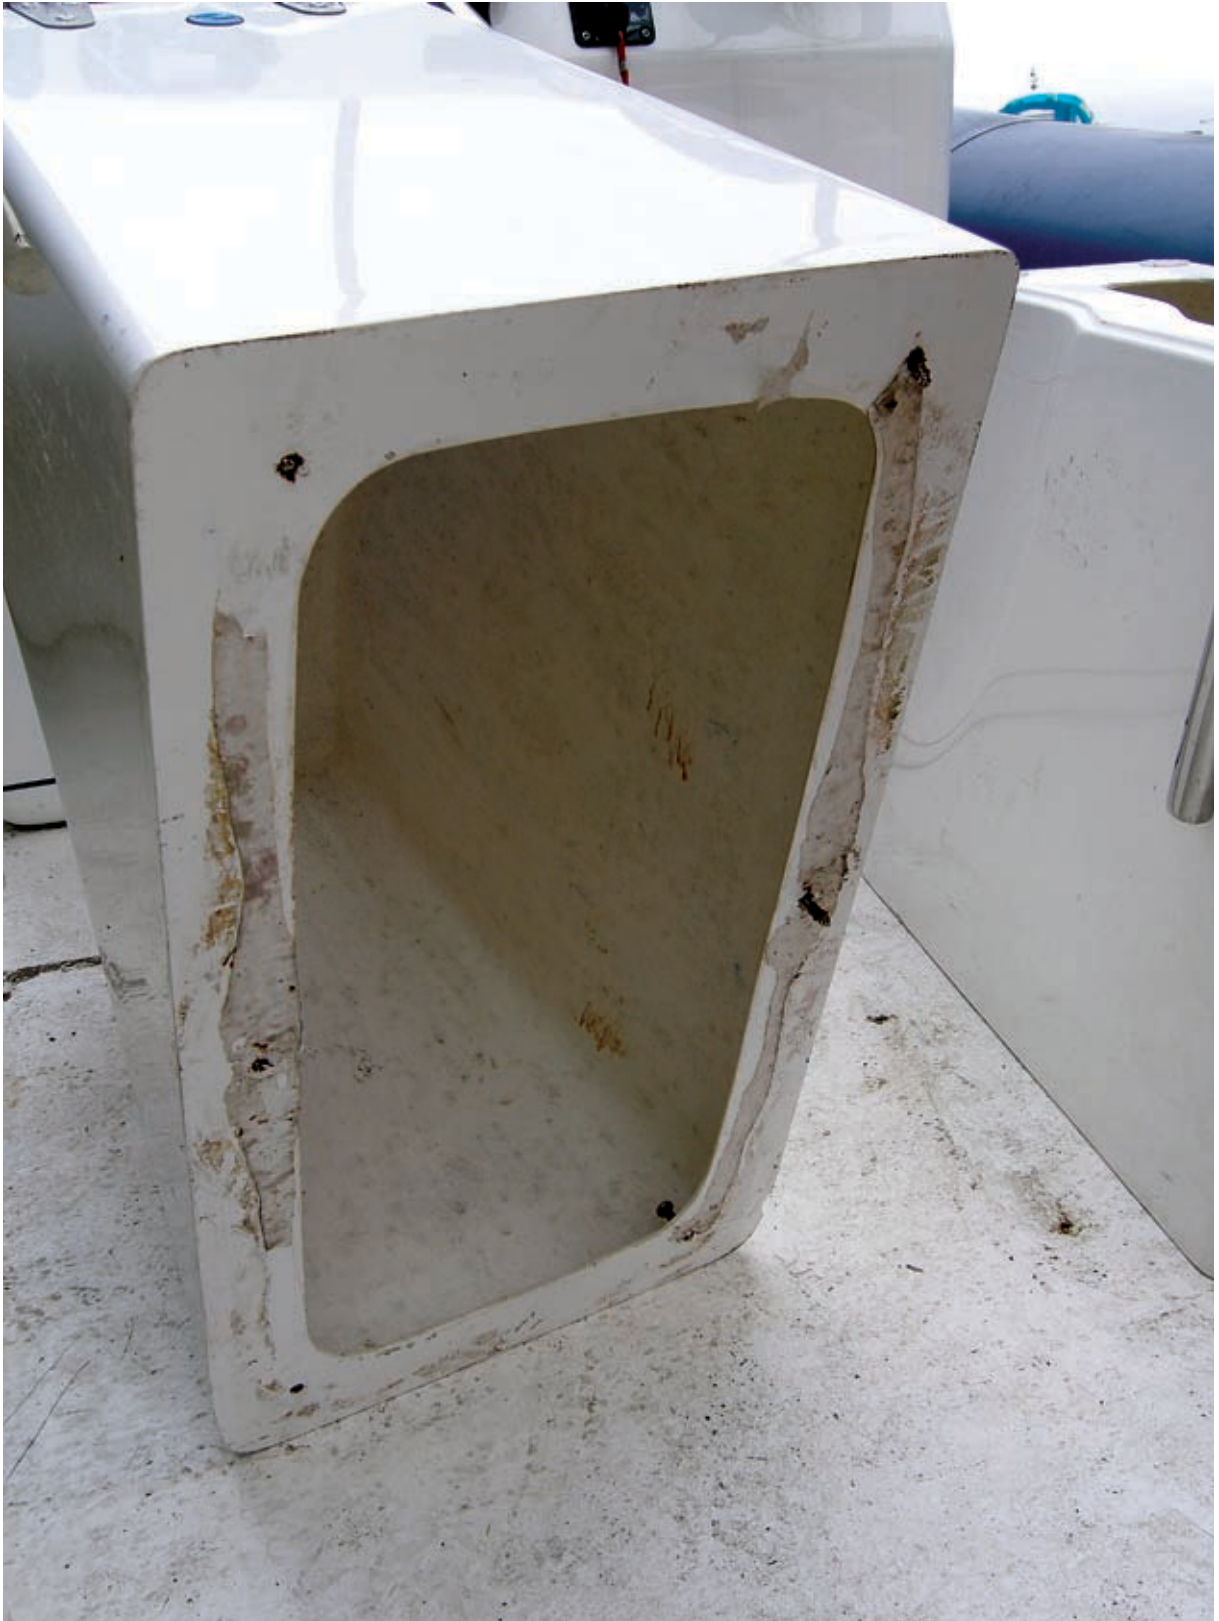
The seat pods and boat were examined after the accident. The glass reinforced plastic (GRP) seat pods had each been attached using 6 × 25mm stainless steel self-tapping screws with penny washers and a bead of a sealant-like substance. The deck was constructed from

18mm plywood, with a 2-3mm GRP skin which was impregnated with small plastic granules to create a non slip surface. Analysis of the sealant was unable to positively identify it as any particular product, but it was established that it was polyurethane-based. Polyurethane adhesive sealants normally provide good adhesion, but in this case poor surface preparation had resulted in ineffective adhesion to the deck, leaving the self-tapping screws as the only means of securing the seats. Over time, water had seeped into the six screw holes and softened the plywood, resulting in the screws pulling out as the RIB turned to starboard, and the weight of the occupants was forced laterally against the seats.

Vessel's seat  
note: wide spacing of securing screws and poor coverage of sealant

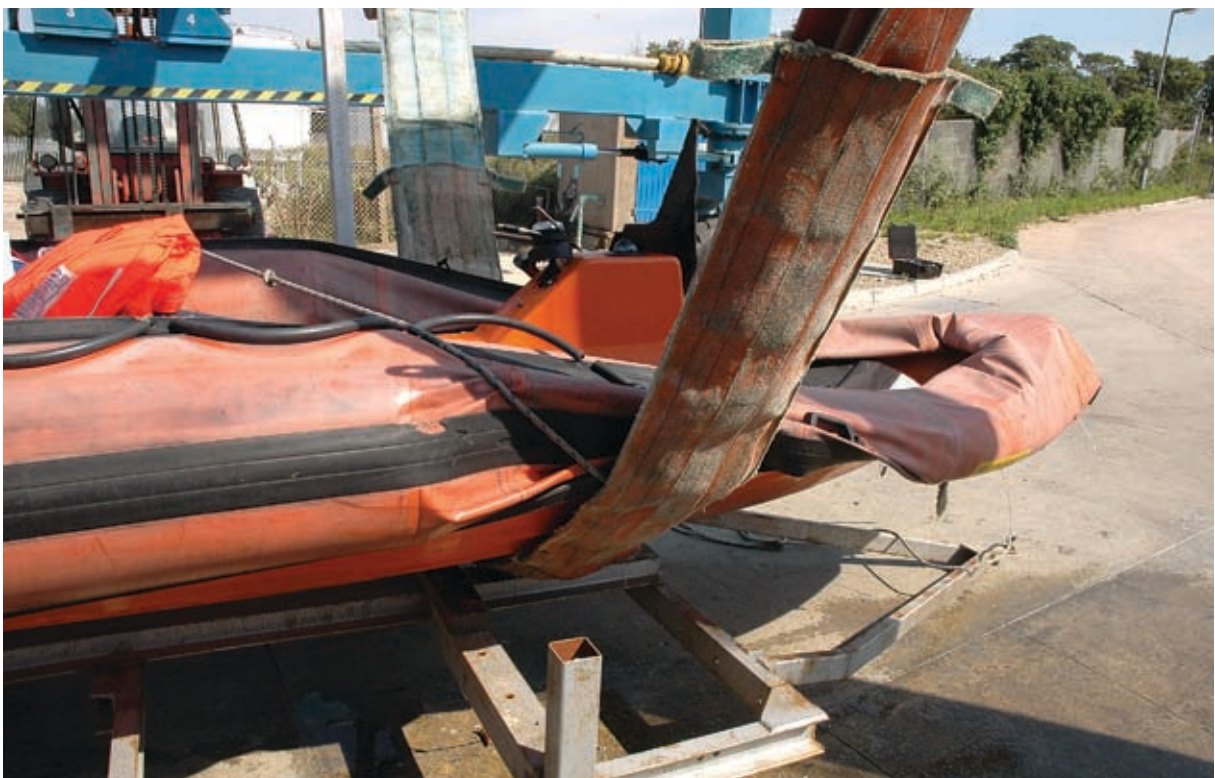
Recovered damaged RIB

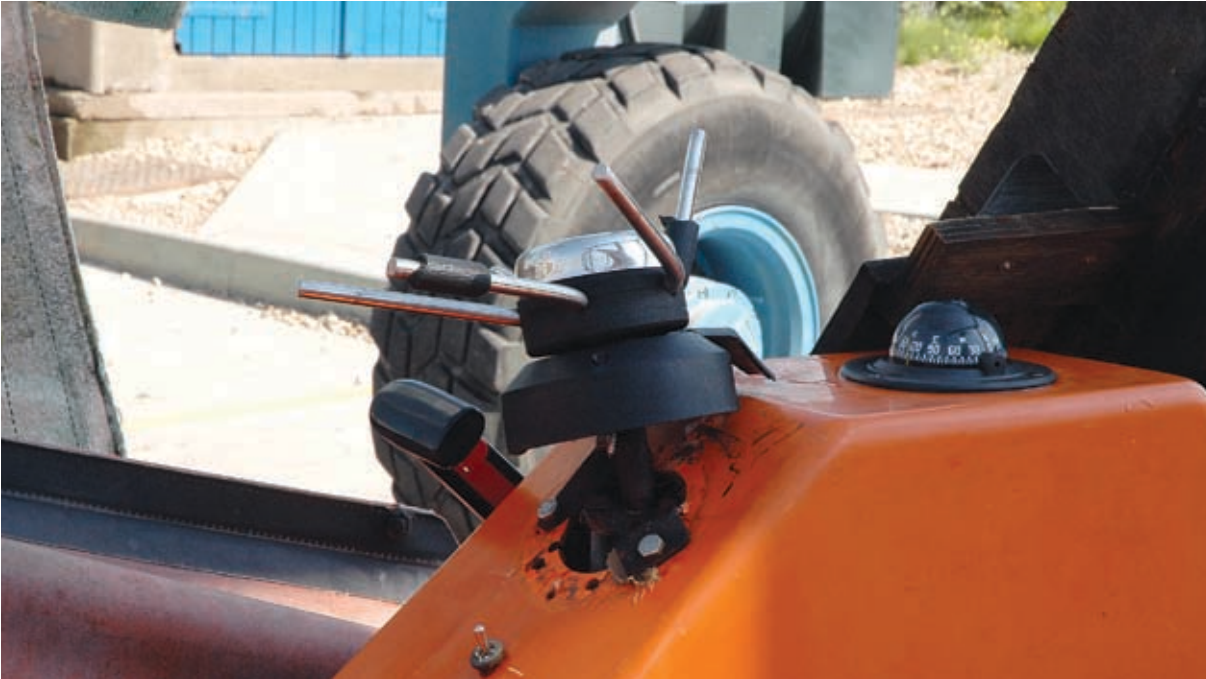
Damage to steering wheel following impact of the skipper

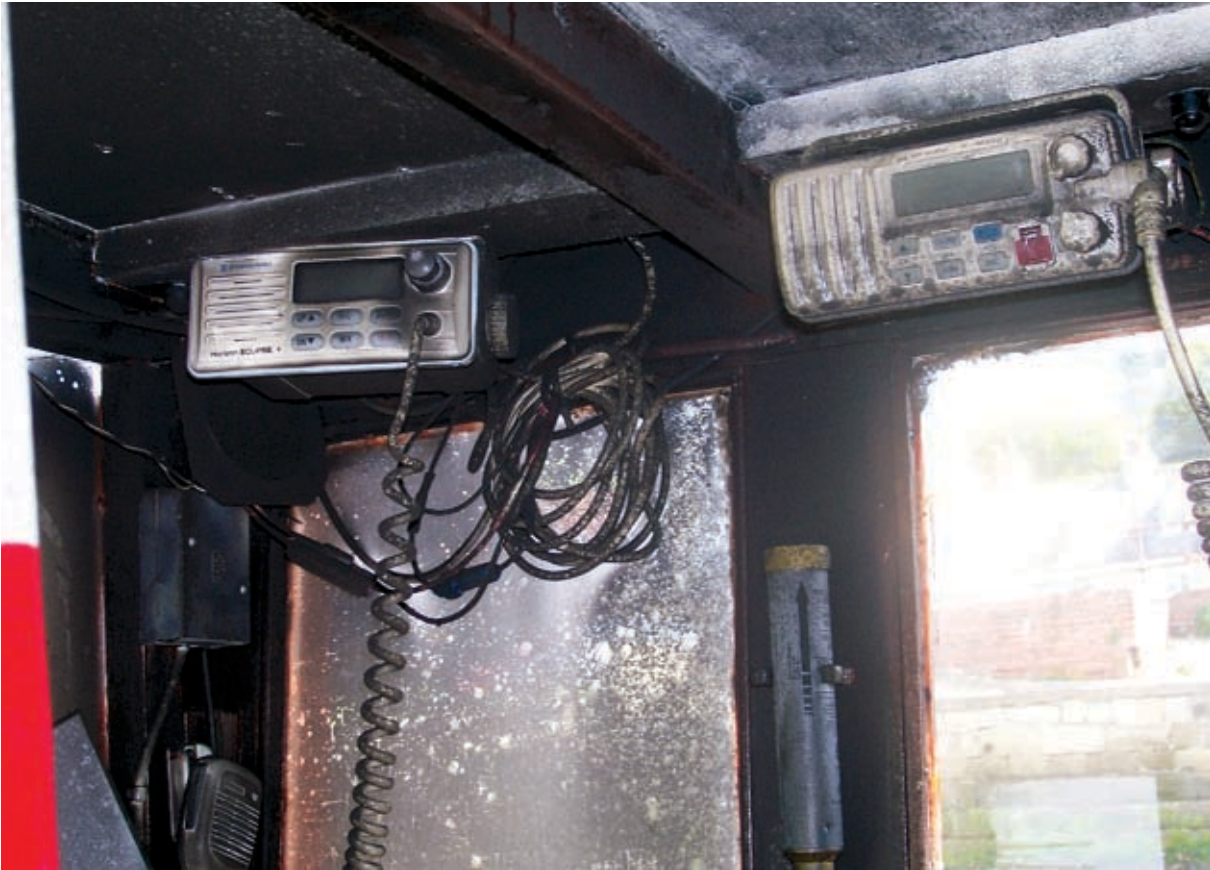
Figure 1

There was smoke damage throughout the wheelhouse (Figure 1). A small plastic cased television had been completely destroyed, and the plastic engine monitoring panel containing the engine key start switch, which was situated directly above the television, was badly burnt.

On investigation, it appeared that the television was left in the stand-by condition because power had not been isolated to the boat's electrical circuits. It is likely that the television's capacitor broke down, igniting the television's plastic casing. The flames from the television then damaged the engine monitoring plastic panel, burning the cable insulation outside the panel (Figure 2). This, in turn, shorted out the engine start circuit, causing the engine to start. Fortunately the wheelhouse was reasonably airtight, and the fire was short-lived.

1. Be cautious about taking the cheap option when fitting electrical components. Select those designed for use in the marine environment and seek professional advice if in doubt.

3. There have been a number of occasions when fires have been caused by electrical circuits remaining powered up on unattended boats. It is always good fire prevention practice to switch off electrical equipment when not in use, and to isolate batteries from electrical circuits when no one is on board.

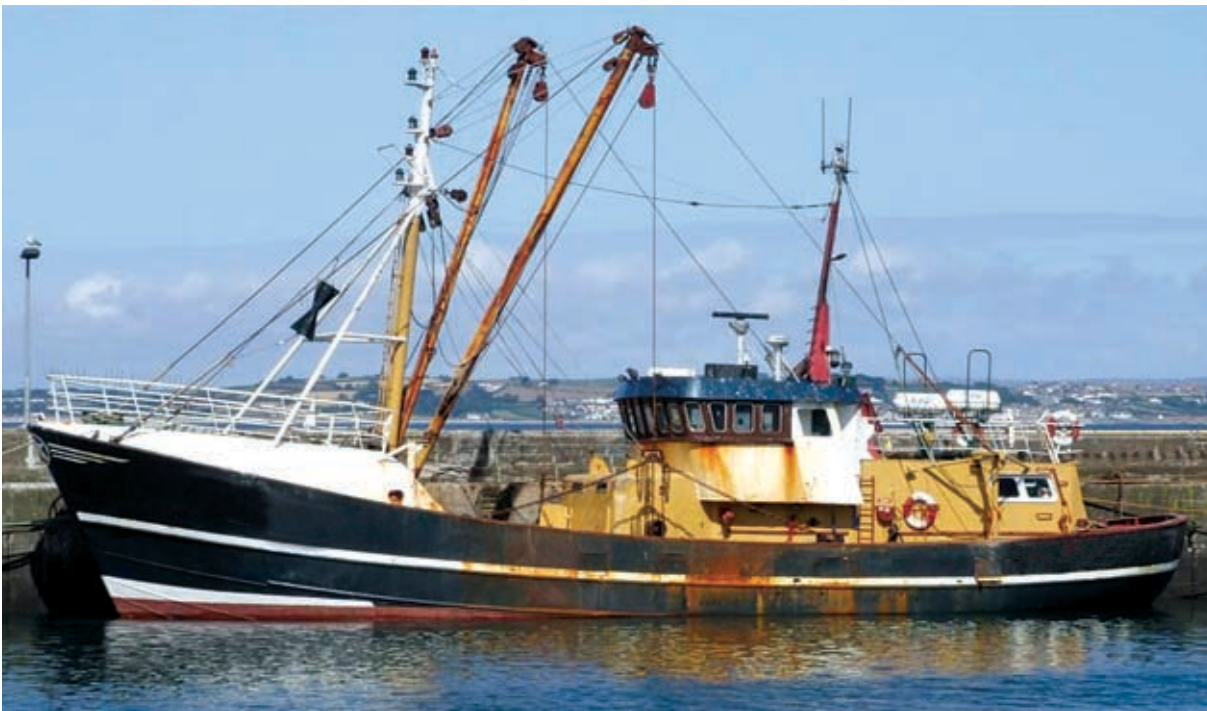
Figure 1: Beam trawler

The trawler's mate saw the yacht closing, but decided to act too late; hampered by his gear he was unable to avoid a collision. The trawler's derrick struck the yacht as it passed

very close by, destroying the mast, boom and sails, and causing serious damage to the deck and hull mouldings. Fortunately, the trawler's derrick passed over the head of the sleeping yachtsman. The undamaged trawler stopped to provide assistance, and the lifeboat was called. The RNLI towed the yacht in to port; her race was over. Fortunately there were no injuries.
