Part 3 – Leisure Craft

They Normally Wore Lifejackets

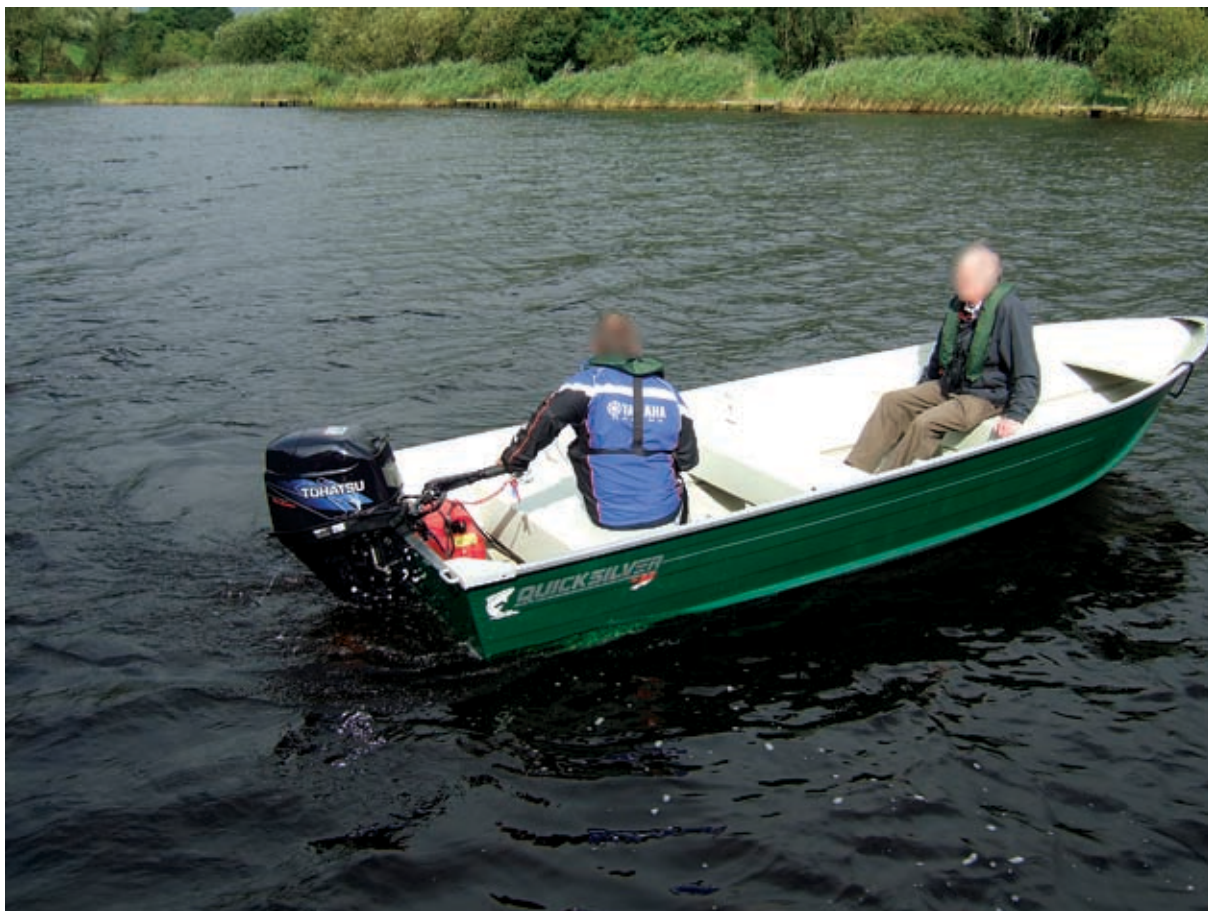
Similar aluminium angling boat

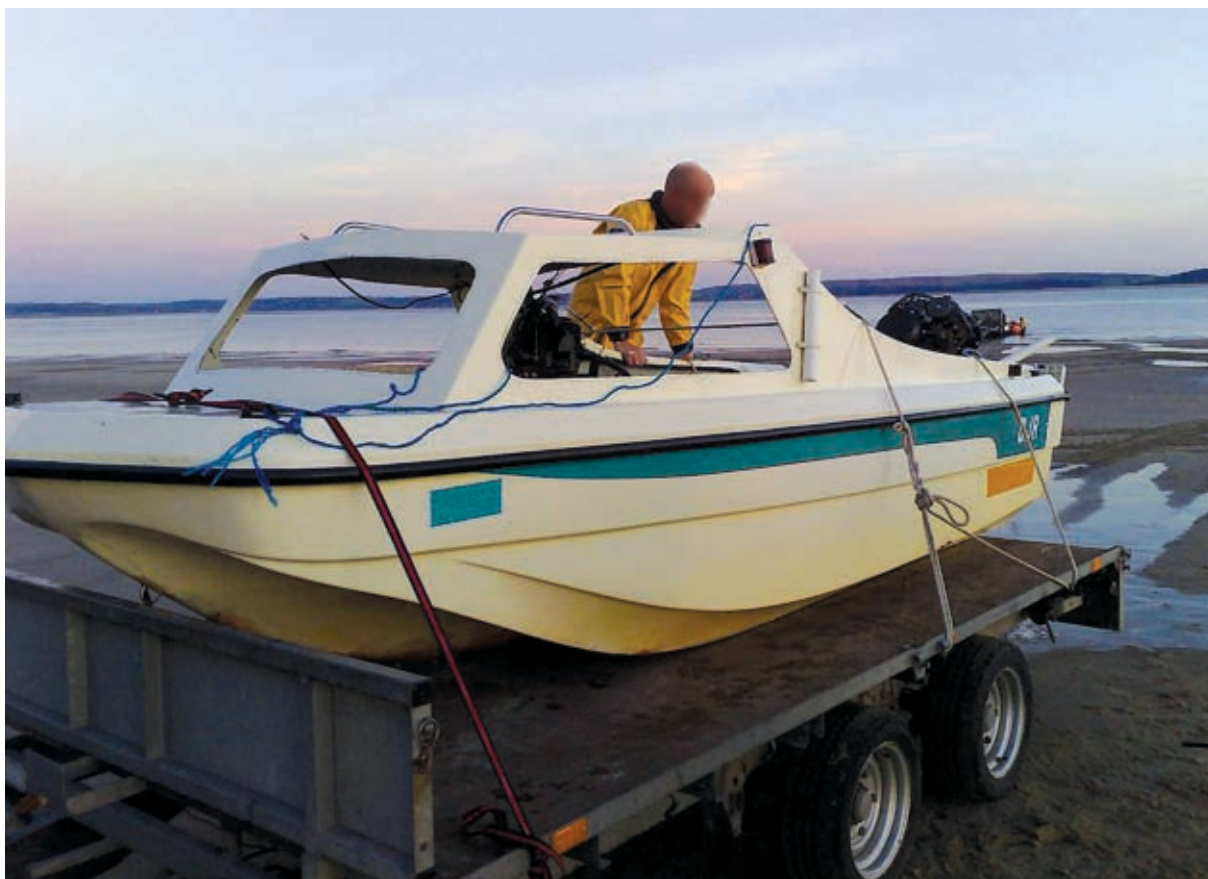
Figure 1: Recovered dory

A 6m open angling boat (Figure 1) fitted with a 4 HP outboard engine, was returning to shore following a fishing trip on an inland loch. Some alcohol had been consumed during the day. The weather conditions were poor, and the boat started taking water over her low gunwale. An automatic bilge pump cut in, but was unable to cope with the volume of water coming over the sides. Consequently, the five crew started to bail out the water using empty cans. A large wave then swamped the boat and engine power was lost. The boat turned broadside to the waves and capsized.

The surviving anglers wore flotation suits over their clothing; the deceased only wore flotation trousers. No lifejackets were worn or carried on board.

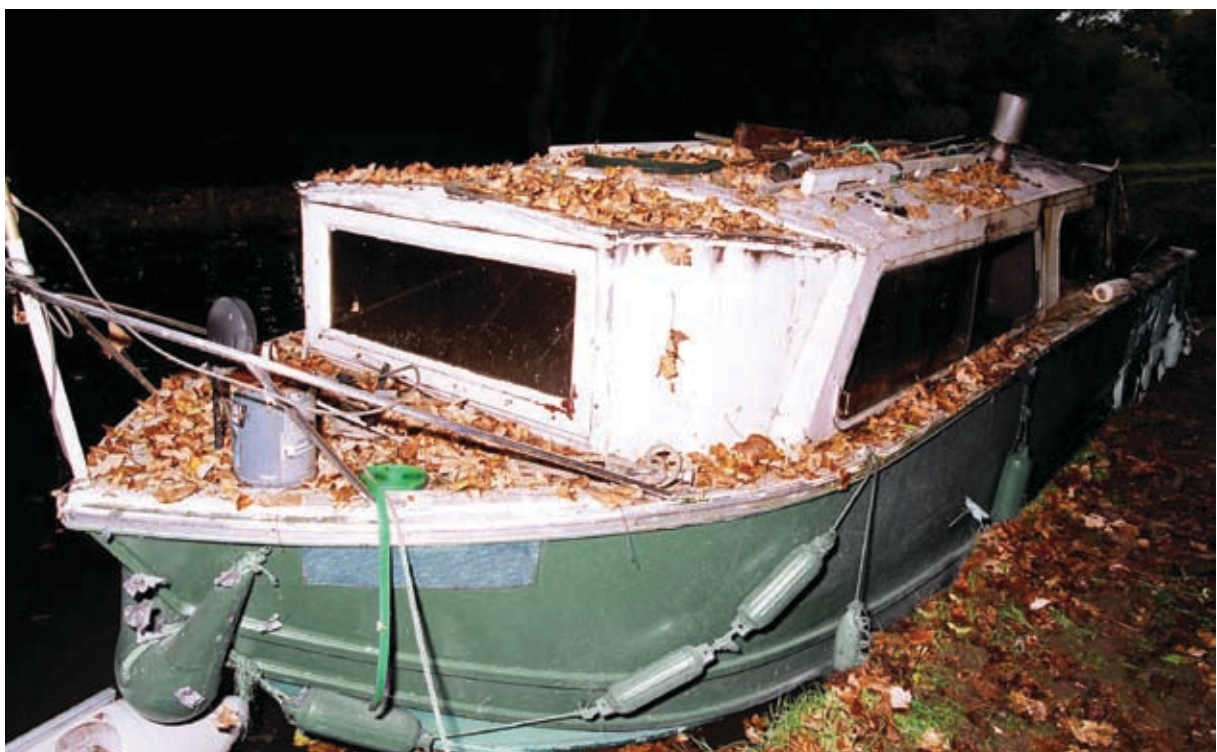
Figure 1: Showing the poor condition of the boat

The boat had been issued with a 4 year Boat Safety Scheme Certificate 2 years previously, confirming that it met the required safety standards at that time. The boat had not been used since then, and its British Waterways Certificate permitting it to navigate had not been renewed. While the outboard engine and partially filled fuel tank were still fitted, there were no toilet or cooking facilities on board and the boat’s general condition had rapidly deteriorated by the time the new owner took possession (see Figure 1).

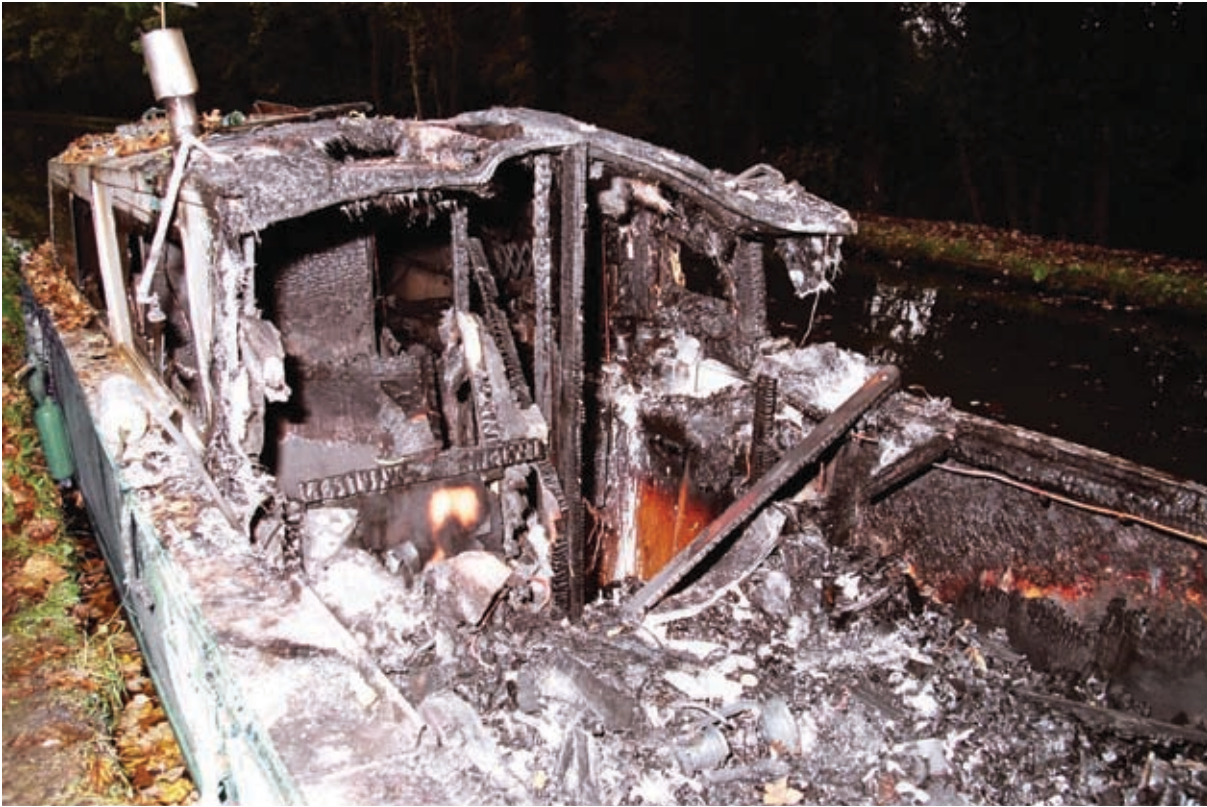
Figure 2: Vessel after the fire

The remains of the owner were found in the fire debris. The postmortem confirmed that he died from the effects of the fire, and not from smoke inhalation, suggesting that he died in the early stages of the fire. A number of paraffin lamps were found in the debris (Figure 2), together with a 5kg gas canister, remains of the outboard petrol tank and a number of cigarette ends. The outboard engine had dropped into the canal as the transom area had been badly burnt.

From the evidence, it is likely that the fire was started either by a discarded, lighted cigarette end, a fallen candle, or from the heat from one of the paraffin lamps. The owner died during the early stages of the fire, possibly as his mattress caught fire, and his immobility would have reduced his chances of escaping. The canvas and plywood coverings, GRP deck, and hull and outboard motor petrol tank contents would all have provided the fuel for this intense and fatal fire.

1. When considering modifications, think about the implications of fire – wherever possible plan to have two escape routes.
2. Avoid the use of open flame items such as candles. If you have to use paraffin or gas lamps, remember the metal and glass surfaces can produce very high temperatures – place them in a stable, out of the way position, well clear of any flammable materials.
3. Do fit smoke alarms, replace batteries and test the alarms in accordance with

4. Avoid placing petrol canisters in between decks or in enclosed spaces. The vapours given off are highly flammable and easily ignited.
5. Make sure that gas appliances are tested, that connections are tight and that gas canister valves are shut when not in use. Remember – bottled gas is heavier than air, and any leakage can easily migrate throughout the boat and is easily ignited.
6. When planning a mooring position, especially a temporary mooring, consider how the emergency services can gain access should you need their help. Mooring close to roads or tracks, where this is possible, will significantly improve the speed of response.
