Report on the investigation of the capsizing of

Plas Menai *RIB 6*

near Caernarfon, Wales, 1 July 2008,

Report No 6/2009
February 2009

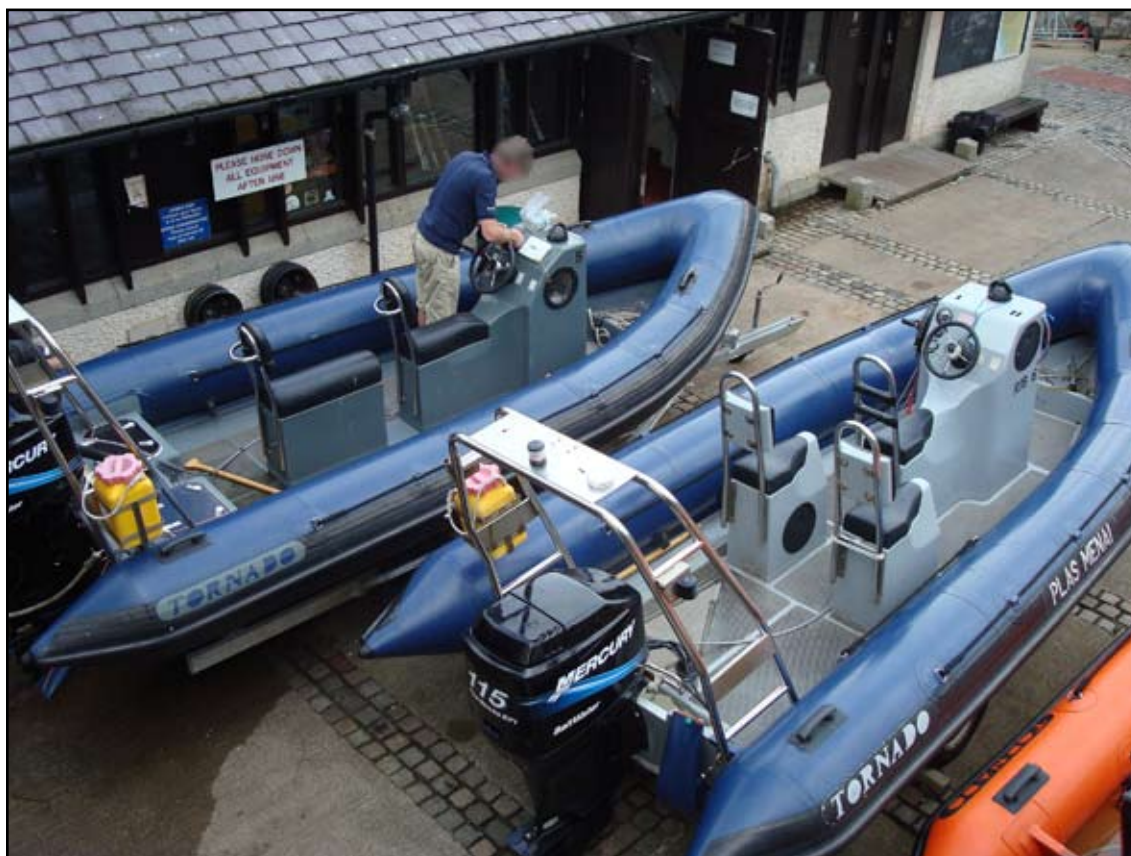
The boats originally allocated were two fast RIBs and a slower workboat. As a result of discussions about the suitability of the workboat, and the perceived expectations of the school group, the course supervisor and SliC allocated a third RIB instead of the workboat in order to give the students a more interesting and exciting activity (**Figure 3**).

RIB 5 and RIB 6

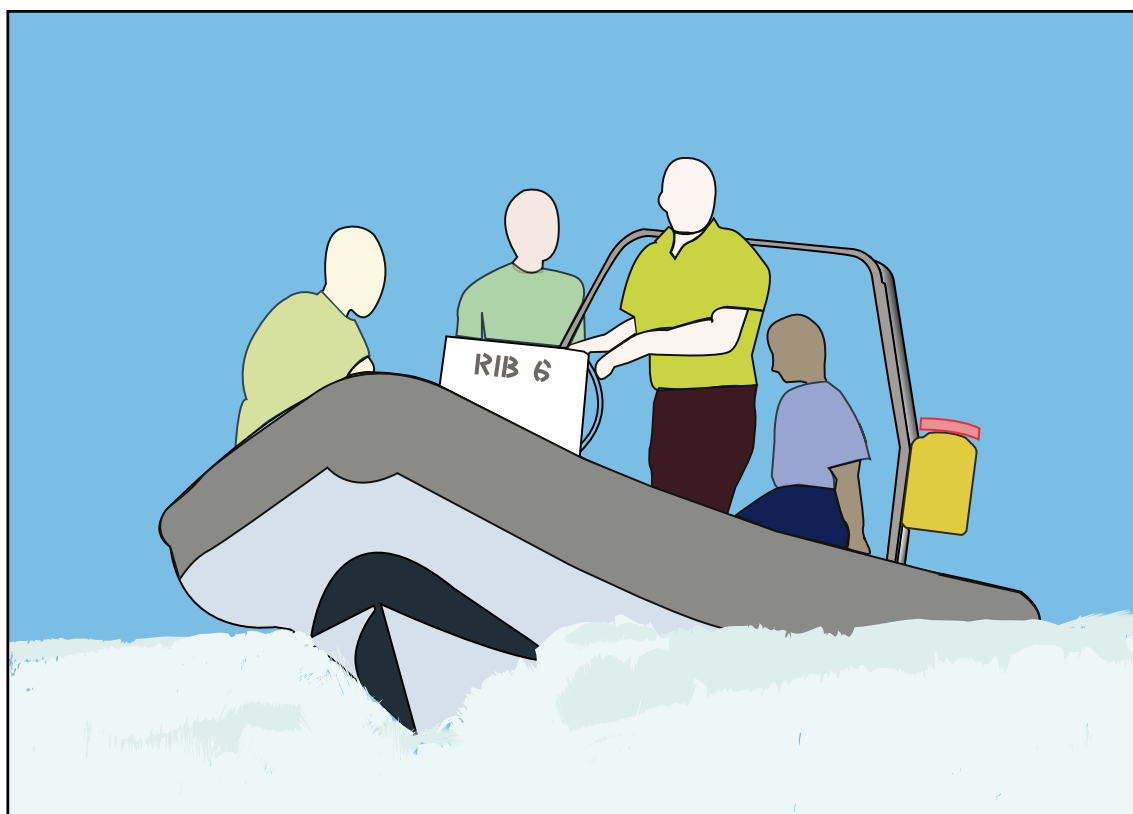
The SliC and JliC drove their RIBs from a position sitting on the jockey seat behind the console. The AI preferred to drive from a position standing next to the helm console on the port side, as she found it difficult to stand up in front of the seat, and felt that this position gave her better forward visibility when operating in waves (**Figure 4**).

Illustration showing *RIB 6* with driver standing at side of console

The AI stood at the port side of the console of *RIB 6* so as to get a better view forward. While this is a recognised technique when conducting powerboat training, it was not appropriate under the conditions prevailing at the time of the accident.

Plas Menai should review the qualifications and experience of instructors and, where necessary, provide further training to cover safe and effective powerboat handling under all local conditions.

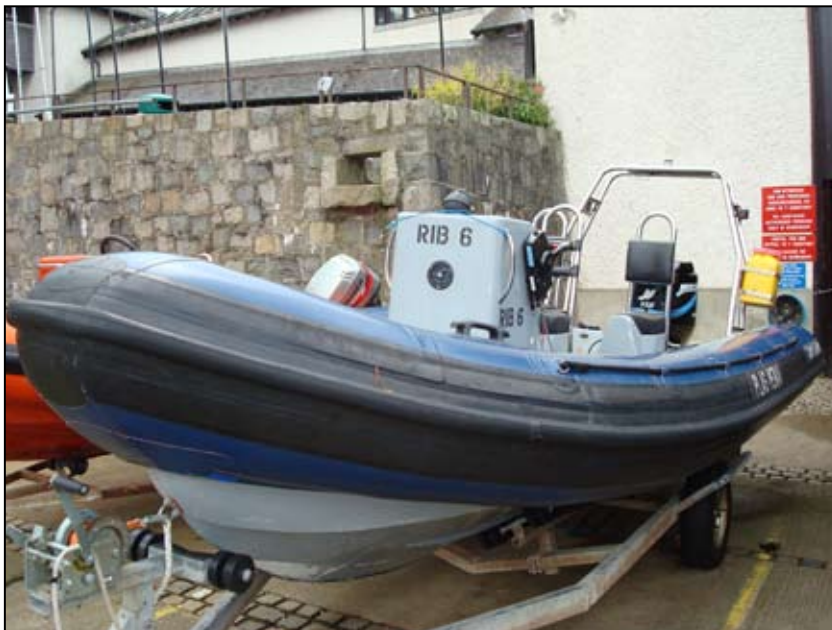
Figure 5

Tornado Boats International Ltd, the manufacturers of this 5.8m RIB, describe the boat as having a pronounced bow sheer and a shape that easily punches through oncoming waves. They also state that the deep Vee-shaped hull allows the craft to operate in the roughest of conditions (**Figure 5**). The RIB was fitted with a CE plate noting it as suitable for use in the Recreational Craft Directive (RCD) category C⁵ "Inshore" area, with a maximum capacity of 10 persons.

RIB 6 seen from bow
