Report on the investigation of  
the contact between  
***Pride of Provence***  
and  
The Southern Breakwater,  
Dover Harbour, eastern entrance  
on  
18 April 2003

Marine Accident Investigation Branch  
First Floor  
Carlton House  
Carlton Place  
Southampton  
United Kingdom  
SO15 2DZ

**Report No 26/2003  
November 2003**

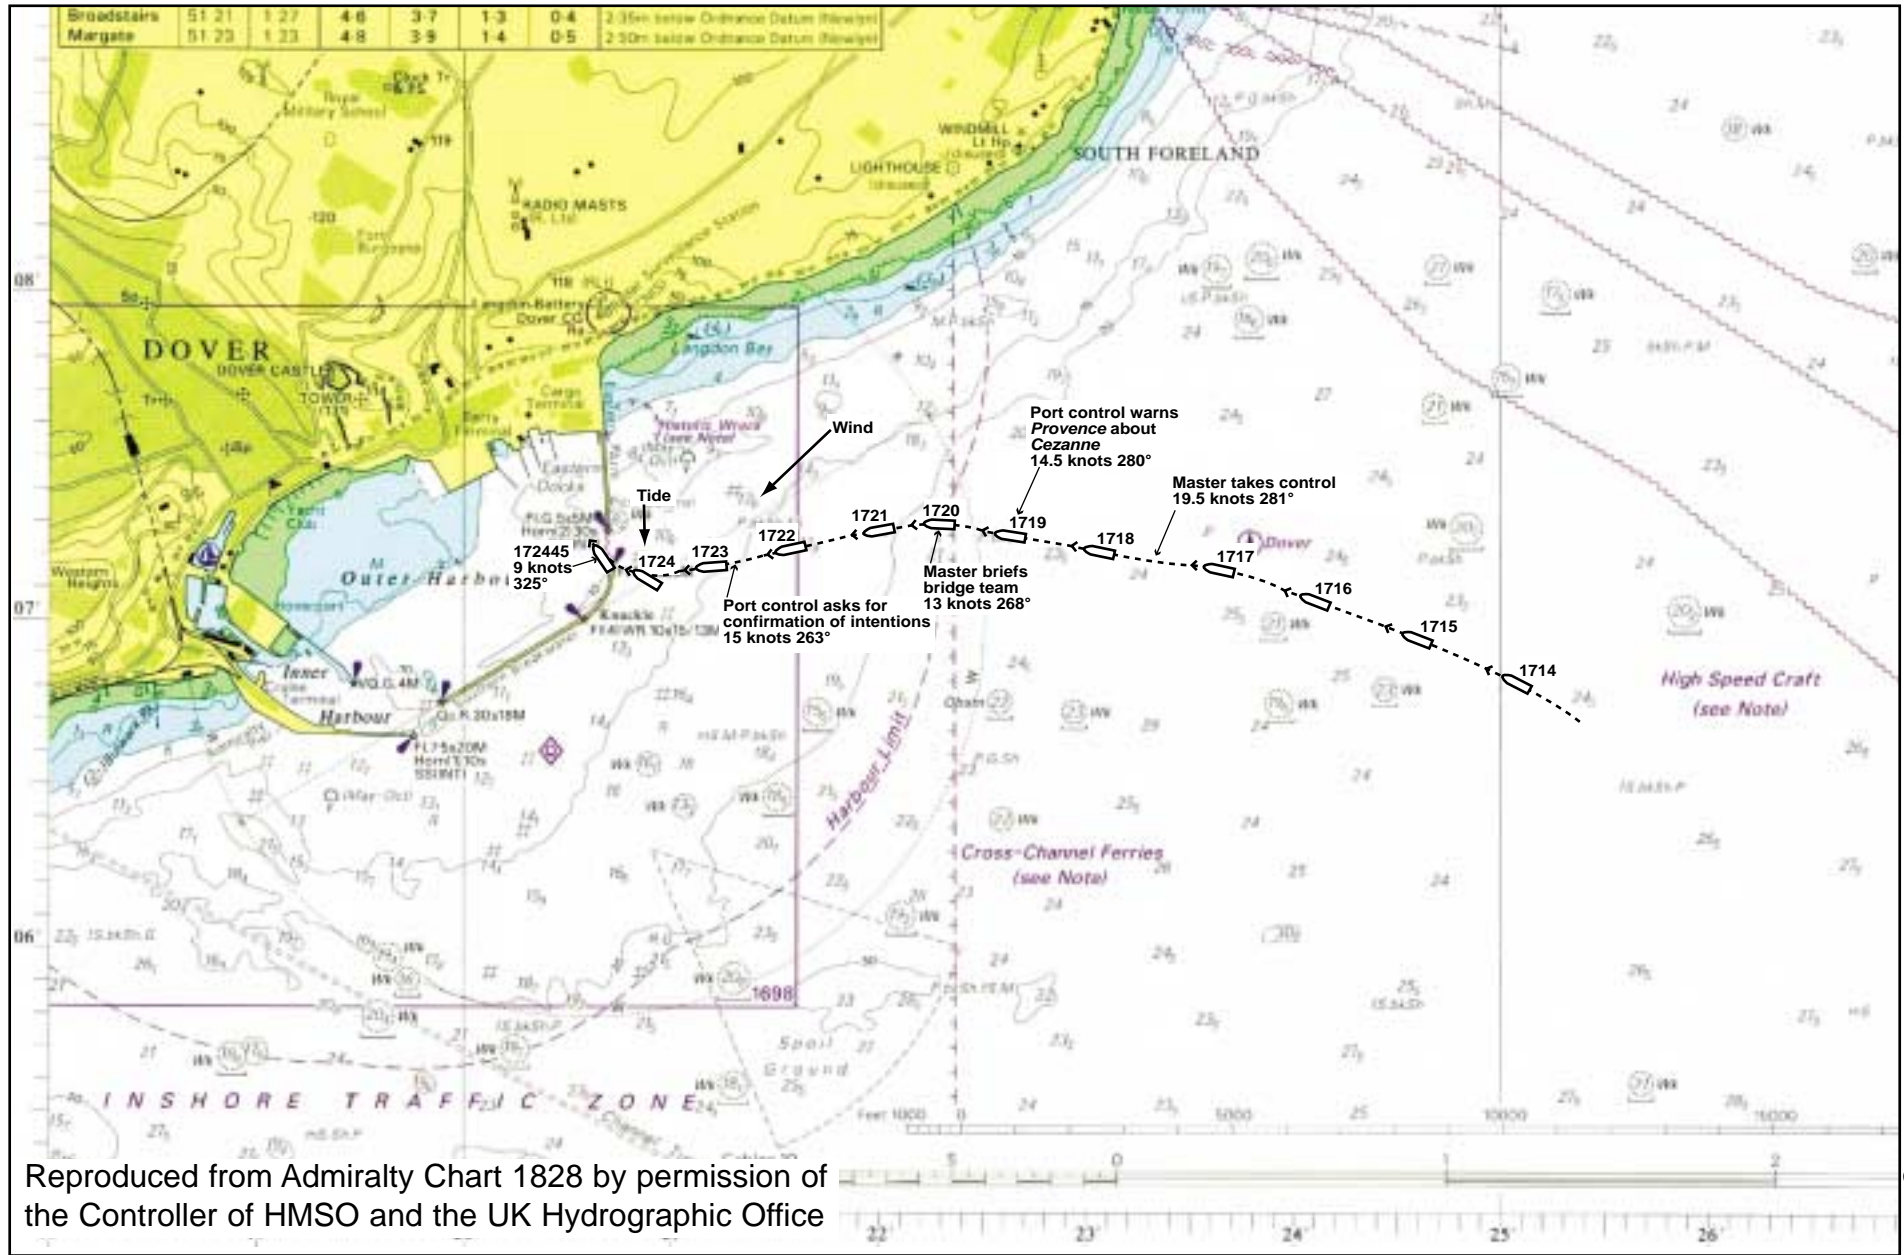
Figure 1

Port Control gave *Pride of Provence* permission to close to 1 mile and told the vessel that *Seafrance Cezanne* still had to berth and *Pride of Aquitaine* would be leaving. *Pride of Provence* was told that her berth would be No 2 and that Port Control would call back. Her speed at this time was about 19.5 knots (**see Figure 1**).

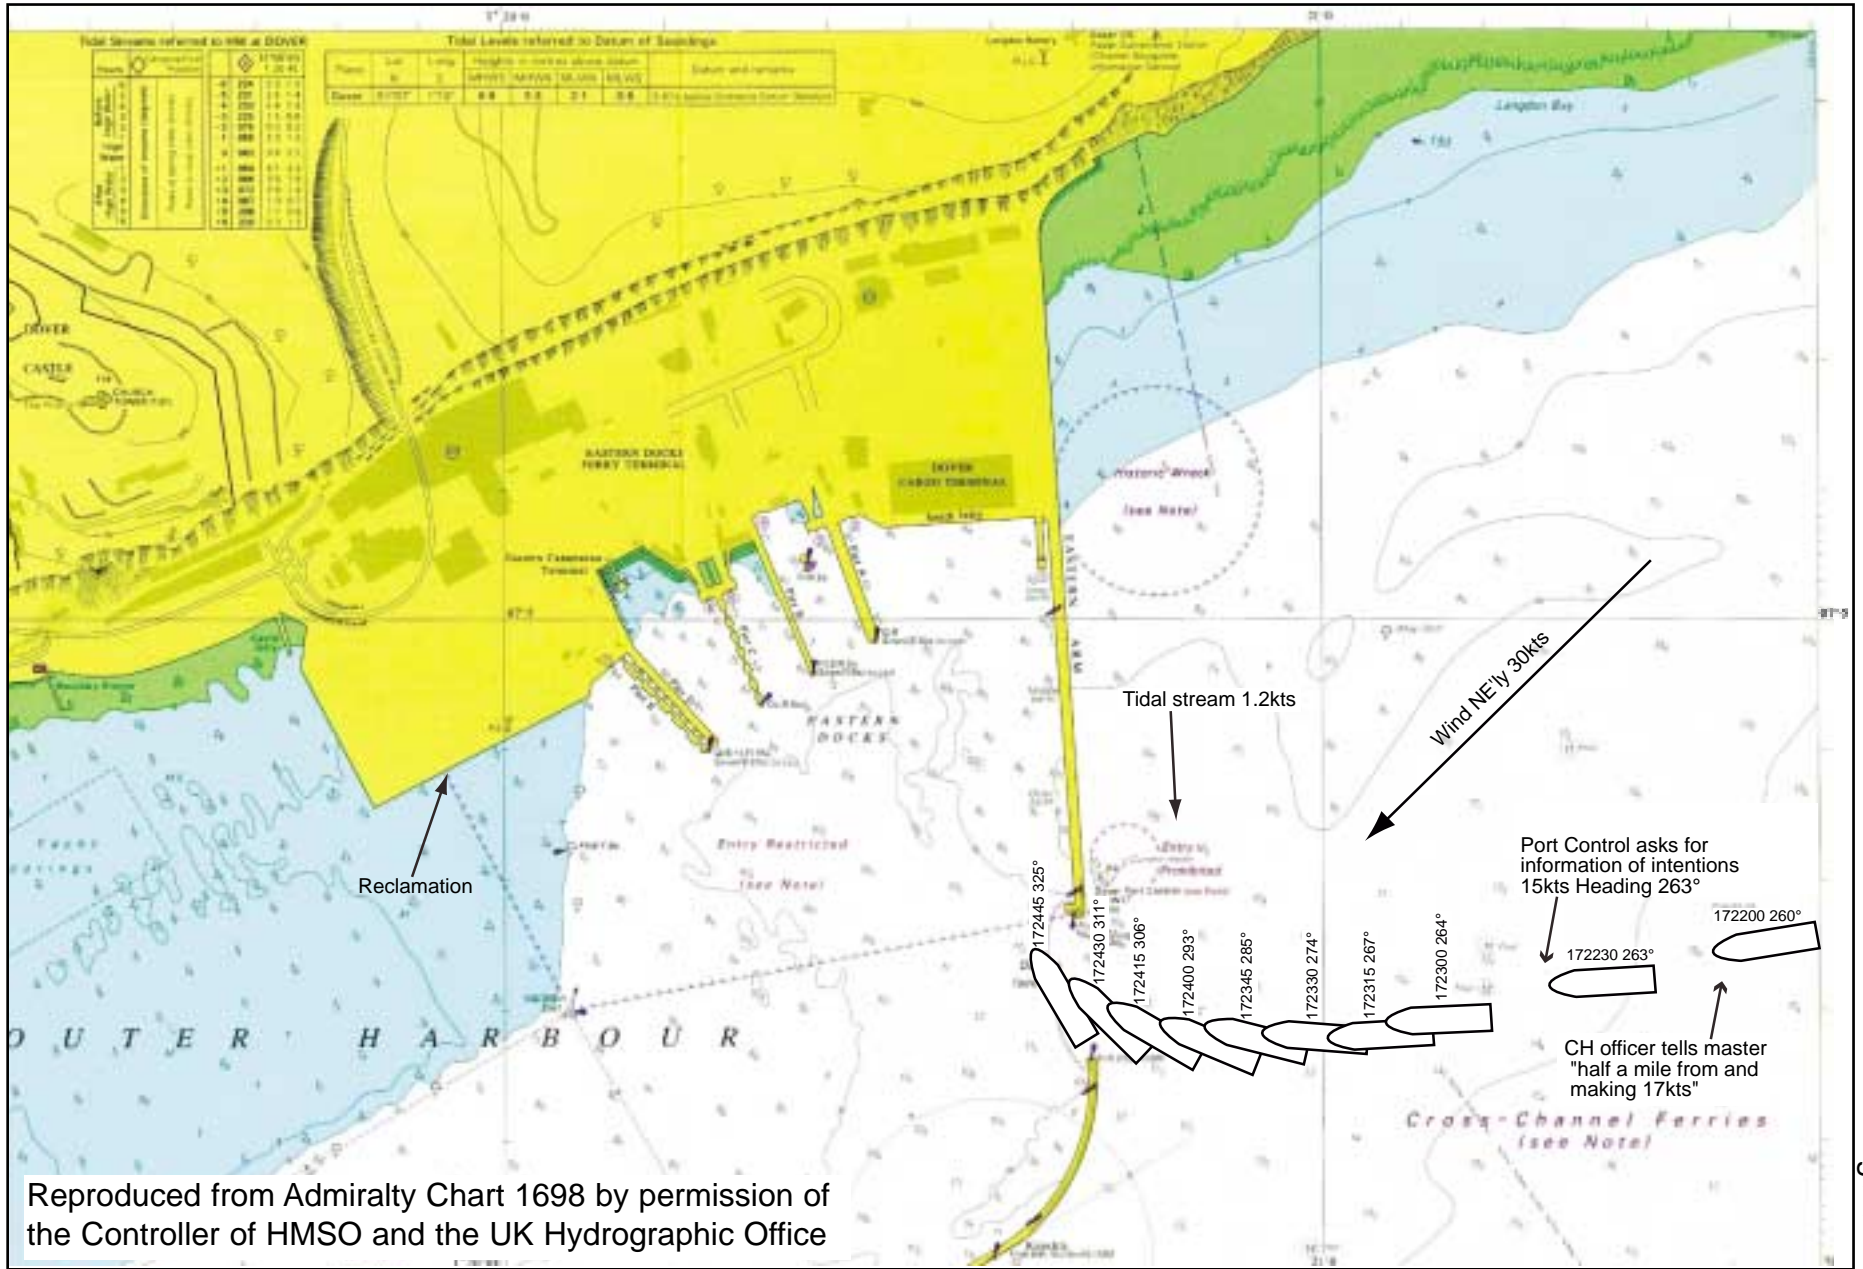
Figure 1A

At 1722, the chief officer told the master that they were ½ mile from the entrance and making 17 knots (**Figure 1A**). At this time *Seafrance Cezanne* was still manoeuvring off Nos 3/4/5 berths in preparation to berth in No 6. *Pride of Provence* was still on a heading towards the end of the southern breakwater of about 260°. The master reduced the propeller pitch.

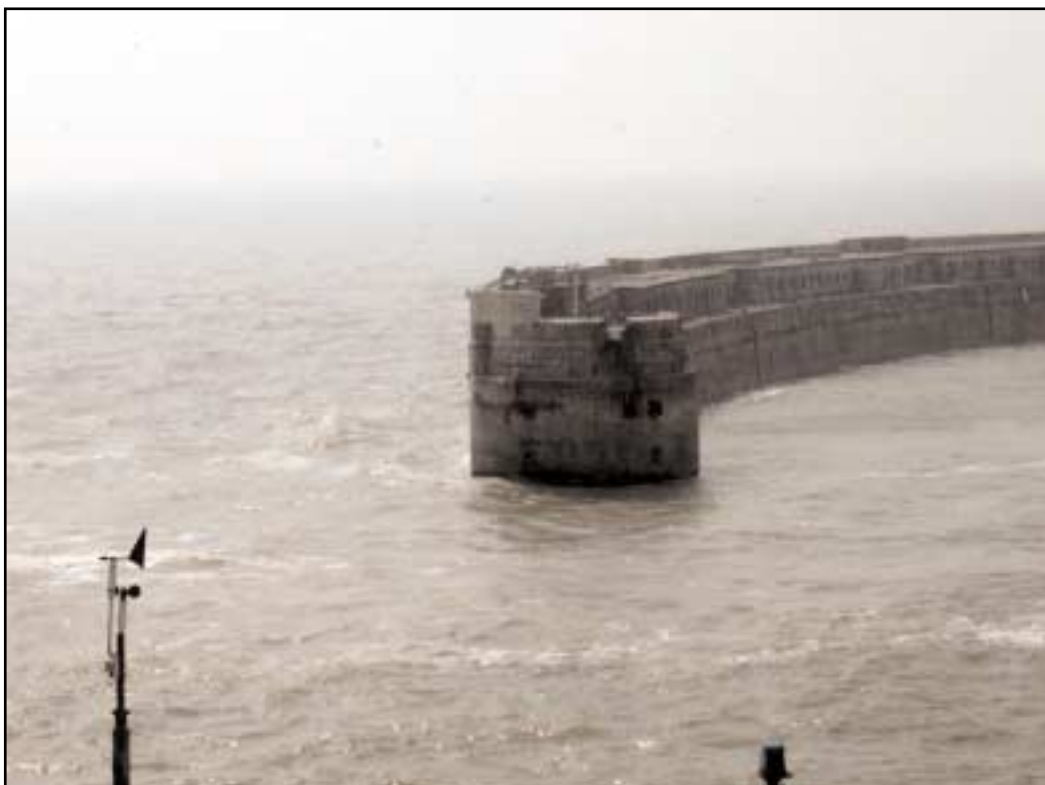
Photograph 3

The end of the Southern Breakwater

The master ordered hard-to-port but the rudder only had time to reach 5° to port before there was a heavy contact between the vessel’s port quarter and the end of the southern breakwater. The time was 1724:45 and the heading at that moment was about 325°. The vessel’s heading had still been swinging rapidly to starboard.

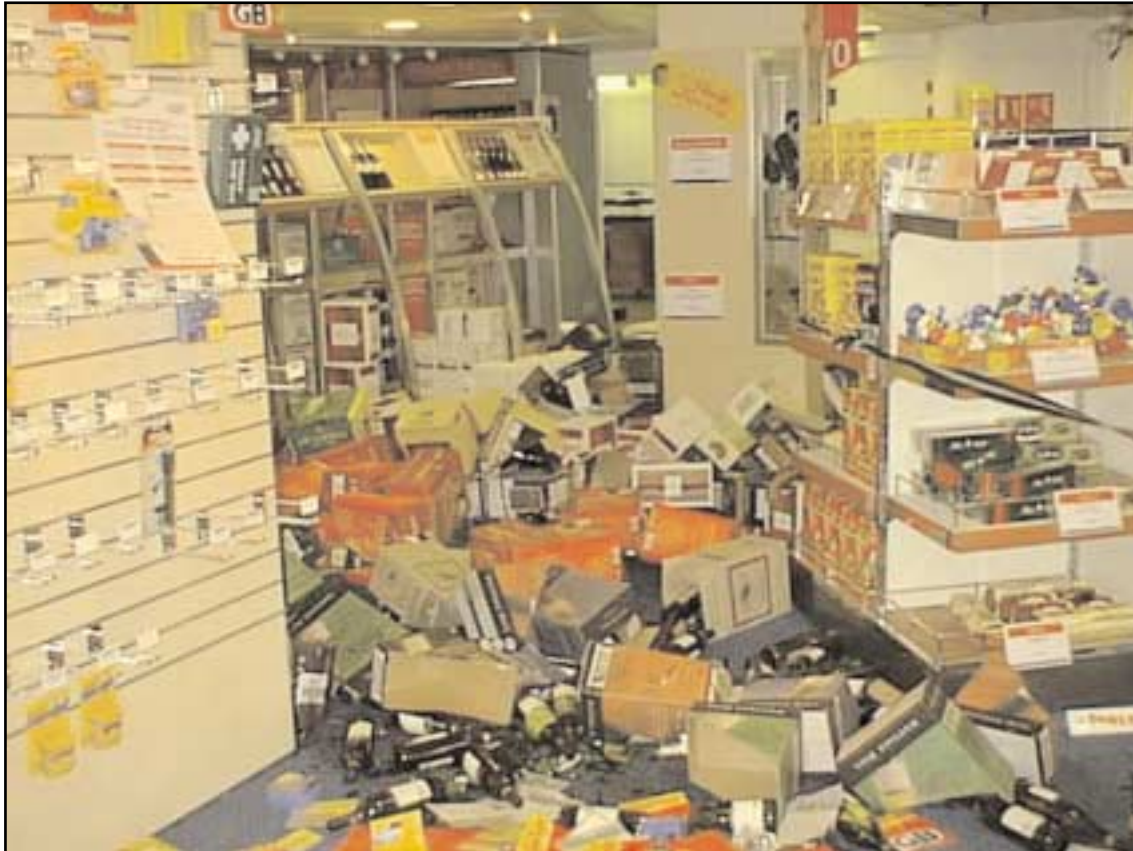
Photograph 5

A number of passengers and crew were thrown to the deck; chairs and tables were overturned and stock was thrown from the displays in the duty paid shopping area (**Photographs 4 & 5**). At least 30 passengers and crew were injured.

One of the shops after the accident

Additionally, in the public rooms and crew spaces, various display cabinets, refrigerated units, loose equipment such as tables and chairs, and a considerable amount of goods in the duty paid shop were dislodged. These items caused injuries to crew members and passengers, and provided hazards from broken glass.

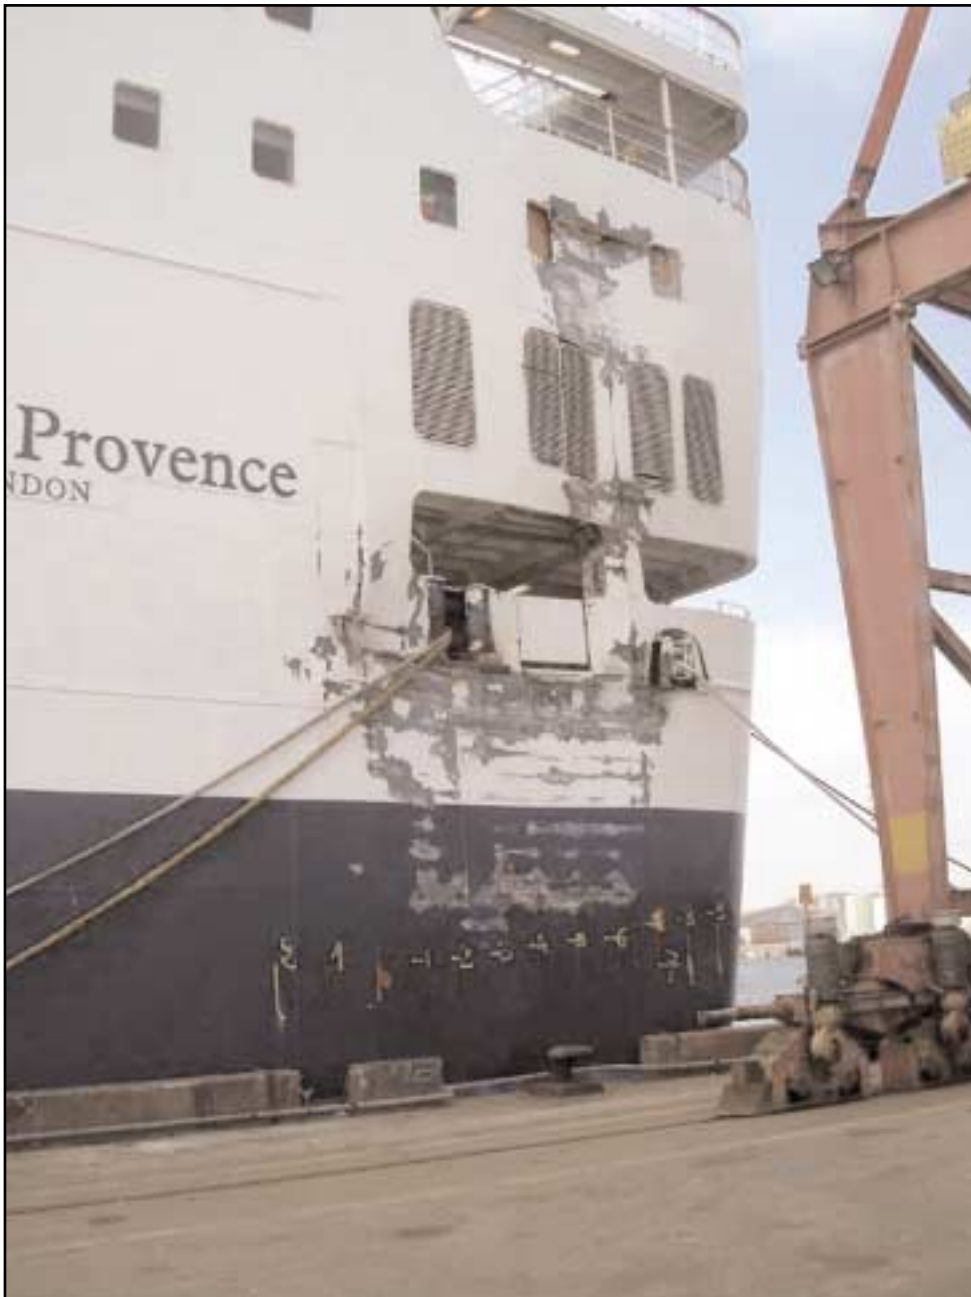
Photograph 6

The vessel had been substantially damaged above the waterline (**Photograph 6**). She was manoeuvred into the bay and she subsequently berthed safely under her own power. Tugs were needed to keep the stern alongside as the collision had damaged the hydraulic motors which served the after mooring winches. The vessel was met on the quayside by paramedics and nine of the injured were taken to hospital for further treatment and observation.

Damage to port quarter

The collision with the southern breakwater of the eastern entrance to Dover harbour caused considerable damage to the port quarter of *Pride of Provence*. The impact left damage in a perpendicular line, indicating a direct blow rather than a glancing one. The hull and superstructure between frames 1 and -11 from deck 2 to deck 8 were most severely affected (**Photograph 6**).

- an emergency escape hatch and access ladder crushed and impassable;
- hydraulic pump and pipework damage with hydraulic oil loss which prevented the after mooring winches from being used;
- damage to a fire door and its frame;

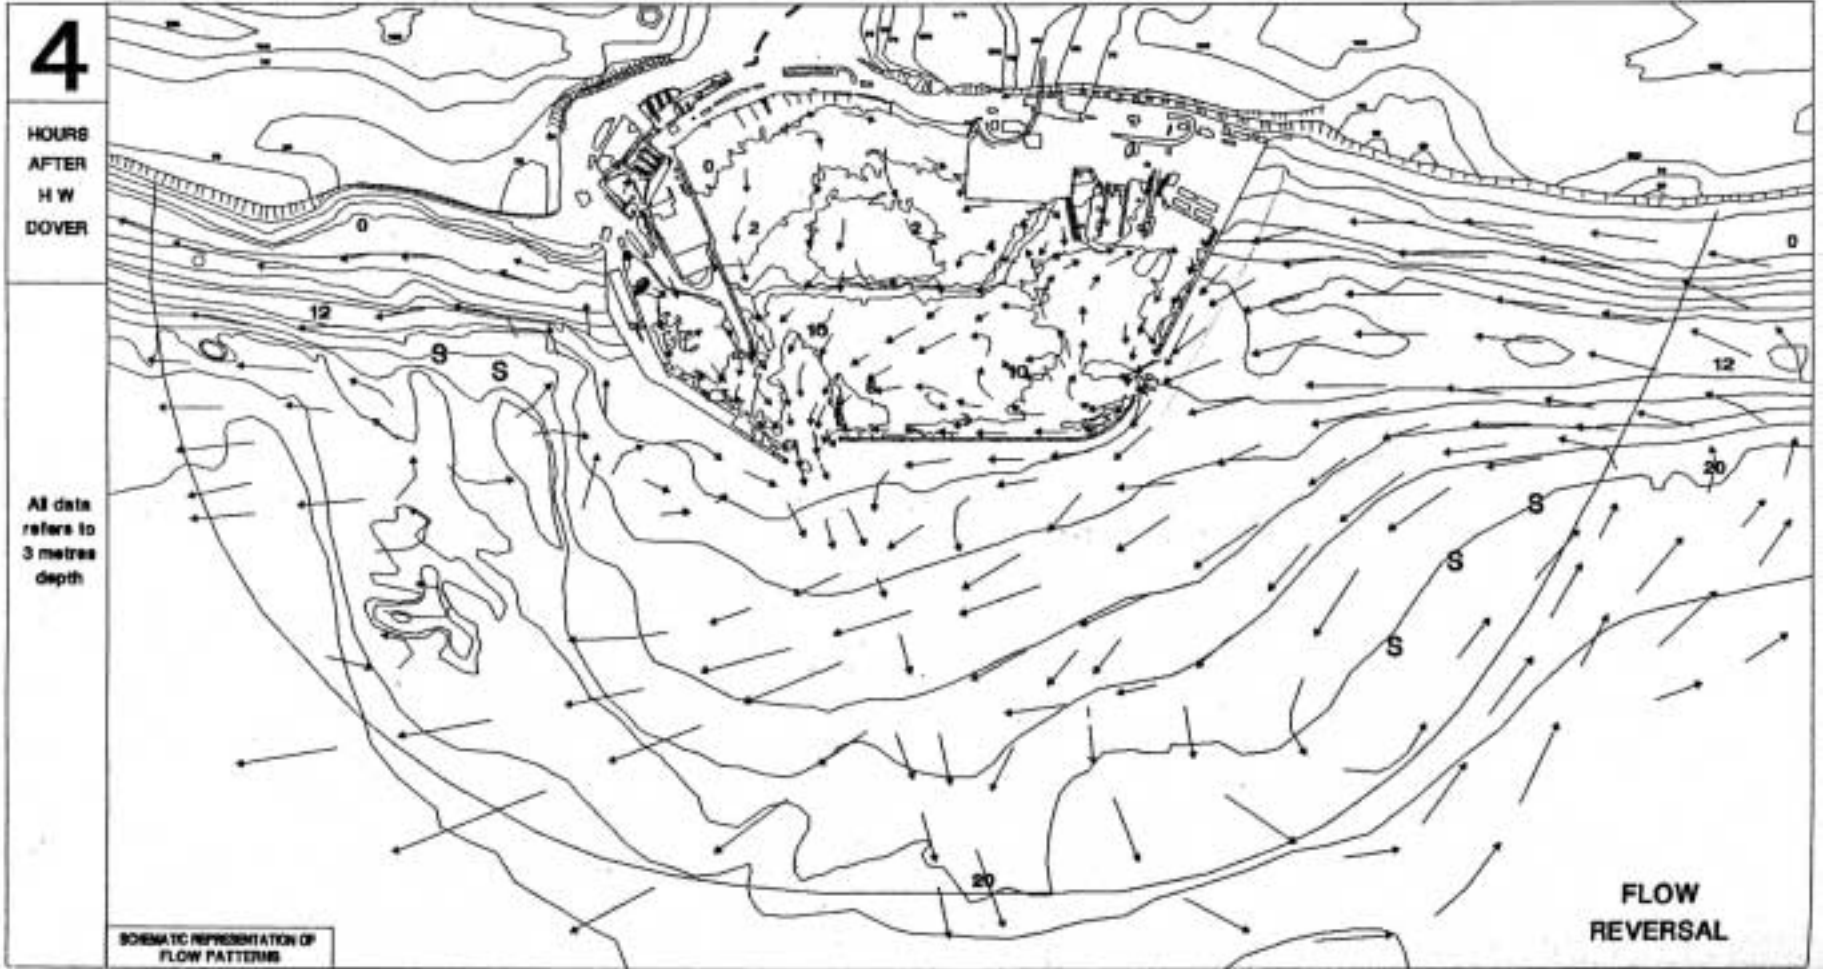
Figure 2

At the time of the accident it was daylight, the visibility was good and the sea state moderate in sheltered conditions. The wind was north-north-easterly 24 knots gusting to 33 knots. High water at Dover had been at 1257. It was a time of spring tides and the ebb tidal stream, running south across the harbour entrance, was measured at 1.6 knots at 2m depth and 1.2 knots at 4m depth (**see Figure 2**).

The tidal streams at about 1700

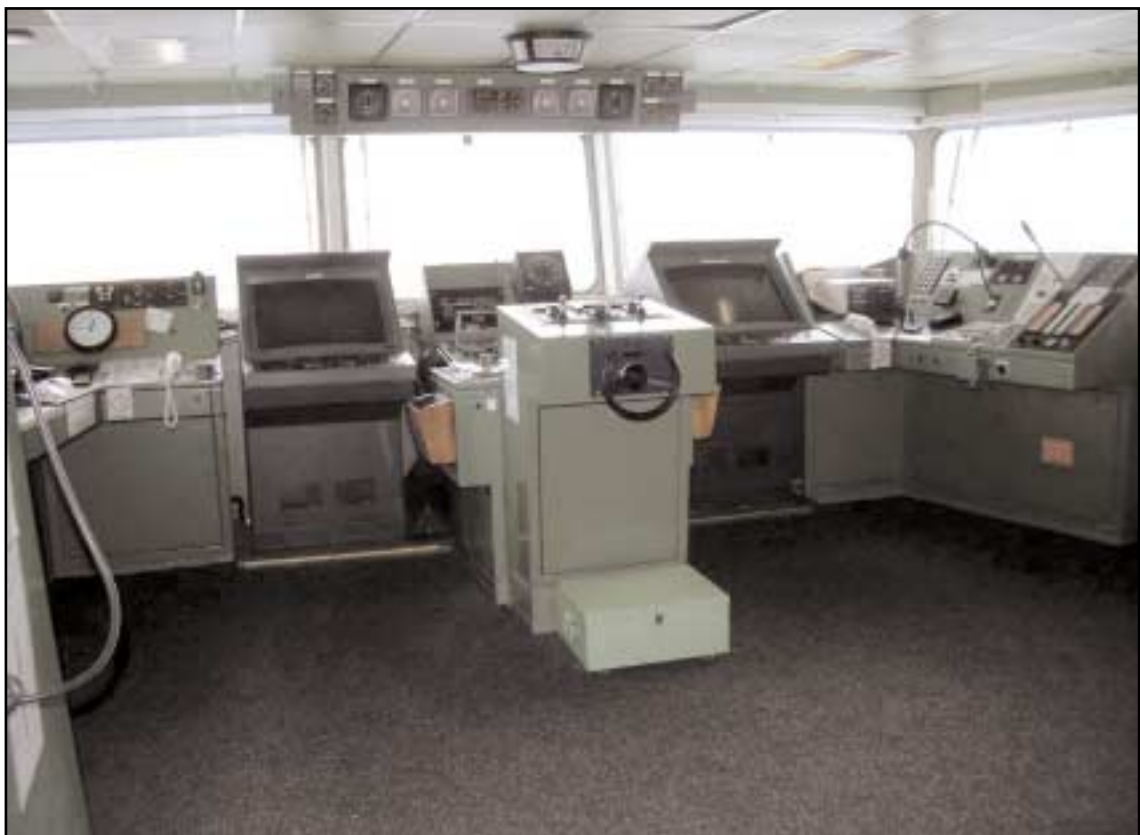
Photograph 7

The central console

At the time of the accident, the master was conning the vessel from a position by the starboard radar at the central control console; the chief officer was next to him by the port radar. A quartermaster was steering from the wheel position and another quartermaster was acting as lookout on the port bridge wing. The second mate had joined the cadet on the starboard bridge wing and the supernumerary master was standing behind the master.

The master had limited peripheral vision from his position and he had no view astern. He therefore relied on radar and information from the lookouts concerning anything close to the vessel on either side and anything abaft the beam. It was difficult to get a clear perception of the rate of turn from the central control position because it was so far forward and had no view astern.
