SYNOPSIS

At 1558 on 10 March 2006, the ro-ro passenger-vehicle ferry *Red Falcon* made heavy contact with the linkspan at Town Quay, Southampton. Eleven people - 8 passengers and 3 Red Funnel employees were injured as a result of the accident, and some of the vehicles on board were damaged.

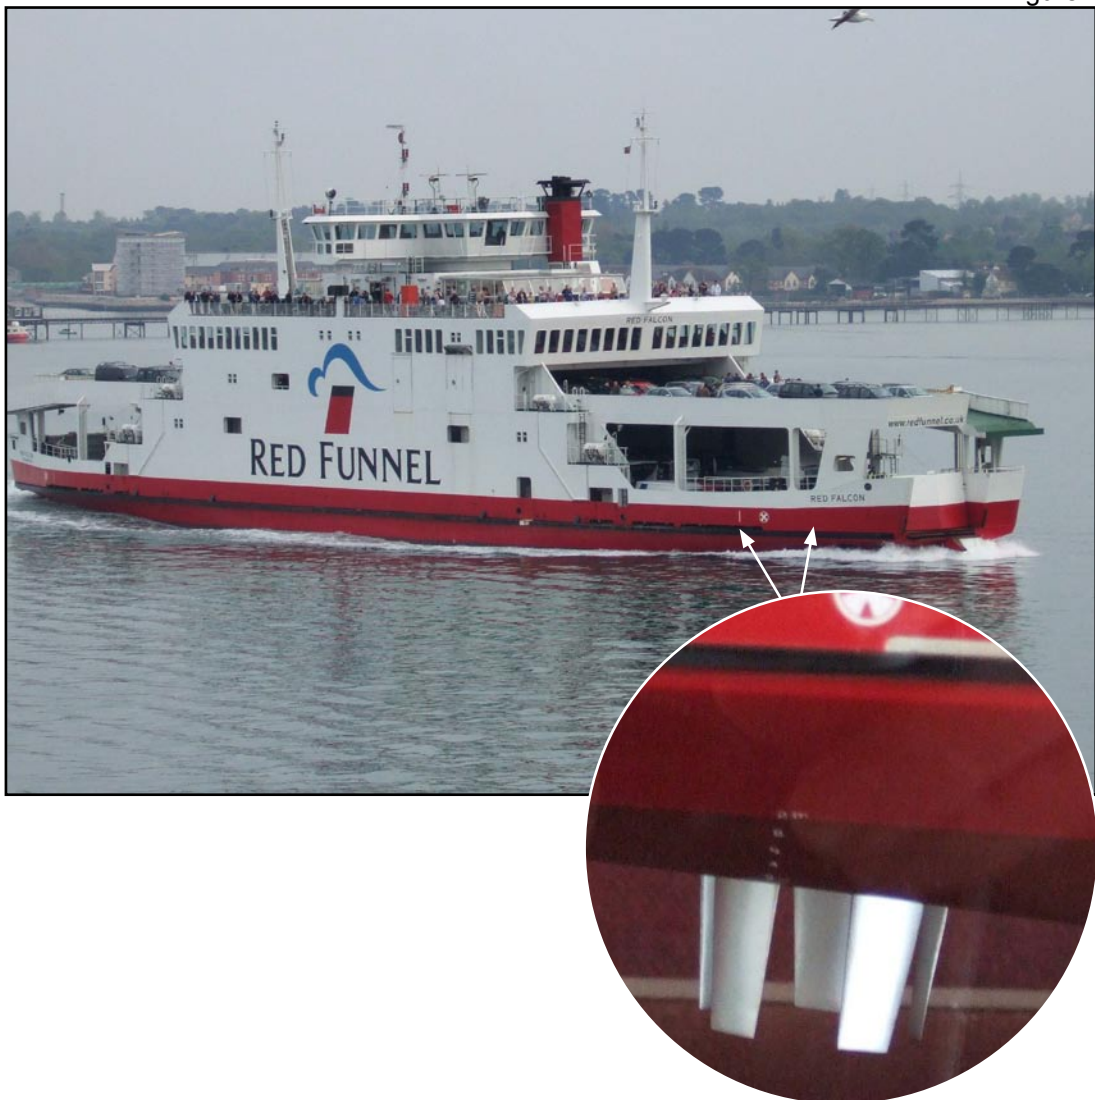
Figure 1

Red Falcon detailing Voith Schneider propeller blades
