Report on the investigation of
the capsizing of

**Army Cadet Force
Rigid Raiding Craft**

In Loch Carnan, South Uist,
Western Isles of Scotland

**Report No 6/2008
March 2008**

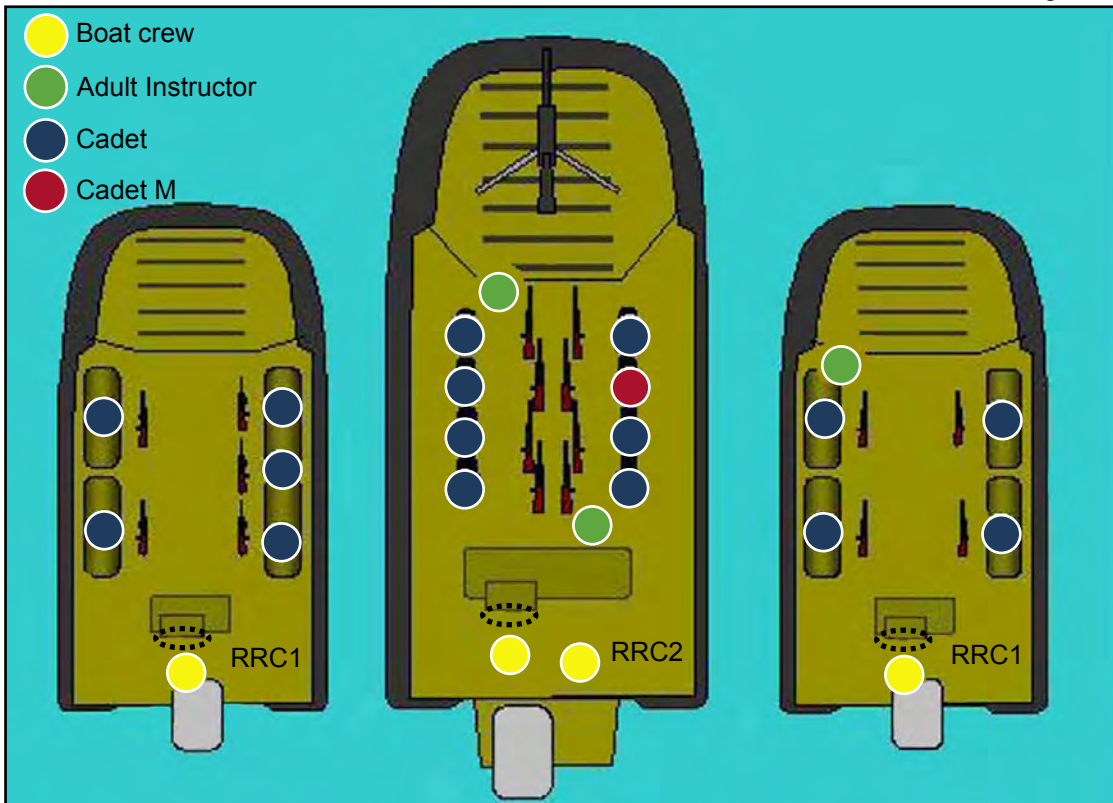
Boat loading at the time of capsizing

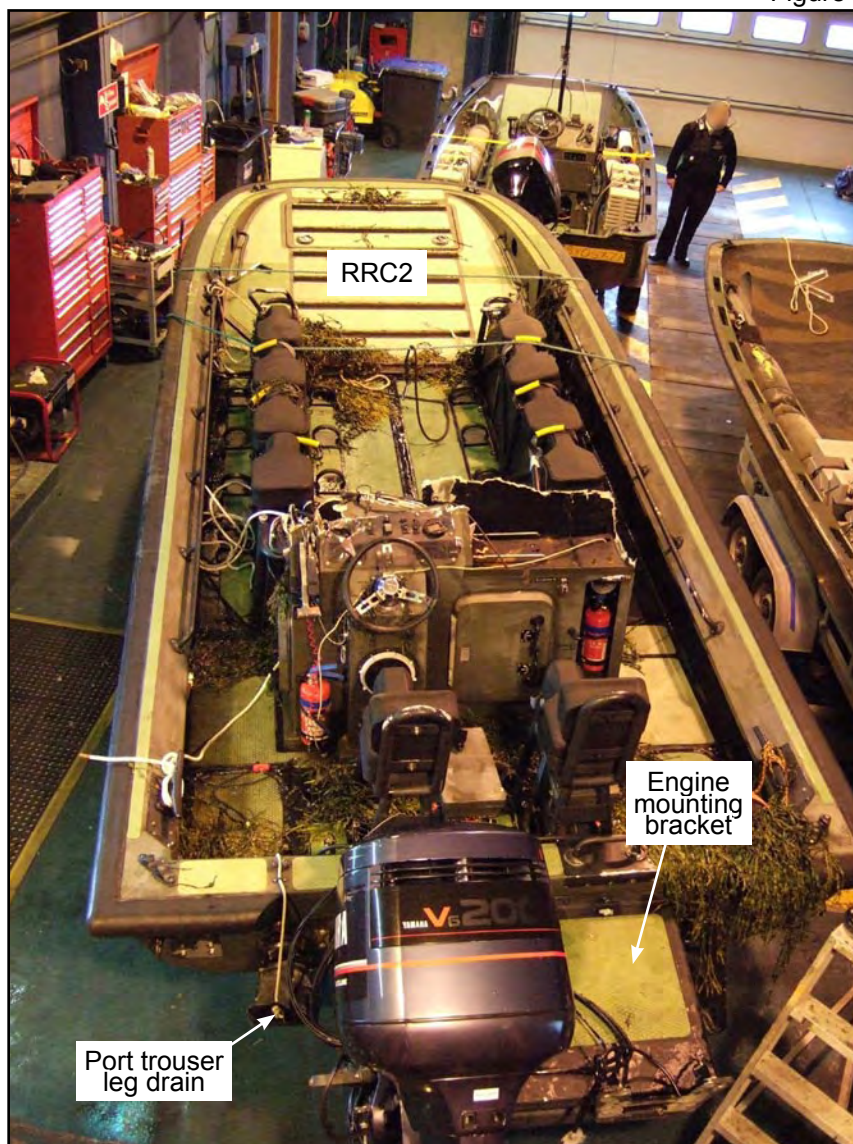
Figure 4

With the exception of the damage caused to the boat's steering console and seats when it landed onshore (**Figure 4**), the interior of the recovered hull showed no significant signs of damage. Evidence of minor damage and earlier repairs was found on the external hull. The hull buoyancy material in an area of damage approximately 12cm long and 2cm wide (**Figure 5**) contained water.

Rigid raiding craft after capsizing

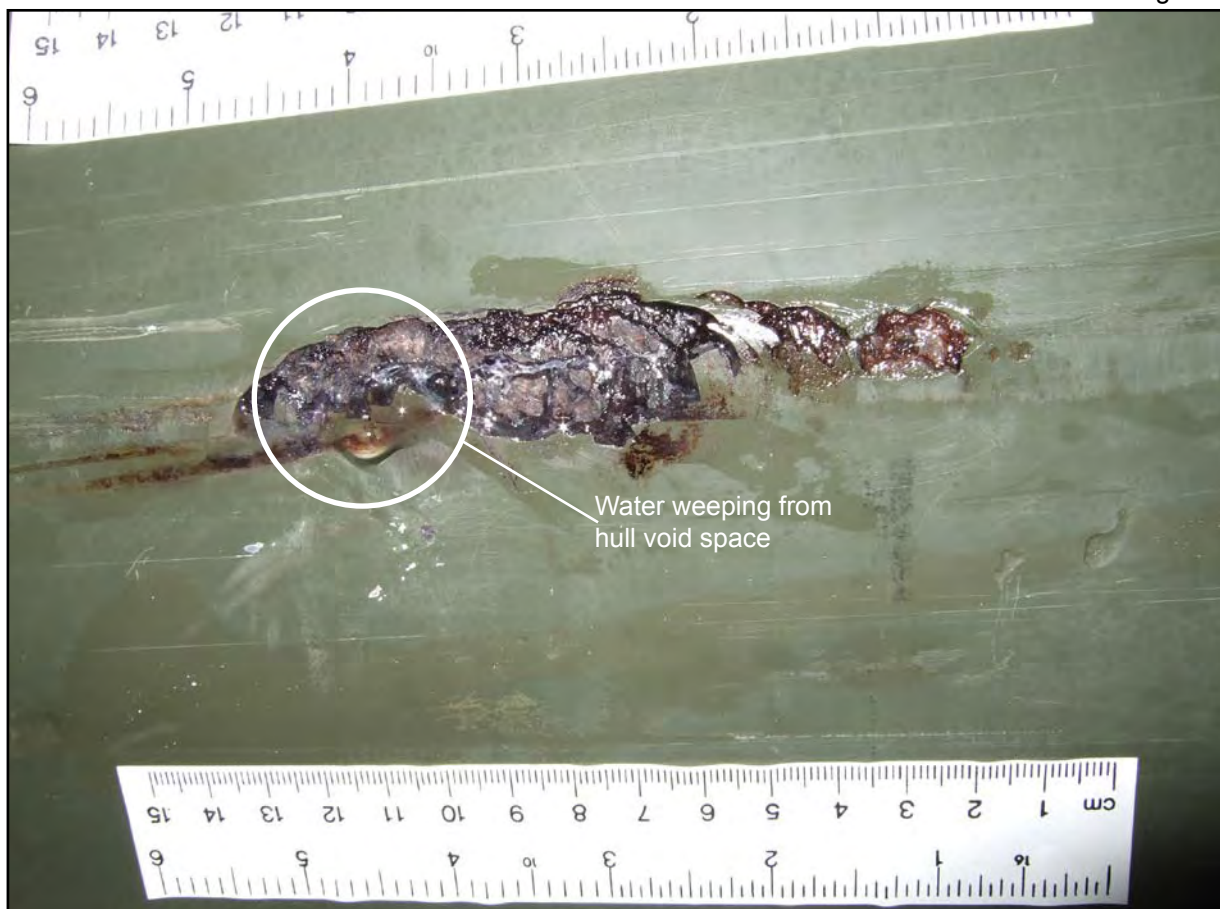
Figure 5

Water weeping from hull void space

Hull damage

The minor damage to the hull of the RRC2 observed following the accident could have adversely affected the buoyancy of the craft to some degree. However, it is not known whether the damage occurred before or after the capsizing and, in view of the results of the trials conducted, it is not considered to have been a contributory factor.

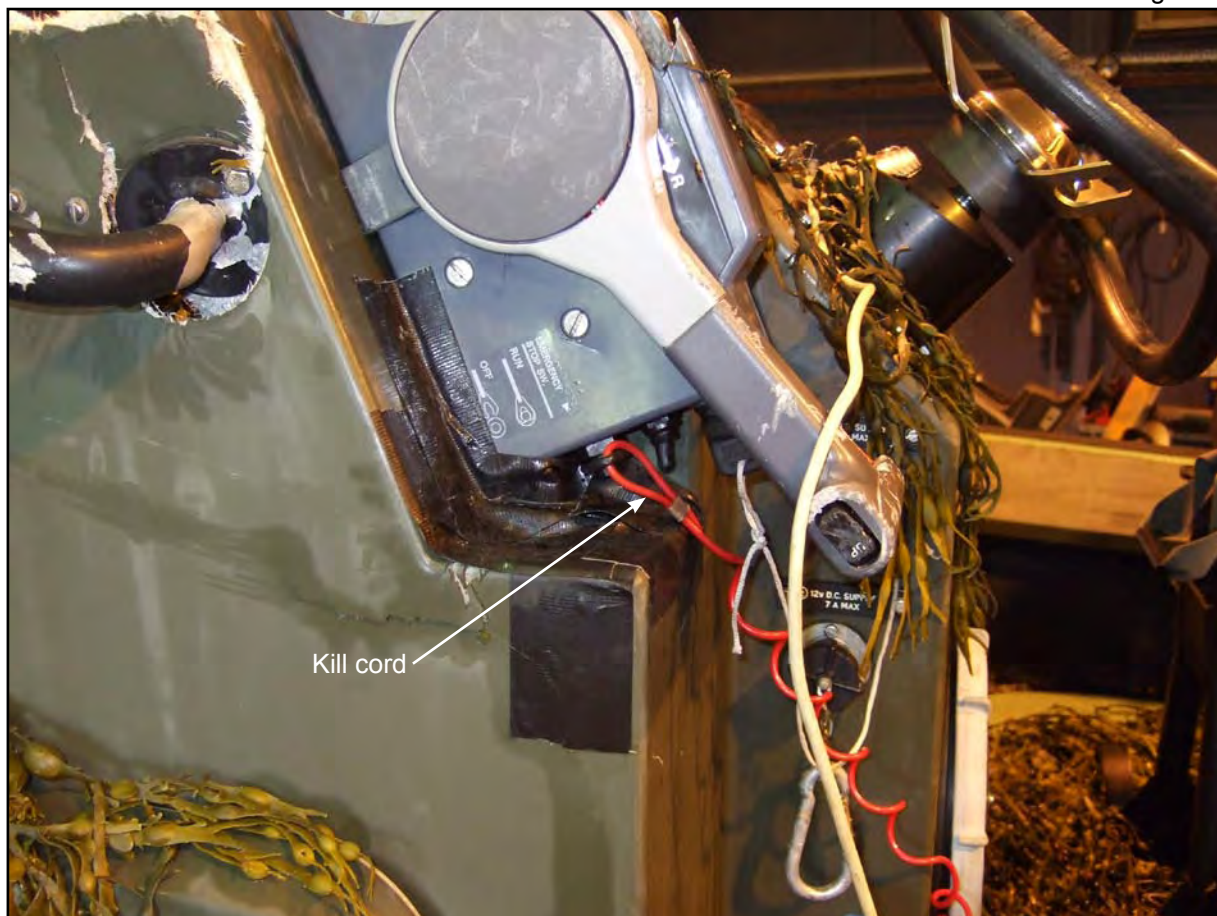
Figure 6

The Yamaha 200BETO, 2 cycle, 6 cylinder outboard motor fitted to the RRC2 was manufactured in 1991. The engine was positioned on the port side of the mounting bracket (**Figure 4**). Although there was evidence of minor water ingress on the spark plugs, the engine was in a sound condition. As the engine was not connected to any electronic control or monitoring device, it was not possible to determine the engine performance immediately prior to the accident. The kill cord¹⁸ was found attached to the engine cut out switch (**Figure 6**).

Kill cord

re-secure the boat's kill cord, which was found attached to the engine cut off switch after the RRC2 had been recovered. In view of the CEO's rest pattern during the week before the accident, it is unlikely that his performance or decision-making was adversely affected by fatigue.

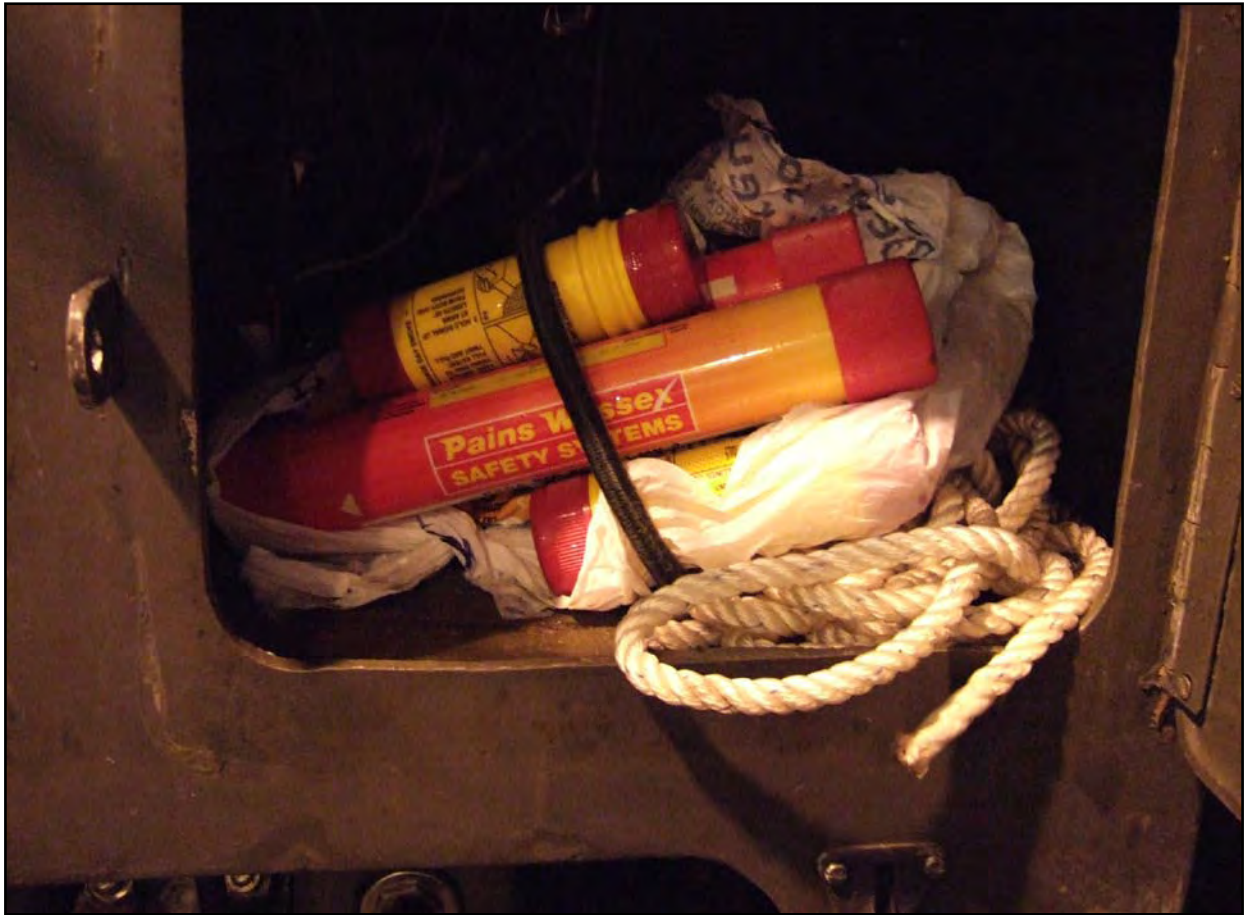
The pyrotechnics found on board the RRC1s after the accident were out of date. The pyrotechnics recovered from the lead RRC expired in June 2006. They were stored in the boat's console cabinet in a carrier bag and were found to be wet and lying in a pool of water (**Figure 7**). The pyrotechnics in the rear RRC expired in August 2005.

Boat one pyrotechnics

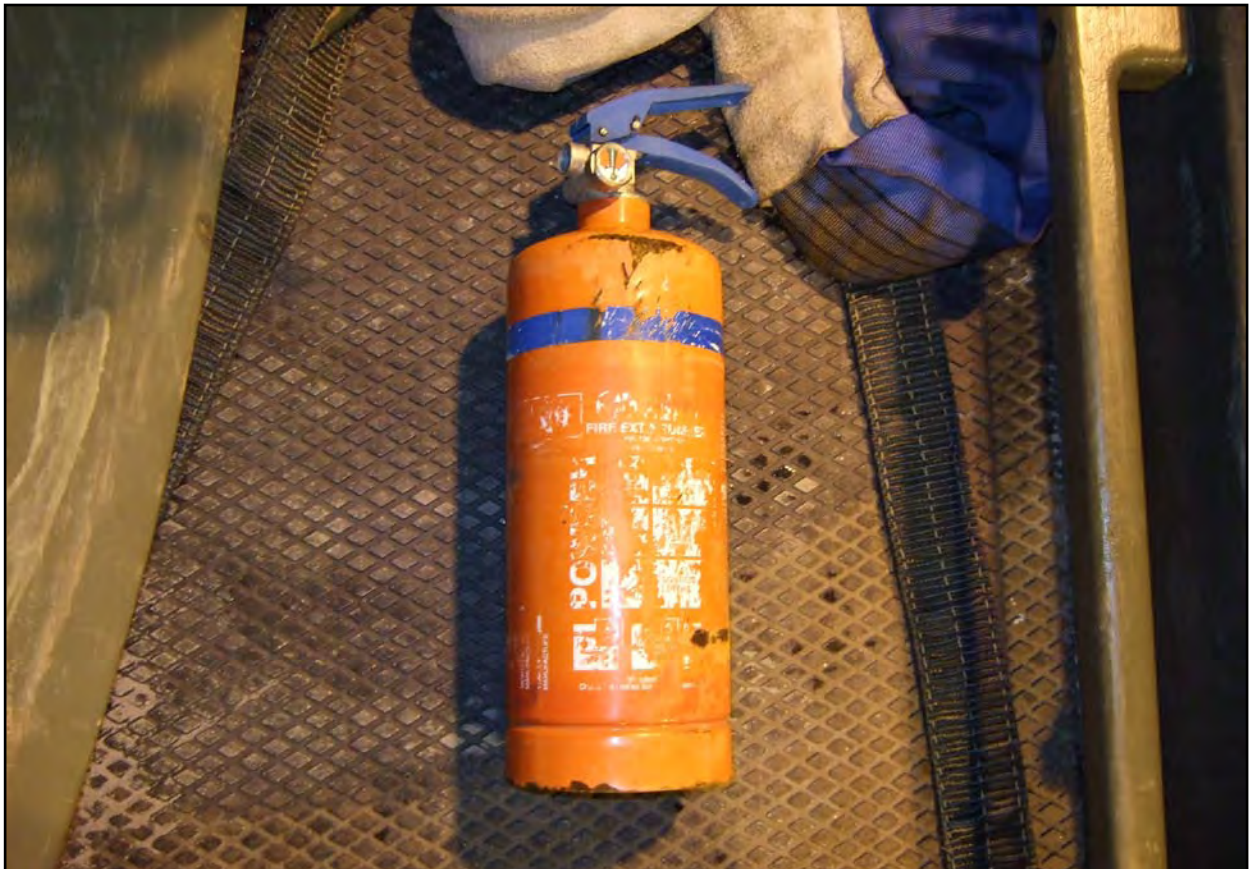
Each boat was equipped with dry powder fire extinguishers. Some of the fire extinguishers were found to be in a poor condition (**Figure 8**). There were no procedures in place to inspect the extinguishers, and their maintenance history was unknown.

Dry powder fire extinguisher from vessel

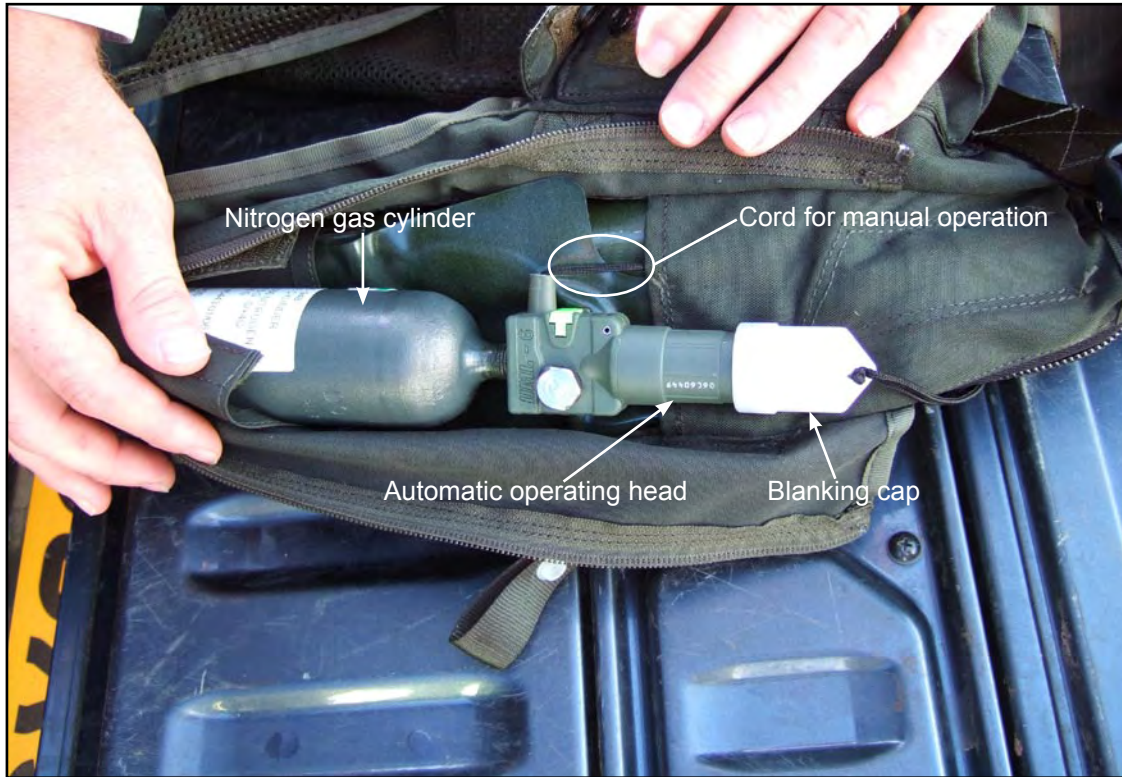
Figure 9

The lifejackets used by the adults and cadets recovered from the water were inspected after the accident, and a number of observations were noted. In particular, the lifejacket worn by the female instructor was found to have a blanking cap fitted over its activation head (**Figure 9**). One of the ATLJs was found to have partially deflated and its gas cylinder was found to be loose. The spray hoods had not been deployed and a number of the high visibility patches had been concealed by the green flaps (**Figure 10**).

Manually operated Landing Craft lifejacket used by the female instructor

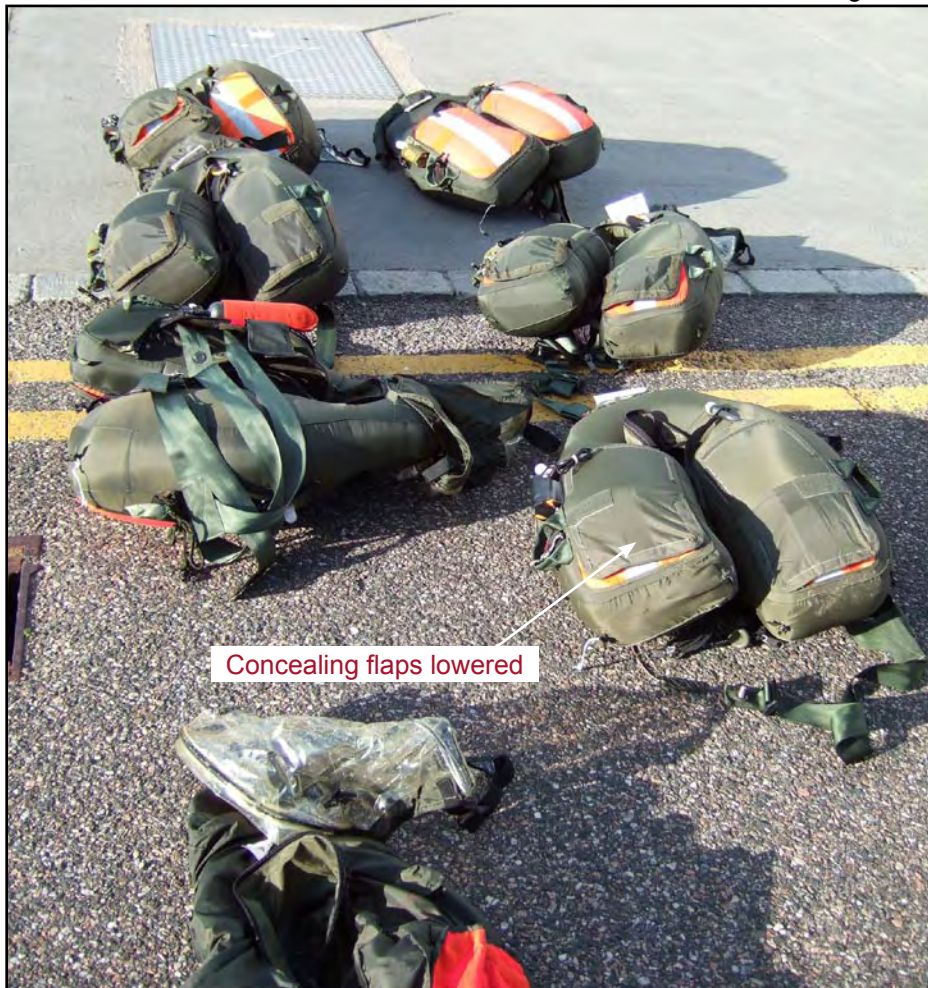
Figure 10

Lifejackets recovered from cadet survivors

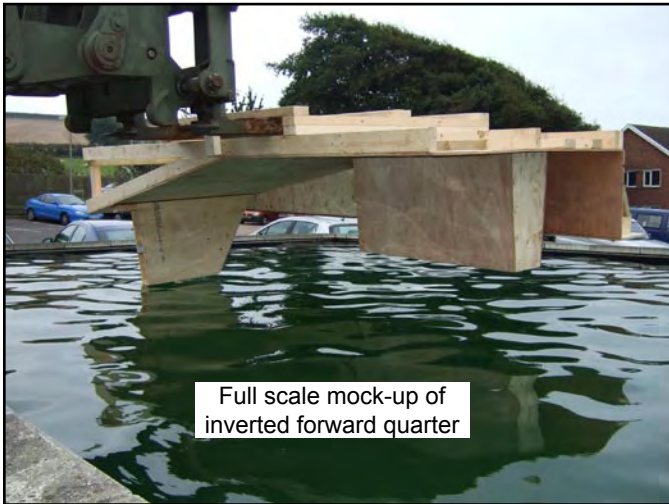
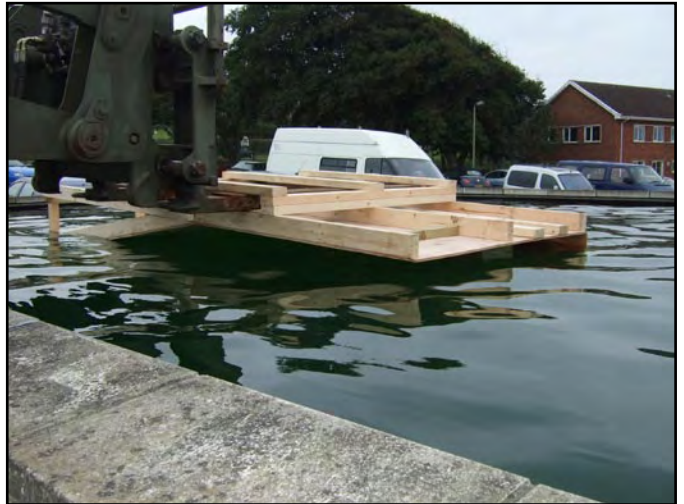
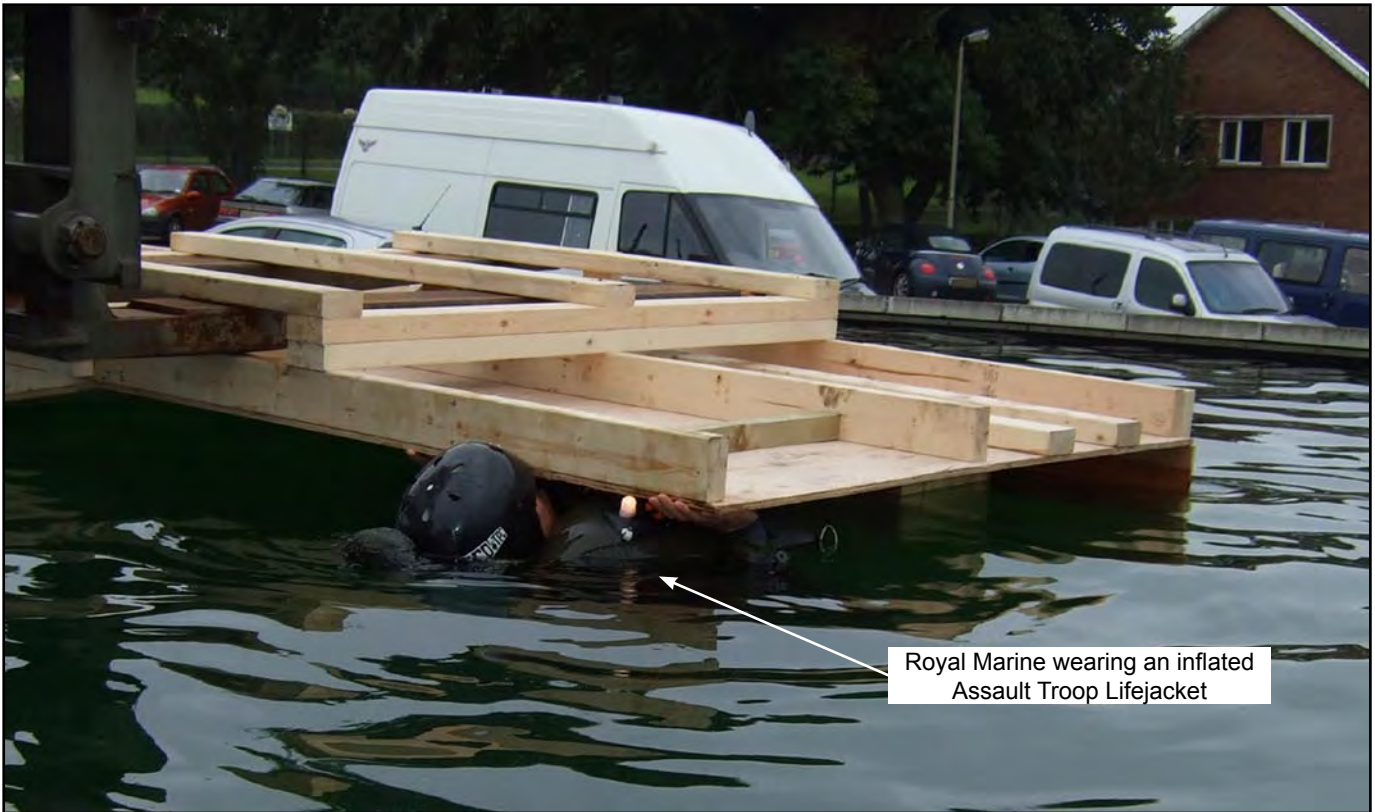
Figure 12

The Fleet Landing Craft and Raiding Craft Trials Authority also conducted a demonstration of the effect of the buoyancy of the ATLJ. For the demonstration, a wooden mock up of the port forward quarter of a capsized RRC2 was constructed and lowered into a pool to leave an air gap similar to the one generated by the upturned craft. A Royal Marine Commando, wearing an inflated ATLJ, was then positioned under the rig and instructed to force his way under the upturned seats. However, the inflated lifejacket pinned him to the deck of the rig and he was unable to make an escape (**Figure 12**). The trial was repeated using an approved 150N buoyancy lifejacket during which the marine found it relatively easy to escape from beneath the rig.

Full scale mock-up of inverted forward quarter

Royal Marine wearing an inflated Assault Troop Lifejacket

Assault Troop lifejacket escape trial

1. The lifejacket worn by Cadet M was not approved for use by children, and its buoyancy was over three times that of the SOLAS approved lifejackets supplied by the MoD for cadet force adventurous training activities. Consequently, once inflated, it would have pinned Cadet M under the craft and prevented her escape. [2.4]

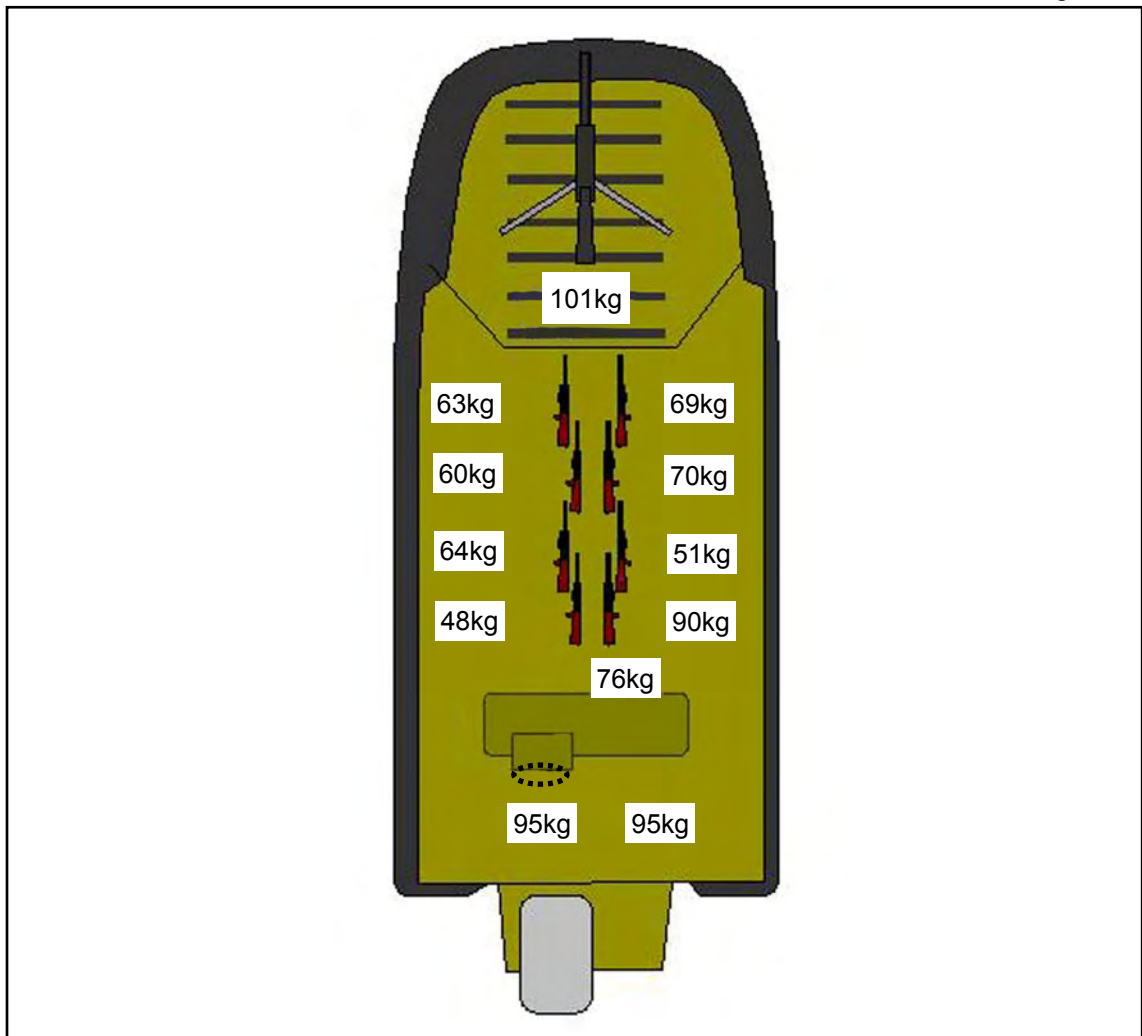
Figure 13

After the water entered the RRC2, it became trapped on the deck because the trouser leg drains had not been lowered and there was no alternative means of escape. In view of the offset position of the single outboard engine (**Figure 4**), it is likely that the vessel was listing to port to some degree. The list increased as the water naturally flowed to, and collected, on the lower side.

Boat weight distribution

The trigger for capsizing was the movement of the cadets seated on the port side towards the starboard side. This transfer of weight induced a heeling moment to starboard, which resulted in the accumulated water flowing across the deck. It is evident that the combined weights of the cadets and water were then sufficient to cause the craft to capsize. This is supported by trials conducted following the accident (**Figure 11**). However, unlike the trials, it is probable that capsizing could not be prevented by the cadet's return to the centre of the craft as the rate of capsizing is likely to have been greater due to the vessel's turn to starboard and the environmental conditions.
