Part 2 – Fishing Vessels

With the Best of Intentions ...

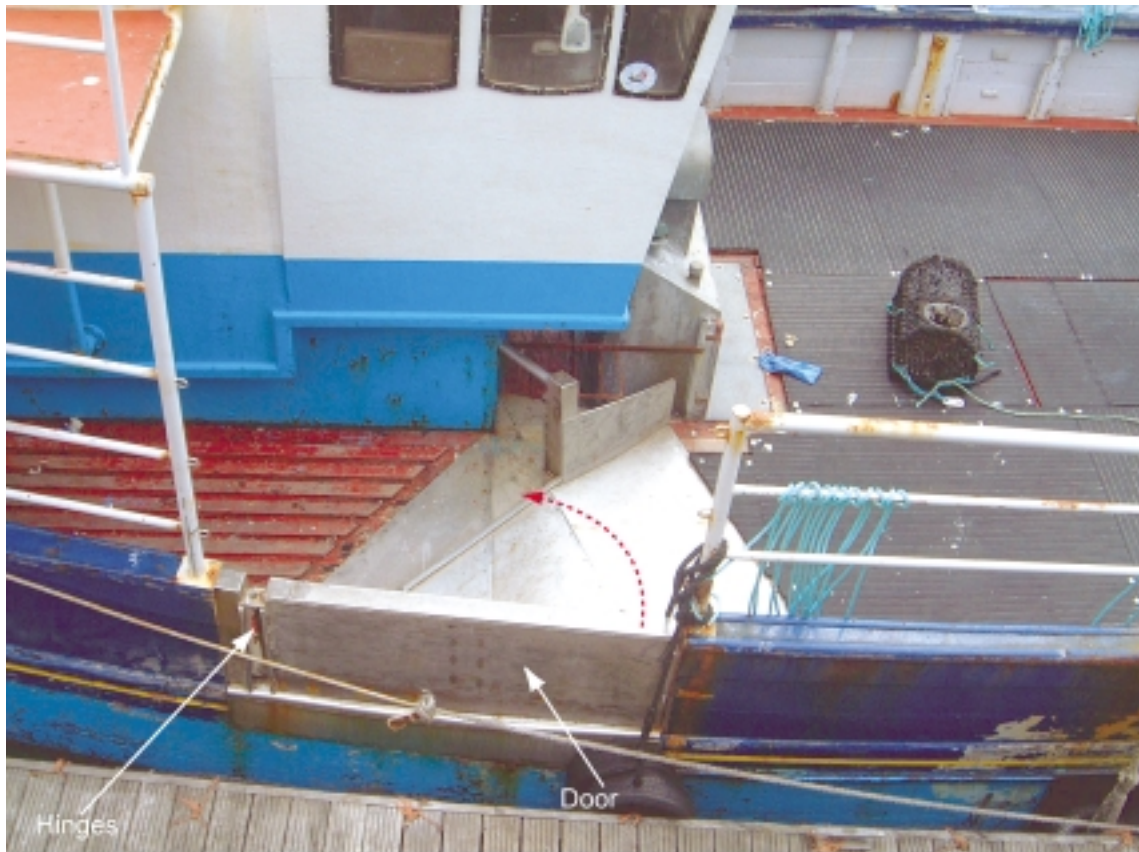
To avoid the hazard of a bight around an ankle, it was decided to move the crewman handling the pots well away from any lines on the deck. This was done by putting a hinged door in the bulwark at one side of the deck which, when opened, allowed the pots to be drawn across the deck by the vessel's forward motion, with only limited intervention from the crew (see Figure).

This arrangement appeared to work well for several months, until a crewman was left working alone on deck one day, just after a string of pots had been shot. The weather conditions were reasonable, but the vessel was rolling a fair amount. He finished the job he was doing and walked past the still open shooting door to return to the wheelhouse. Unseen and unheard by the rest of the crew, the crewman lost his footing and fell overboard through the open door.

1. The owner's risk assessment did not extend to considering the hazards associated with the modifications, namely the dangers of the open shooting door.
2. Whenever a risk assessment suggests modifications to equipment or procedures might be beneficial, the hazards associated with the changes should be run through a new risk assessment. Only if the level of risk is reduced by the proposed changes are those changes worthwhile.
3. The practice of blocking off a second access route between the working deck and the wheelhouse forced this crew to walk past the shooting door, which was a substantial hazard when open.
4. Once in the water, the crewman was unable to stay afloat because he was not wearing a lifejacket or other buoyancy aid. His loss from the vessel had been noticed so quickly that, had he been able to remain afloat, for even a few minutes, he might have been safely recovered.

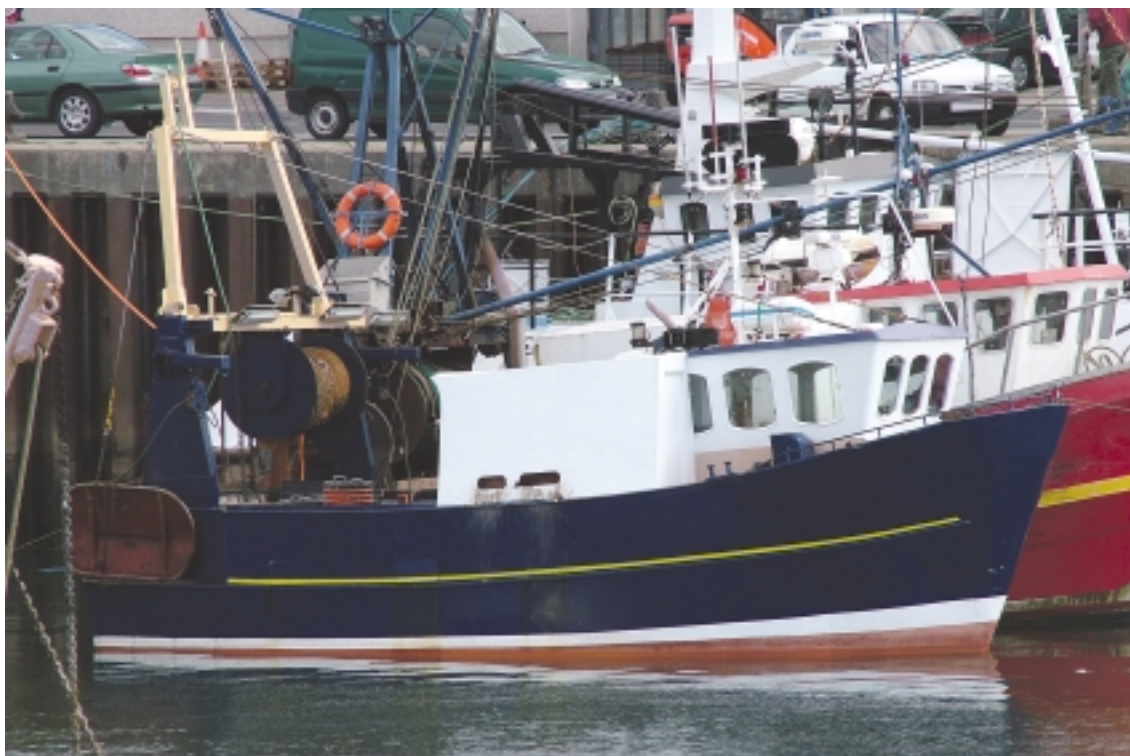
Figure 1

A prawn trawler (Figure 1) was returning to port after a night's fishing. The skipper was helping the deckhand tail prawns on the working deck, but was periodically returning to the wheelhouse to attend to the navigational watch. He saw another small fishing vessel ahead during one of the periods when he was looking out. The skipper thought that this vessel was either hauling or shooting pots, and was underway at about 2 knots, in which case he would pass well astern of her. Having made this assumption, he returned to the working deck, thinking that he was safe. But the other fishing vessel was in fact adrift, and was not under command, after having suffered an engine failure. The vessels collided about 10 minutes later.

1. The skipper of the prawn trawler was away from the wheelhouse for at least 10 minutes before the collision. It is not acceptable to leave the wheelhouse to help with processing the catch; a continuous navigational watch must be kept. The collision regulations are quite clear on this.

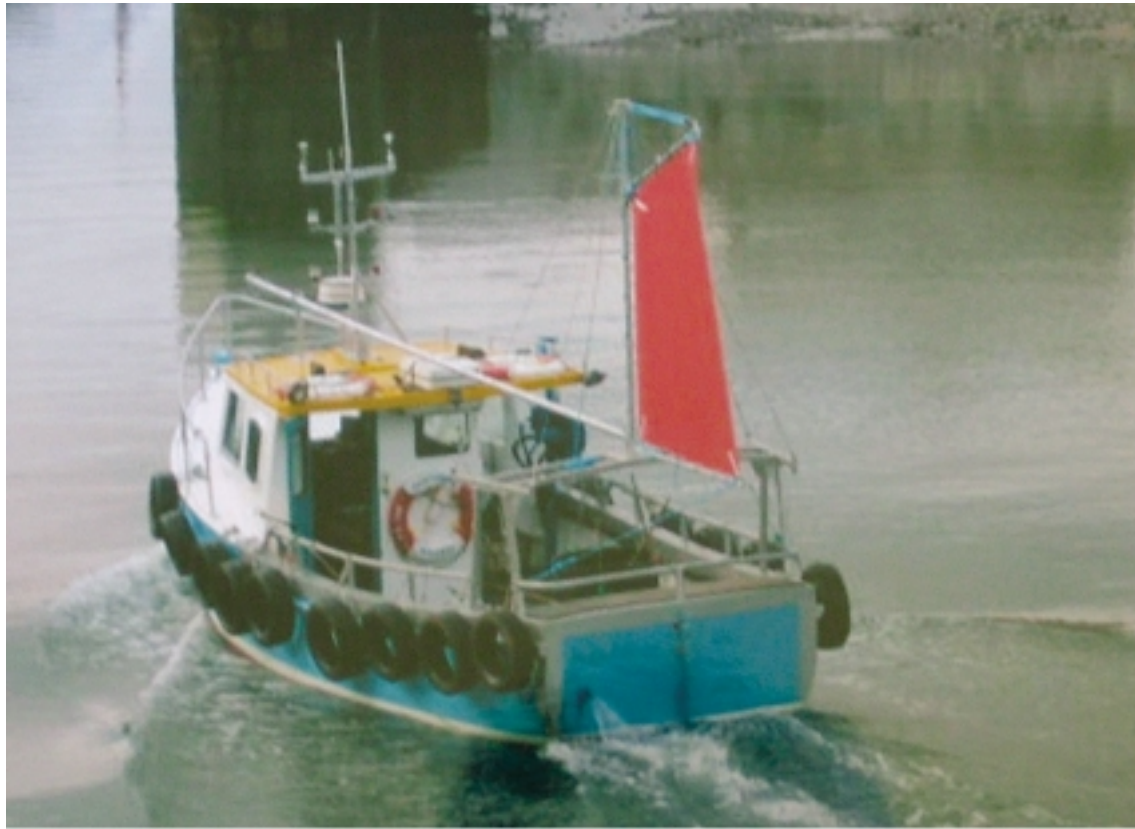
Figure 2

slow speed to give the crew time to tail the prawns before reaching port. The other fishing vessel was a potter (Figure 2), and had broken down when on passage to her grounds.

About 15 minutes before the collision, the potter's skipper saw the prawn trawler and steered to pass well in front of her. However, the problem with his vessel's engine led to him stopping directly ahead of her. He tried to attract attention by using his VHF radios and a portable foghorn, but these messages were not heard. No one appeared to be in the other vessel's wheelhouse. The skipper and his deckhand watched the trawler as it bore down on them, and they jumped onto the other vessel once the collision had taken place. It was just as well that they did this, because the potter's hull was penetrated and she flooded and sank shortly after the impact.

local initiative. However, it failed to deploy when the vessel sank – either because the hydrostatic release was incorrectly fitted, or because it became snagged in the mast or rigging.

3. It is possible that the liferaft on the potter failed to deploy because it had been incorrectly fitted or poorly sited. The free issue of liferafts is an excellent safety initiative, but they must be installed correctly. Fishermen who fit liferafts should follow the instructions very carefully. If there is any doubt about the correct procedure, assistance from an experienced seafarer such as a lifeboat man or harbourmaster should be sought.

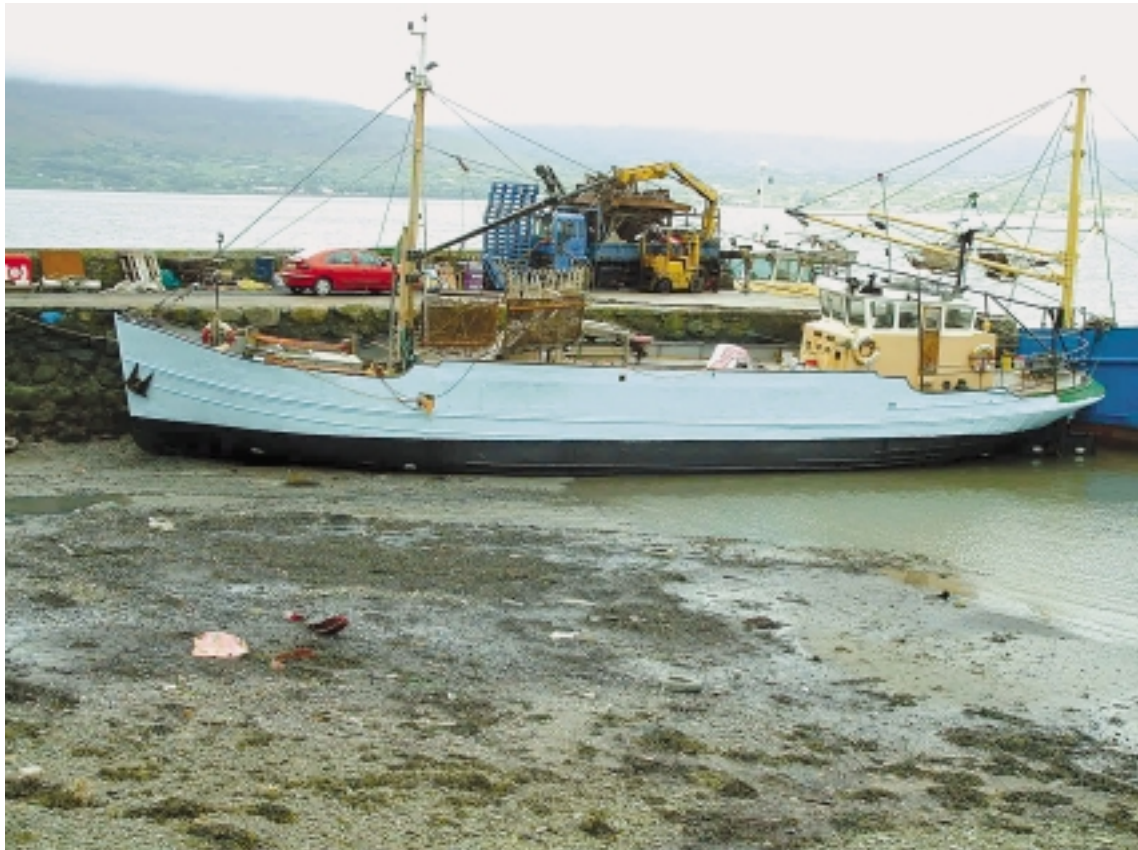
Figure 1 – General view of vessel

A 26 metre mussel dredger (Figure 1) converted from a Dutch river barge, built in 1908, was flagged into the UK register in 2002 having been inclined and surveyed. An MCA approved stability book was produced, setting out loading conditions, but it was not normal practice to hold it on board. Modifications, which added weight to the vessel, were made following inclining, but the MCA was not notified.

The vessel was arranged with a single continuous double bottom extending only under the two holds. A “tell tale” pipe with valve fitted in the after engine room drained any water which accumulated in the double bottom. The skipper noticed that there was a trickle of water coming from the pipe, but was unconcerned about it and did not investigate it further. There were no wing tanks to aid buoyancy.

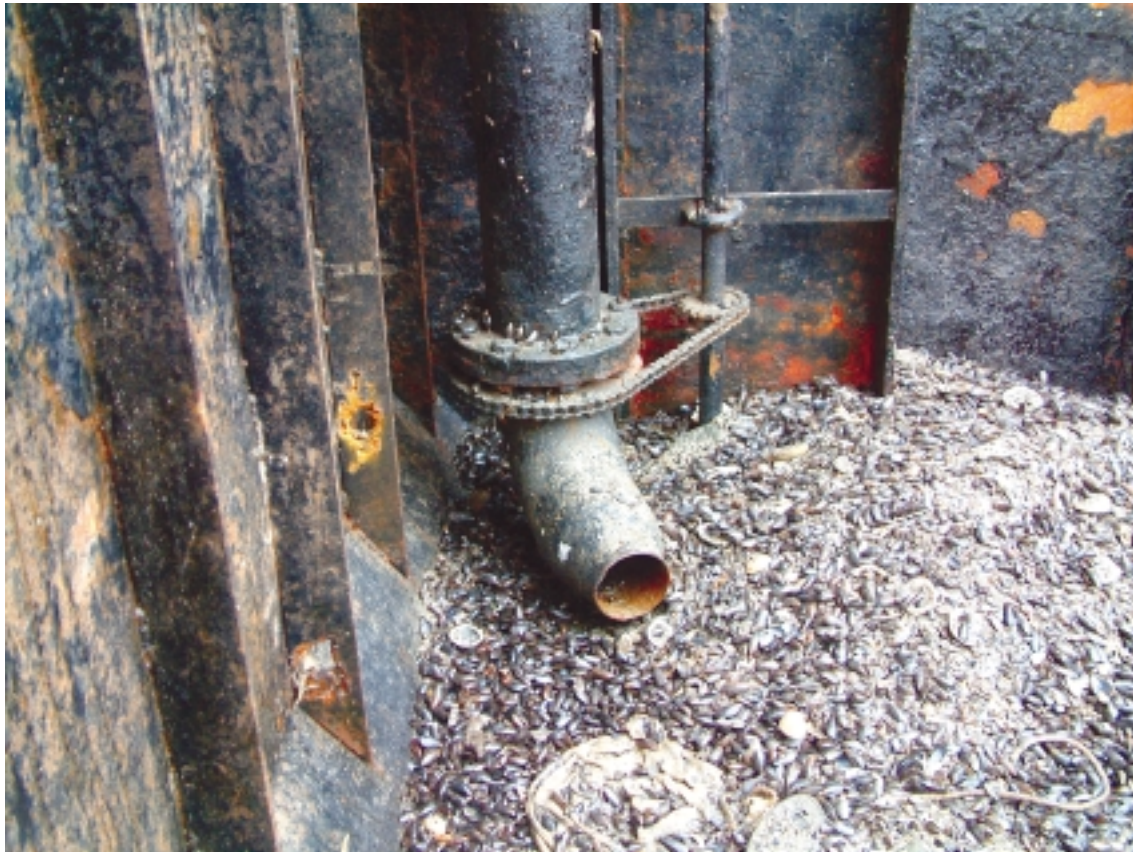
Figure 2 – Slusher jet

pressure salt water “slusher” pump used to drive the mussels out of the seeding hatch using the directional “slusher” jet (Figure 2).

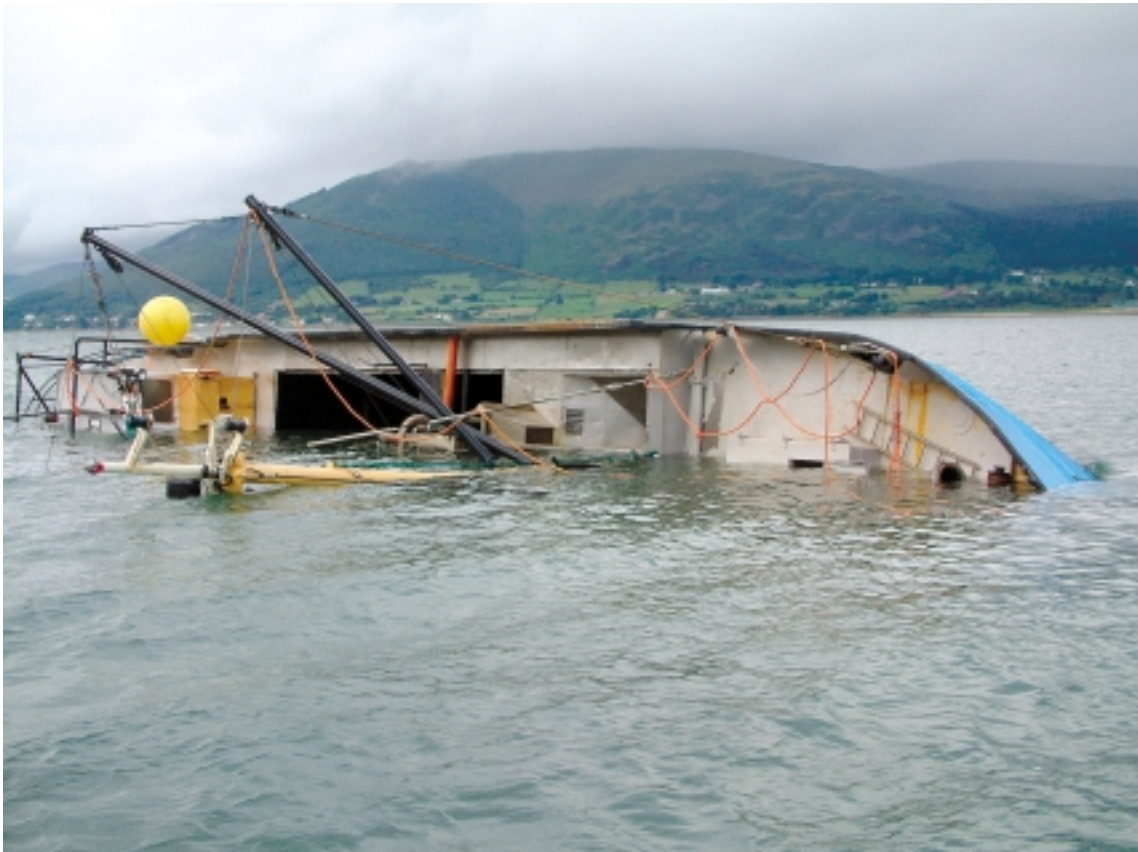
downflooding of the forward hold. The vessel continued to roll over, coming to rest on top of the mussel bed, leaving her port side clear of the water (Figure 3).

Figure 3 – Vessel capsized

Following remodelling of the stability of the vessel, it was found that the probable cause of capsize was an obstructed seeding hatch. This led to an increase in the water level in the after hold, coupled with free surface in the double bottom and a cargo shift.

1. It is no use signing the stability book just to satisfy a regulatory requirement. It is a live document which must be carried on board for reference purposes to check that loading conditions are not exceeded. Keeping the book in an office serves no purpose!

2. It would be very helpful to skippers if holds were indicated internally with a load line, to ensure that loading is not exceeded. A welded plate could serve such a purpose.

4. Where additions or disposition to weights are made to the vessel, the MCA should be notified, as stipulated in the stability book, so that the effect on stability can be assessed.

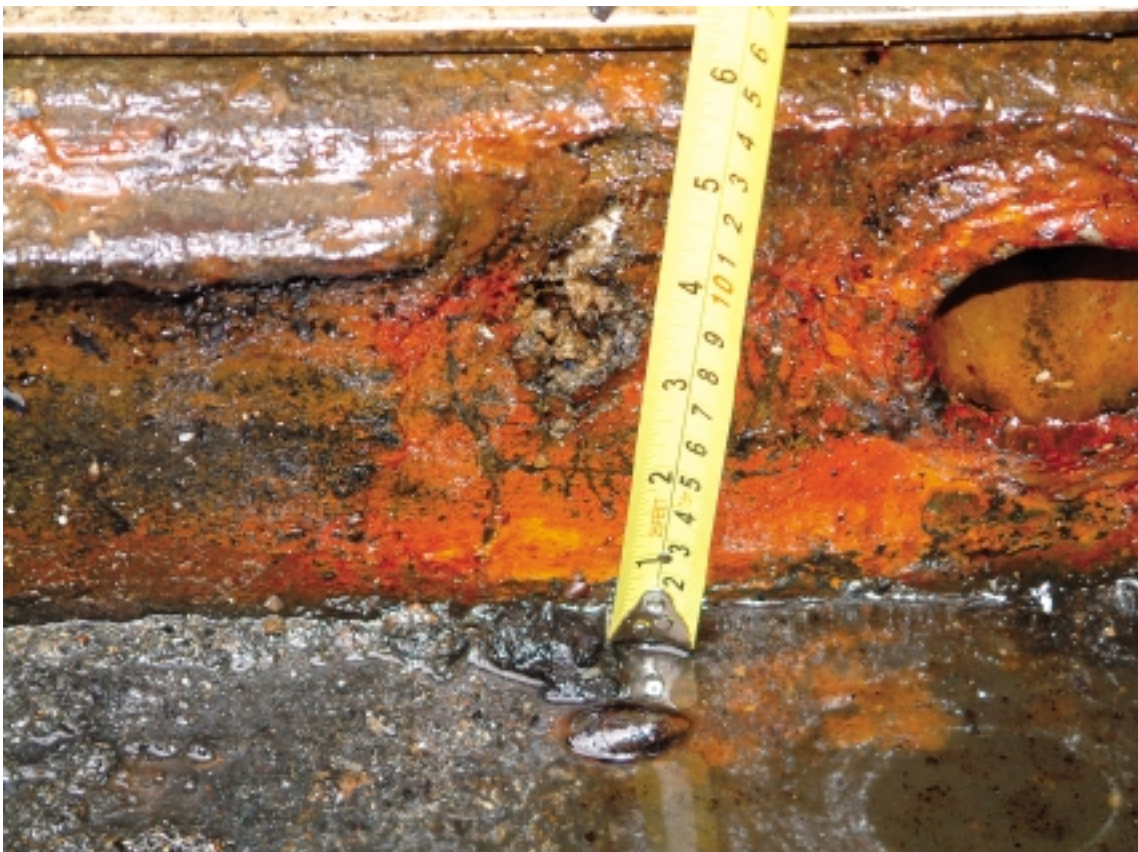
Figure 4 – Plate corrosion

During the accident investigation, it was found that the double bottom “tell tale” pipe isolating valve was blocked. Once cleared, water gushed out, proving that the double bottom was flooded. The cause of ingress was found to be plate corrosion in the after hold bilge suction well (Figure 4). Now this is not a big problem if the double remains pressed full, but the slight drainage into the engine room removed some water, which resulted in a large free surface effect.

3. If water is seen to be leaking from a “tell tale” system it should be investigated without delay. The investigation does not end there: the cause of water ingress must be determined and rectified. Your life could depend on it.

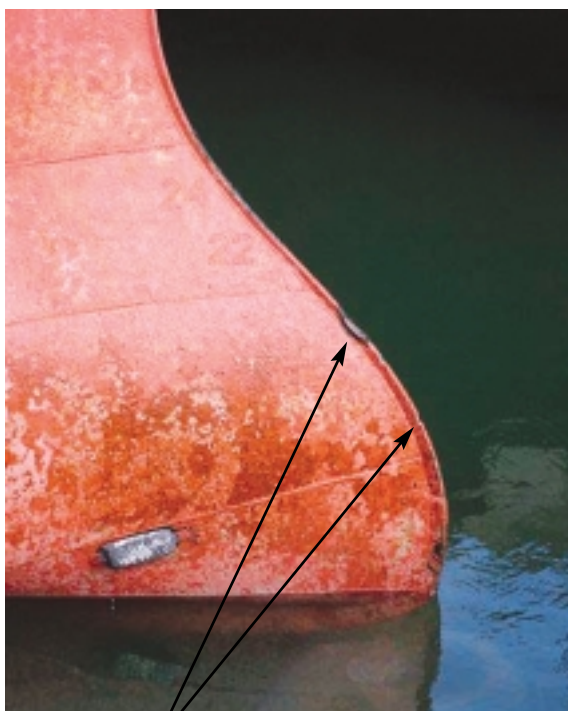
Minimal damage caused to bulbous bow of first fishing vessel

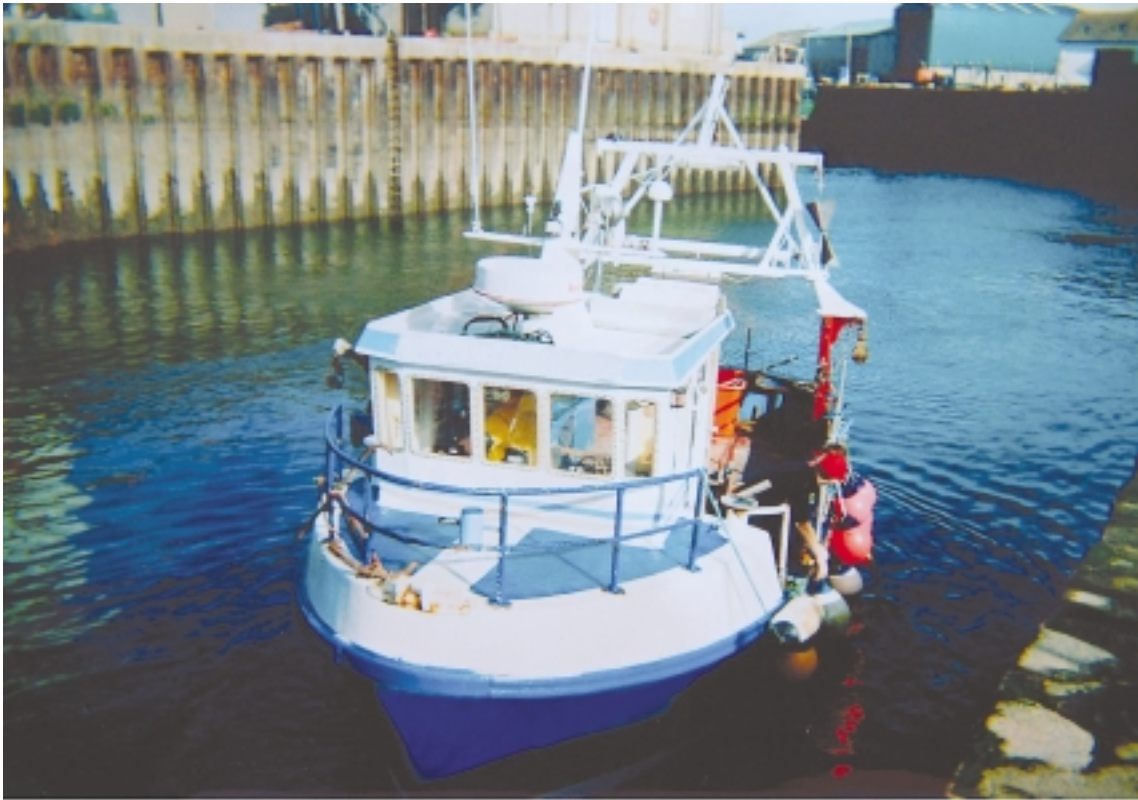
Figure 1

An 8.7m potting vessel (Figure 1) capsized rapidly and without warning while starting out on passage back to her home port at the end of a day's fishing. The two crew members were thrown into the sea; neither was wearing a lifejacket. The vessel righted herself, and the deckhand returned to the partially submerged hull and was able to release the liferaft. He managed to inflate it, and board it from the water. The skipper, who had been seen on the surface, was lost from view before the deckhand could paddle the liferaft to him and was not seen again. The vessel sank shortly afterwards.

Analysis of the evidence indicated that flooding of the engine space, caused by a failure in the salt water cooling system, probably led to the loss. The vessel was not fitted with an operational bilge alarm, and there was no other warning that flooding was taking place. The engine space extended the

length and width of the working deck, and had a free surface area of over half the vessel's water plane area. Consequently, the amount of floodwater to cause instability did not have to be great. This could be why neither crew member noticed any change in the handling of the vessel before she capsized.

1. Bilge alarms have been mentioned many times before in Safety Digest articles. They are a vital piece of safety equipment, and must be tested before the start of every voyage to ensure they are working. Bilge alarms should be fitted in all the main compartments, but especially in the engine space. A single alarm is sufficient if it is robust and of good quality; better still, two units can be fitted.
2. Lifejackets are another regular feature of the Safety Digest, and their importance cannot be overemphasised. Over many years, MAIB inspectors have heard all the arguments highlighting the problems associated with the constant wearing of self-inflating lifejackets. But the problems are minor in comparison to those faced by a person in the water,

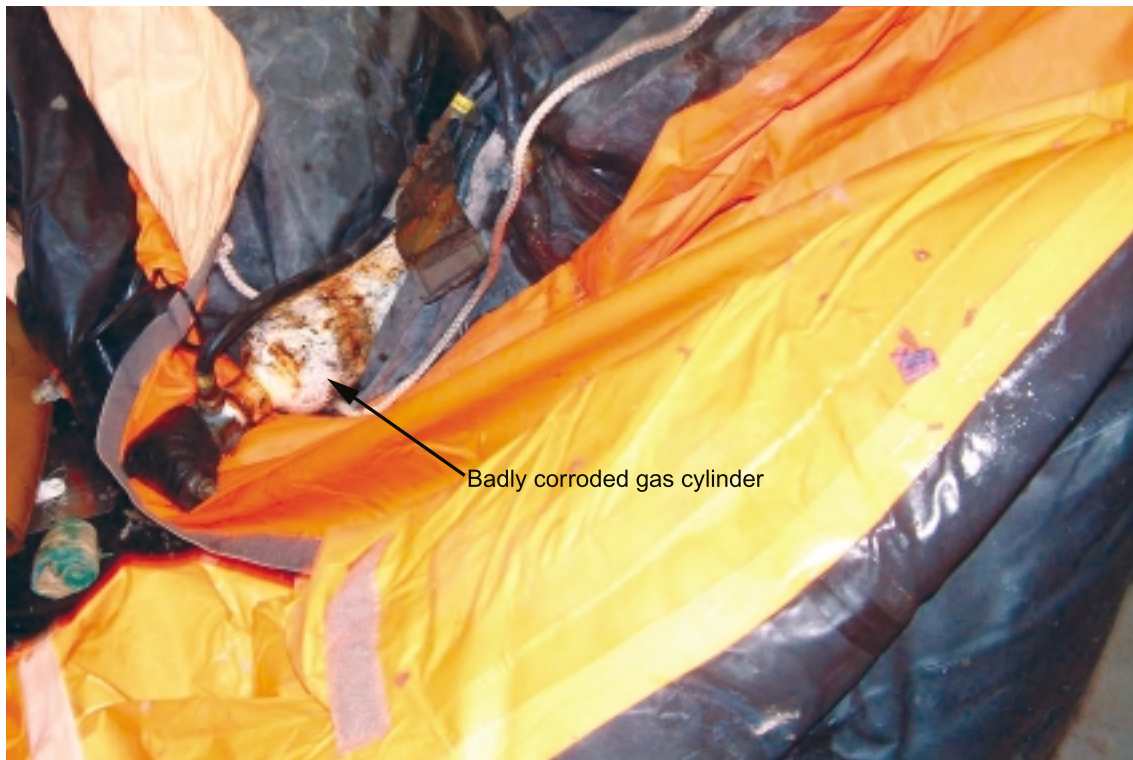
Figure 2

The liferaft had not been serviced for many years (more than 12), and it was fortunate that it inflated when the deckhand pulled the painter, particularly as the gas cylinder was badly corroded (Figure 2). The condition of the liferaft fabric and equipment was also very poor, resulting in the deckhand spending a very uncomfortable night in it. The flares, torch and liferaft lights did not work, and no reflective tape was fitted to the canopy.

almost impossible to see without any form of illumination. The buoyancy tubes were leaking air, and the floor was leaking water, so the deckhand spent most of the night either pumping or bailing.

3. A fishing vessel of this size does not have to carry a liferaft, although the benefit of having one has been dramatically demonstrated by this accident. Government agencies in many parts of the country now issue liferafts free of charge, so if you own a small fishing vessel, you should take advantage of this initiative if it is available. Once a liferaft is installed, it should be serviced in accordance with the manufacturer's instructions.
