# Part 3 – Leisure Craft

# Junior Powerboat Racing Accident Raises Safety Concerns

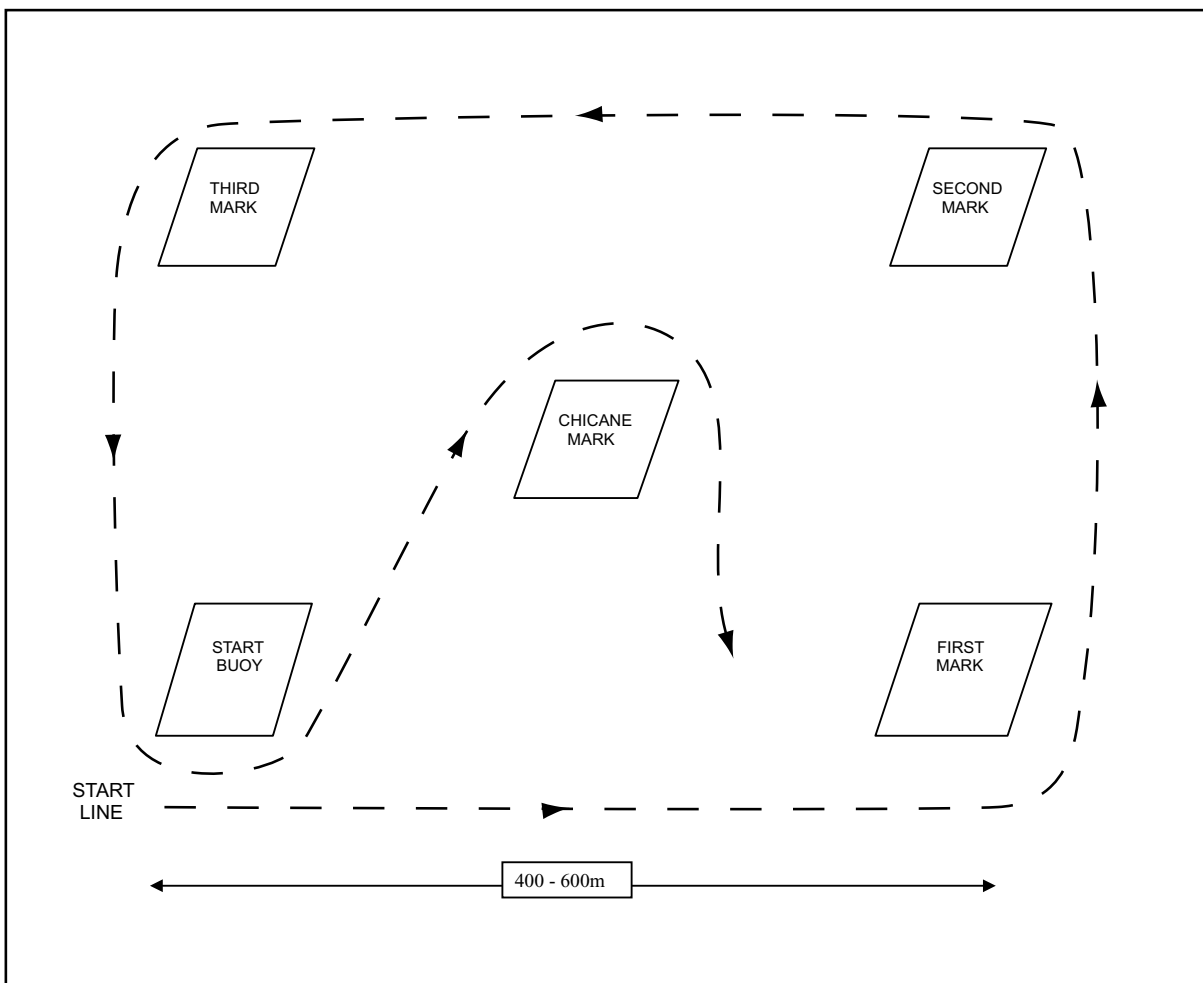
Figure 2 – Typical course

speeds of about 27mph in calm conditions. Consideration had also been given to the optimum standard race and course design for the new class. It was decided that head-to-head racing around a smaller, but similar, course to that used by adults, would best meet the objectives. The chosen course design was roughly rectangular, with a dog-leg in one of the longer sides (Figure 2).

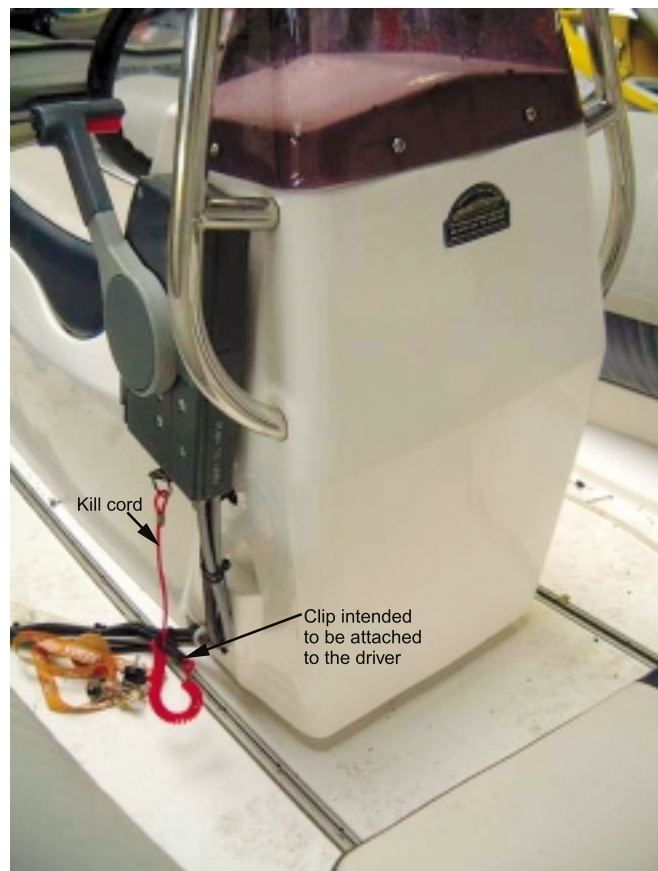
Figure 1 – Photograph showing console and kill cord

As a 4.5m RIB with three teenage occupants approached the beach to pick up a wakeboard, it passed a line of markers indicating the boat was entering an area in which a 4 knot speed limit applied. The driver reduced speed to about half throttle, and commenced a slow left-hand turn. During the turn, the console on which the driver was sitting, and to which the steering wheel was mounted, detached from the deck (Figure 1). The driver was unable to maintain his balance, and fell over the boat's port side and into the sea.

1. Had the kill-cord fitted to the RIB been used, the injuries caused by the propeller would have been avoided. A RIB driver does not expect to be thrown from his or her boat, and therefore it is not difficult to see why some drivers might see the wearing of kill-cords as unnecessary, or even as an insult to their ability. However, this accident shows that the unexpected does happen, and that people do get seriously injured as a consequence. It is common sense to use the kill-cord; it is foolish not to.

2. Although many boats' fittings and accessories might appear to be secure, this should not be taken for granted. Wear and vibration take their toll over time, and can result in catastrophic failure of some fastenings, particularly on high-speed craft. Periodic inspection of these items takes little time, and increases the probability of the detection of loose items in time to allow remedial action to be taken and potential accidents averted.

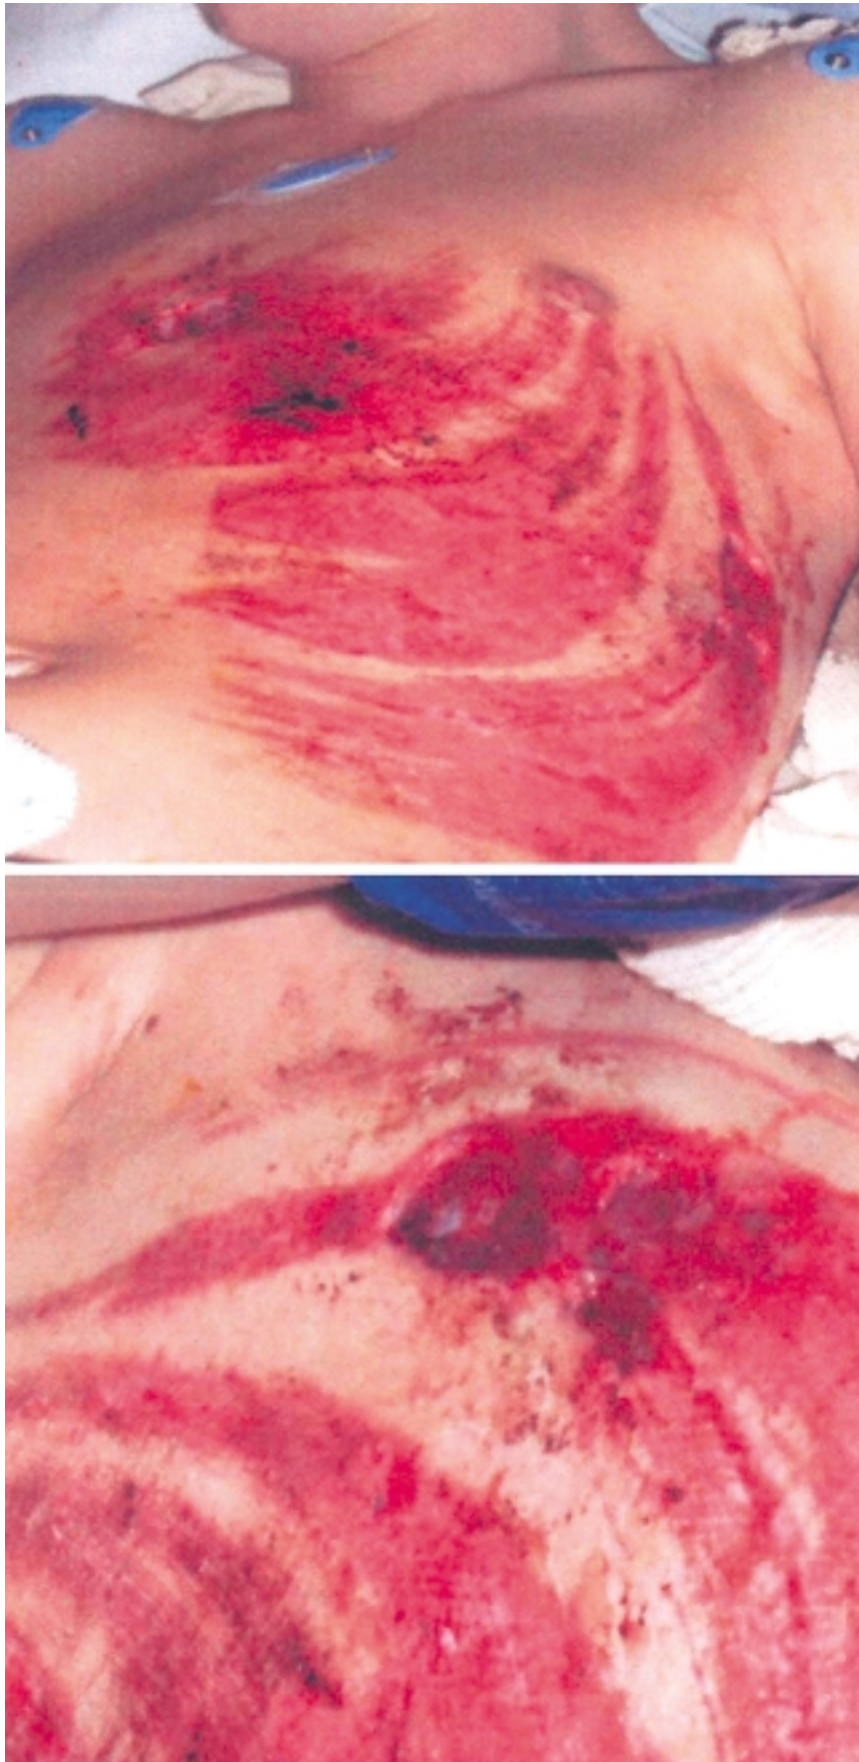
Figures 2 and 3 – Injuries to passenger

Fortunately, the accident was seen by another powerboat in the vicinity, which managed to pass a line to the people in the water and tow them clear. The injured passenger sustained deep lacerations to his chest and left side (Figures 2 and 3), and was taken to hospital by air ambulance. He remained hospitalised for 3 weeks. The RIB, escorted by a local lifeboat, circled for about 30 minutes until it finally beached in an area which had been cleared of many other, varied activities by local authority officials. The flares carried on board the RIB were found to be out of date.

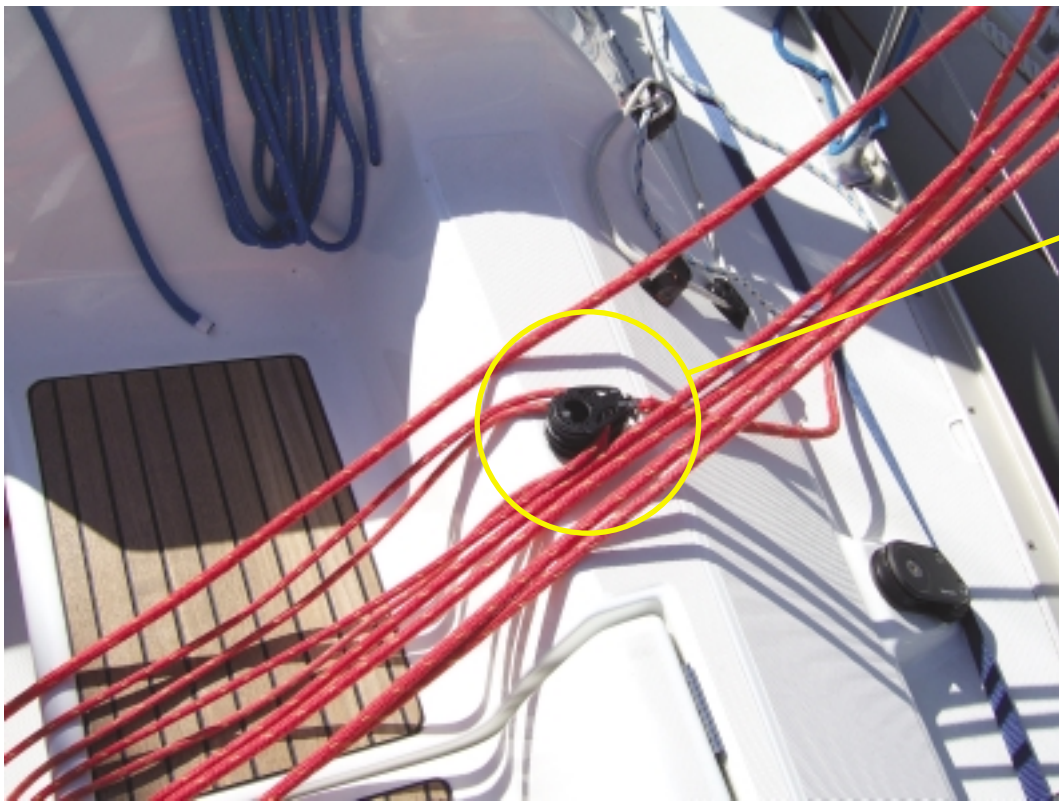
Figure 1

The yachts were sailing under mainsail only; one with a single reef and one with 2 reefs in the main, and in both cases the injuries occurred as the boats were gybed. Both injured persons were struck by the fine tuning block (Figures 1 and 2), which is part of the falls of the main sheet, as the boom passed across the cockpit.

As the boats were gybed the injured persons were both struck in the head by the fine tuning block and were thrown against the side of the cockpit. Both suffered life threatening injuries as a result of the accidents and spent a considerable time in the intensive care unit of the same hospital.

Fine tuning block

1. Skippers should ensure that their crew briefing takes account of the individuals' previous experience and their familiarity with the rig and fittings on the boat.
2. The main hazard associated with a gybe is generally perceived to be from the boom. This accident shows that all crew must be aware of the dangers of being struck by the sheets and associated gear as the boom passes safely overhead.
3. Charter companies should take into consideration that the members of a crew taking a boat on bareboat charter might not have sailed together before, and their handover briefing should include reference to the particular hazards on the vessel which the less experienced members of the crew might not have previously encountered.

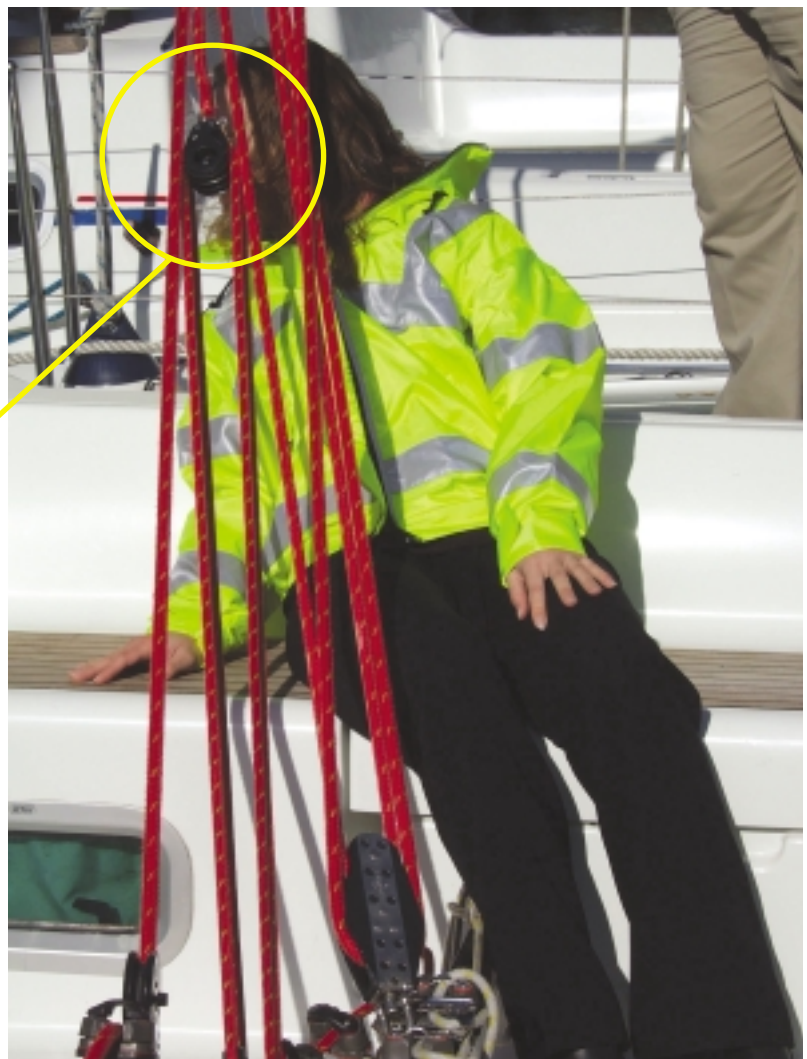
Figure 2

The fine tuning block is at head height when sailing — crew should keep clear of this, particularly during a gybe
