Part 3 – Leisure Craft

Secure Anchorage Proves to be Anything But

Divers at Work in Port – Ensure Everyone is Fully Aware Before Signing the Permit

Kill Cords Save Lives, When Used Properly

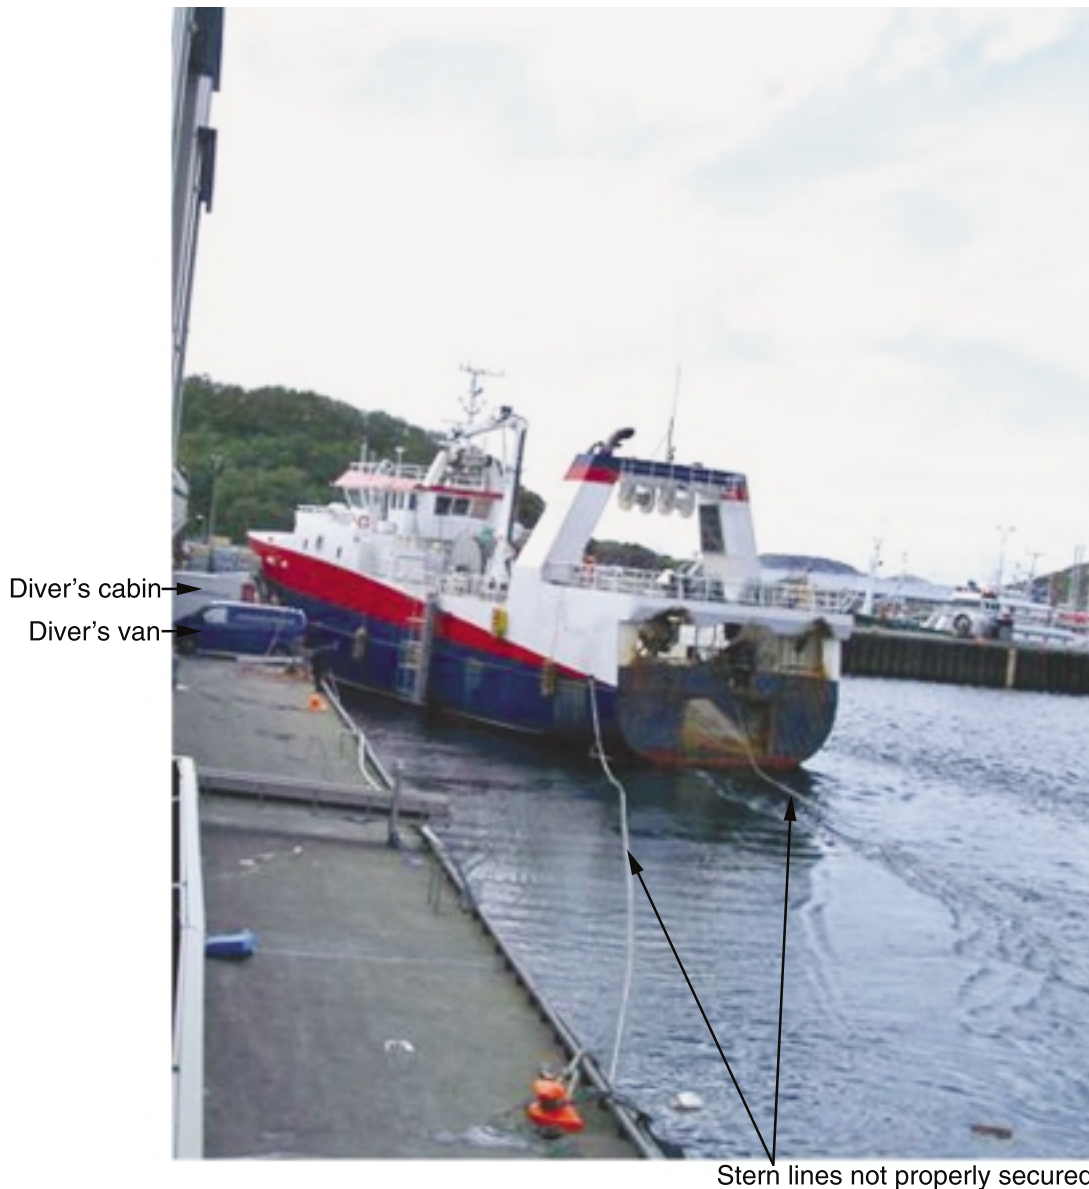
Figure 2

The vessel was subsequently brought under control and a fault was identified in her propeller pitch control system. It was also noted that the vessel had not been properly secured because some of the mooring lines had paid out when she moved ahead.

2. A ship's engineer should never permit the propeller shaft to be turned without the express permission of a responsible person on the bridge.

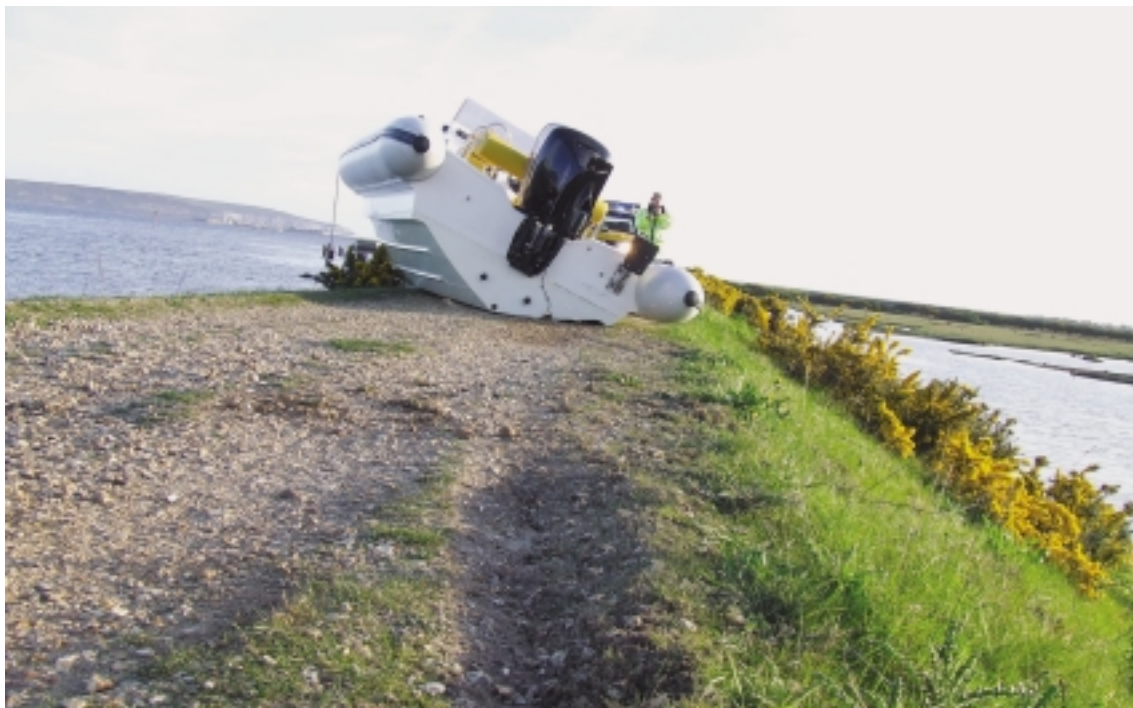
The RIB continued at high speed, constantly turning in a spiral and, fortunately, moving away from the people in the water. It grounded at speed and climbed to eventually come to rest on a footpath on top of a sea wall (see photograph).

RIB photographed after accident

2. The engine kill cord should be connected to the driver's leg or lifejacket harness. Had the kill cord operated correctly in this case, the boat would have remained in the immediate vicinity to provide a possible lifesaving platform. If neither man had been hurt, they might even have been able to reboard the boat and restart the engine. It is also worth noting that the consequences in this case could have been even worse had the boat circled, as a number have done in the past, and then run over the people in the water.

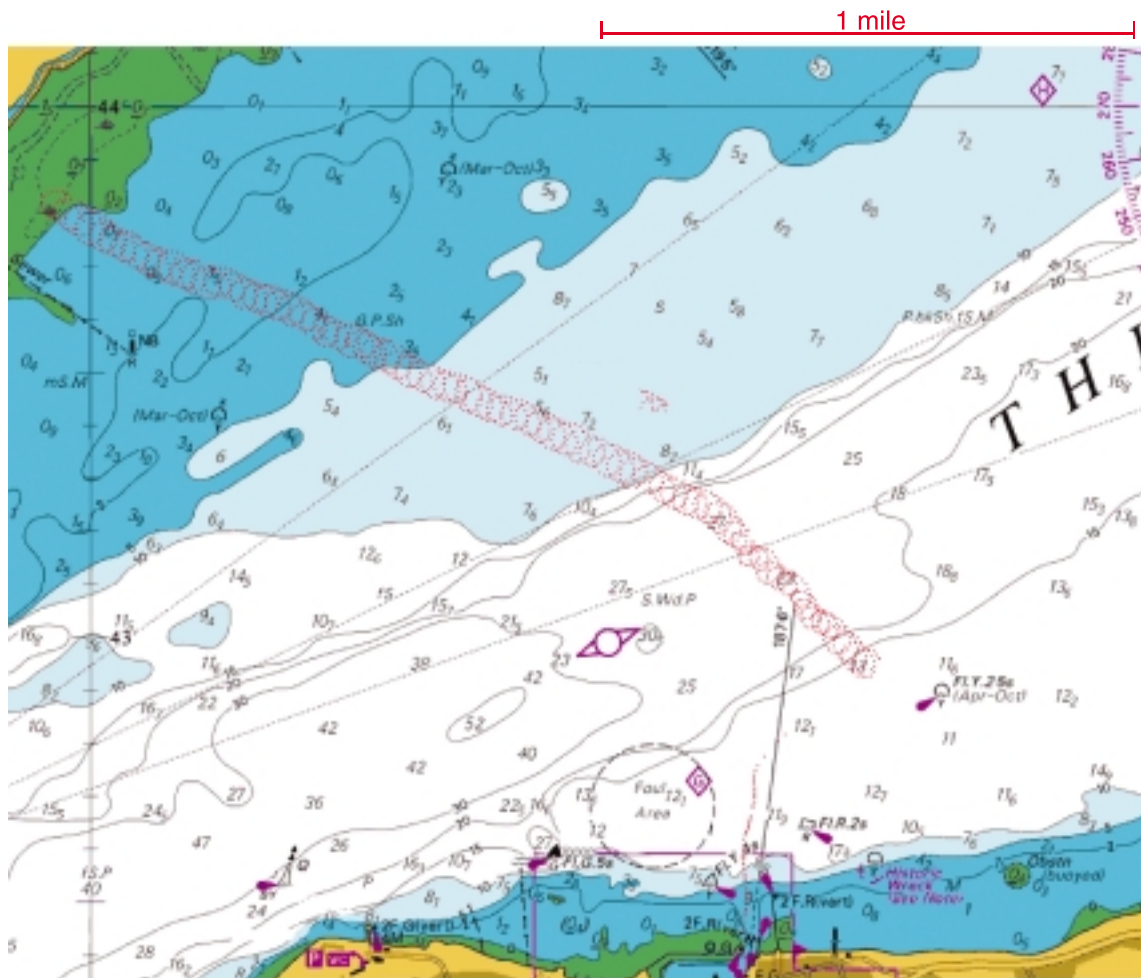
Just before midnight the GPS alarm woke the skipper. He jumped out of his berth and saw that they were 0.04 mile out of position. He started the engine and donned a lifejacket, telling his crew of four to do likewise. By the time he was on deck, the depth sounder was showing minimal depth, and almost immediately the keel touched the bottom. Attempts to motor off failed and the yacht soon listed by 20° to starboard, with the wind and sea on the port bow. A "Pan Pan" was sent and acknowledged by the local coastguard. The local lifeboat was dispatched to the scene but had some distance to travel.

It was soon established that the yacht was on a reef and was being driven on by the weather. The angle of heel increased to 30°. The crew managed to recover the anchors during this time so that they could be deployed again when necessary.

Vessel's actual GPS track after incident

2. However unappealing the setting of an anchor watch might be, a forecast giving high winds and changes of wind direction through 90° overnight might have given pause for thought in what was a relatively tight anchorage. GPS alarms are a useful aid, but in this case did not give the skipper enough time to react. Alarms have to be set to a range sufficient for them not to trigger every time the boat veers normally, but to sound when 'serious' movement has taken place.

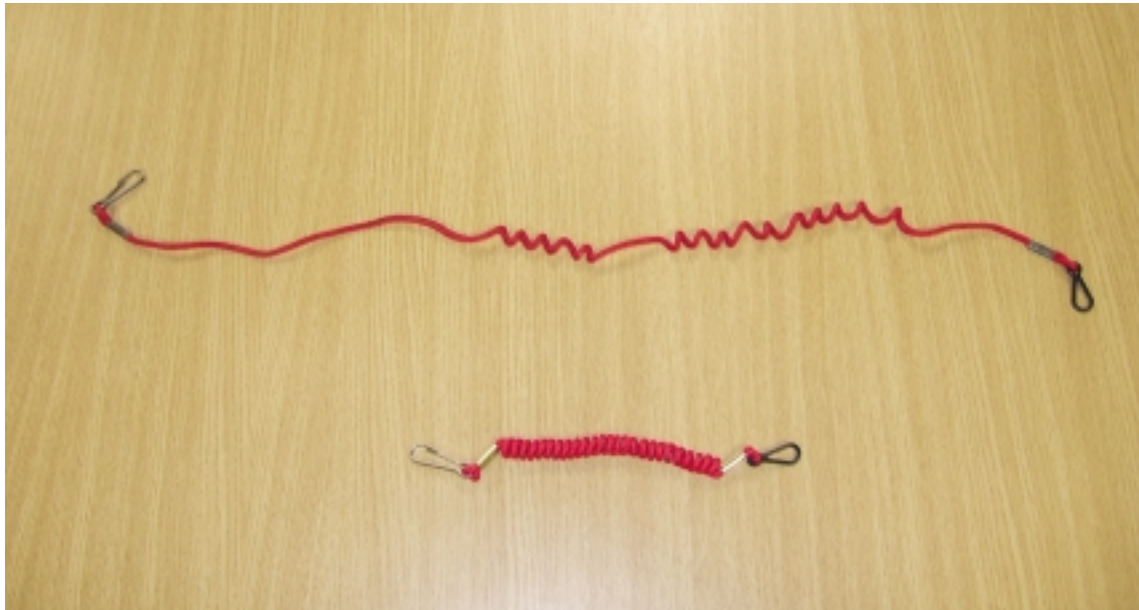
boat, and his instinctive reaction had been to turn to avoid it. This had occurred at high speed and at a time when the passenger had momentarily released his grip on the steadying grab handles to retrieve an object from the floor of the boat. While the boat heeled in the sudden turn, the driver reached across the controls to try to steady his friend. This left neither the driver nor the passenger holding on tightly, and resulted in both men being tipped from the boat. In reaching to steady his friend, the kill cord had become entangled with the throttle controls, and despite the cord being stretched as the driver entered the water, it slipped off his wrist before it acted to stop the engine.

Stretched kill cord in comparison with new item
