Part 2 – Fishing Vessels

Smoking Kills!

Assumptions (Based on Scanty Information) Lead to Collision

Fire at Sea – Be Prepared, Be Trained – It Could Be You Next

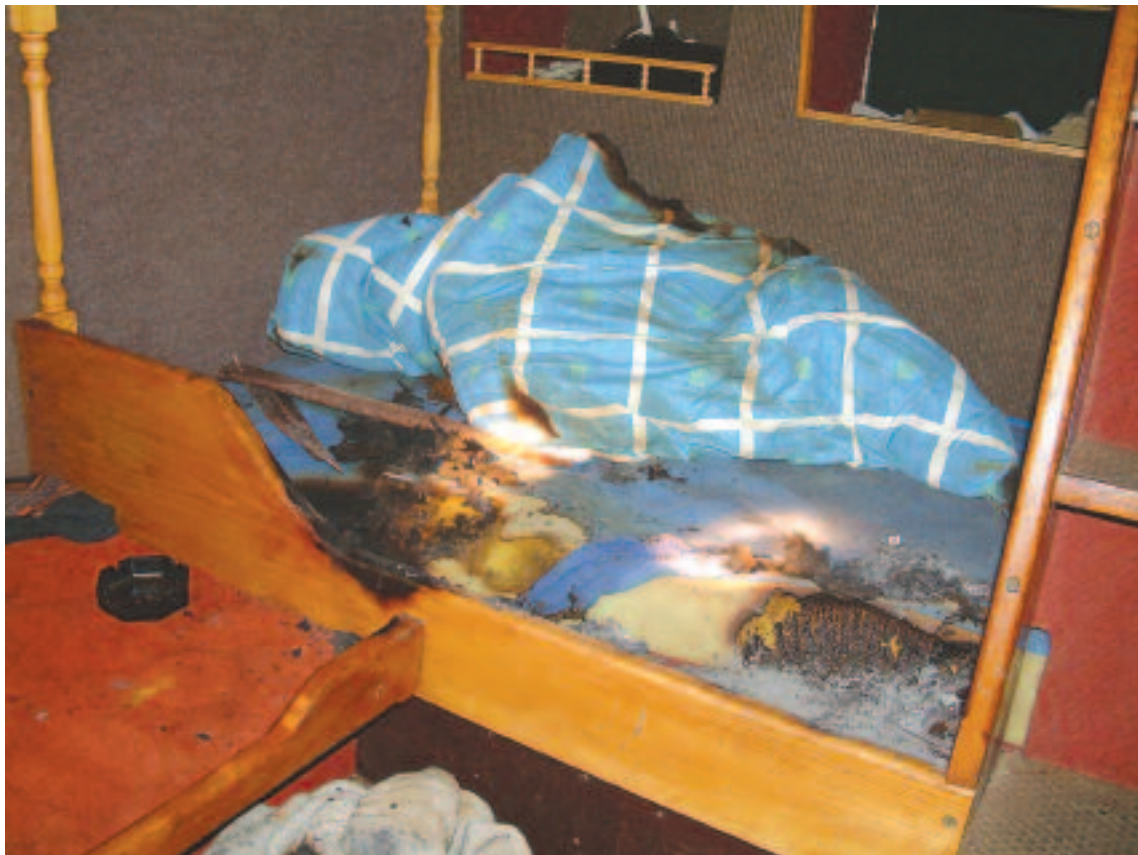
As he smoked, the crewman either fell asleep or became unconscious, and his cigarette started a smouldering fire which burnt a small amount of the bunk's foam mattress and woodwork (see photograph). The crewman died without regaining consciousness as the fire consumed the oxygen in the space and gave off toxic fumes.

1. Neither the owner nor the skipper permitted smoking in the accommodation space, for good reason. However, perhaps due to the influence of alcohol, the crewman forgot this policy and paid the ultimate price.
2. A smoke alarm might well have prevented this tragic accident. A simple domestic fire alarm costs very little and merely requires a new battery periodically. Fitting a smoke alarm is easy, and it may well save you or your crew's life. It is intended that a smoke alarm will be required on all decked vessels covered by the revised Small Fishing Vessel Code to be issued in the future.
3. Where possible, use non-combustible materials on board your vessel, or materials which are resistant to ignition. They will reduce the chances of a fire starting, or, if one does start, will help prevent it spreading quickly.

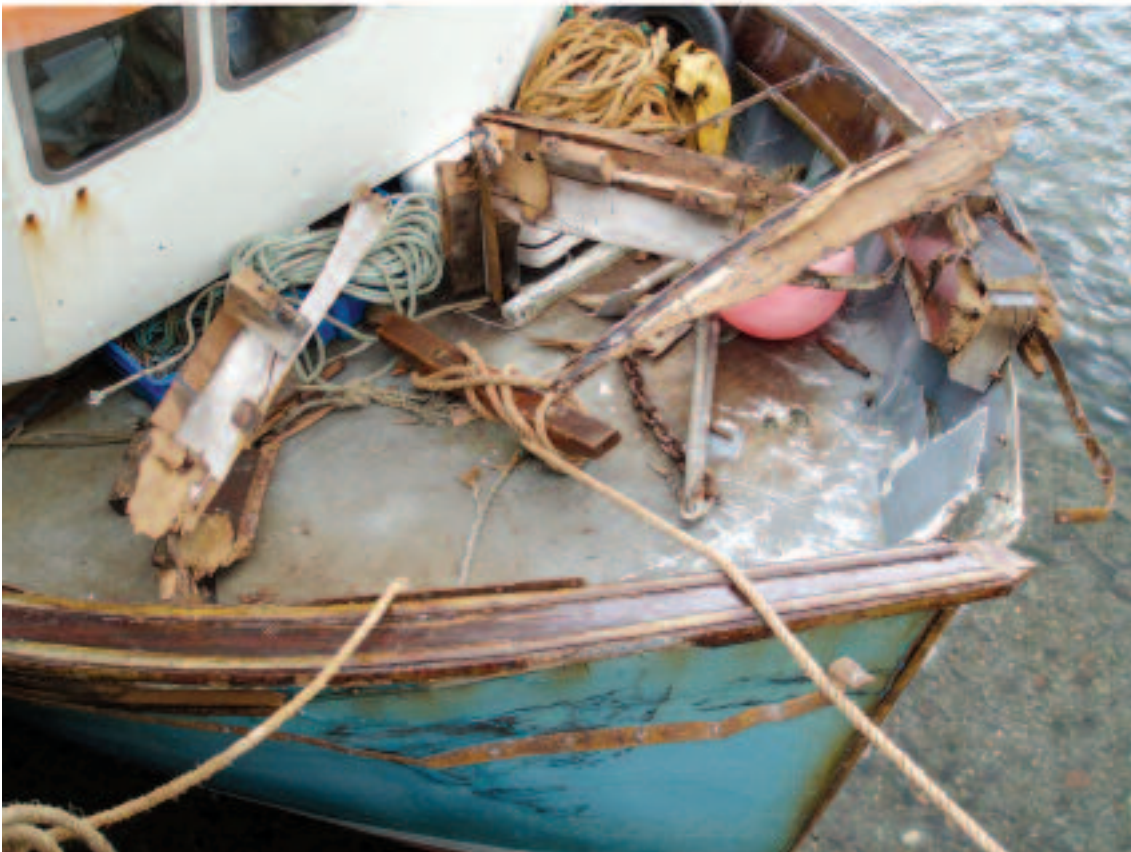
The vessel remained seaworthy, despite damage to its starboard bow (see photograph). The skipper called the coastguard by mobile phone, as power was not initially restored to the VHF; he calmly reported his position, that he had just been in collision with something he had not seen, and that he could see a tug steaming away from the scene. The coastguard then called out the local lifeboat to escort the fishing vessel, under its own power, back to its home port.

Photographs showing bow damage

1. The assessment of risk of collision on both vessels was poor as both made assumptions based on scanty information. The International Regulations for Preventing Collisions at Sea, Rule 7, identifies the correct way to assess risk of collision. If both vessels had complied with this Rule the accident could have been avoided.

2. The lookouts kept by both vessels failed to enable a full appraisal of the situation and of the risk of collision, (Rule 5). It is important to ensure that as much information as possible is gathered from the lookout, in this case had both vessels scrutinised each other with binoculars, they might have realised that their initial assumptions were not reliable and that an earlier alteration of course was required by both vessels.

3. The tug could and should have warned local shipping via a “Securité” VHF broadcast when the navigation lights on the tow failed. Vessels should consider the use of such broadcasts if they have information which could be of significance to other vessels in their immediate vicinity.

4. The tug could have elected to show the lights and shapes for a vessel “restricted in her ability to manoeuvre” as the size of the barge and adverse weather conditions did restrict the tug’s ability to deviate readily from its course [Rule 3 (g) refers]. The display of these lights would have facilitated a more thorough assessment of the situation by the fishing vessel by alerting it to the fact that this was not a normal power driven vessel as the skipper assumed.

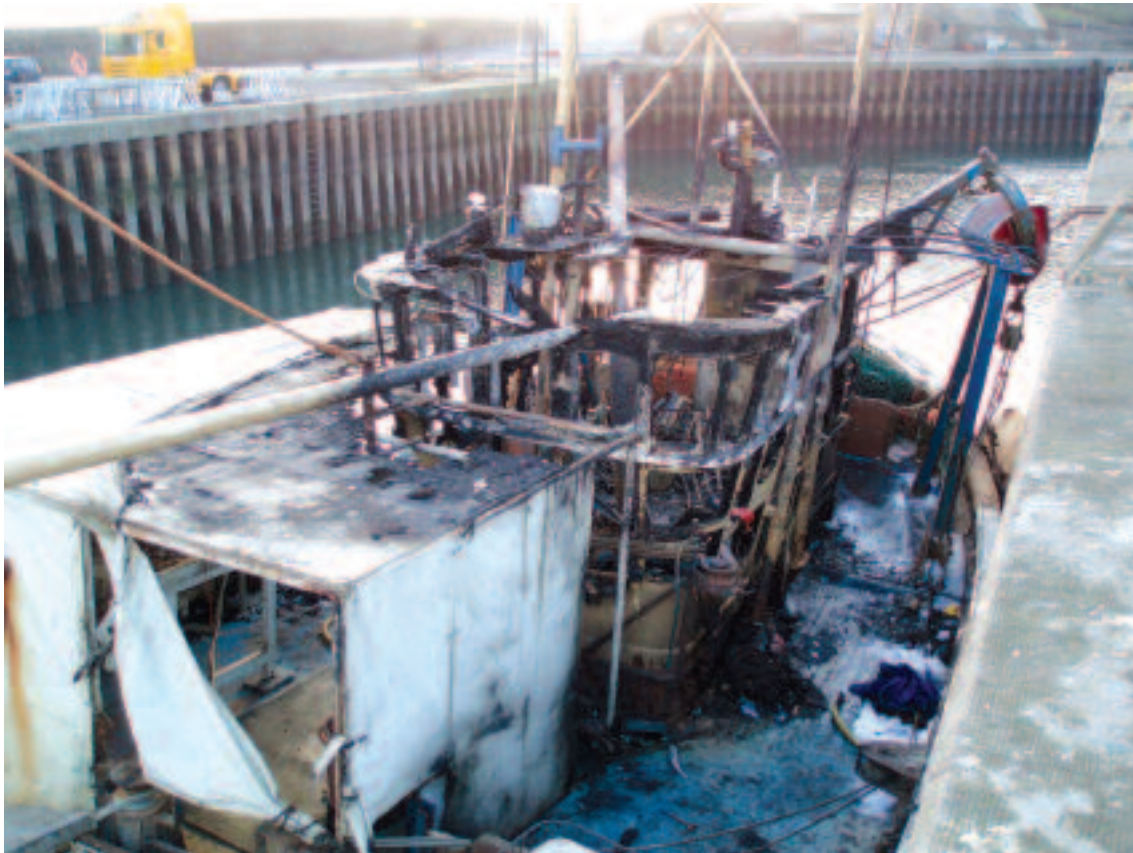
Two fishing vessels from the same port caught fire while at sea within a few weeks of one another. One vessel burnt out and sank; the other's wheelhouse and mess room were destroyed.

One fire probably started in the galley/cooker area; the other might have been caused by an electric cabling fault. In both cases, however,

the speed of fire spread and the damage incurred means that the exact causes will probably never be known.

1. Ensure that everyone on board has attended the requisite statutory training courses in fire-fighting, sea survival and first-aid. These accidents, and the fact that no lives were lost, demonstrate the importance of fishermen attending these courses.
2. Ensure that everyone on board is very familiar with the emergency equipment carried: both location and use. Both these skippers had ensured that their crews knew where the safety gear was and how to use it.
3. The galley stove provides an obvious source of ignition. Ensure that this is only for heating up food and drink – and not the boat!
4. The insulation of electrical wiring should be checked at regular intervals. It is almost impossible to visually inspect wiring on board any vessel, and the only way to ensure it is in good condition is to have it tested by a professional. It is worth the cost!

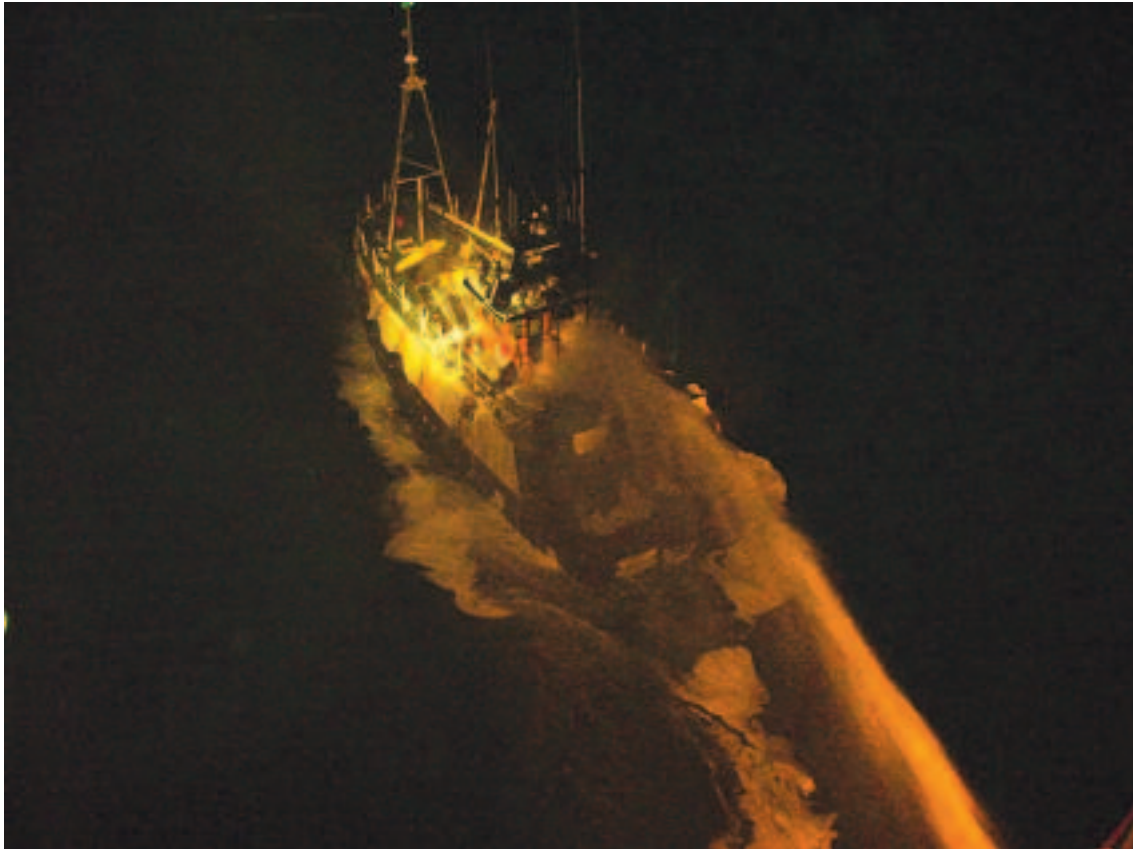
The mate went into the engine room and saw an orange glow near the deck, in the area of the main batteries. He and the skipper set off two fire extinguishers, but were beaten back by thick smoke. They closed down the engine room ventilation openings on the upper deck and tried to operate the emergency fuel shut

Smoke now filled the wheelhouse, having risen through unsealed conduits and wiring looms between the engine room and wheelhouse control panel. The skipper had to stand outside and use the radio through an open window to send a “Mayday” signal. The mate switched over to the emergency power supply, but could not isolate the main batteries. The crew put on lifejackets and immersion suits, and then launched the liferaft. Before climbing down to the liferaft, the skipper and mate attempted to rig a towing bridle forward, but

Smoke from the wheelhouse had dispersed, and down below, the galley appeared undamaged. The mate entered the cabin and saw where fire had damaged the starboard side. He went forward to the engine room door and cracked it open. Thick smoke and noxious gases escaped and the skipper pulled him clear. They waited on the upper deck for a few minutes and then returned to the engine room. The smoke had cleared, and the mate was able to enter the engine room. He heard a crackle and then saw a glow of fire in the far corner.

For a while all seemed well, with the boat having a small list and sitting only slightly lower in the water than usual. However, in the early hours of the following morning she broke her tow and sank.

1. Electrical systems and insulation material should be checked carefully to minimise the risk of fire.
2. Emergency engine and fuel system shut down methods should be tested regularly and repaired if they do not operate correctly.
3. Engine rooms should be checked to ensure that they can be fully closed down in a fire situation to prevent smoke spreading and to give CO₂ drench systems the maximum chance of success.
4. Do not put yourself back into danger by returning to the scene of a fire too soon. Re-opening a compartment causes air to enter, which may then allow a fire to re-ignite. Engine room fires may require many hours to cool before re-entry can safely be made. Compartment re-entry should be made by properly trained firefighters with the correct fire fighting equipment and breathing apparatus.
