Part 2 – Fishing Vessels

Delay Structural Repairs at Your Peril

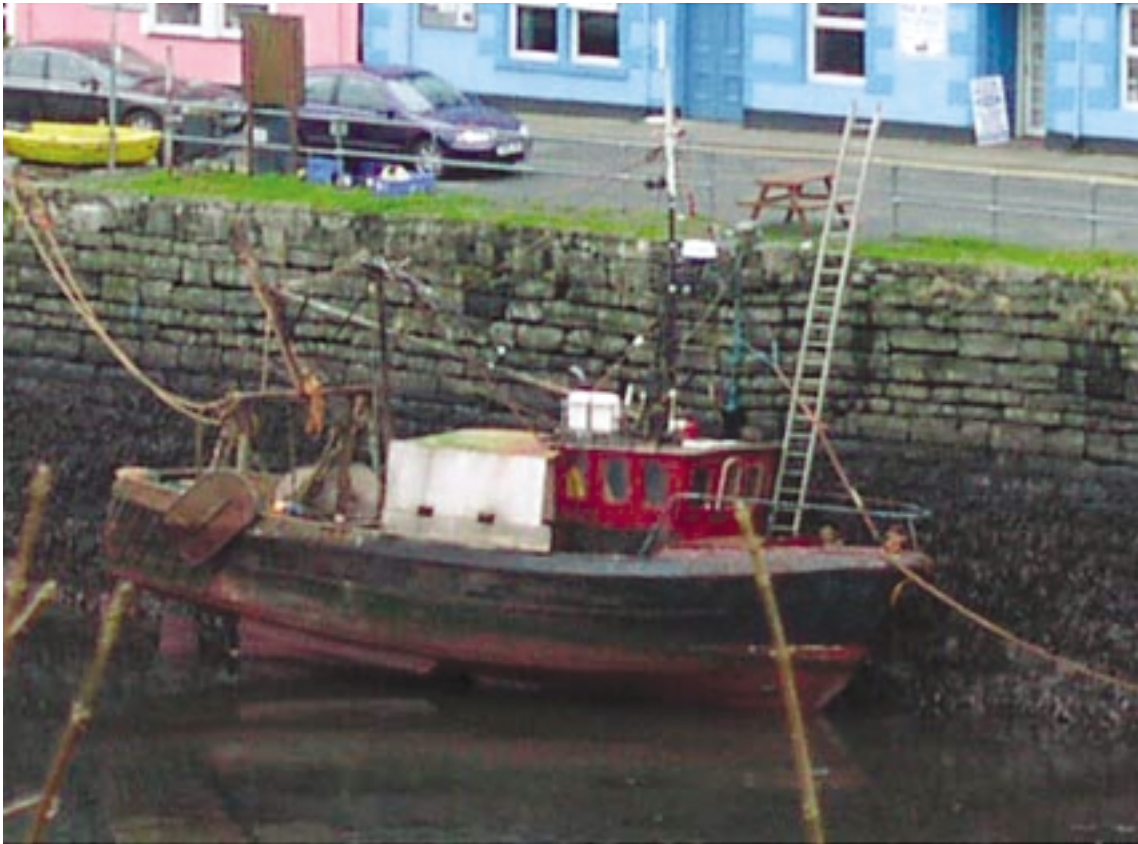
Figure 1

The skipper had mixed success at fishing, so money was fairly tight. This might help to explain the extremely poor condition of the vessel (Figure 1). On many occasions, harbour authorities and other skippers had advised him to attend to the poor – and in their view, dangerous – structural condition of his vessel. There were holes and splits in the weather and forecastle deck and bulwarks. The fish hold did not have a watertight cover or even a tarpaulin to cover the hatch boards, and there was virtually no paint protection to prevent hull corrosion (Figure 2).

It is very difficult to understand why the skipper did not heed the advice of his peers, harbour authorities and contractors, and deal with the severe hull and bulwark plate wastage. It must have been abundantly clear to him that the vessel was in a poor material state and was at severe risk of flooding, but he was happy to risk his life and take it to sea. Sadly, in this case it was once too often.

1. Skippers and owners of fishing vessels must ensure their vessels are safe to proceed to sea. This means that watertight hatches and doors should, indeed, be watertight and the structure should be in a seaworthy condition. Do not delay repairs – the situation will only get worse.
2. The condition of a ship's hull will inevitably deteriorate over time. However, ensuring that the paint preservation is intact and regularly touched up, is one, relatively cheap and effective way of protecting structure against corrosion. In this particular vessel, it was difficult to find evidence of any external paint coatings.
3. Regularly examine upper deck, non-watertight hatch arrangements. The risk of downflooding through fish hold hatches that are fitted with boards can be much reduced by fitting tarpaulin covers over them.

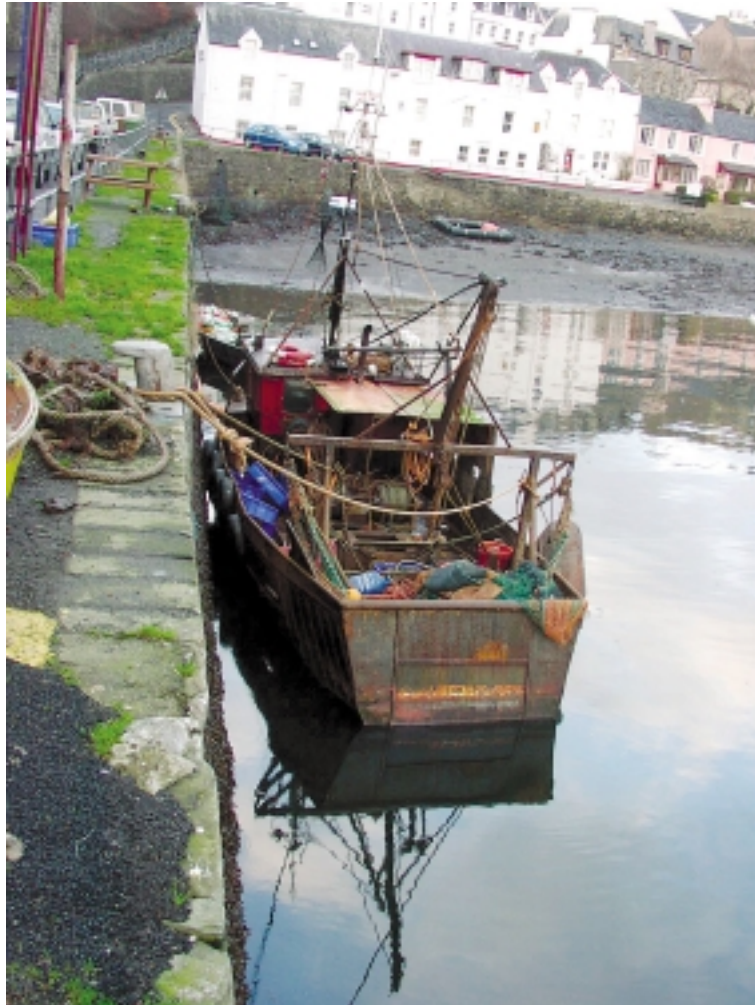
Figure 2

Over the years, some attempts had been made to carry out patch repairs to the deck. But these had to be frequently abandoned because of the lack of parent metal to weld to and could be considered as only temporary measures. Perhaps this was because permanent repairs would have been too costly and burdensome for a commercial venture that was, at best, marginal. Although regarded as a capable skipper, those who knew him, found it extremely difficult to balance this with his ambivalent attitude towards the condition of his vessel.

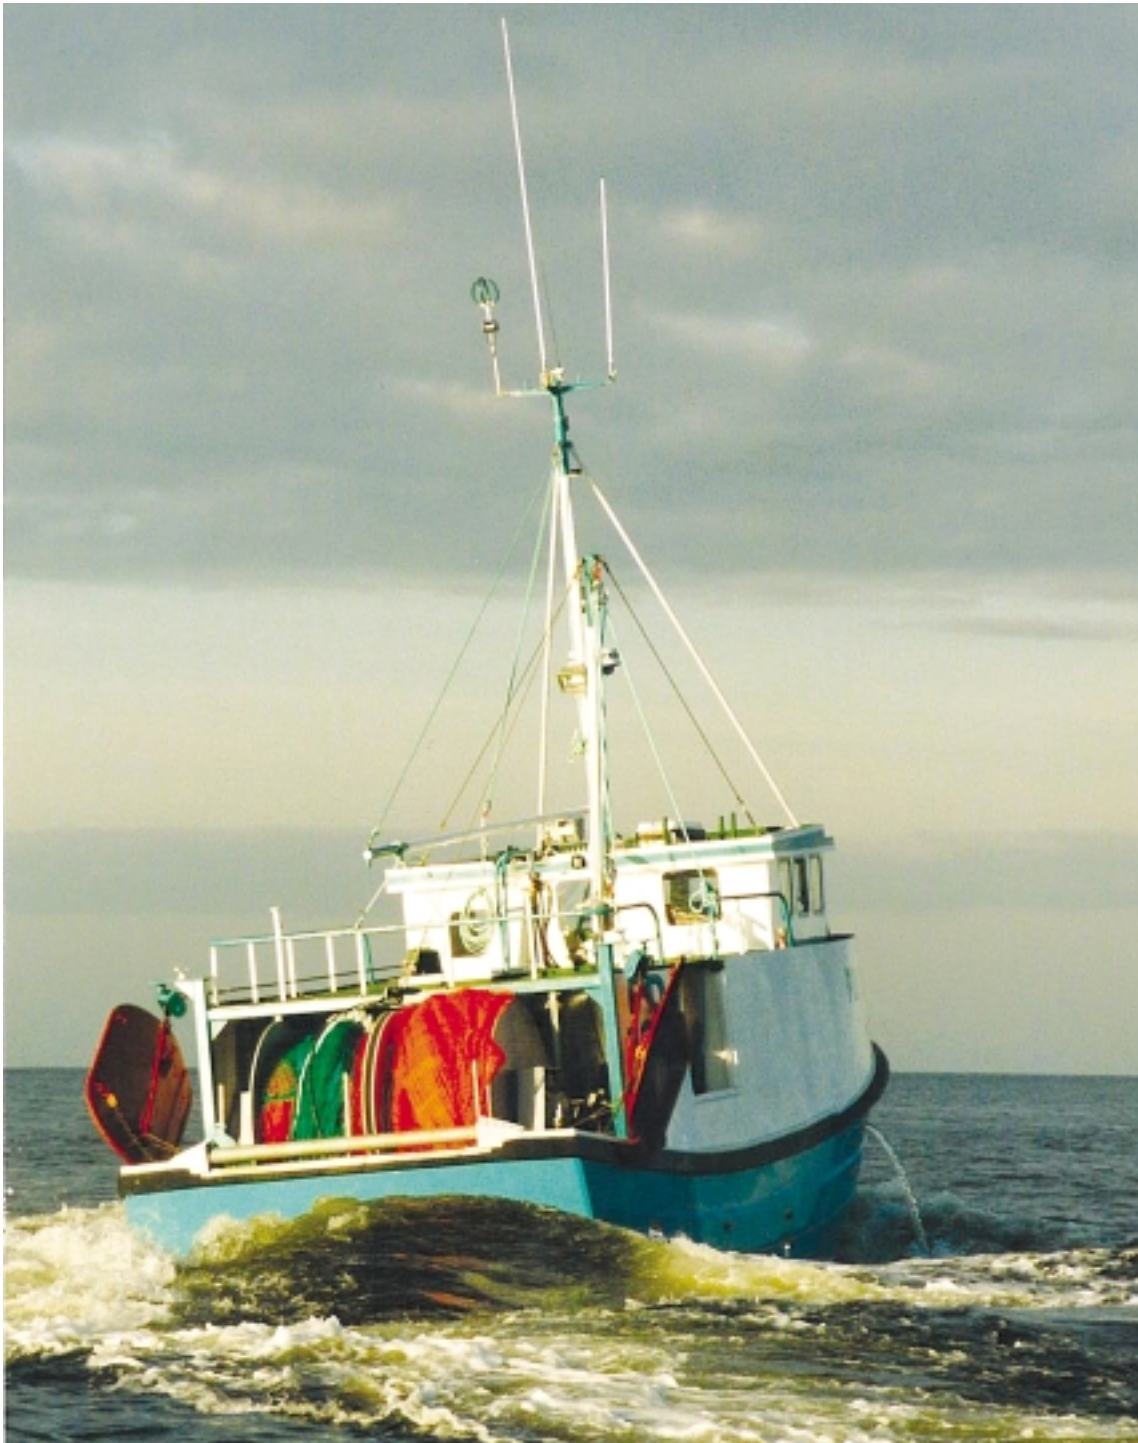
A 9.8m long fishing vessel (photograph) with two people on board was swamped by a wave which came over her stern while her trawl was snagged on a seabed obstruction. Floodwater

There was no minimum freeboard requirement for a fishing vessel of this size, but there was for an equivalent sized workboat. If the workboat standard had been applied to this vessel, she would have been about 5 tonnes too heavy. She was overloaded with equipment and fittings, and her freeboard and buoyancy were inadequate as a result.

3. The area of freeing ports on this vessel did not meet the basic minimum guidance. When the effect of the shelter was taken into account, her freeing ports were woefully inadequate. Trapped water on a vessel can easily cause capsize, and adequate means for water to quickly escape should be provided. If your vessel has a shelter which could trap water on the after deck, try to avoid operating while stationary and stern-to the sea waves.

2. The standard for workboats provides useful guidance. A fishing vessel with a continuous watertight weather deck and a length of 9.8m would require a minimum freeboard of 415mm when fully loaded. If your vessel meets this description, but with reduced freeboard, you need to be aware that she suffers from a lack of buoyancy which may substantially reduce her capability to survive in certain circumstances.

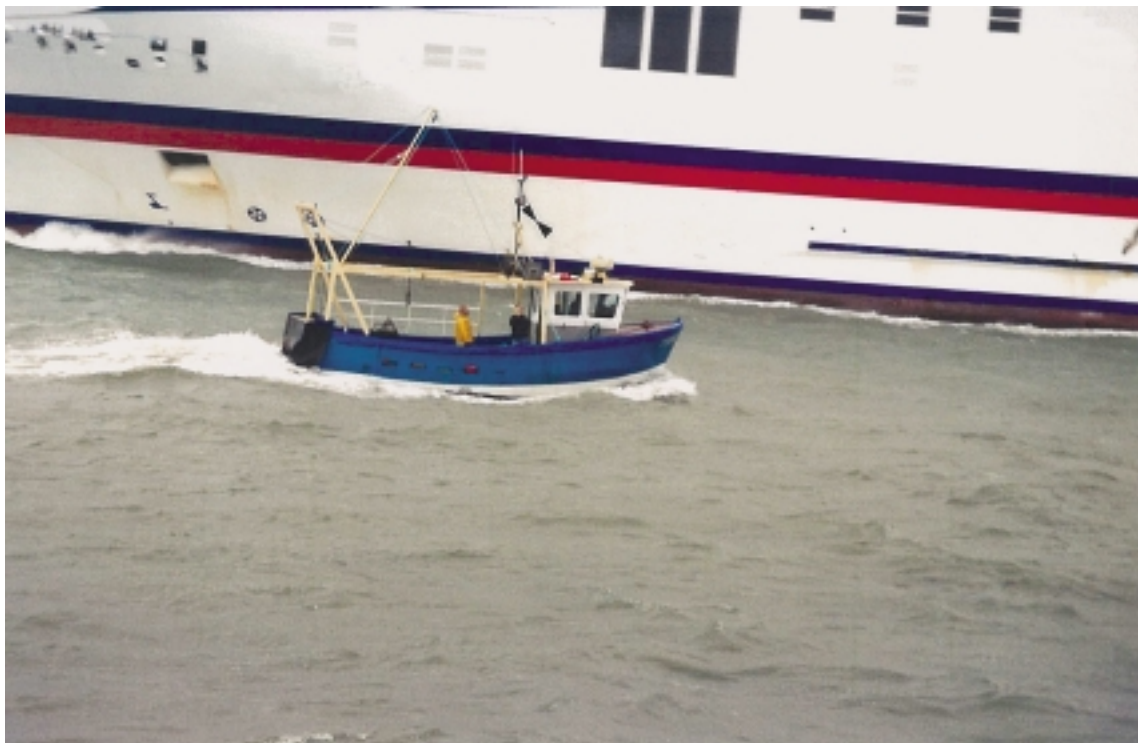
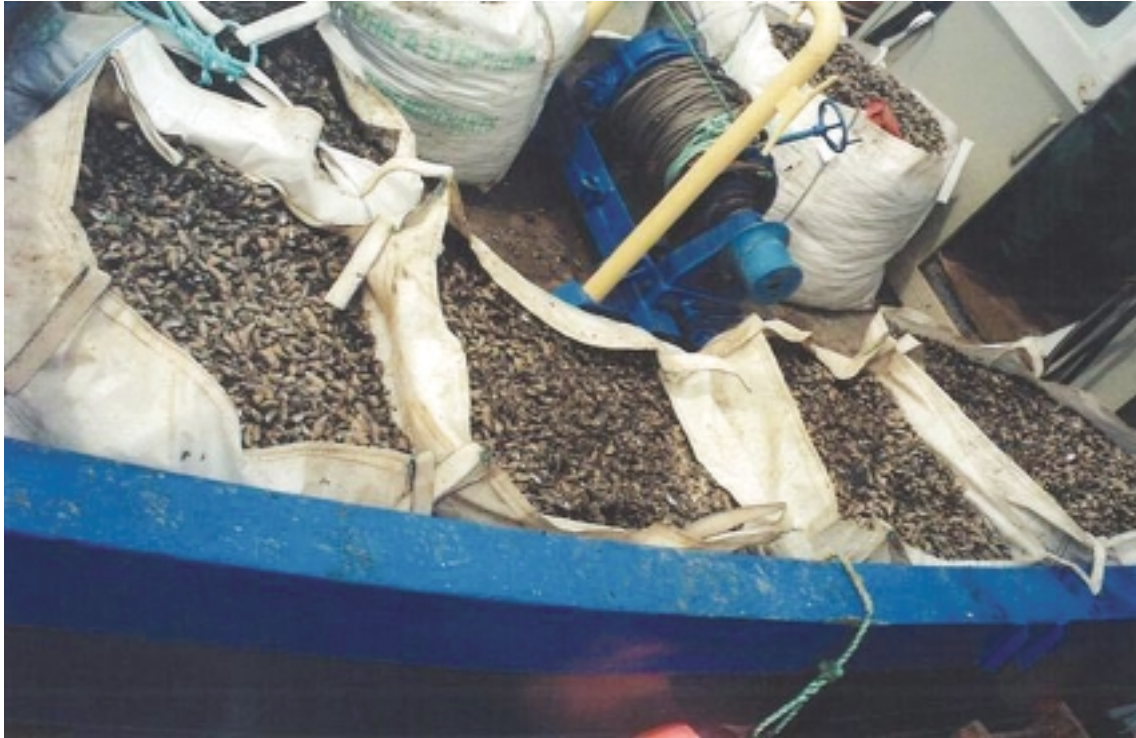
Over the years, fishermen have thought of many ideas to reduce time spent alongside and unloading the catch. Recently, some fishermen have taken to loading their shellfish catch into 1 cubic metre aggregate bags, which are more commonly used in the building industry by builders' merchants. These bags are stowed on the open deck and unloaded quickly by crane.

1. Both the owner and skipper failed to notice the serious stability implications of the bags having no means of drainage. Using these bags had the same effect as blocking the vessel's freeing ports, because water could not escape. Be aware of the dangers of water trapped on deck. It can happen quickly and unexpectedly. Always ensure that freeing ports are kept clear, and that containers on deck have adequate drainage holes.
2. Fishermen on small vessels should consider wearing constant wear buoyancy aids all the time at sea. The MAIB frequently comes across accidents where vessels capsize suddenly, with little or no warning. In such a circumstance, it is *too late* to scramble around to find the lifejackets which are often stowed in the most inaccessible location.
