Report on the investigation of
the collision between
mt *Saetta* and mt *Conger*
on completion of a ship to ship transfer
9.5 miles south east of Southwold, UK
on 10 August 2009

Marine Accident Investigation Branch
Mountbatten House
Grosvenor Square
Southampton
United Kingdom
SO15 2JU

Report No 3/2010
March 2010

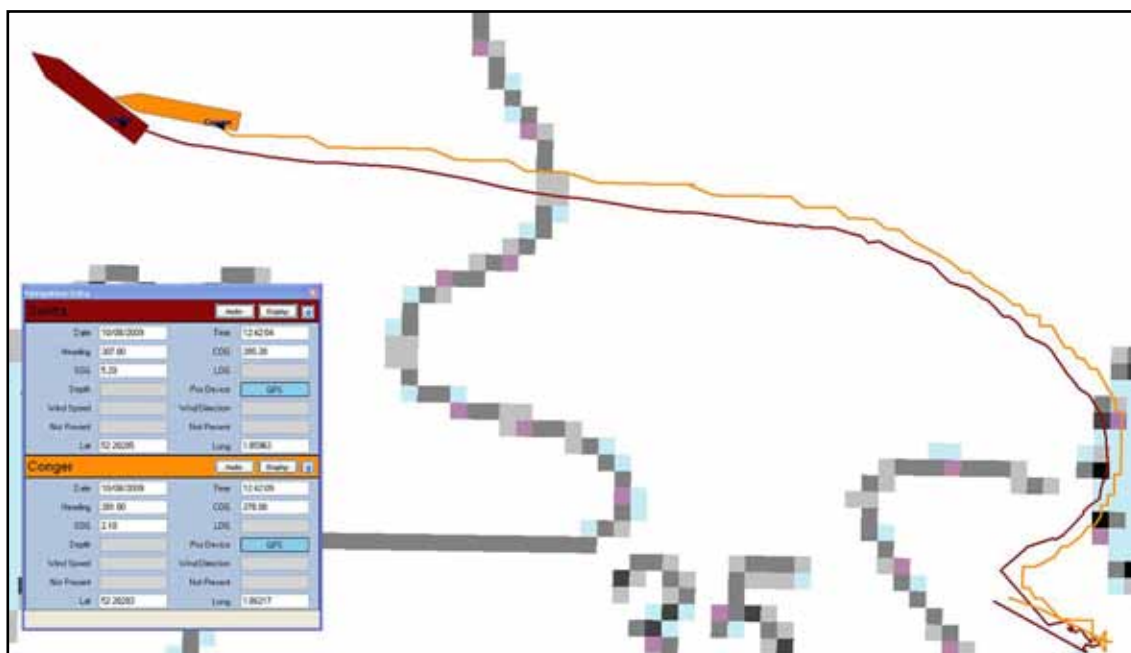
Figure 4

AIS tracks of vessels (collision)

Just prior to the collision, the superintendent had assessed that *Saetta's* pivot point was forward of *Conger's* bow, and ordered *Saetta* to 'full ahead' and 'hard to starboard' in an attempt to manoeuvre her clear. *Saetta's* master remained unaware of *Conger's* engine problems and had started to issue his own helm and engine orders to try and avoid a collision, but he had not informed the superintendent of his actions.

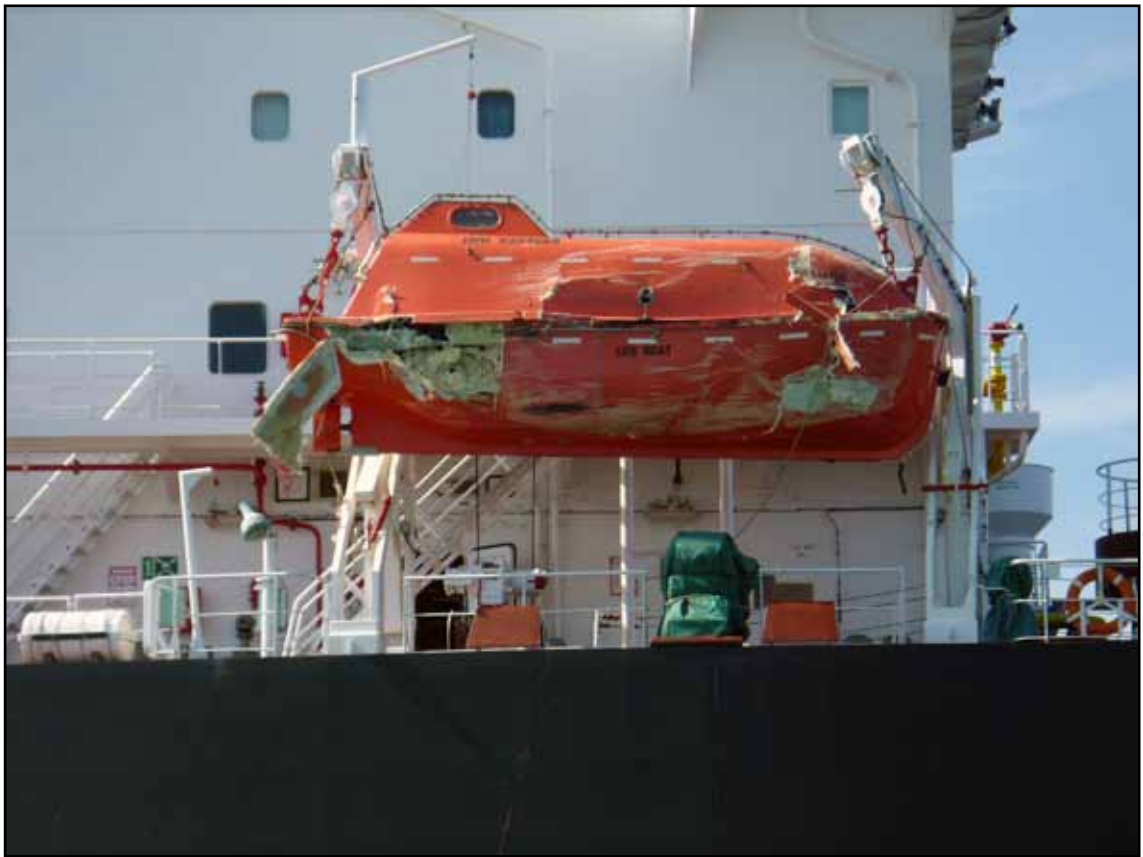
Figure 5

Saetta suffered structural damage to her starboard lifeboat (**Figure 5**) and the lifeboat davit arm (**Figure 6**). *Conger* suffered only scratches to her paintwork (**Figure 7**).

Damage to *Saetta's* starboard lifeboat

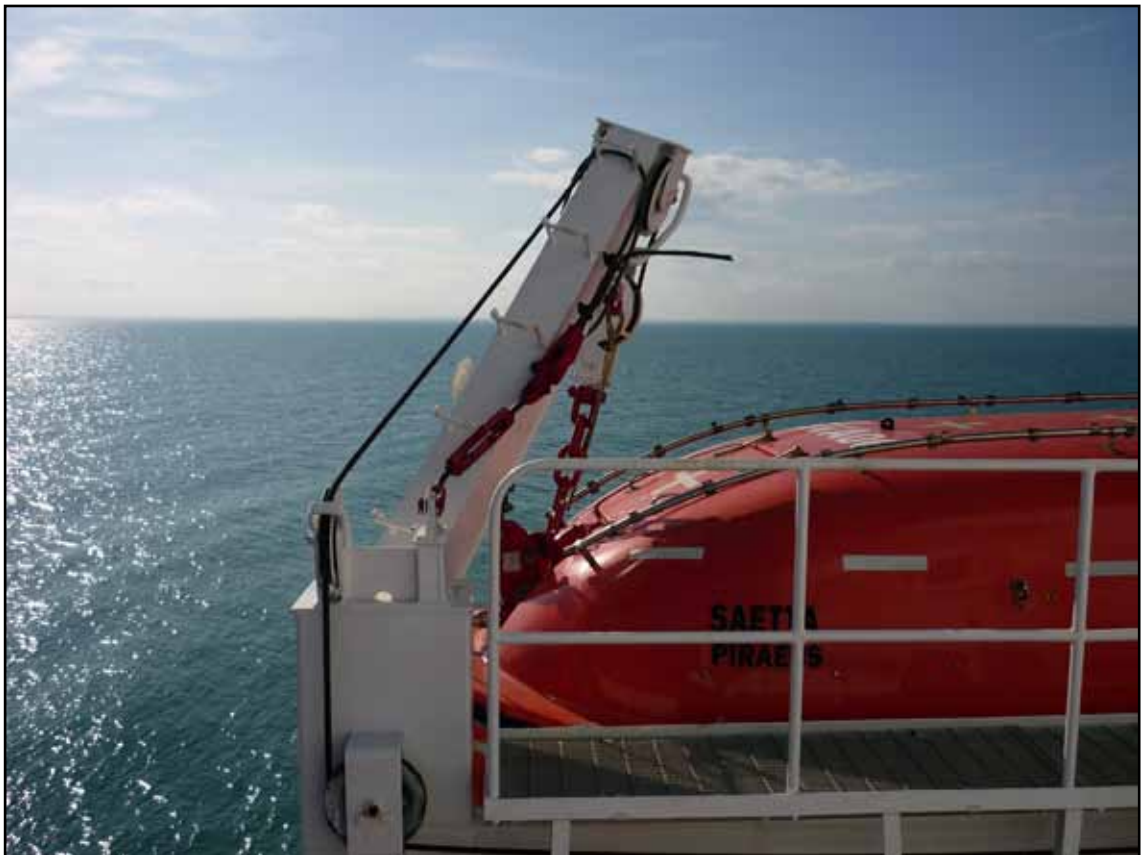
Figure 6

Damage to *Saetta's* starboard lifeboat davit arm

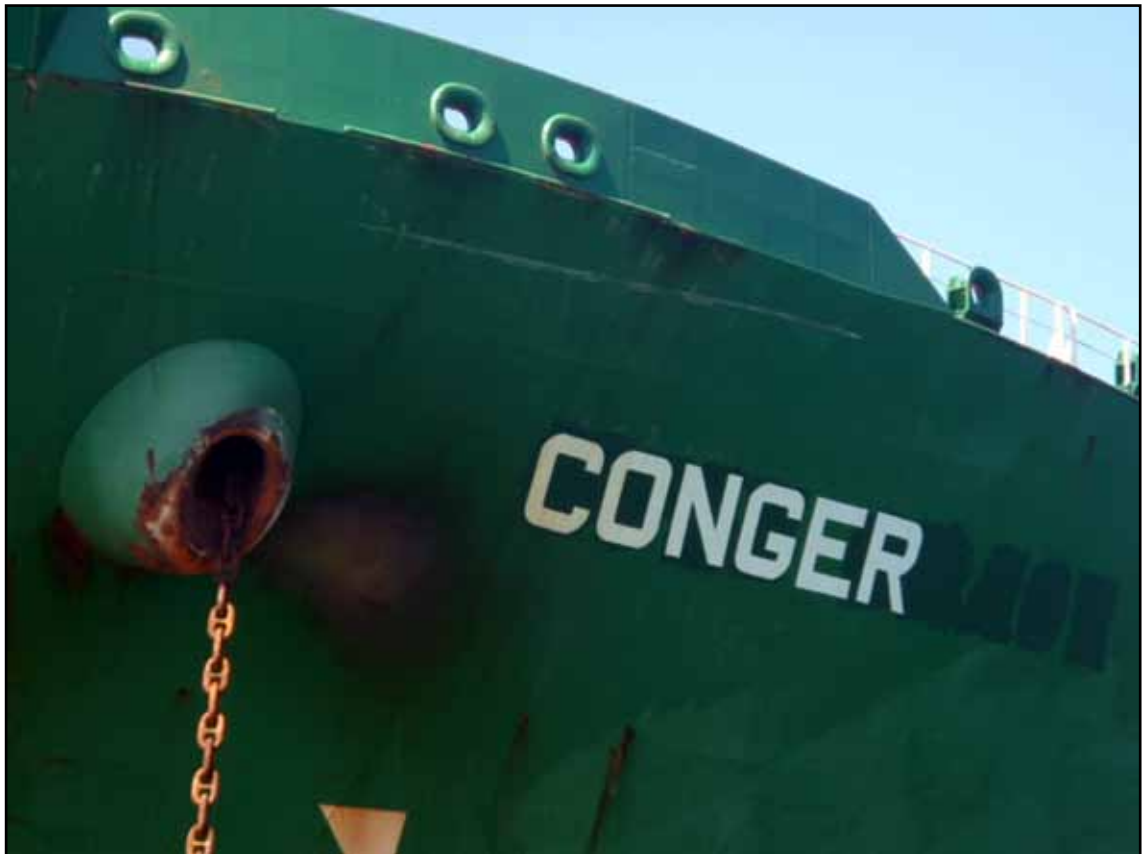
Scratches to *Conger's* paintwork
