# Part 3 – Leisure Craft

## Fatal Injuries From Propeller

# A Change of Mind

#### **ACCIDENT WITH THREE FATALITIES 21 AUGUST 2006**

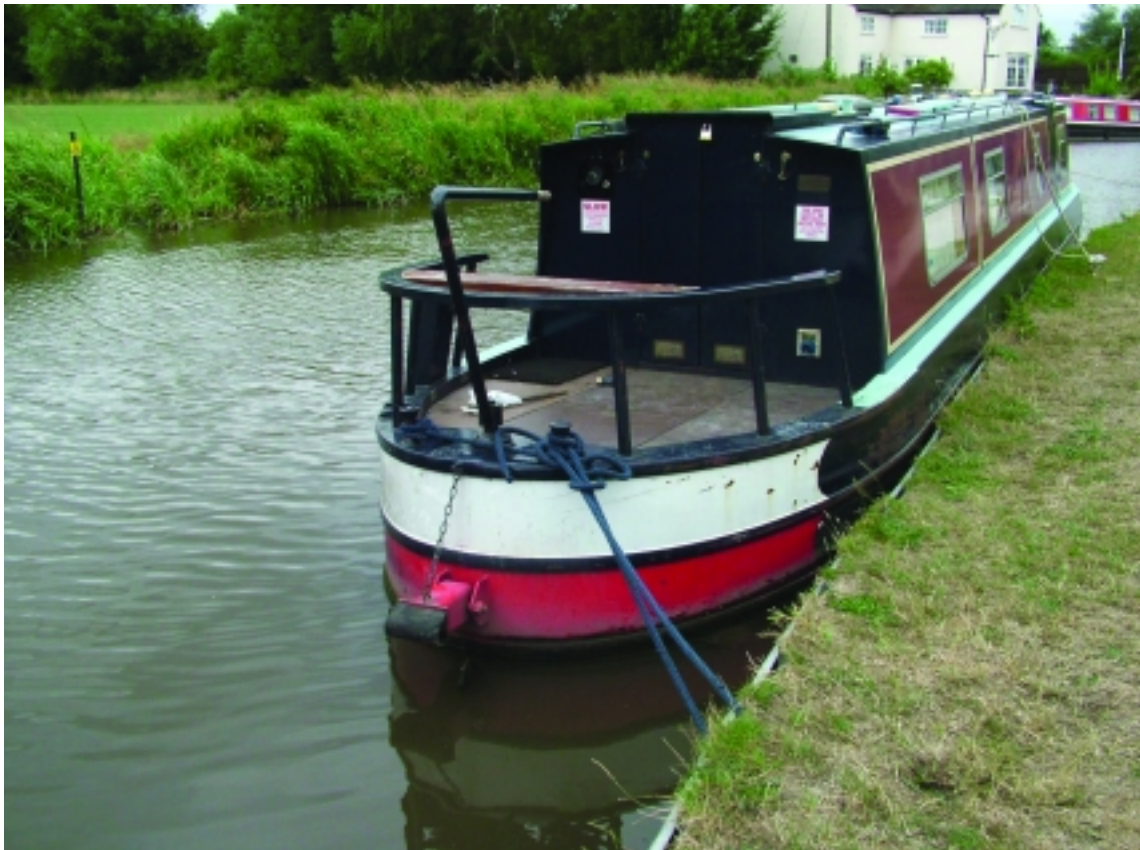
The boat then made contact with the canal bank, and the helmsman was seen to tip over the guard rail, which was at about knee height and fitted round the cruiser style stern. He managed to hold on briefly, with his legs hooked over the rail, before dropping into the water on the outboard side. The crewman with the stern line jumped back on board and stopped the engine, but could not see the helmsman in the water. Although buoyancy aids were available on the boat, the helmsman was not wearing one. A lifebuoy was thrown into the water, but with no sign of the helmsman, the crewman jumped into the canal to assist. The crewman quickly found the helmsman's leg, but could not pull him free. Another family member and the helmsman of another boat jumped into the waist deep water to assist, but the helmsman was entangled in the propeller.

the emergency services, who had quickly arrived at the scene, the helmsman was recovered to the canal bank. He had suffered severe injuries to the back of his shoulders and head, and his left arm was very nearly severed. He was pronounced dead at the scene.

1. Although serious accidents are rare on the inland waterways, boaters, and particularly those new to boating, should be aware of the potential hazard posed by a rotating propeller.
2. All responsible people on board should be familiar with the actions to take in an emergency, and be able to stop the propeller quickly if needed.
3. Boaters should check canal maps for potential obstacles such as locks and bridges, and slow down if the view ahead is obscured to avoid having to make difficult manoeuvres at short notice.
4. Although hand rails are not required on narrow boats, where they are fitted, they should be of an appropriate height to prevent people from falling overboard near the propeller.

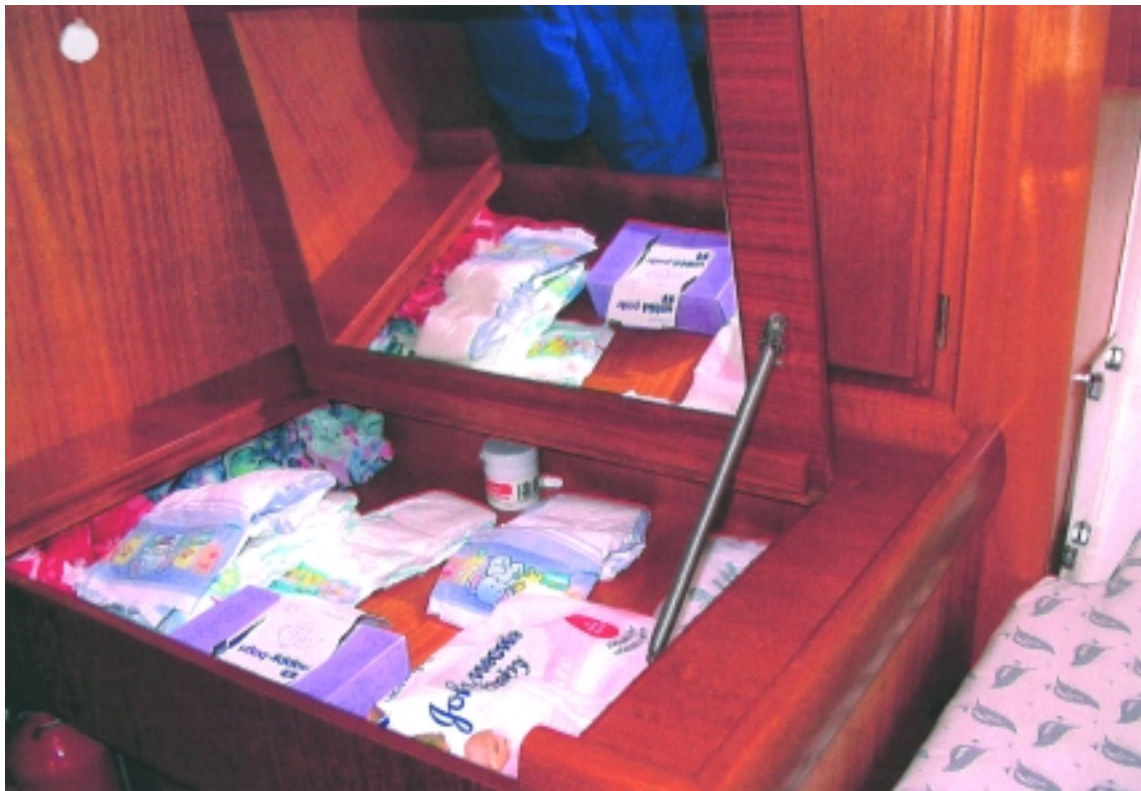
A 10.6m yacht was returning to its home port with its owner at the helm. The boat had been recently purchased by the owner. As the yacht neared the entrance to the harbour, the wife of the skipper was down below getting their 14 month old son ready for bed in the forward cabin. The infant was laid down on a bunk adjacent to a storage unit with a lid that was secured open by a rigid spring mechanism. As his mother turned her back for a moment, the boy rolled over and sat up and, in doing so,

deflected the spring that was keeping the locker lid open. The lid came crashing down, trapping one of his fingers.

1. Make sure any heavy locker lids or chart tables can be secured open and do not pose a significant hazard.

2. Special care needs to be taken where children can easily reach securing mechanisms. If children travel on your vessel, it is worth considering your craft's arrangements from a child's perspective to avoid potentially nasty accidents such as this.

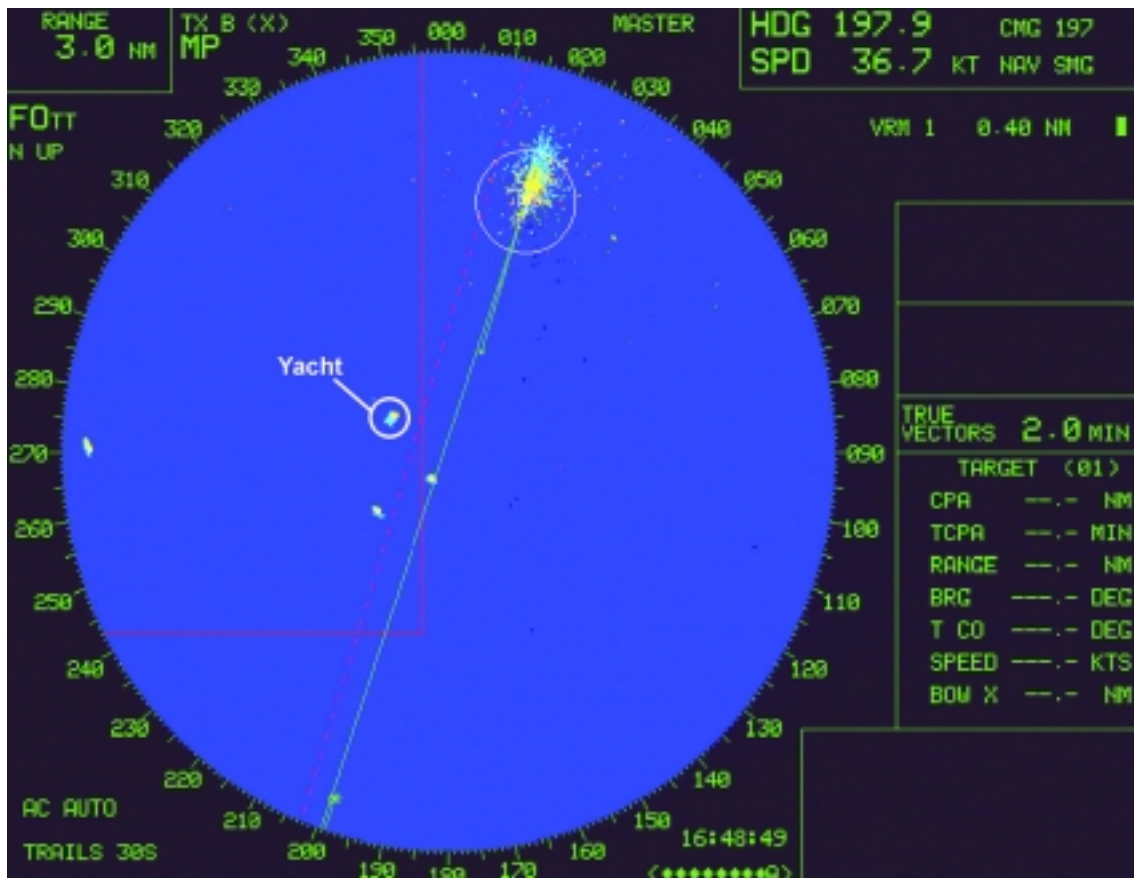
Figure 1: VDR extract of HSC

The motor yacht was first sighted at about 10 degrees on the starboard bow at a distance of about 3.5nm (Figure 1) and appeared to be crossing and on a collision course. The master of the HSC, being the give way vessel, decided to alter course 15 degrees to starboard which, by the time he had done so, put the motor yacht 1.6nm away and fine on his port bow (Figure 2).

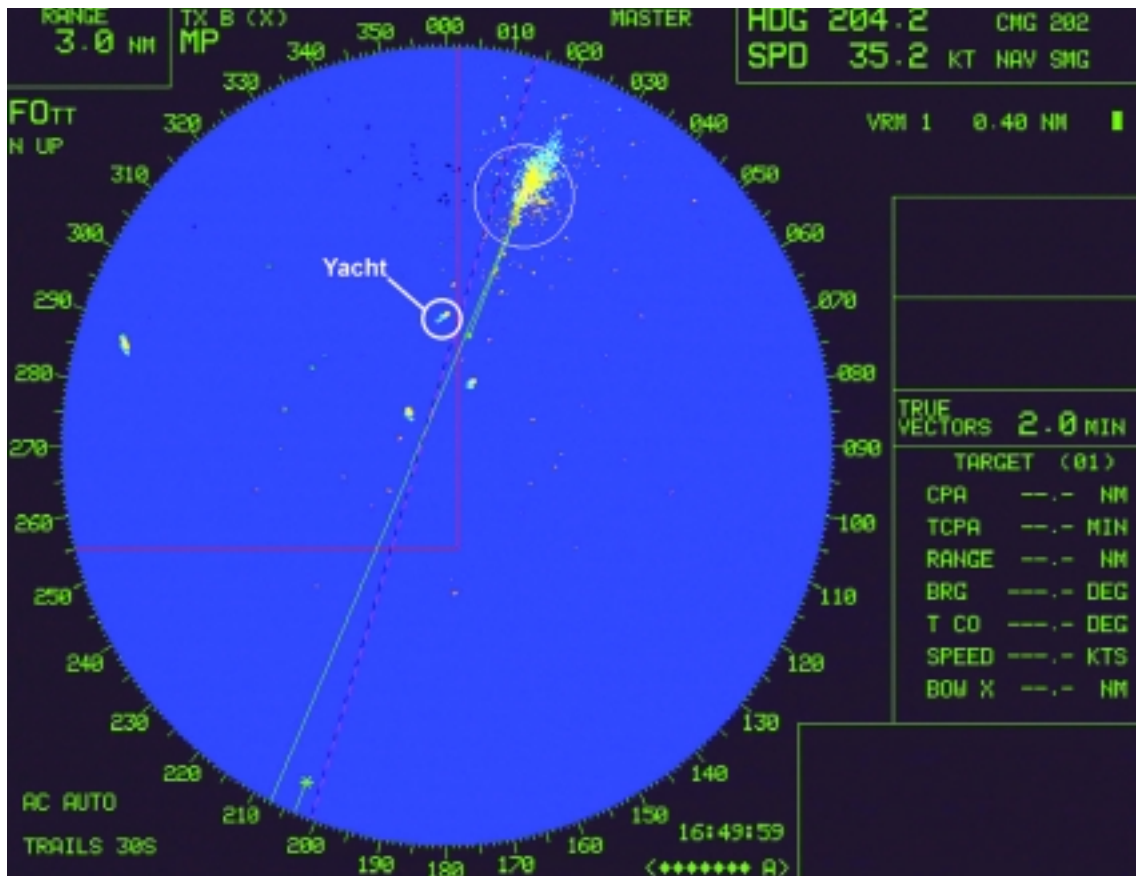
Figure 3: VDR extract of HSC

For some unexplained reason, the master changed his mind at a distance of about 1nm and altered course to port by about 10 degrees (Figure 3). The astonished skipper of the motor yacht stopped his engines to increase the passing distance, and the HSC passed 2.5 cables ahead. The skipper and crew of the yacht had been frightened by the experience, which was made worse by having to brace themselves against the effects of the HSC's wash.

3. Even HSCs must obey the COLREGs! In this case, the master of the HSC should have taken early action to clearly indicate his intentions. He should then have maintained that course until past and clear and, most definitely, should not have changed his mind and altered at the last minute across the bow of the yacht. There was no navigational reason for him to have to pass closer than, say, a mile from any craft in the vicinity.

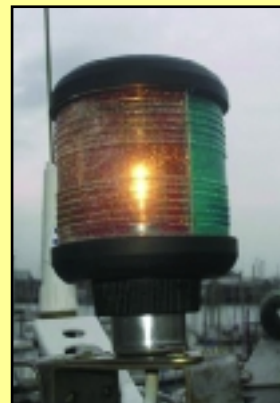
- i. The lenses of navigation light units similar to the one fitted to *Ouzo* are prone to crazing which substantially reduces their efficiency. **(as shown on photo)**

**Yacht owners should make every effort to ensure that their navigation lights are fully effective, and their characteristics understood.**
