Report on the investigation of the death by asphyxiation of

two crewmen on board

***Sava Lake***

**Report No 15/2008  
September 2008**

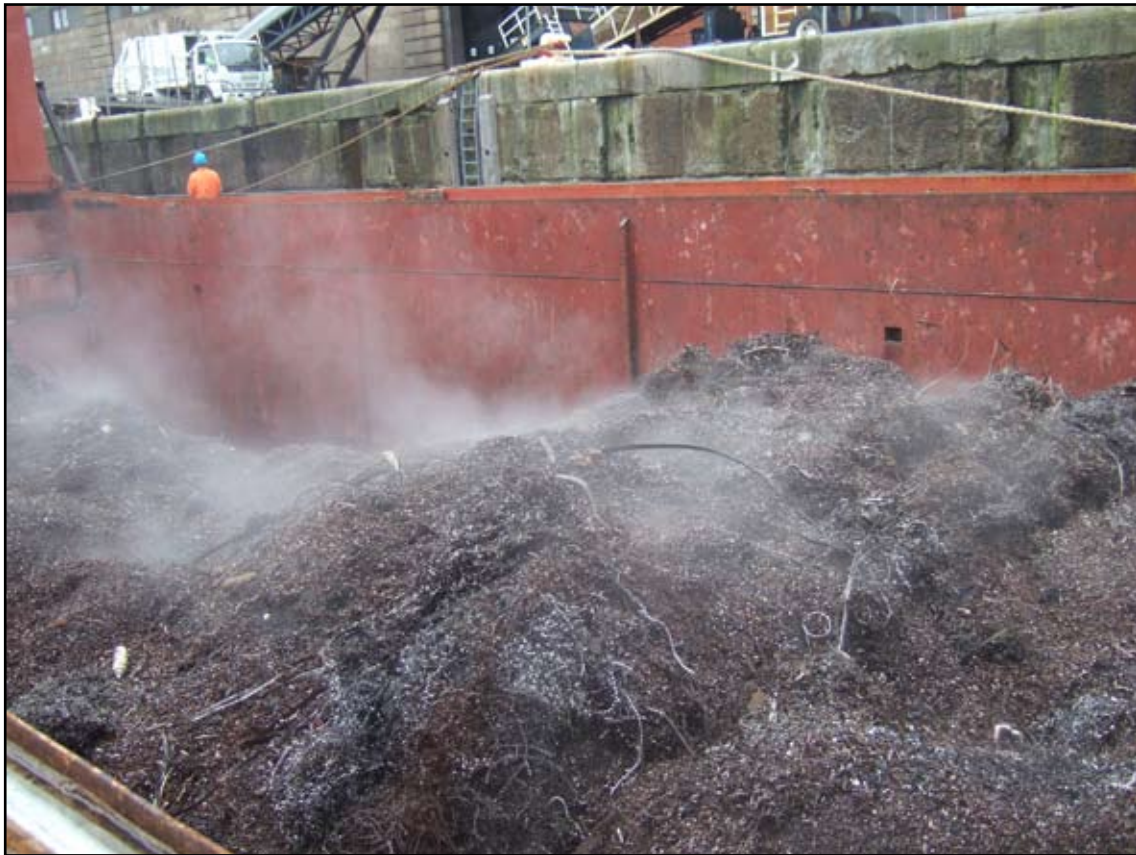
Steel turnings on board *Sava Lake*  
(as photographed in Dover on 19 January 2008)

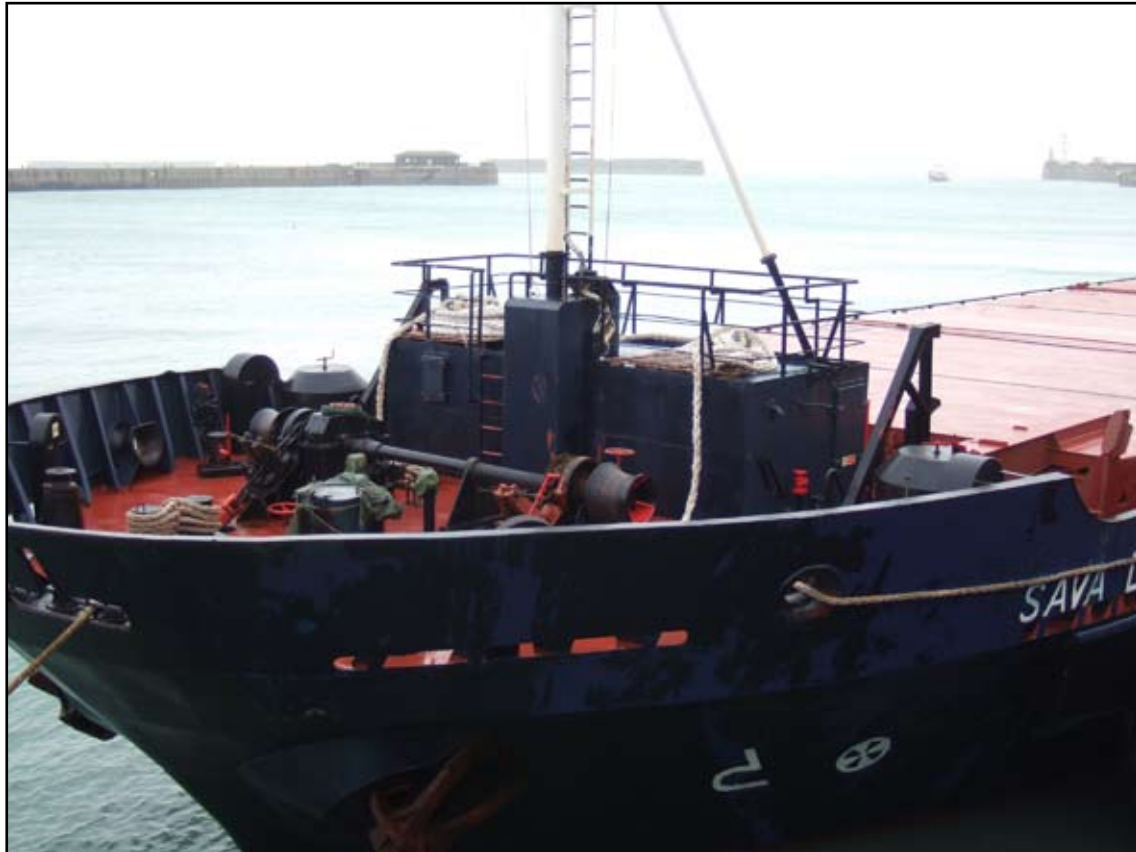
Figure 7

On departure Horsens the forward deck (**Figure 7**) was secured for sea. *Sava Lake* crossed the southern Baltic Sea in moderate weather conditions, initially destined for the Kiel Canal. The master routinely advised the crew not to go forward during the voyage, particularly when heavy weather was forecast, without seeking permission from either the chief officer or himself.

Forward deck of *Sava Lake*

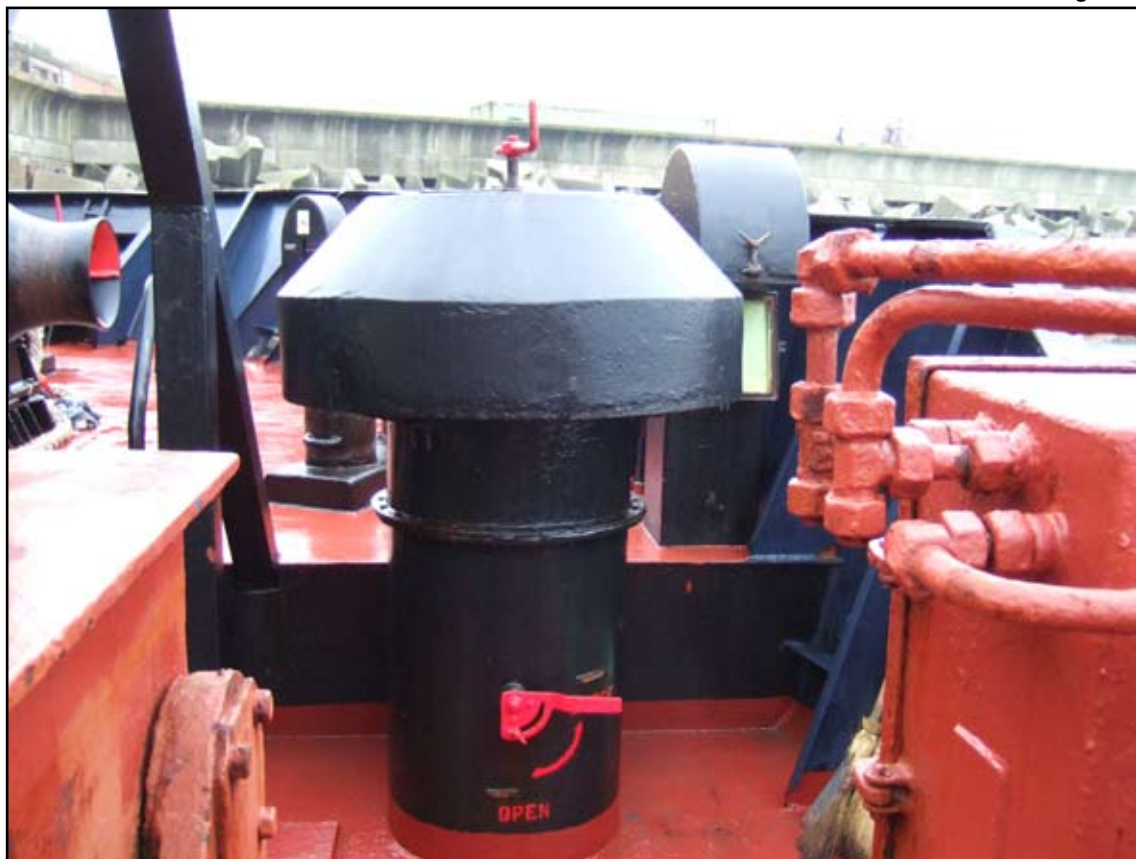
Figure 8

Starboard forward cargo mushroom ventilator and fire damper

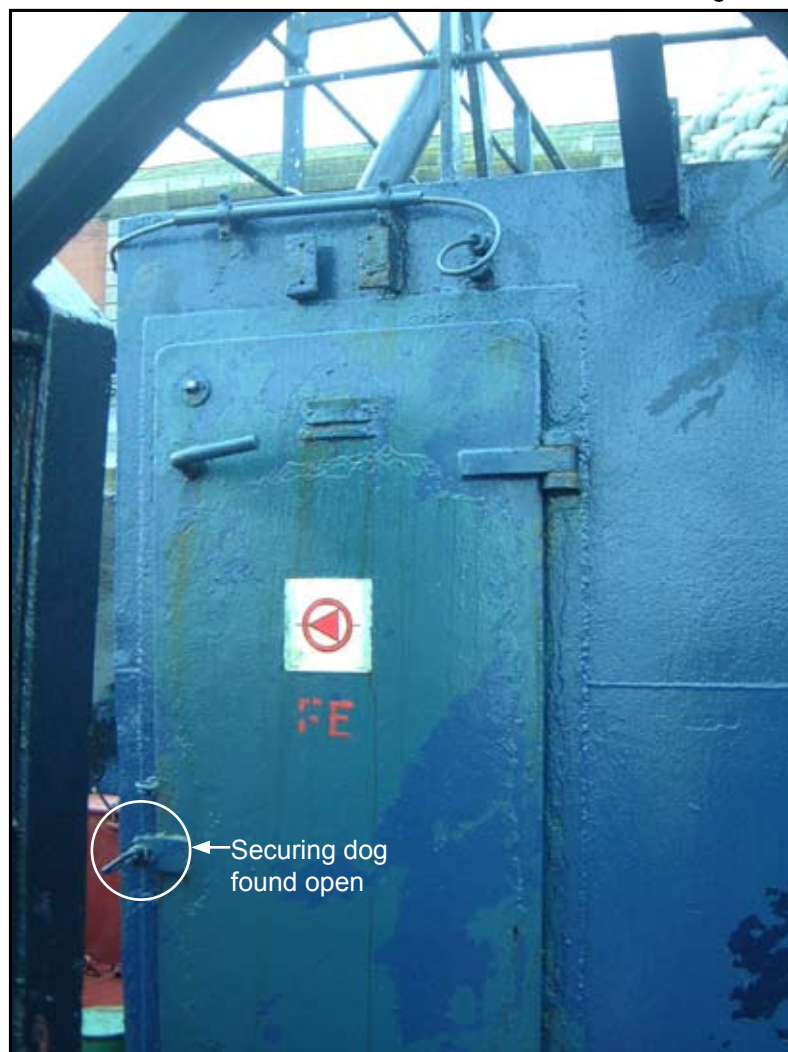
Figure 10

The chief officer noticed that the weather tight door to the forward store was closed, but that the locking securing arrangement was not closed as he would have expected (**Figure 10**). The chief officer opened the door to the forward store and saw the two missing men lying motionless at the bottom of the ladder.

Weather tight door to forward store

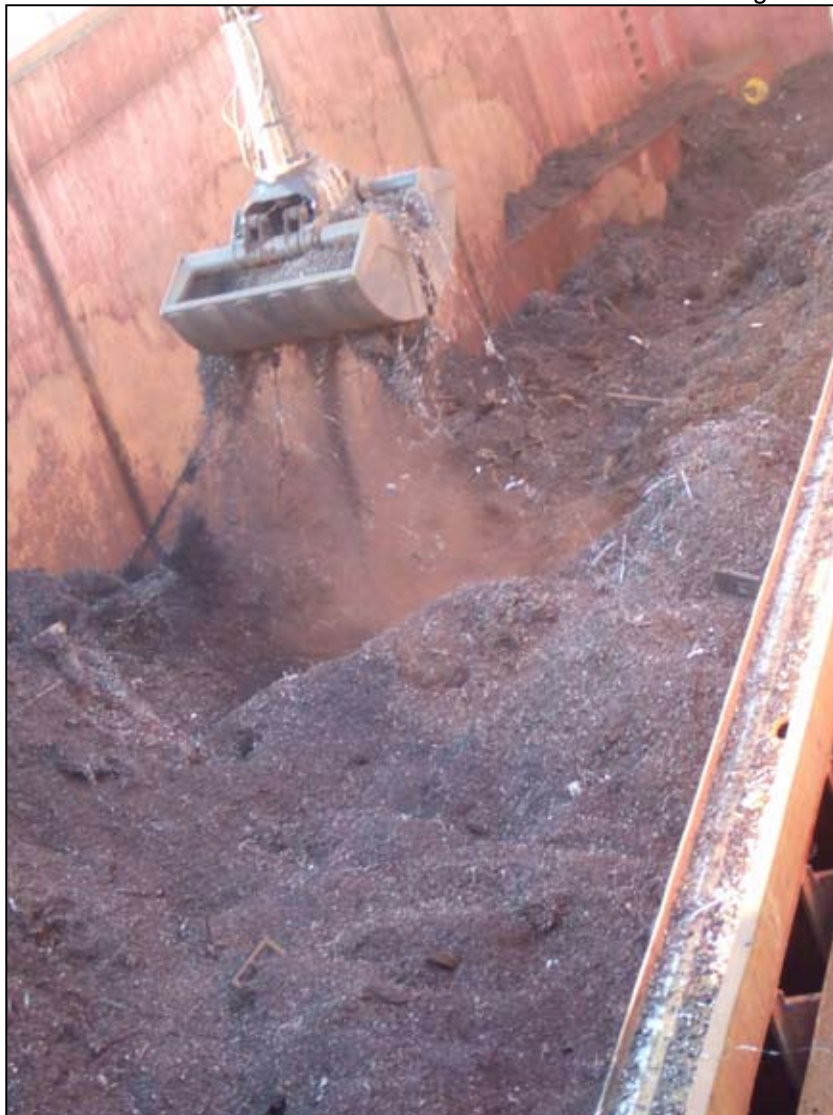
Figure 12

The cargo was unloaded in Newhaven on 6 February (**Figure 12**) when it was noted to be heavily oxidised.

Cargo unloaded in Newhaven

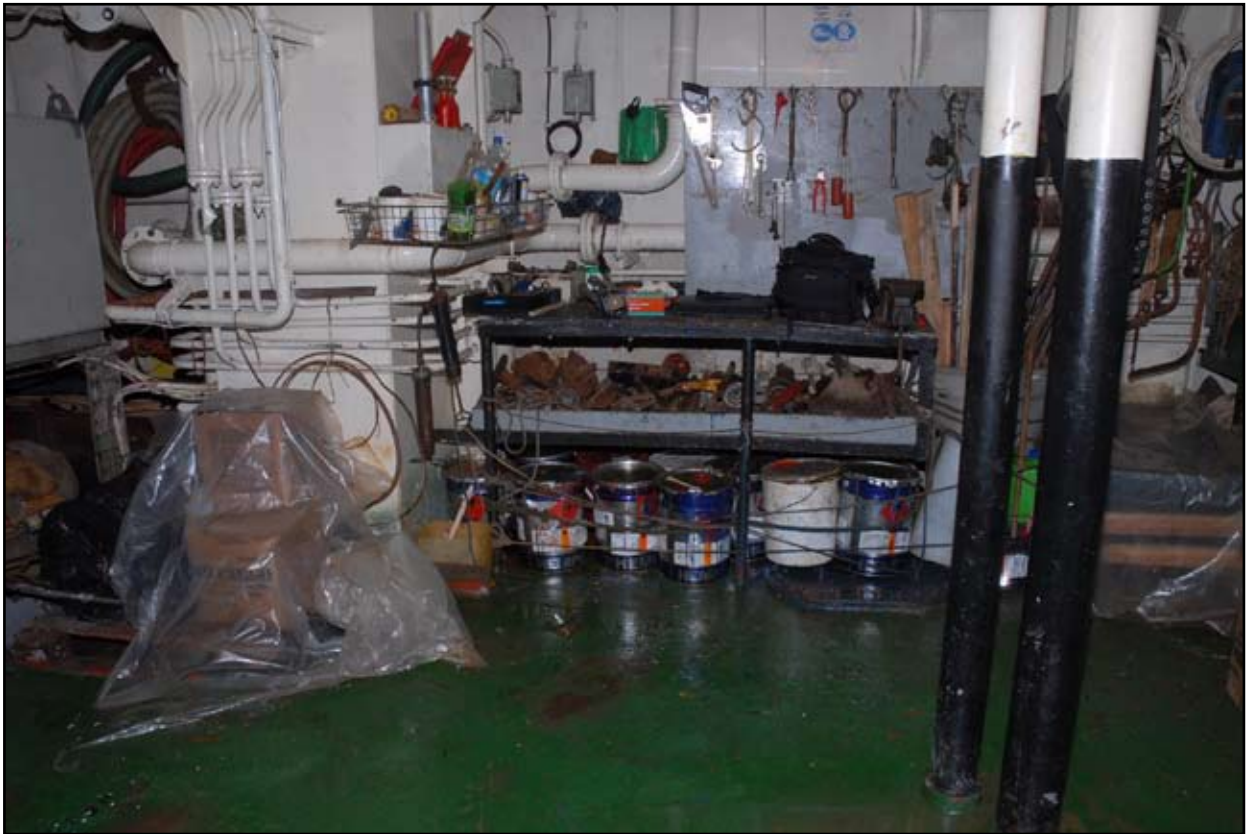
Figure 17

The forward store was used as an AB's workshop and store, and contained the usual deck workshop tools and small quantities of paint and chemicals (**Figures 17**). The space also contained electrical switchboards for deck machinery, hydraulic oil tanks and provided storage for *Sava Lake's* forward mooring ropes when these were not required on the fore deck.

Forward store

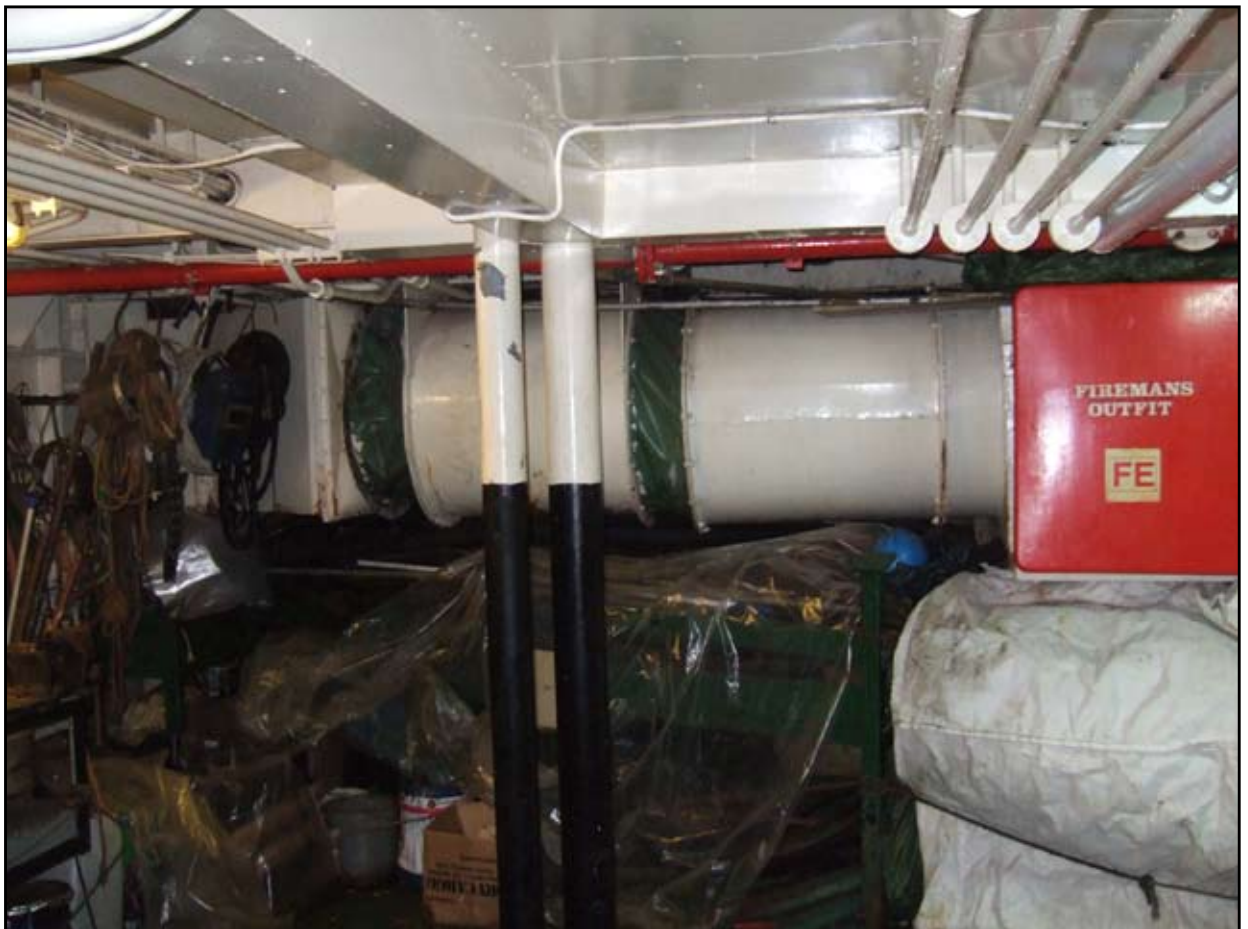
Figure 18

Forward store - port cargo ventilation trunking

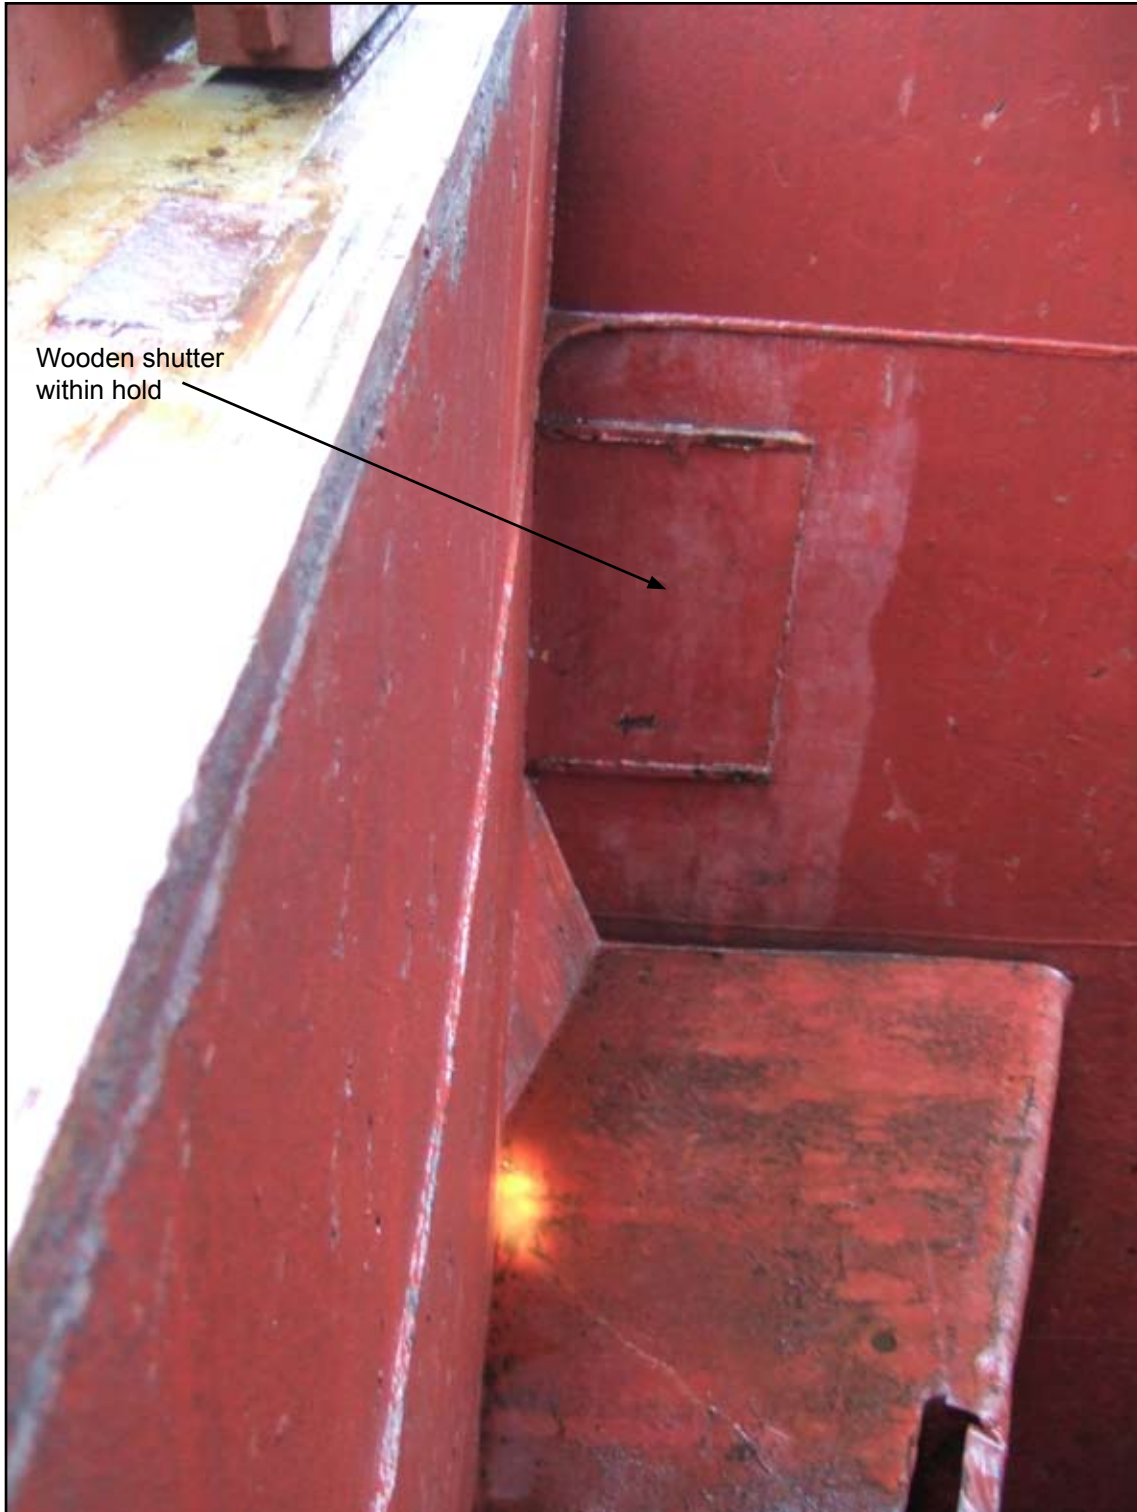
Figure 22

Wooden shutter to cargo ventilation system - port forward cargo hold

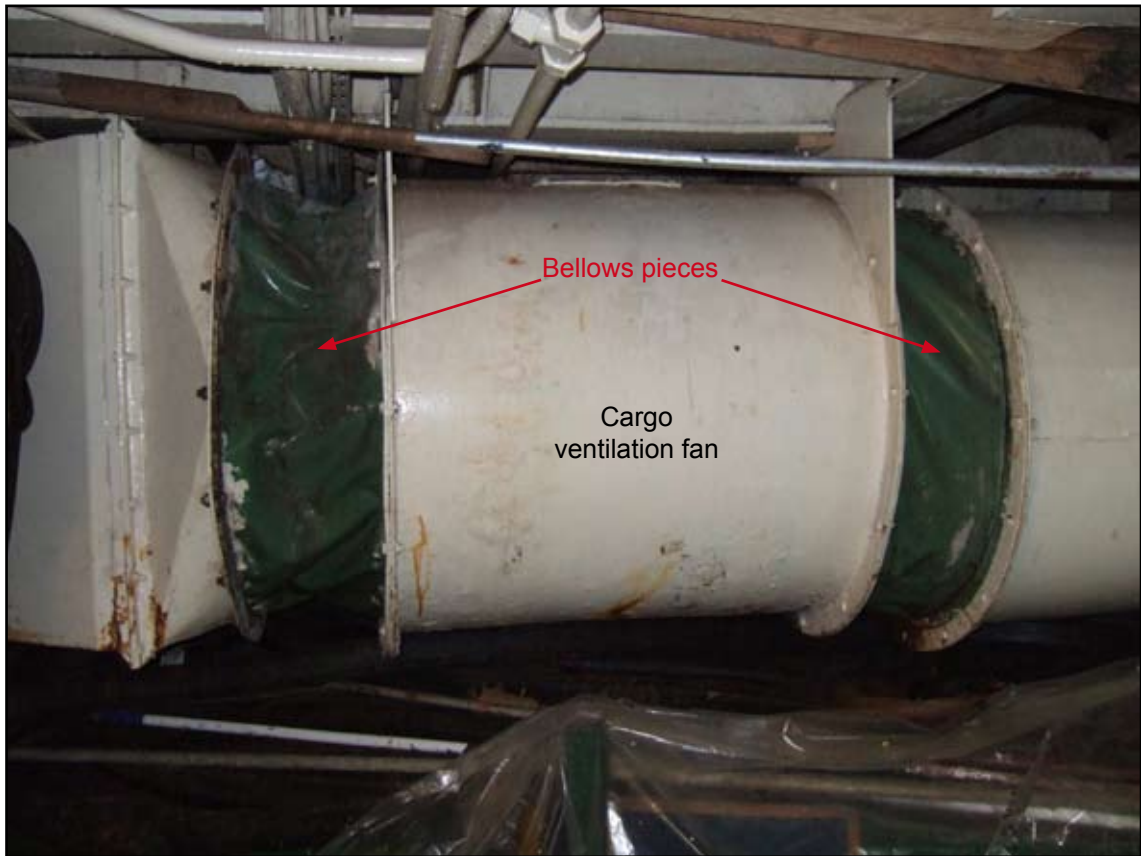
Figure 24

Cargo ventilation fan and bellows pieces

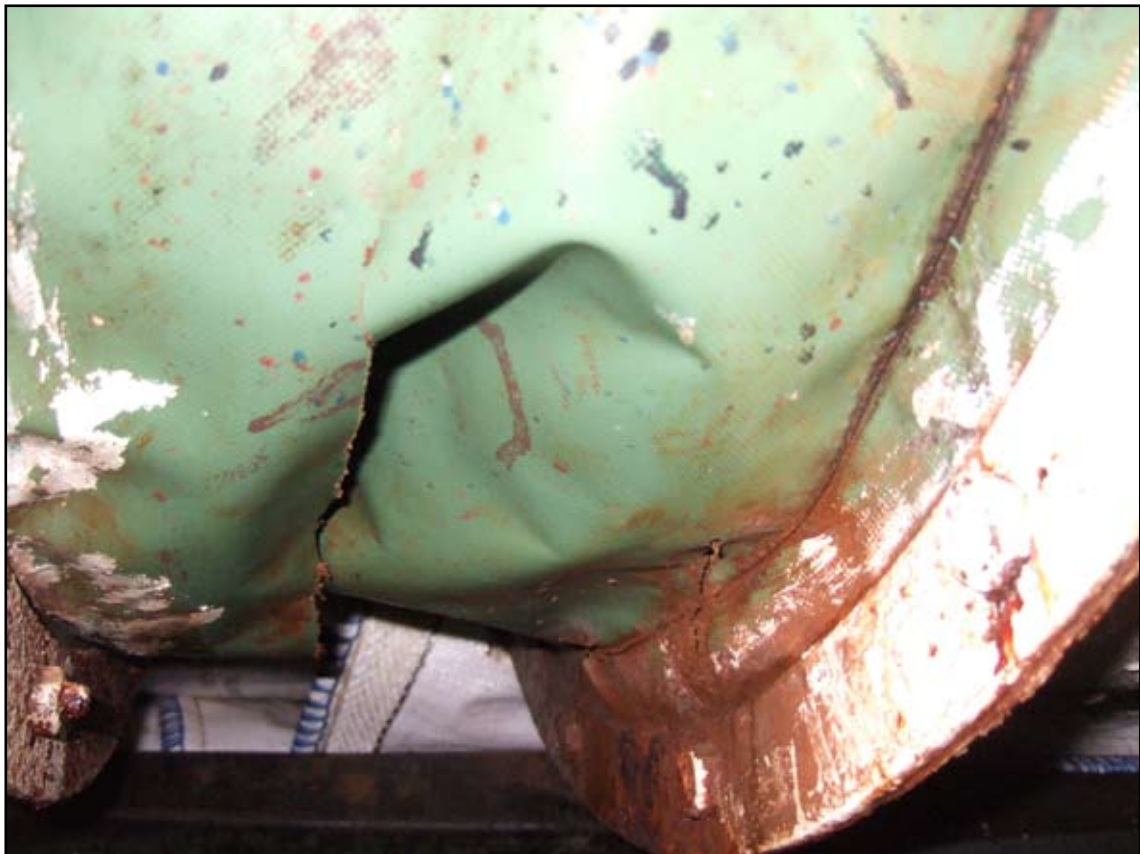
Figure 25

Three of the four bellows pieces were found to have been cut to create openings of up to 30 cm at the bottom of the ducts. The cuts had allegedly been made by an earlier crew of *Sava Lake* to allow for the drainage of sea water during heavy weather and to facilitate the removal of cargo residue that had been drawn in from the adjacent hold (**Figure 25**).

Cut bellows piece

The cuts in the flexible bellows pieces fitted to the ventilation ducts that ran through the forward store created an air path between the store and the adjacent cargo hold. This created an “unsafe condition” that, with the right combination of cargo and circumstances allowed a noxious atmosphere to develop within the forward store.

The cargo ventilation system had not been used for a considerable time, and the implication of the cut bellows had not, therefore, been recognised. Although the chief engineer tested the ventilation fans monthly, there was no routine for visually inspecting the system as a whole and the defective trunking bellows pieces went unnoticed. A thorough routine visual inspection of the ducting could have shown the cuts in the ducting, and raised awareness of the inadequacies of the system design.
