Report on the investigation of

the collision between

Scot Isles

Wadi Halfa

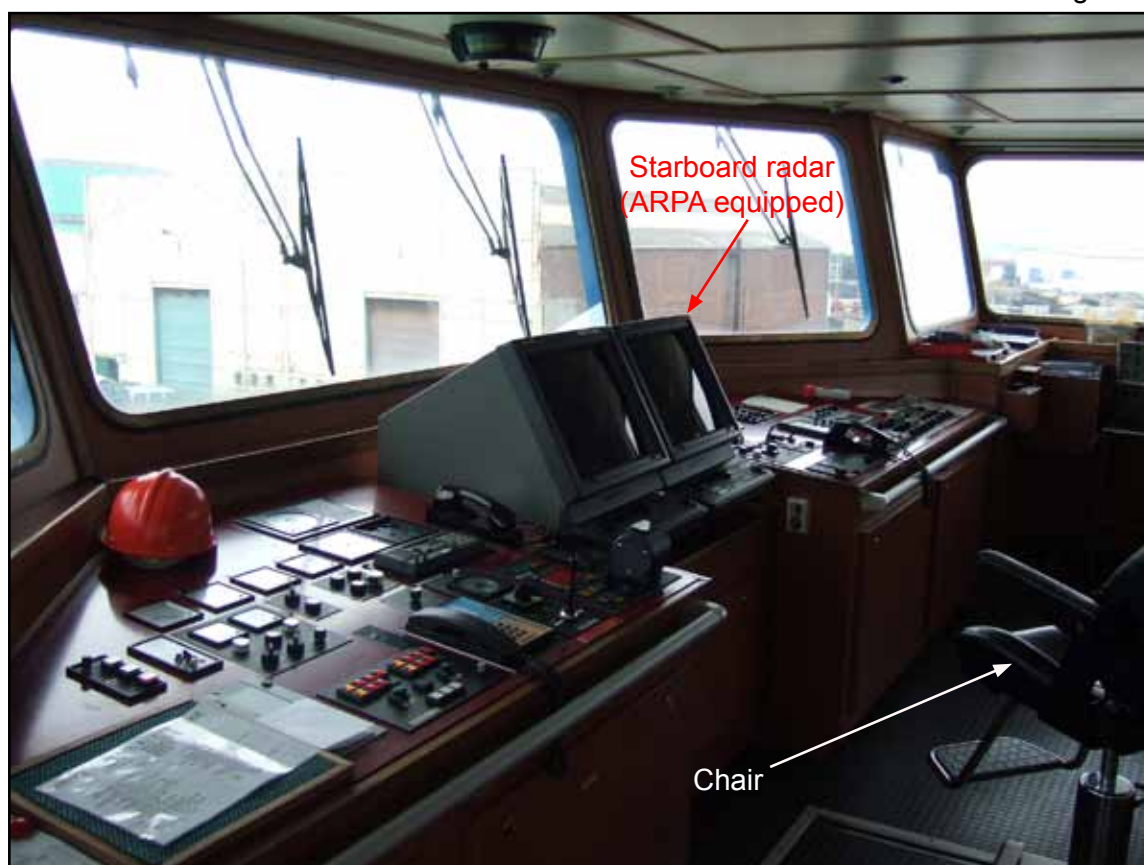
At about 0435 the lookout reported to the chief officer, who was sitting in the wheelhouse chair (**Figure 3**), the red navigation light of a vessel at about 3 points (34°) to starboard of *Scot Isles*. The lookout then advised the chief officer, who made no comment, that he was leaving the bridge to undertake his safety rounds. The chief officer had not registered the lookout's report of the other vessel.

Scot Isles - interior of wheelhouse

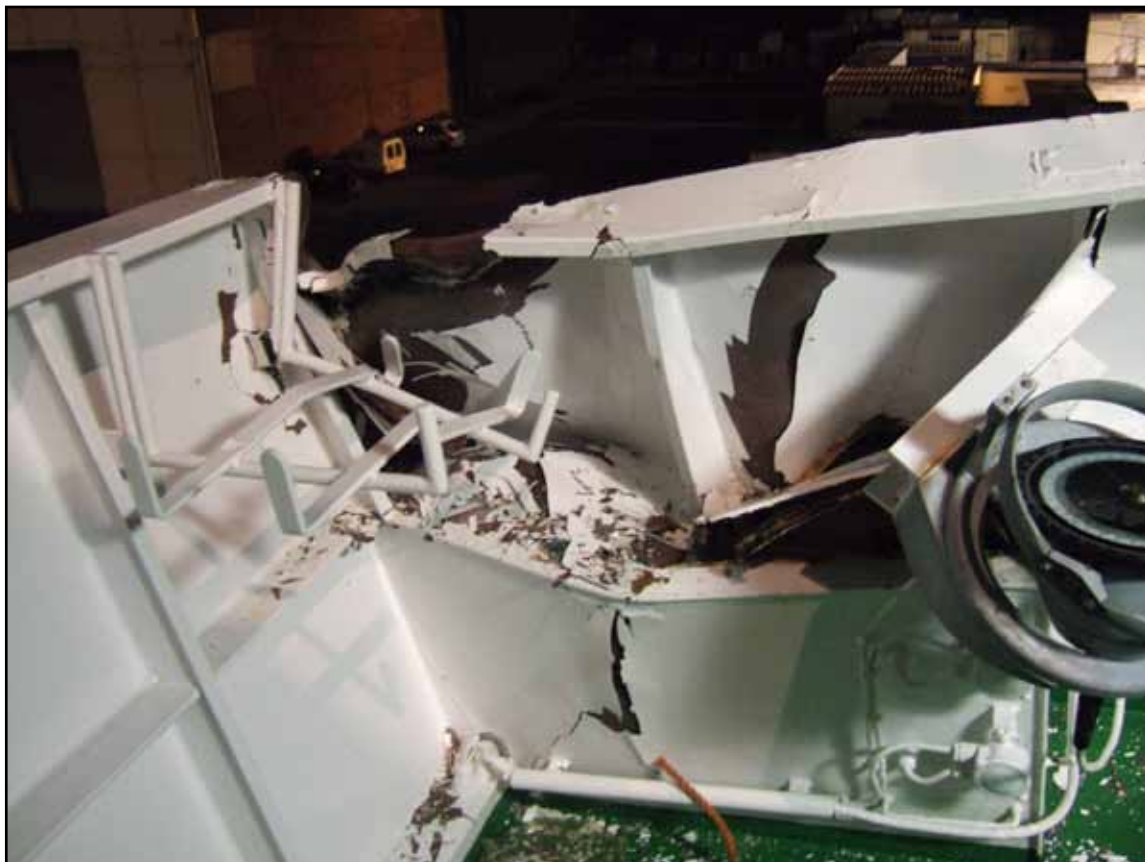
The master asked the chief officer what had happened and was informed that an overtaking vessel had collided with *Scot Isles*, causing damage to the starboard bridgewing. The master looked at this damage (**Figure 5**) and realised that the smoke, which the second officer had initially thought to be a fire, was in fact from the bridgewing smoke float which had been activated by the collision.

Scot Isles - damage to starboard bridging

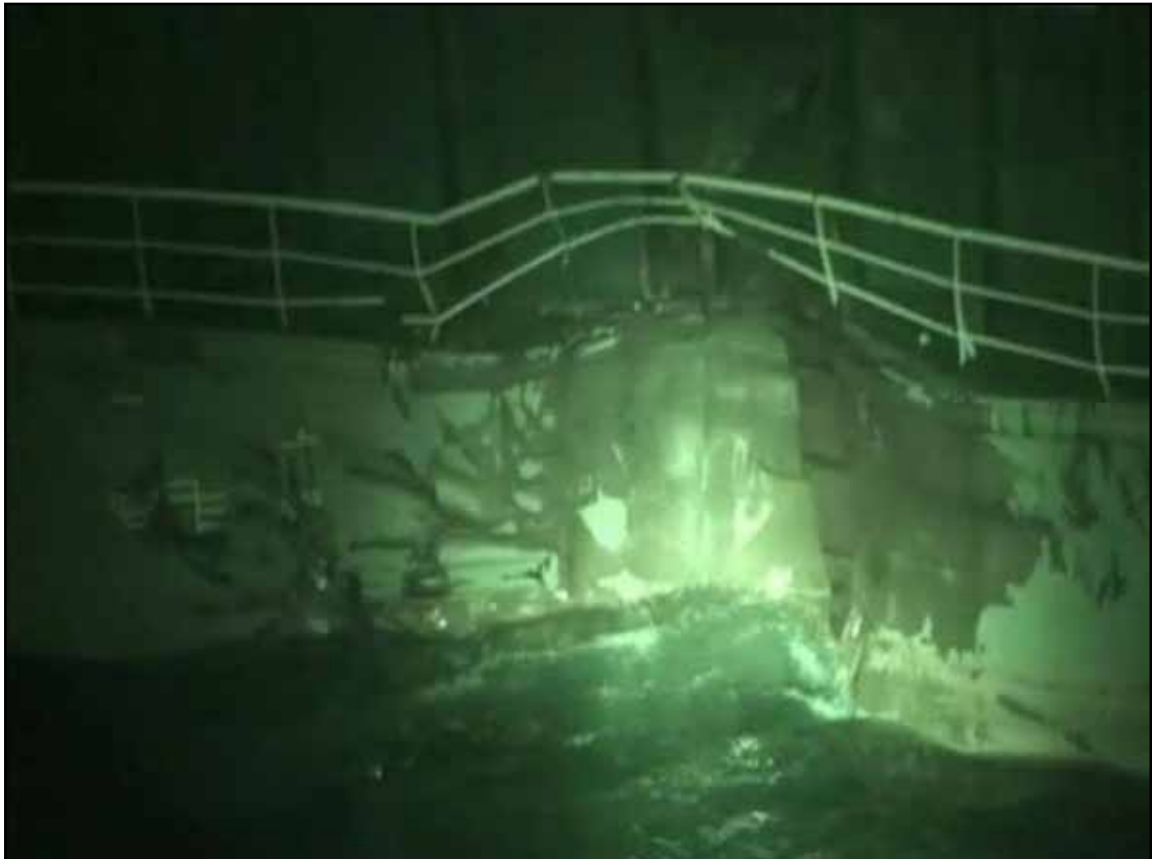
Figure 6

At 0630 a French naval helicopter arrived overhead of *Scot Isles* and carried out a searchlight inspection of the hull. The extensive damage to the starboard side shell plating, amidships, was now illuminated (**Figure 6**).

Scot Isles - photograph of damage to the hull

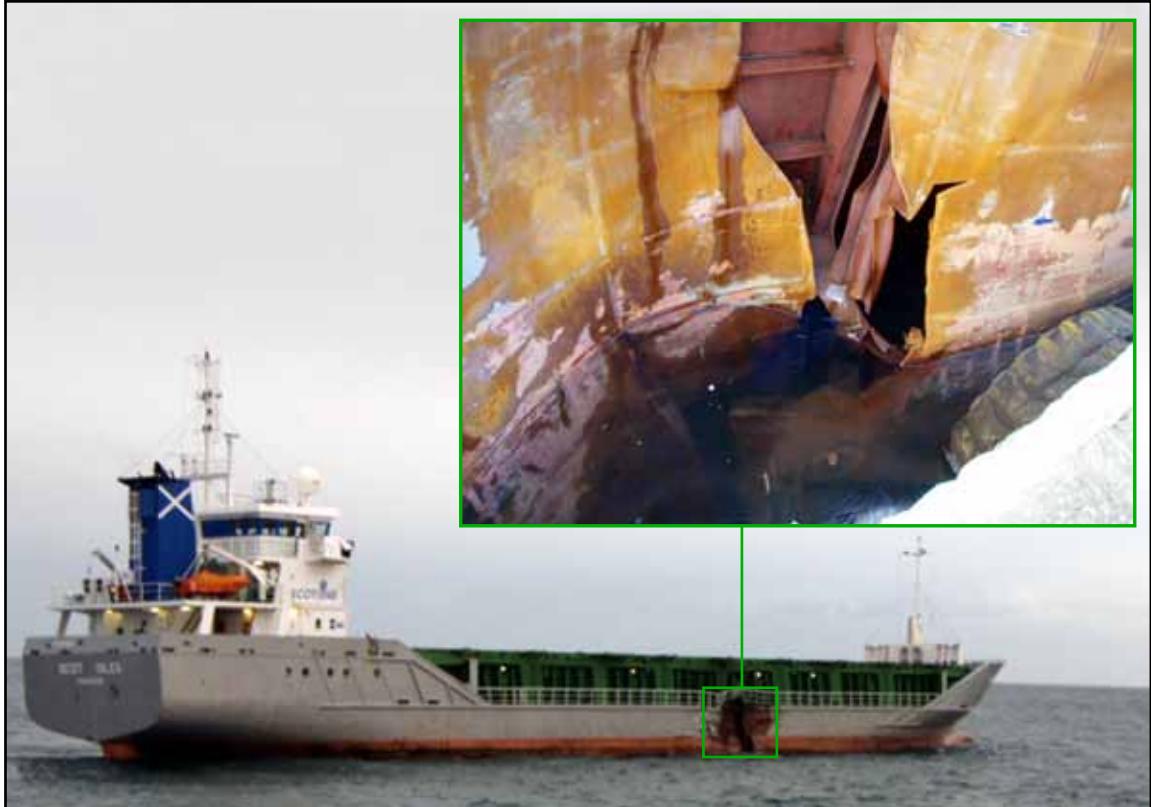
At twilight, about 0645, the master saw evidence of oil in the water beside the vessel, emanating from number two starboard wing fuel tank, which had been ruptured by the collision. He then instructed the engineers to list the vessel to port and to transfer oil from the damaged tank into another fuel tank to prevent further pollution.

At 0850, two French marine officials boarded *Scot Isles* to inspect the damage and assess the pollution. They informed the master that, due to the extent of the damage (**Figure 7**), all the oil in the tank had been lost into the sea and that he should cease transferring from the tank.

Scot Isles - damage overview

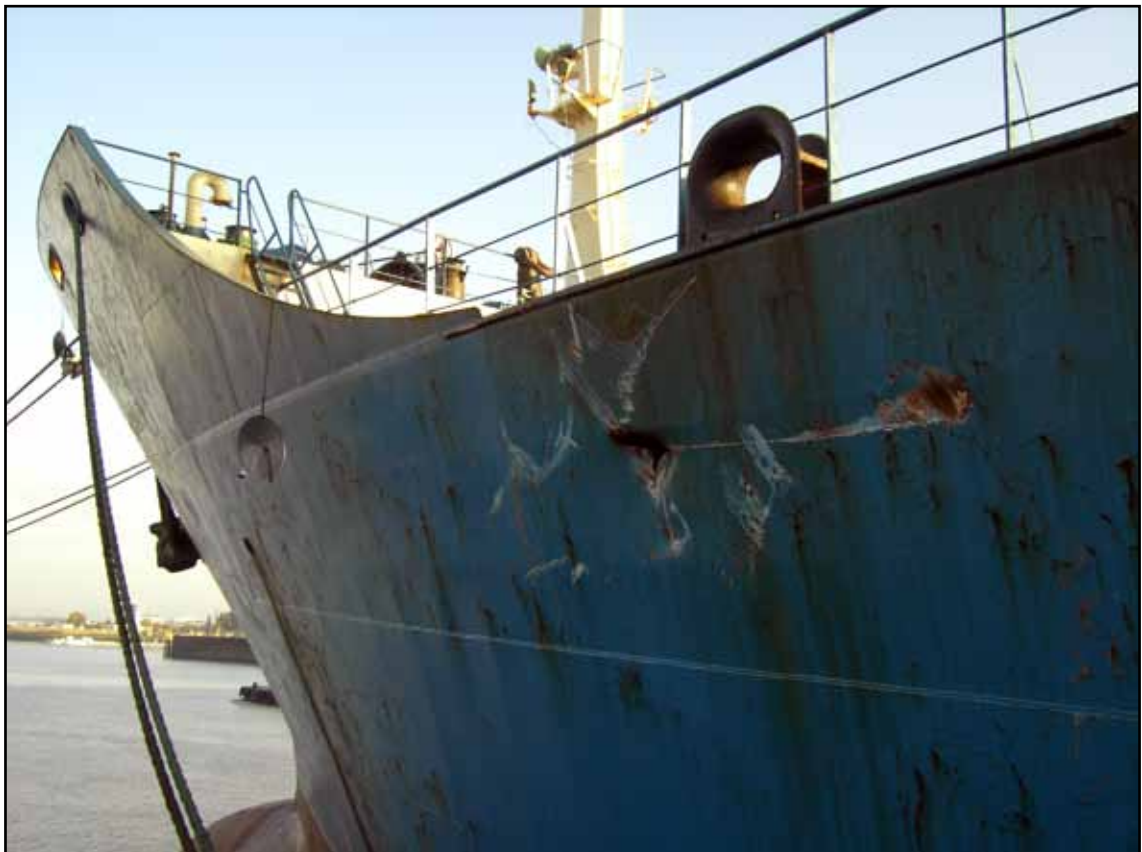
Figure 8

The chief officer returned to the bridge and told the master that the only apparent damage to *Wadi Halfa* was a small hole in number one port wing ballast tank, approximately 25cm long and about 50cm below the main deck level (**Figure 8**).

Wadi Halfa - shell plate damage to number one port wing ballast tank

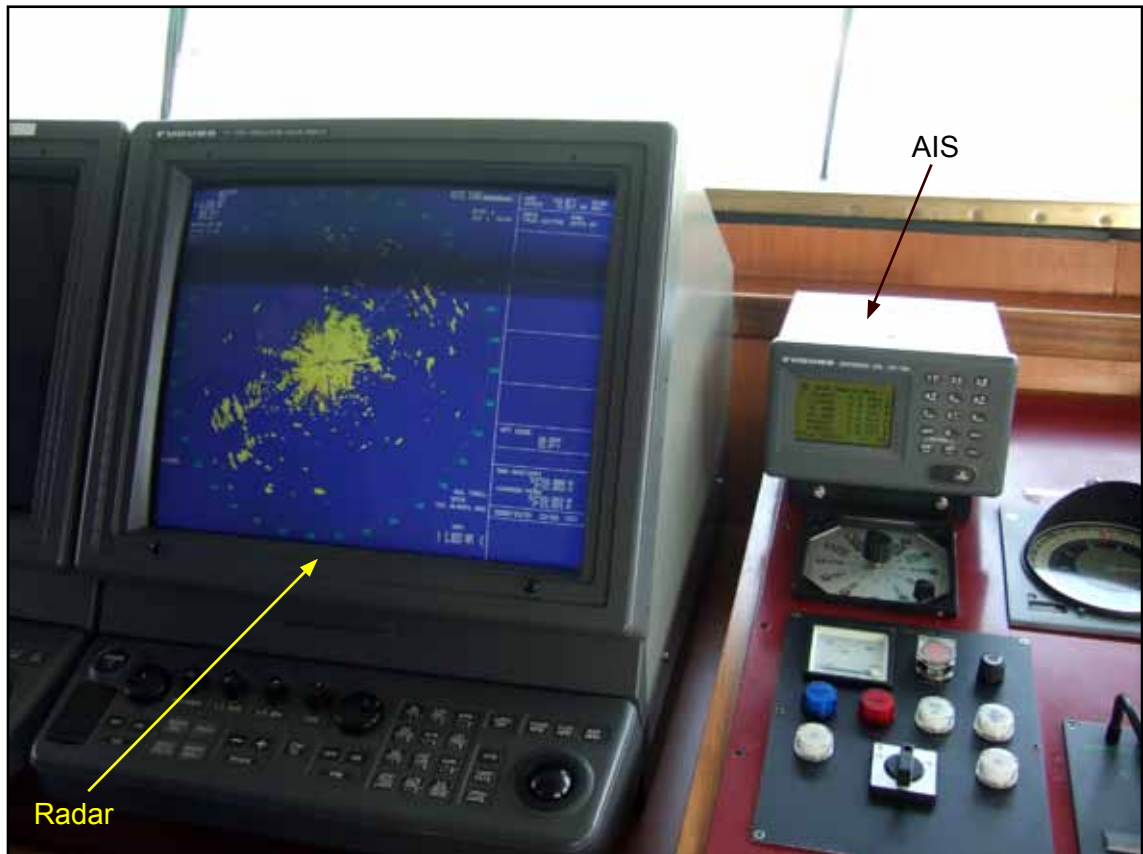
The chief officer was sitting in front of a radar fitted with ARPA, but this facility was not used to acquire and plot any of the radar targets, which could have enabled an early assessment of risk of collision to be made. The information displayed on the AIS receiver (**Figure 10**), located beside the starboard radar, giving the names and relative positions of the closest six vessels, was also not used.

Scot Isles - wheelhouse, location of AIS receiver

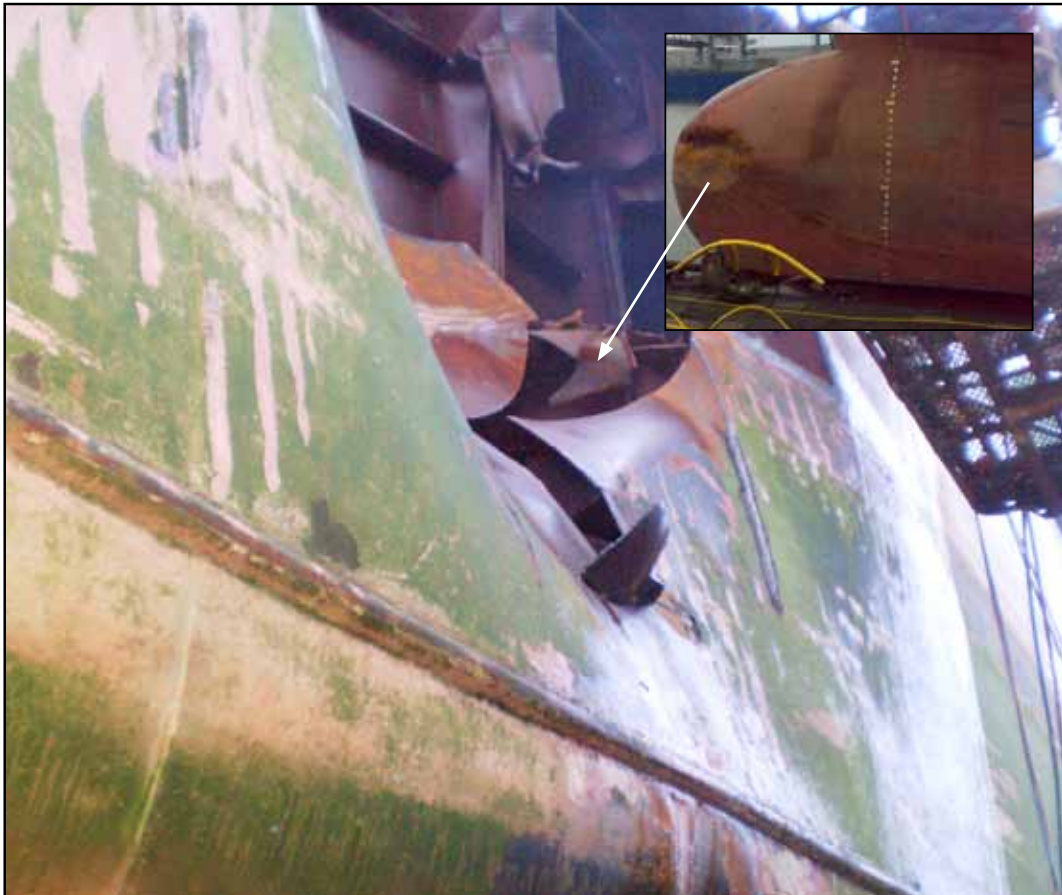
Figure 12

The shape of the damage caused to the shell plating of *Scot Isles* (**Figure 12**) matched the profile of *Wadi Halfa*'s bulbous bow. The distance, measured from the bulbous bow to the hole in number one port wing ballast tank on *Wadi Halfa*, corresponds with that from the hull damage on *Scot Isles* to her starboard bridge wing.

Scot Isles and *Wadi Halfa* - comparison of damage

From this evidence it can be seen that the initial point of contact was between the port side of *Wadi Halfa*'s bulbous bow and the starboard hull, amidships, of *Scot Isles*. The two vessels then came together bodily, which resulted in the secondary damage to *Scot Isles*' starboard bridgework and to *Wadi Halfa*'s shell plating in way of number one port wing ballast tank.
