Report on the investigation of the
grounding of the cargo vessel

Sea Mithril

on the River Trent

Report No 16/2008
September 2008

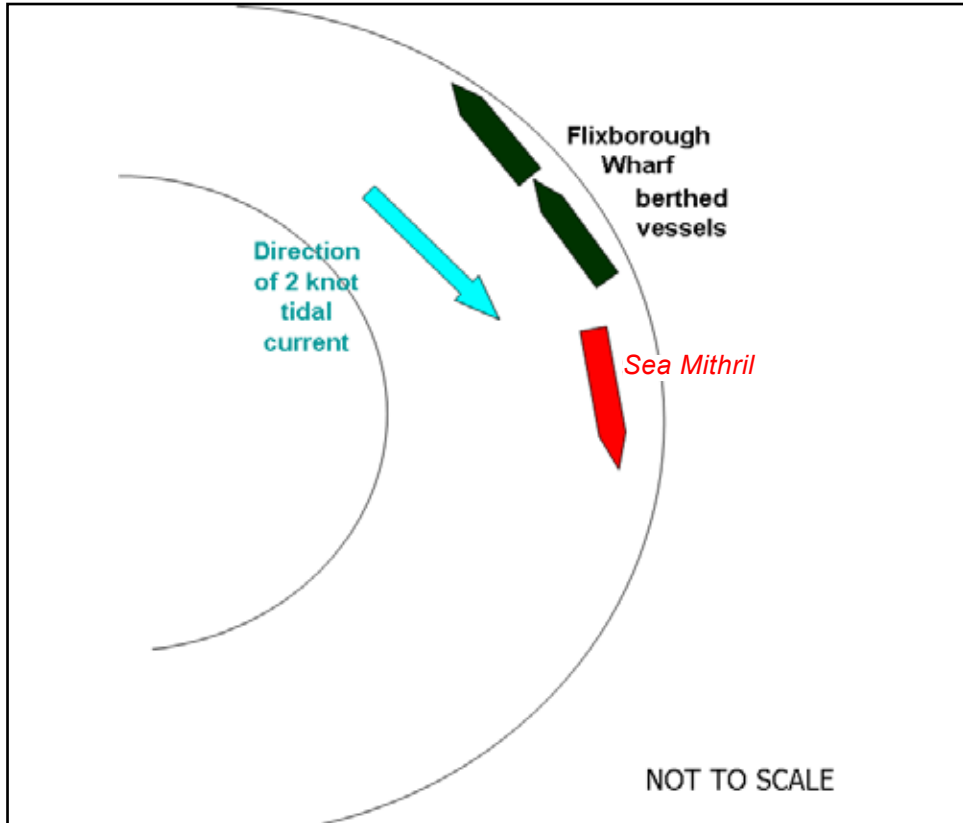
By the time *Sea Mithril* had cleared Flixborough Wharf, her speed had reduced to about 2.5 knots over the ground and she was being swept bodily towards the left-hand bank by the flood tide (**Figure 5**). The pilot advised the master to steer to starboard. When he noticed the vessel's speed from the radar display he immediately advised the master to "speed up" and "come more to starboard." Reed beds were then seen to port, and a few moments later the vessel momentarily touched the river bottom at her stern near the left-hand riverbank.

Diagram showing the position of *Sea Mithril* after passing Flixborough just prior to her touching bottom for the first time

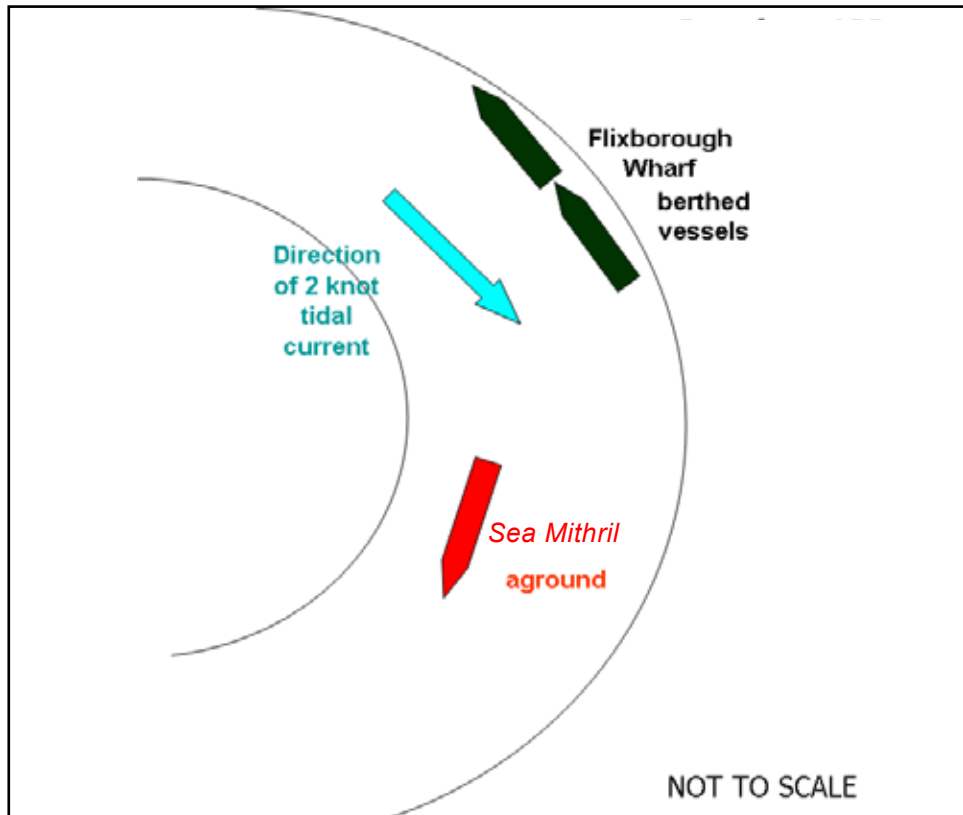
The master quickly put the azimuth controls to full ahead and to starboard. The vessel turned sharply and began to head across the river. The pilot realised *Sea Mithril* was now in danger of grounding in the shallows near the opposite bank and advised the master to turn back to port. Although the master put the engine controls to port, the vessel ran gently aground at 0425 (**Figure 6**).

Diagram showing the position of *Sea Mithril* when aground for the second time

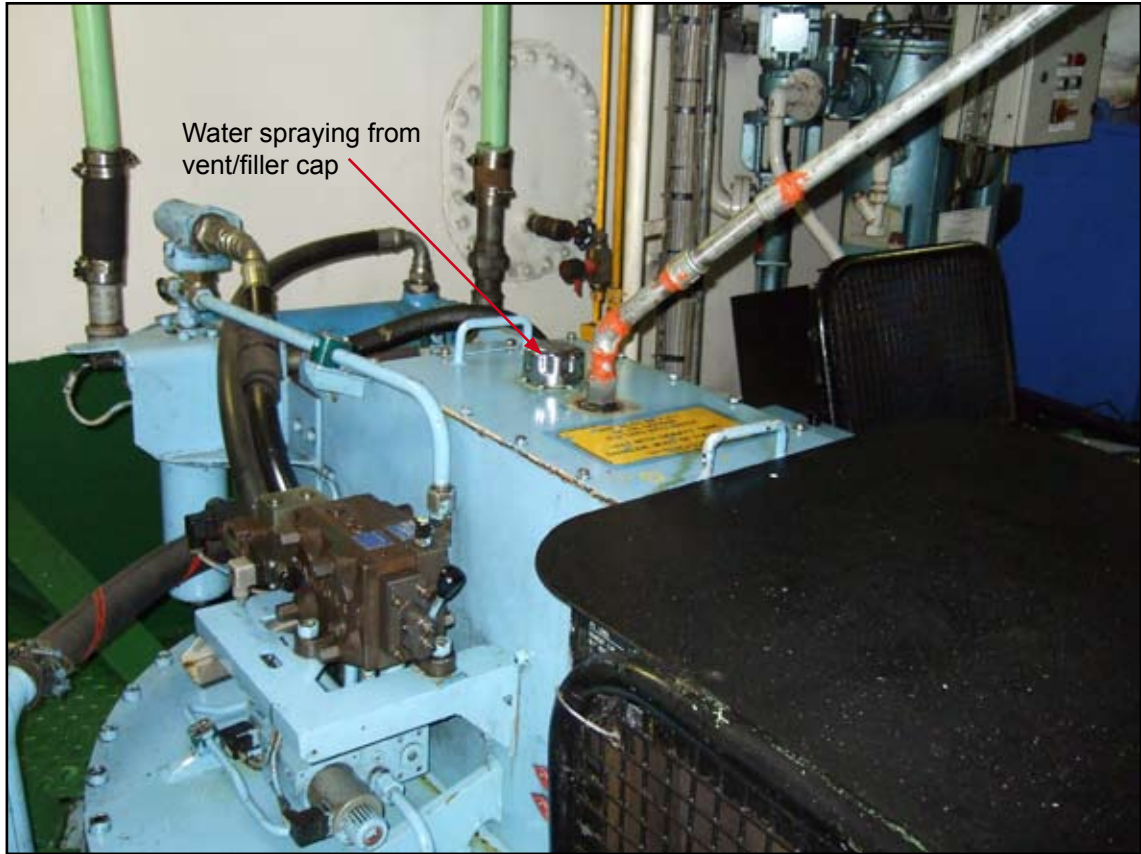
After several minutes, the engineer arrived on the bridge and told the master that water was spraying from the port azimuth oil vent in the engine room (**Figure 7**). The master replied that he wanted to continue running both engines until the vessel had re-floated and was safely alongside. This exchange was in Russian and the pilot was not made aware of the problem that had been reported. All empty spaces and the cargo holds were sounded, but no other water ingress was found.

Photograph showing position of water ingress

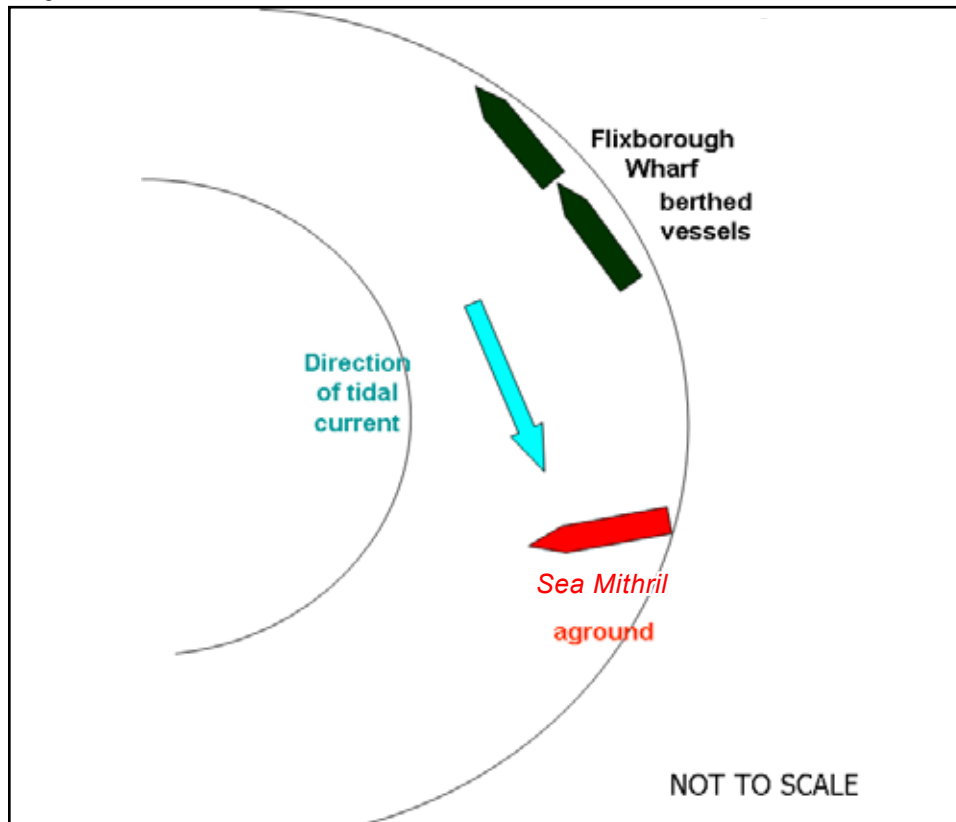
The vessel re-floated at 0447 and, with her engines operating at full astern, she moved rapidly towards the other side of the river, stern-first. The master put the engine controls to full ahead, but this did not prevent the vessel grounding for a third time (**Figure 8**), albeit momentarily.

Diagram showing the position of *Sea Mithril* when touching the river bottom for the third time

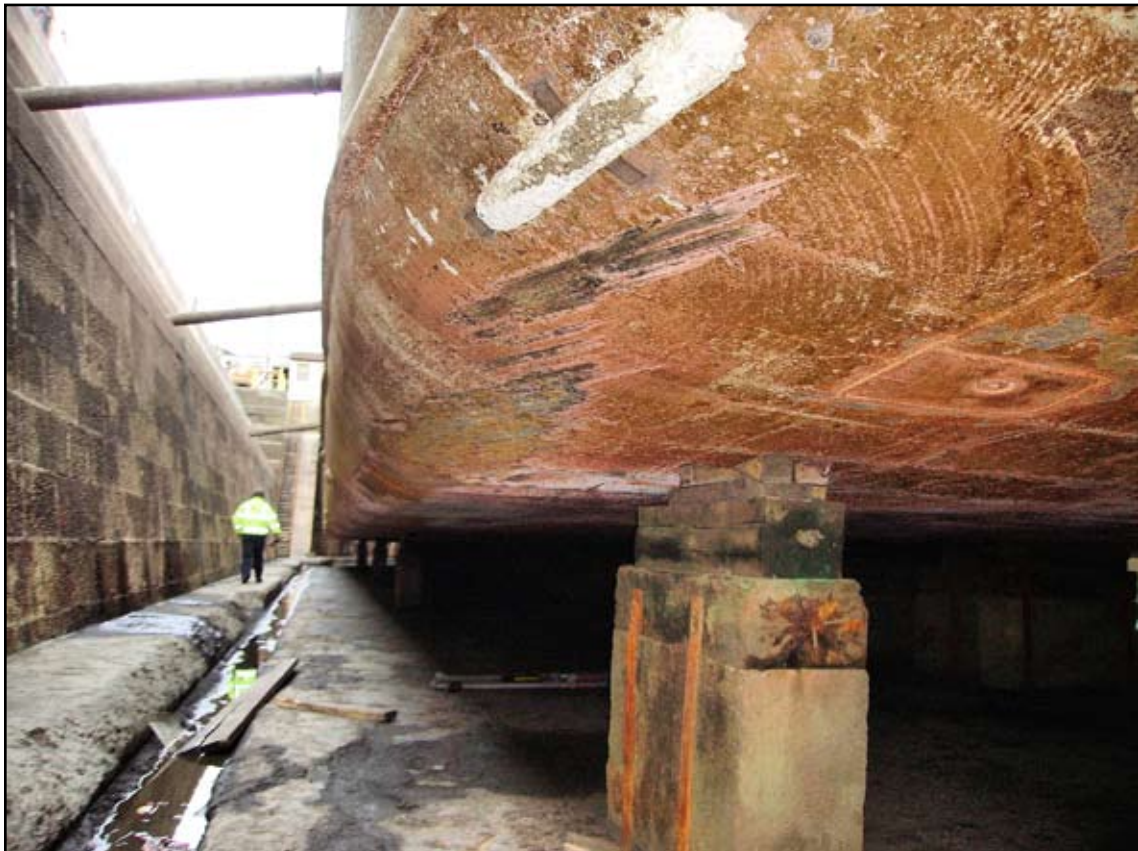
Figure 10

During an inspection at Grove Wharf on 19 February 2008, the vessel's port azimuth pod casing was found to be fractured and its propeller blades badly damaged (**Figure 9**). The vessel was given dispensation to sail to Leith, Scotland, for repairs. ABP Humber was informed of the vessel's condition but was not made aware that the damage had been caused during the groundings the previous day. *Sea Mithril* sailed from Grove Wharf on 19 February with a pilot embarked. She was escorted by a tug during her passage down the Trent and Humber and, at the request of the ship's manager she was closely monitored by the Coastguard during her passage to Leith, where she arrived the following day. When the vessel was later dry-docked it was established that, in addition to the damage already identified, the port azimuth drive shaft had to be replaced. There was also evidence of recent coating damage under the vessel's port quarter (**Figure 10**).

Paint damage to the underside of the hull on the vessel's port side
