Report on the investigation of the injury to
a member of the crew on board the fishing vessel

Sian Elizabeth

14 September 2006

Report No 3/2007
March 2007

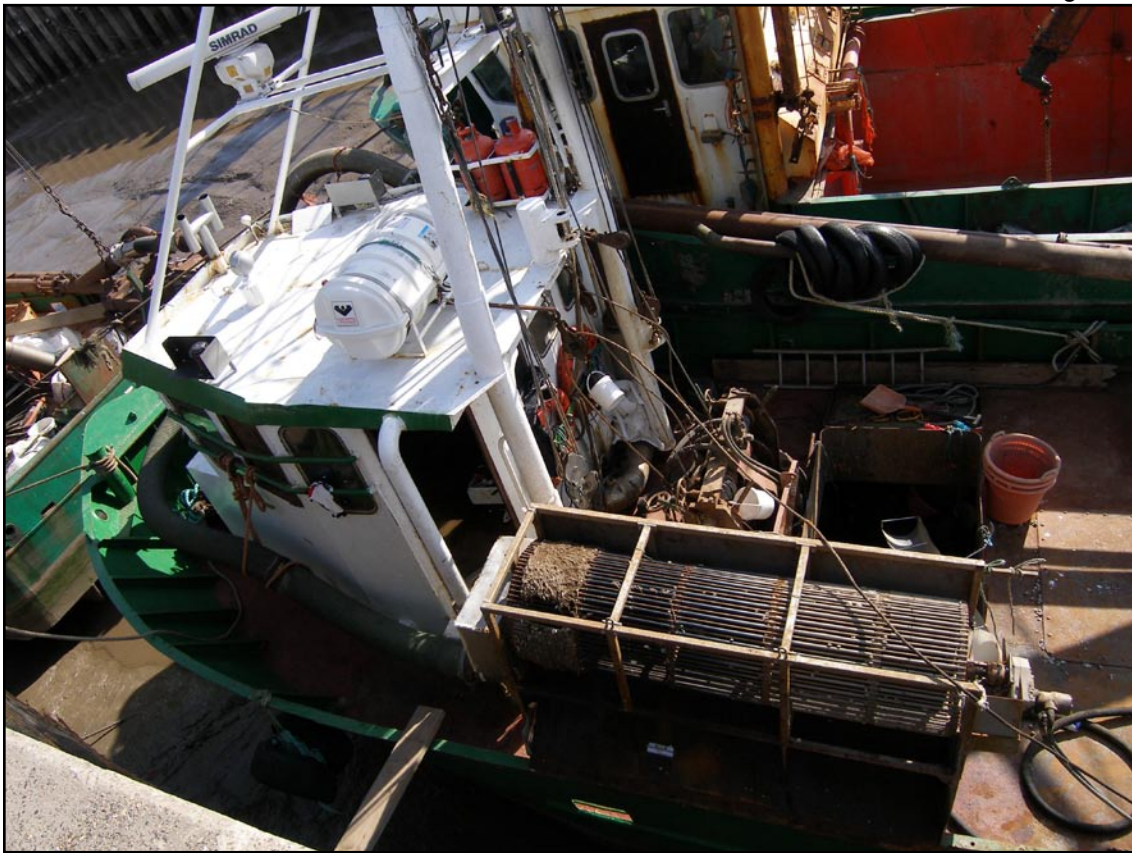
Figure 1

The riddle - plan view

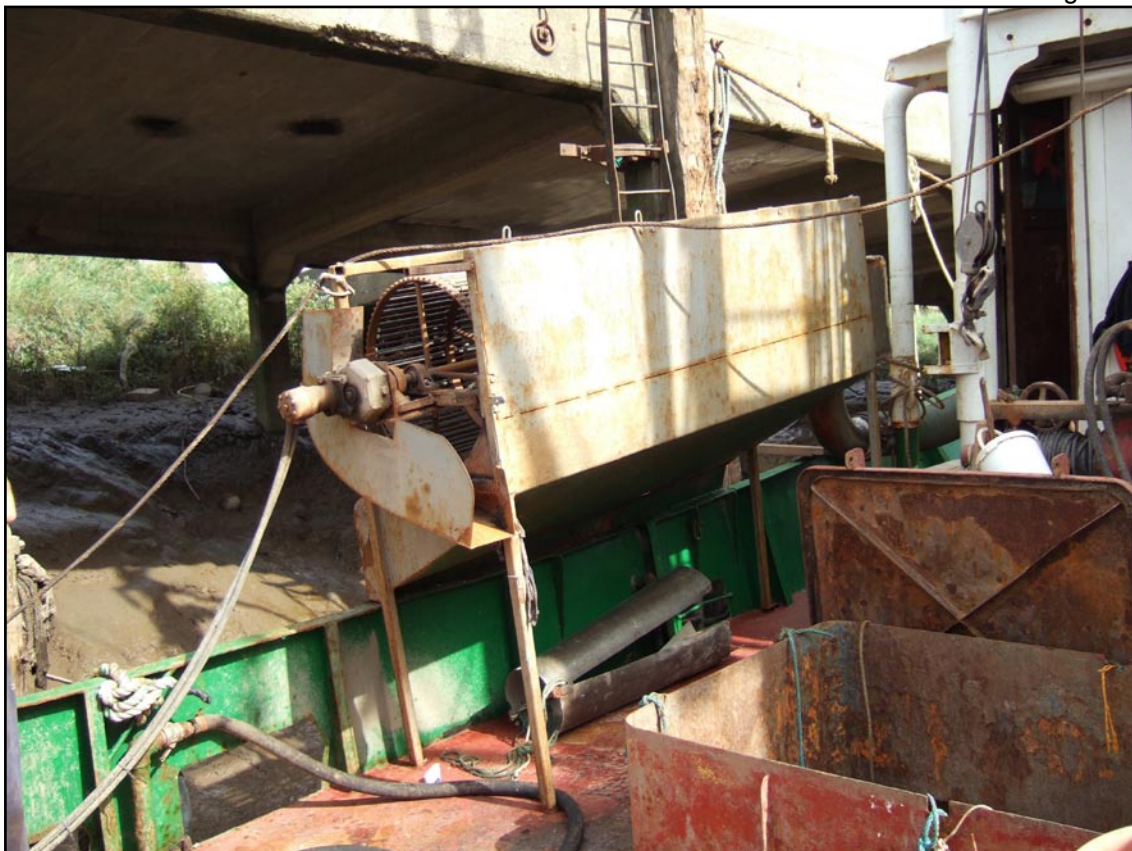
Figure 2

The riddle - seen from aft

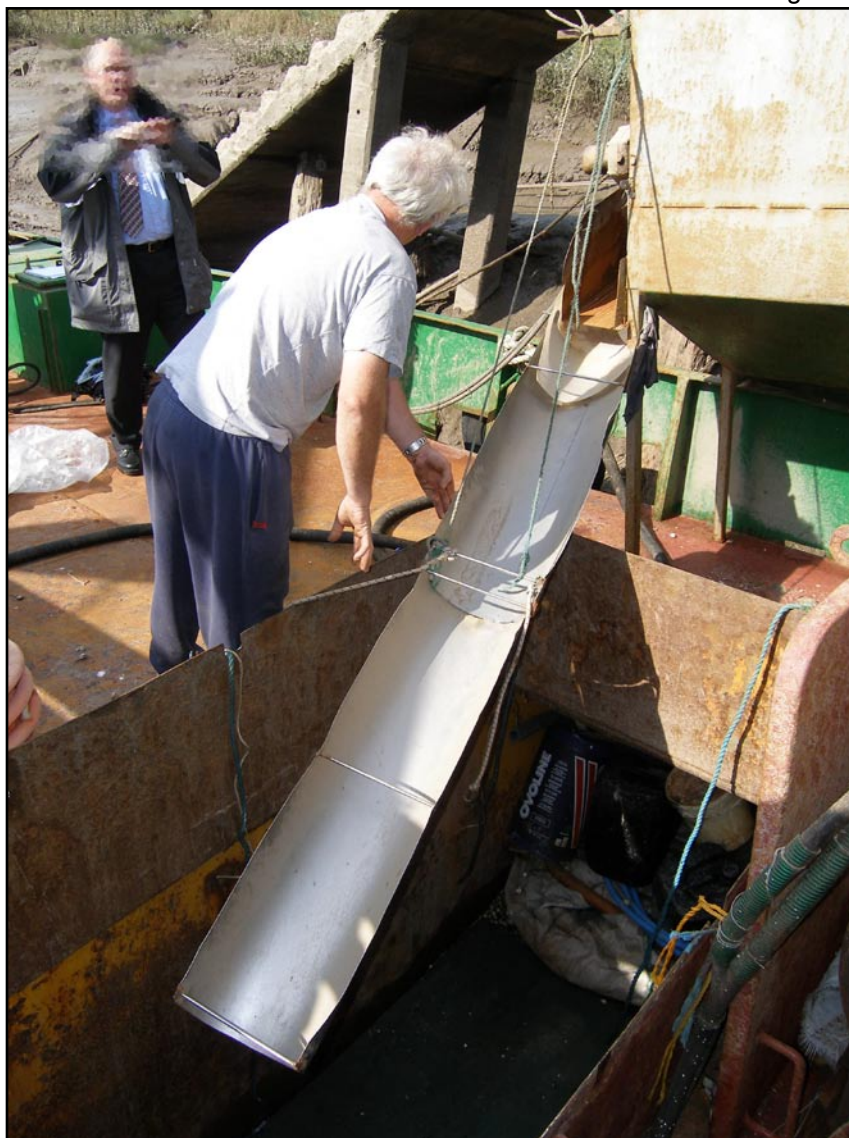
Figure 3

Clearing the chute by hand

As the senior crewman directed the cockles from the end of the chute into the bags in the hold, the new crewman would ensure the cockles ran freely from the end of the riddle by scraping the chute by hand. The top of the chute at the end of the rotating riddle was susceptible to blockage with mud and cockles and required clearing, particularly when the hold was being filled. This was a right handed job and the new crewman's recollection was that he had been told that, if necessary, he could rest his left hand on the hydraulic motor which drove the riddle (**Figure 4**).

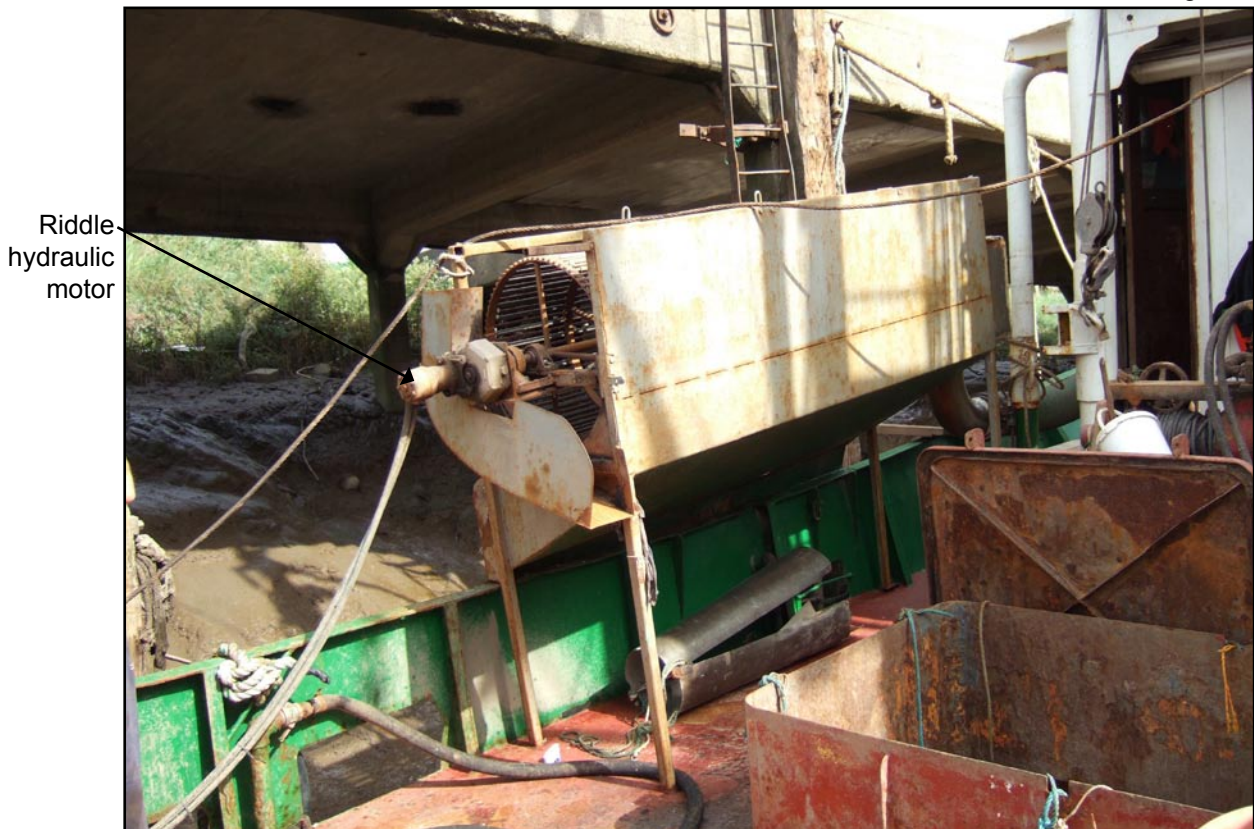
Figure 4

Just before 1400, as the new crewman was scraping the cockles from the chute with his right hand, he moved his left hand to the structural cross member of the riddle, believing there was enough space for his hand to grip the support and be clear of the rotating inner drum (**Figure 5**). The rotating drum of the riddle caught his thumb, fracturing his wrist and pulling his arm into the riddle arrangement before fracturing his left elbow. The abrasion of the cross member also removed the skin from his inner left elbow.

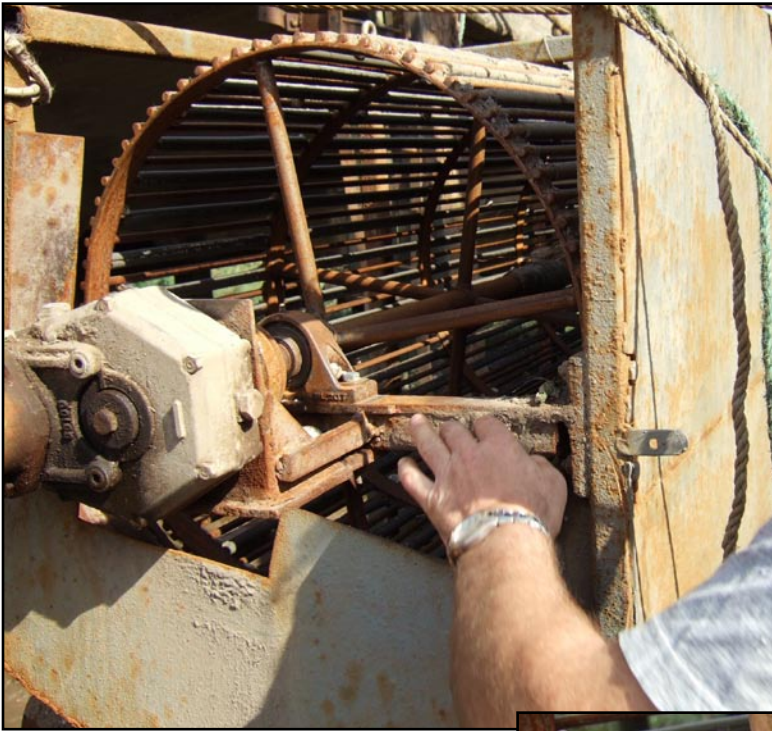
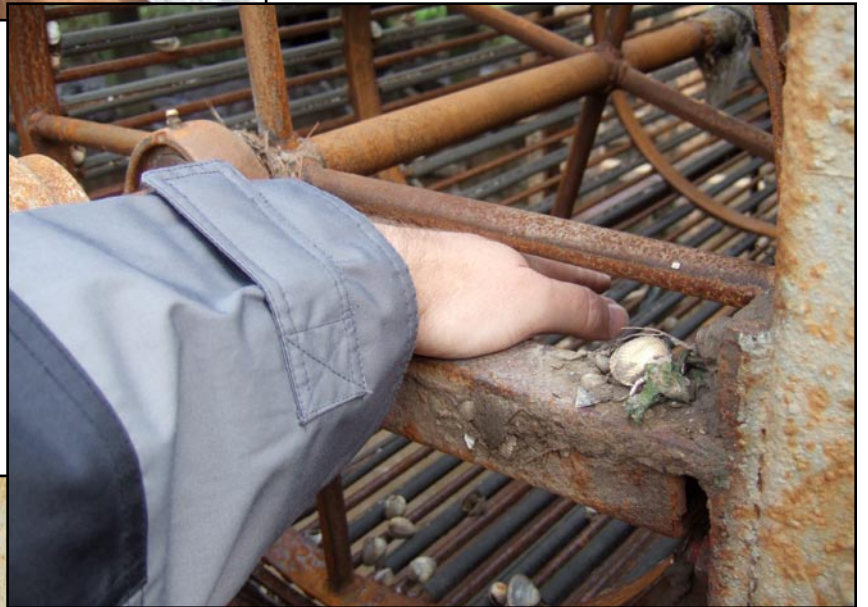
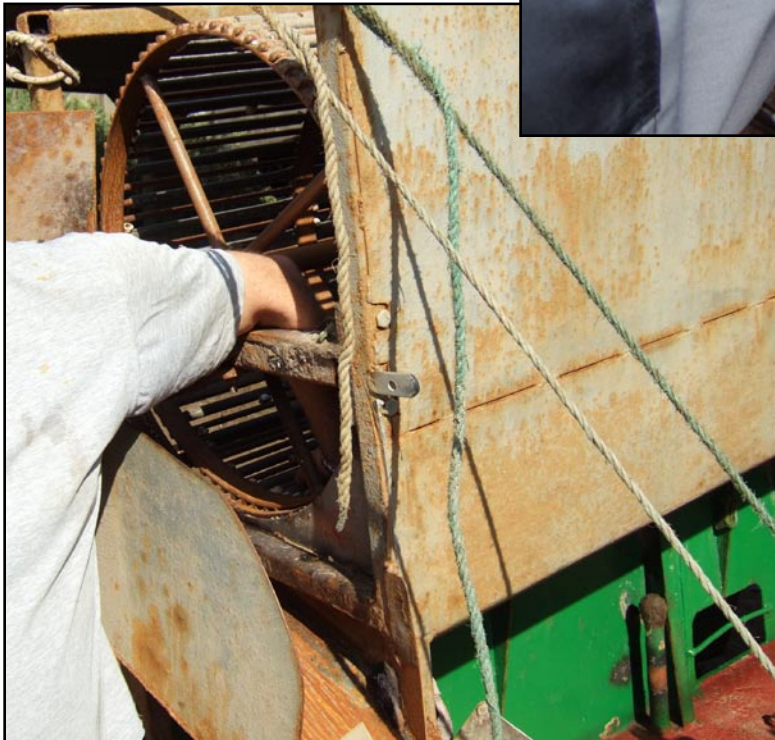
Figure 5

The unguarded riddle construction formed a shear trap that caught the crewman's left thumb and pulled his left arm into the riddle, causing serious injury.

Sequence showing how the crewman's arm was caught in the shear trap

The investigation found that the accident was a consequence of the unguarded rotating riddle drum creating a shear trap risk close to the operating crew when sorting the shellfish on deck. The injured crewman was a young, untrained and inexperienced fisherman who was unaware of the dangers posed by the unguarded riddle. A number of factors have been identified which allowed this situation to exist.

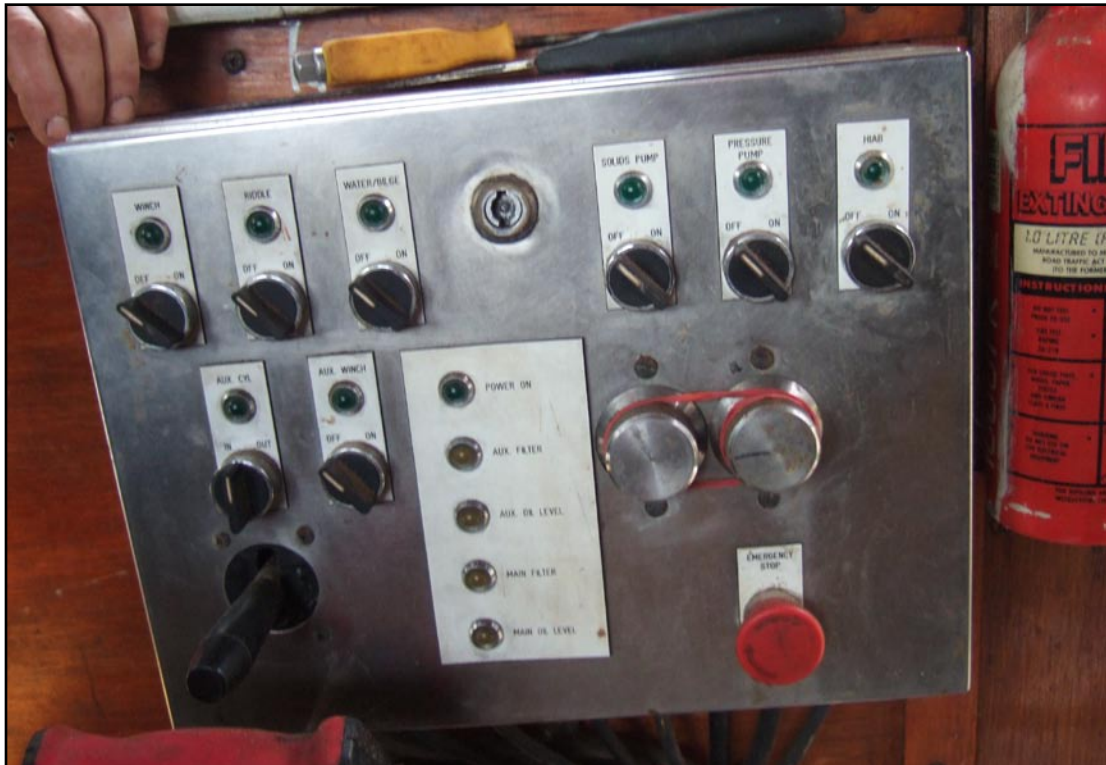
In the wheelhouse, the skipper heard a shout, and when he saw the injured crewman on deck he quickly stopped the hydraulic power using the stop button on the control panel on the aft bulkhead of the wheelhouse (**Figure 6**).

Hydraulic Control Panel

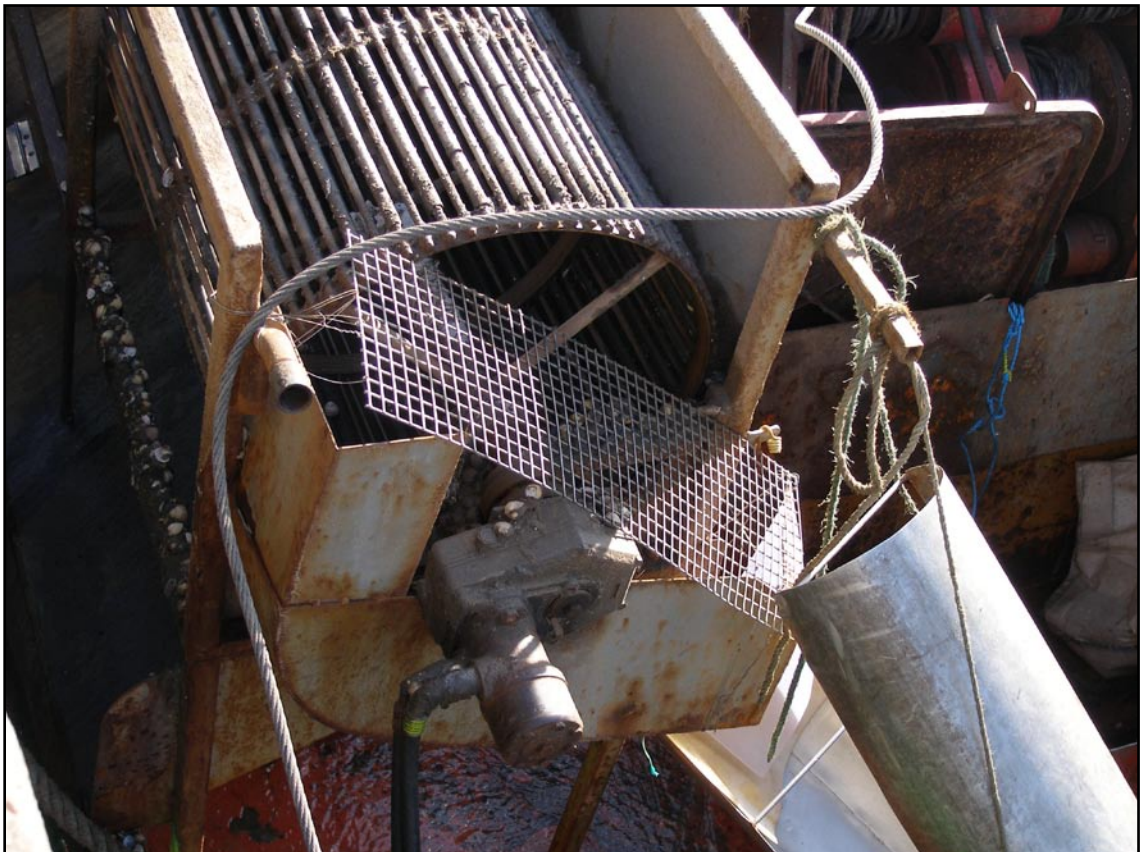
Figure 8

Temporary guard

- Fitted a temporary guard over the riddle end to remove the shear trap posed by the rotating machinery (**Figure 8**).
- Fitted the riddle with a water flow from the upper end of the chute to assist in washing the cockles and remaining mud down the chute. This has reduced the frequency that cockles need to be scraped down the chute by hand.
