Report on the investigation of
Sichem Melbourne
making heavy contact with mooring structures
at Coryton Oil Refinery Terminal
on 25 February 2008

Report No 18/2008
October 2008

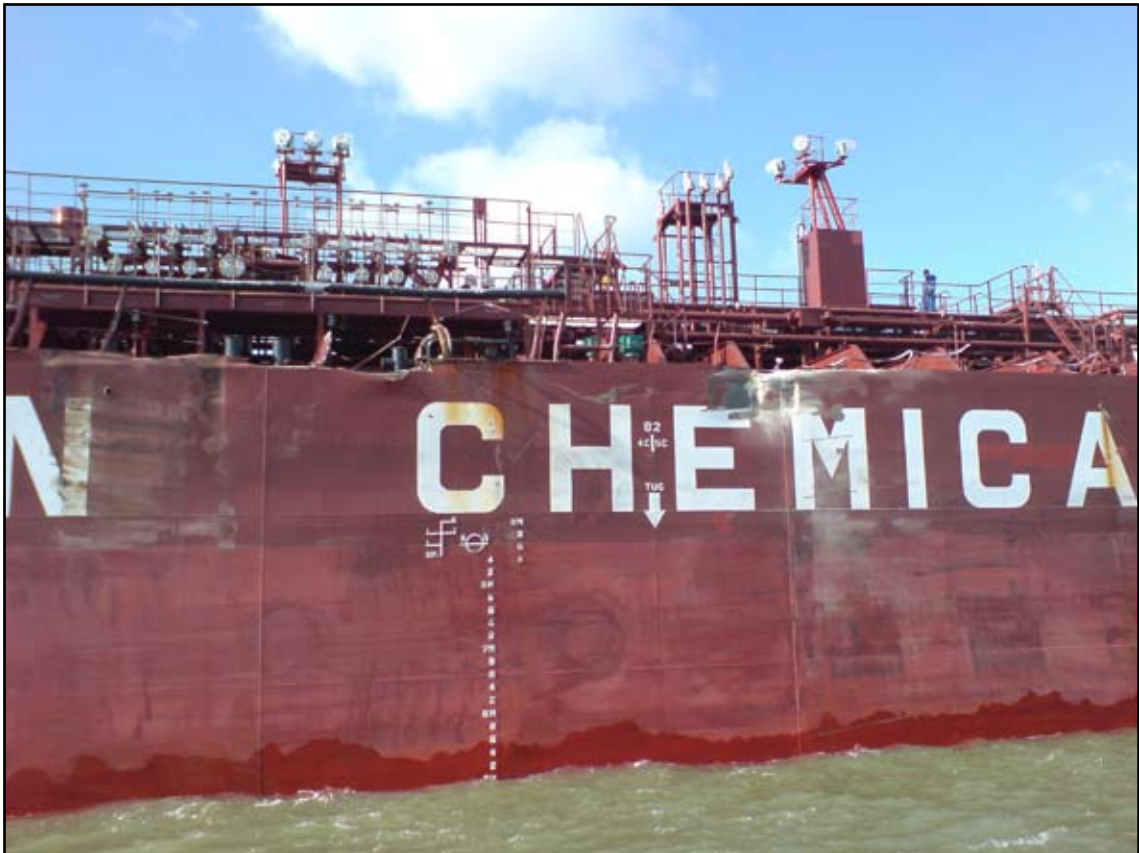
Figure 3a

At daylight the next morning the full extent of the damage to both ship (**Figures 3a, b, c, d**) and mooring structures (**Figures 4a, b, c, d**) was established. The mooring dolphins were inspected by divers for foundation damage, and were deemed secure. Temporary repairs were carried out above water and the dolphins were declared sound enough to attach ropes to, and safe for personnel.

Damage to *Sichem Melbourne*'s sheer strake and deck edge

Following an inspection of *Sichem Melbourne's* main engine controls and hull damage by a surveyor from the ship's classification society, Det Norske Veritas (DNV), the ship was allowed to sail, in ballast, to a repair yard. Her full term Safety Construction Certificate was withdrawn and a short term certificate, valid for 6 days, was issued in its place. No deficiencies were found with the engine control system and the ship's manager made arrangements for hull repairs to be carried out.

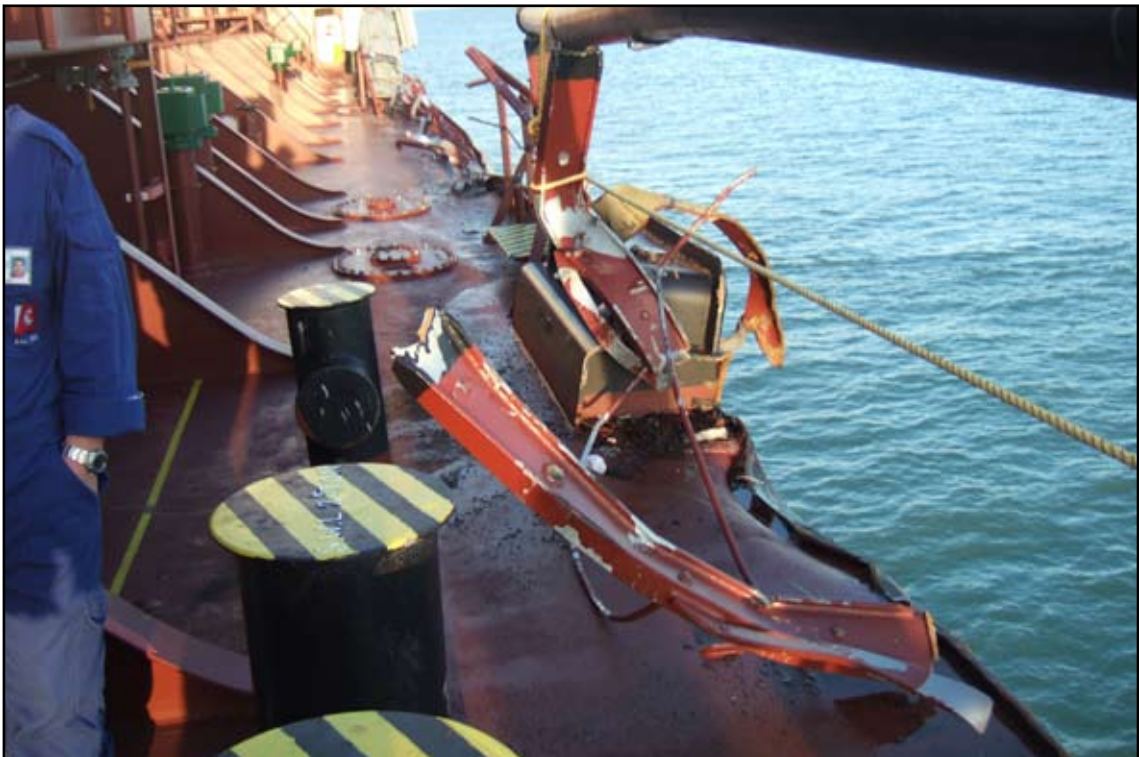
Figure 3b

Deck edge damage

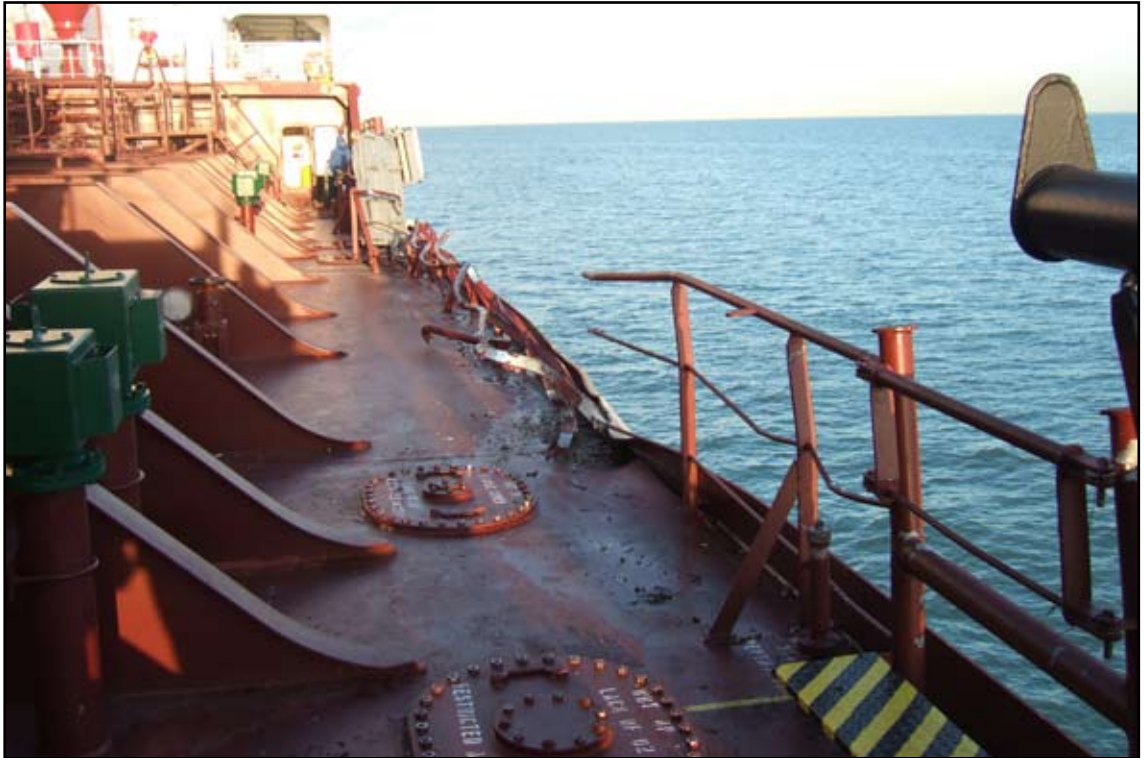
Figure 3c

Rail damage

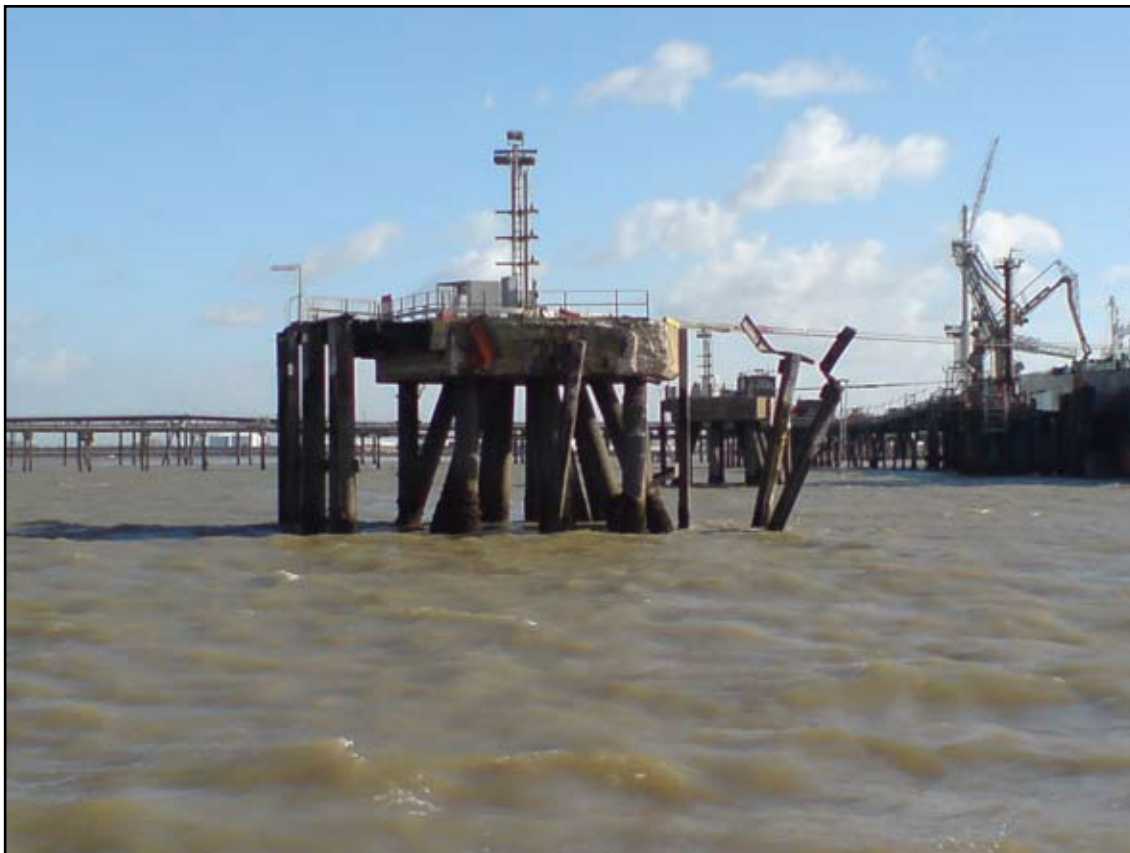
Figure 4a

Damage to MD 41 mooring structure and stern lines leading to *Thornbury*

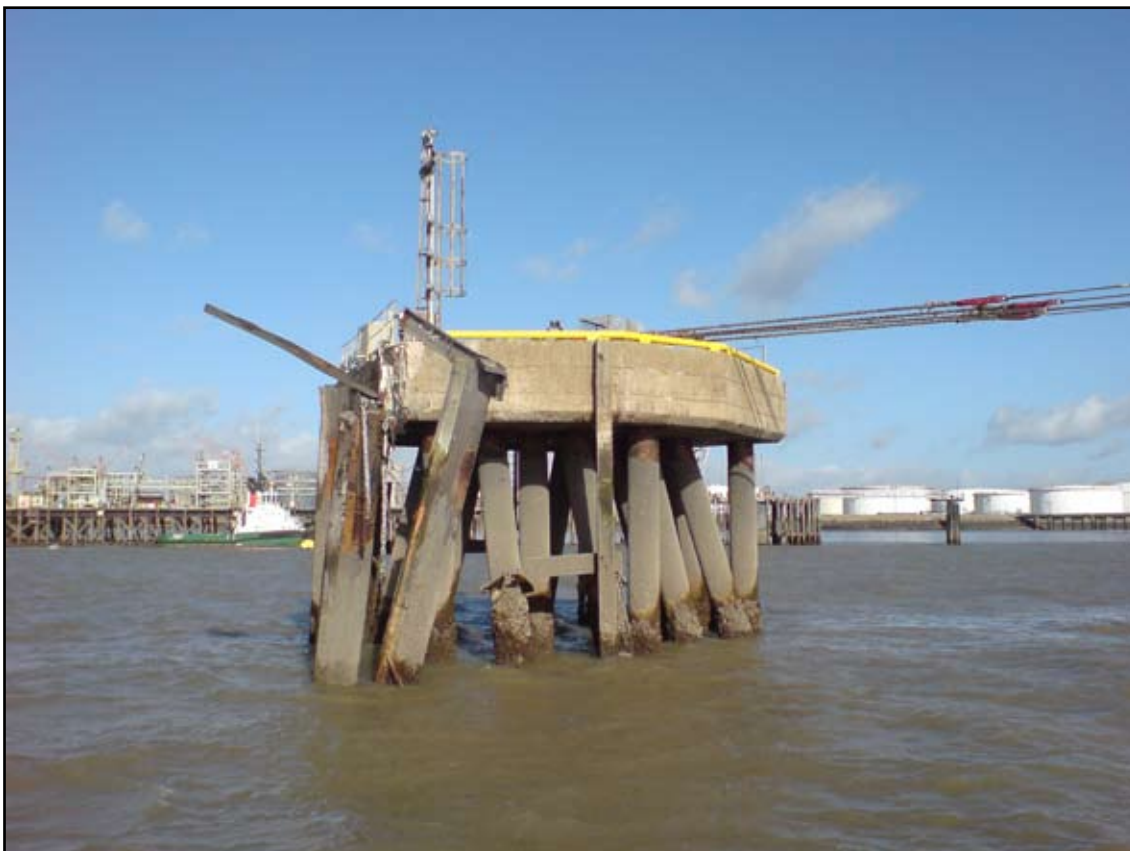
Figure 4b

Damage to MD 41 mooring structure and stern lines leading to *Thornbury*

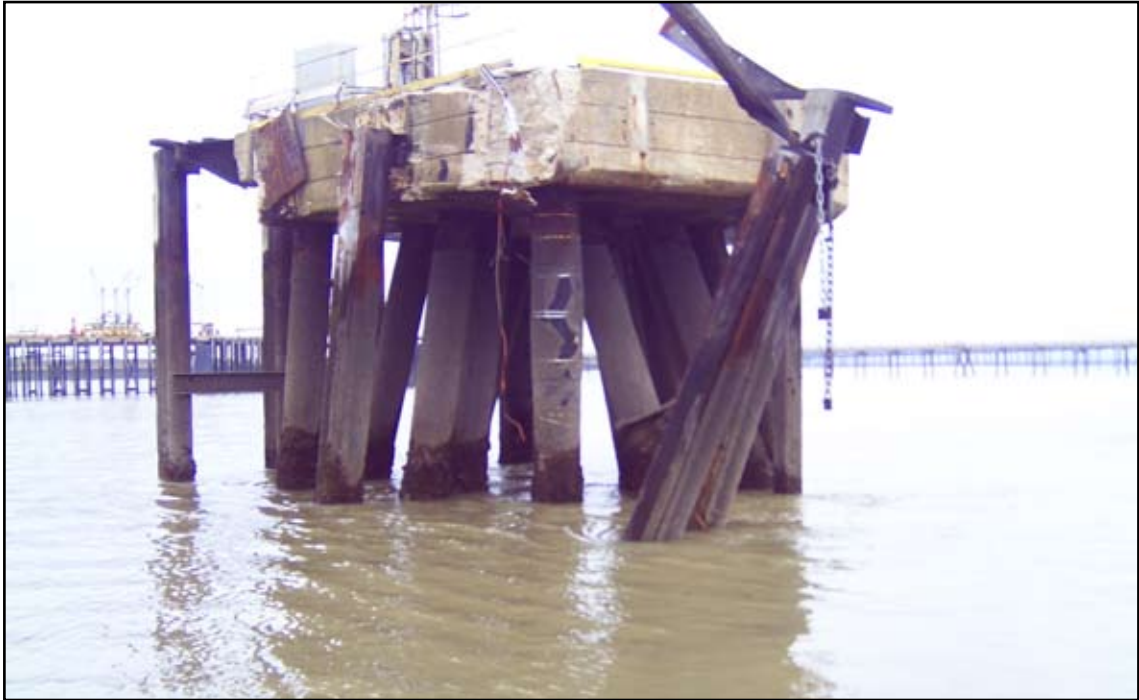
Figure 4c

Damage to MD 41 mooring structure

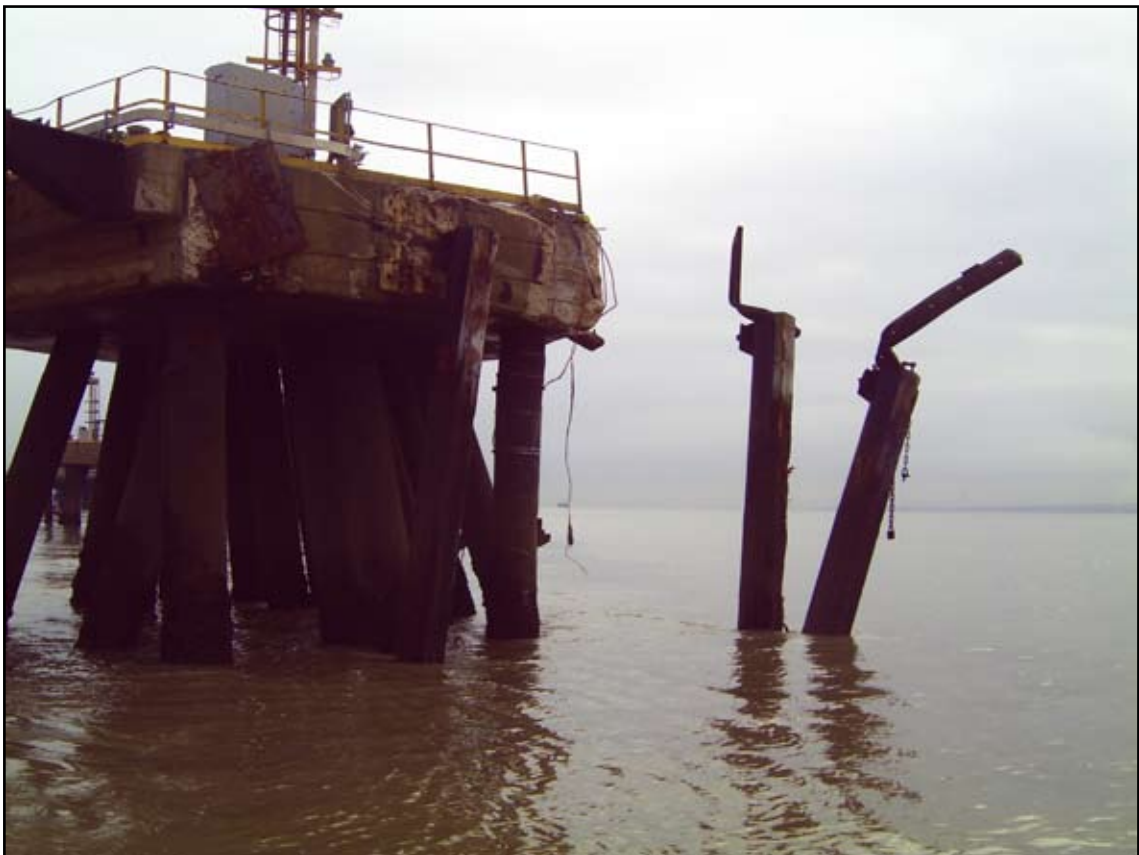
Figure 4d

Damage to MD 41 mooring structure

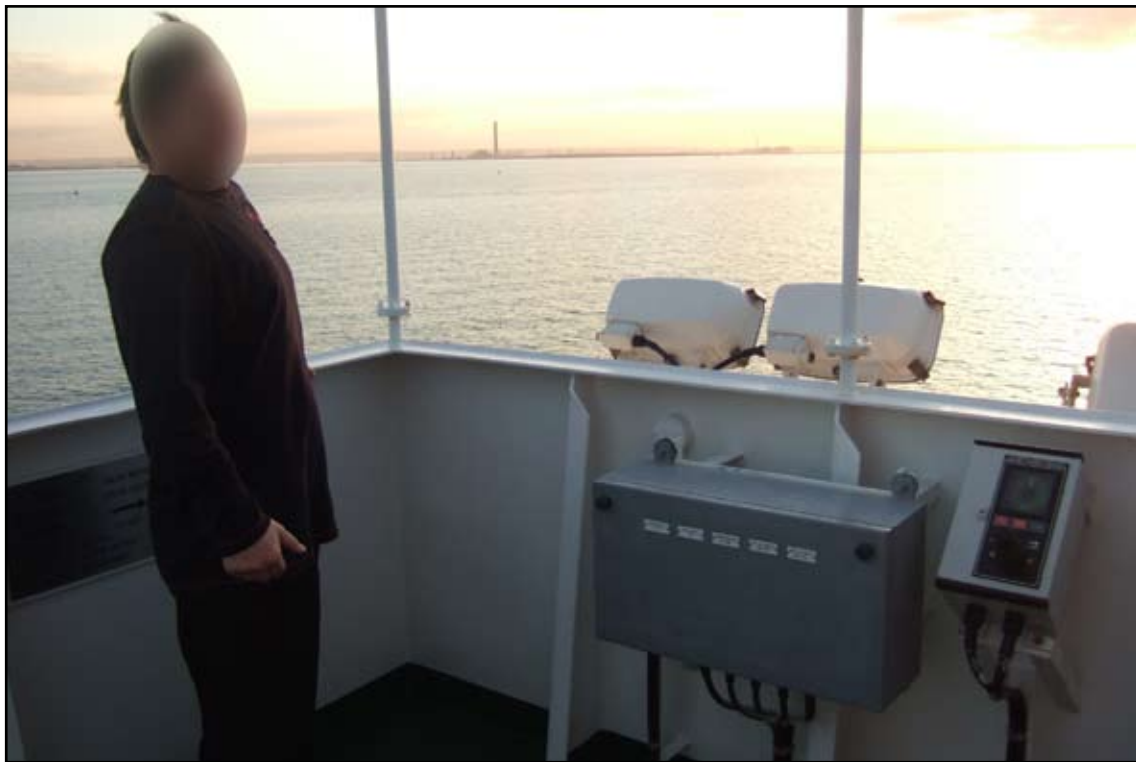
Figure 5a

At the time of the accident, the bridge was manned by the master, pilot, chief officer and a helmsman. The chief officer and helmsman were positioned by the bridge telegraph and helm respectively, while the pilot and master were stationed on the bridge wing with the master in position to control the bow thrusters (**Figures 5a, b**). The bow thruster control was placed in a convenient position for operation on the bridge wing, but the pilot's view of this was obscured by the master's body.

Bridge wing and bow thruster control

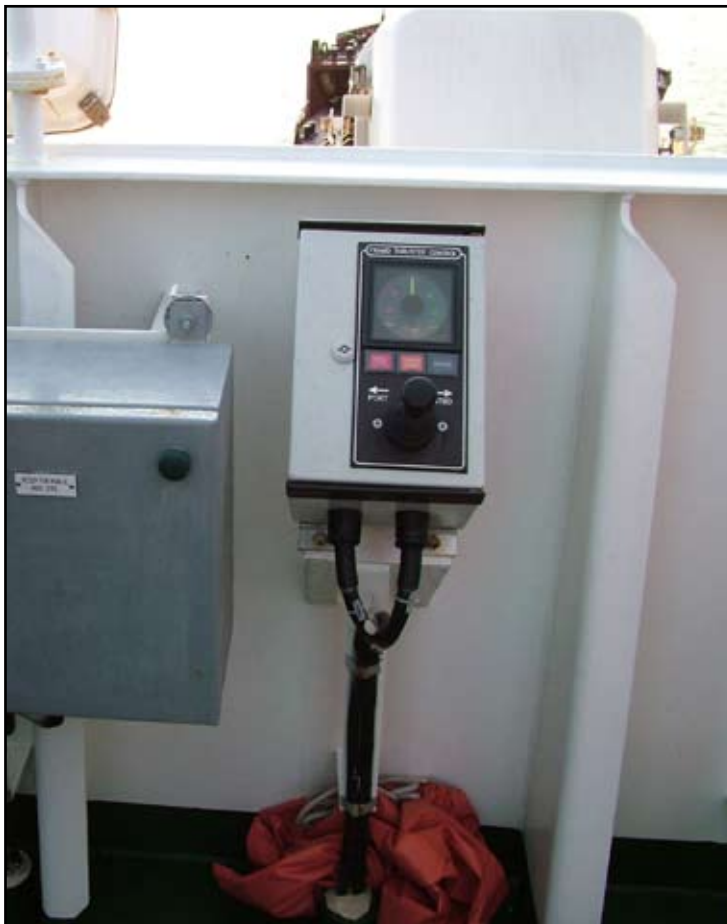
Figure 5b

Detail of bow thruster control
