Report on the investigation of the collision between

Skagern and Samskip Courier

in the Humber Estuary

Report No 6/2007
April 2007

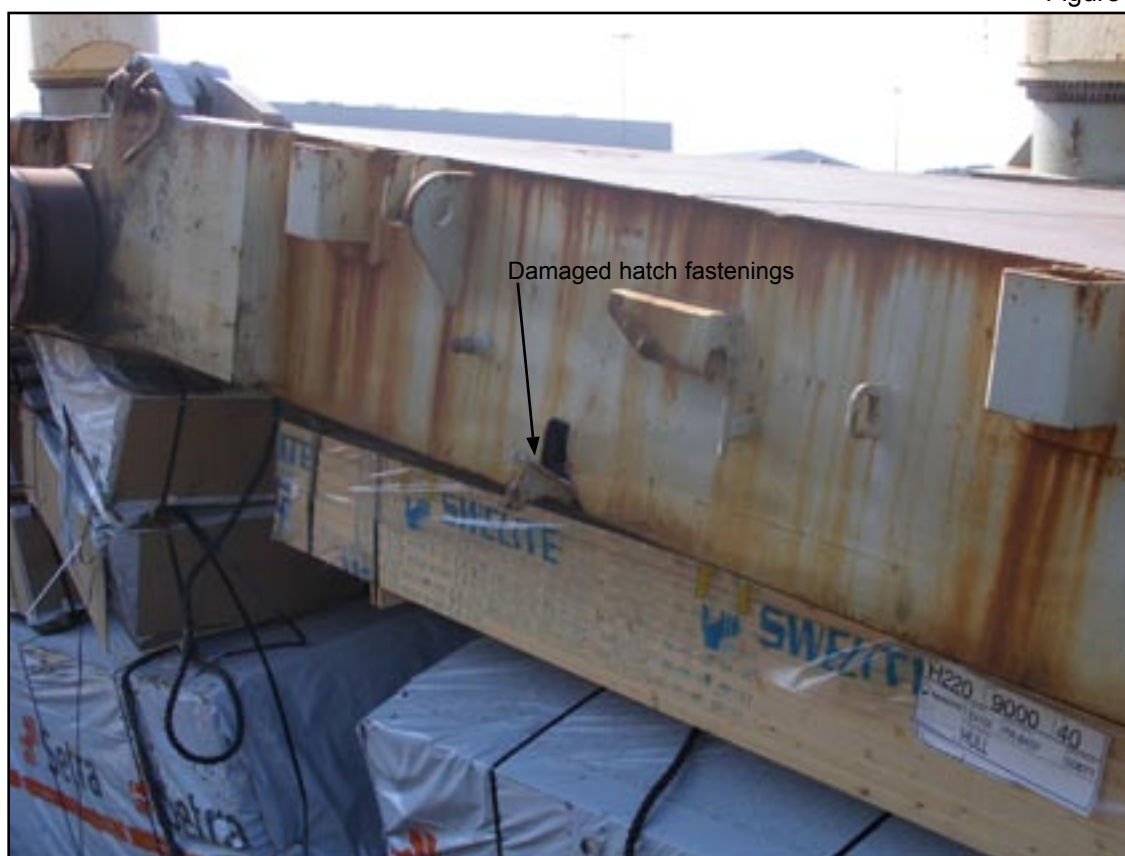
Figure 8

As they moved slowly upriver, the bilge pumps were operating to capacity and the damage control party regularly kept the bridge informed of water ingress; in the first 15 minutes the water level in No1 hold reached 10cm. Soon after this, the master was informed that they had 1.5m of water in No1 hold and the previously empty starboard double bottom tank forward was now full. Their passage upriver drove water into No1 hold at an ever increasing rate as the vessel's forward draught increased. Fortunately, Nos 1 and 2 holds were separated by a cofferdam, so there was little concern about water gaining entry through this to No2 hold. However, the rising water level in No1 hold caused the cargo of timber stowed within the hold to float, which in turn exerted pressure on the hatch covers to the extent that they began to buckle. Soon after this, the fastenings began to render under the pressure (**Figure 8**). In consultation with Humber Estuary Service's Pilot Operations Manager (POM), it was agreed that the master should attempt to put *Skagern's* bow onto the sand of Hull Middle shoal because it was considered essential that the vessel did not sink in mid channel.

Skagern's hatches forced up by pressure of floating cargo

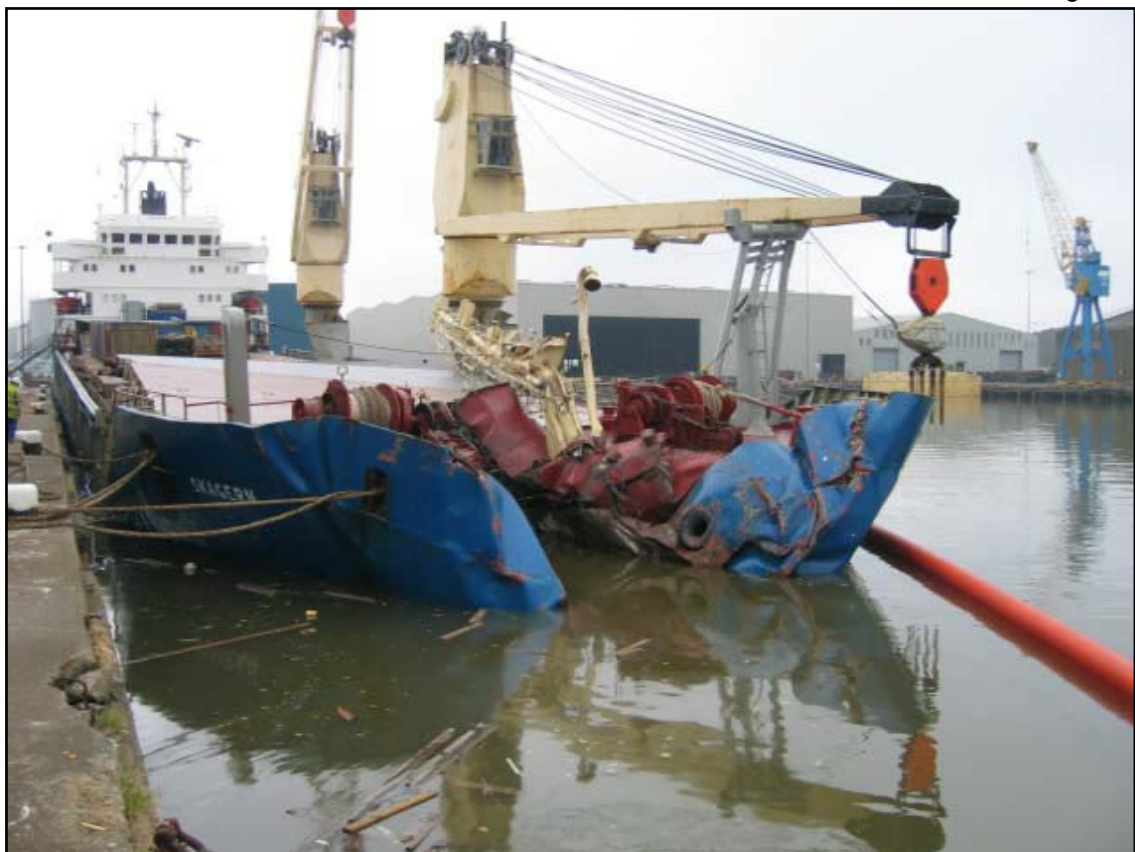
Figure 9

The stern-first tow was completed successfully, and by 04:30 on 8 June, *Skagern* was safely alongside in King George Dock, Hull (**Figure 9**). SOSREP had been previously notified of the accident and the possibility of pollution, and as soon as *Skagern* was moored up, anti-pollution booms were deployed to contain any possible oil spill. Once alongside her berth, progressive flooding through vents and conduits caused the vessel to go down further by the head until, gradually, her bow sank and settled on the dock bottom (**Figure 10**).

Skagern alongside King George Dock

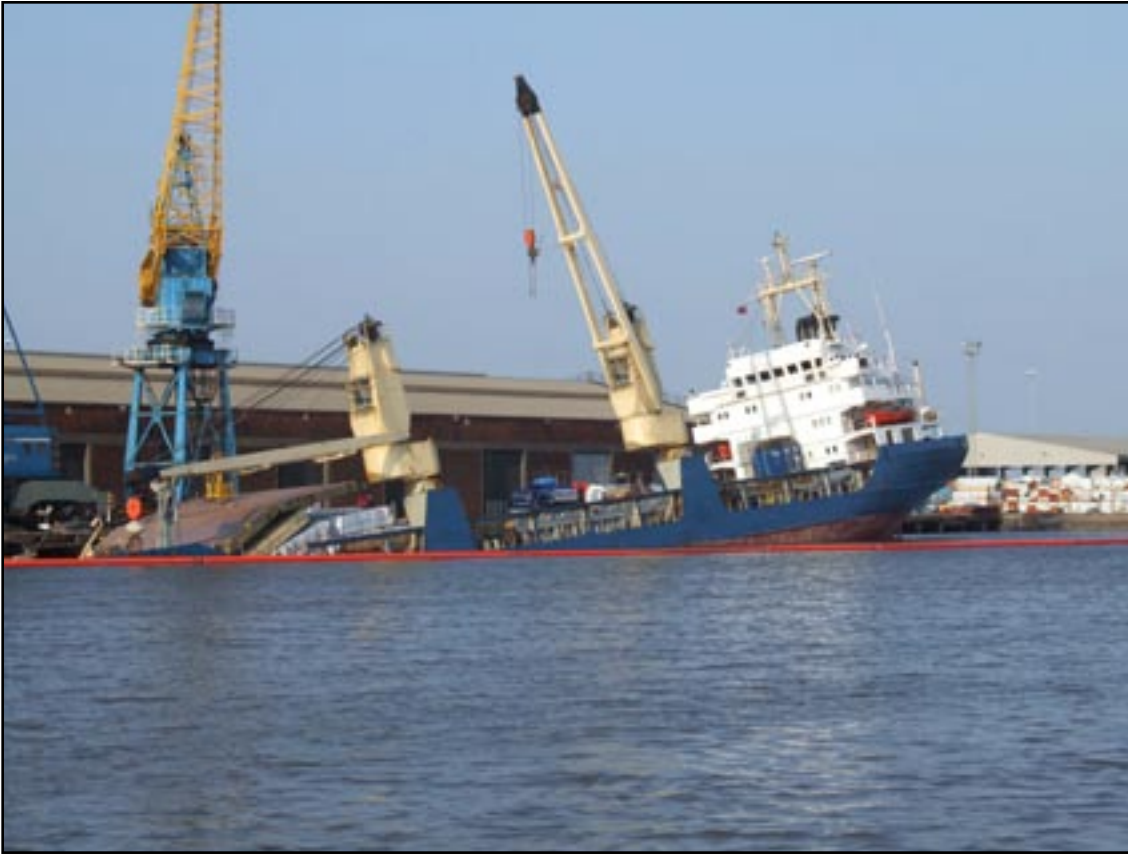
Skagern's bow settled on dock bottom

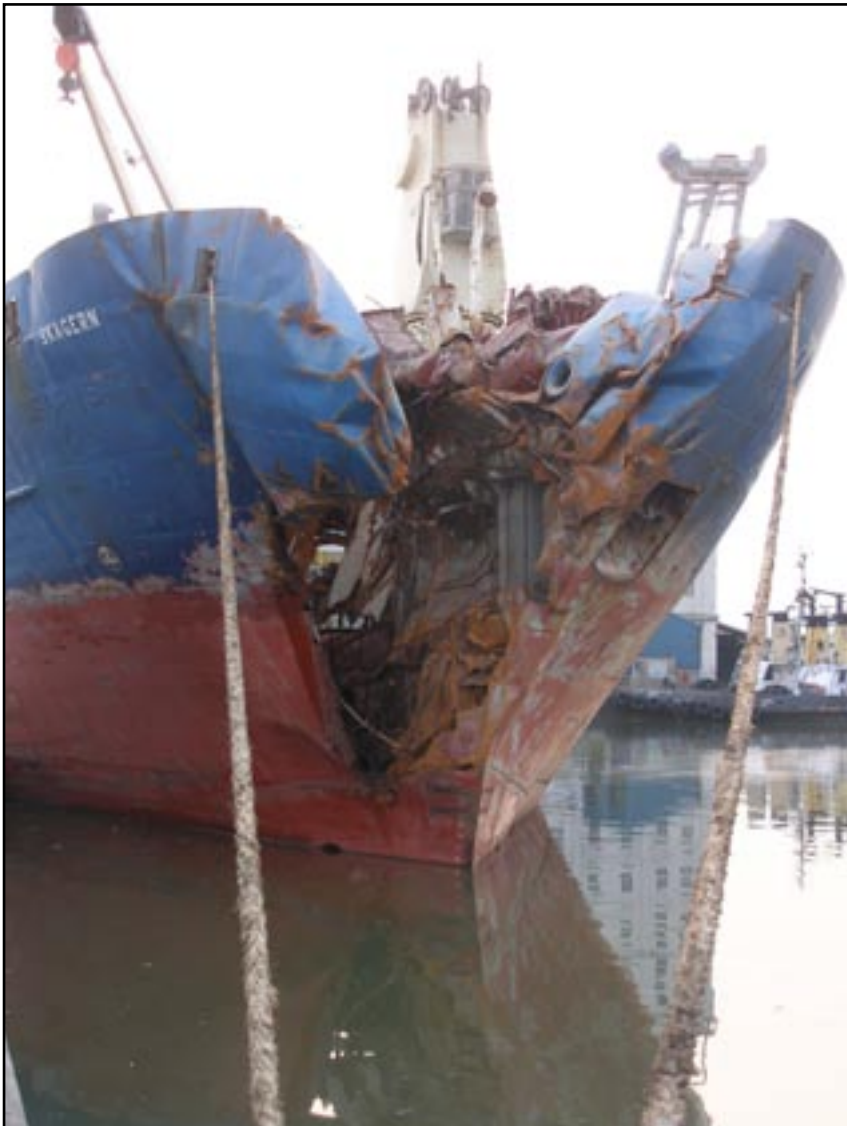
Figure 11a

A full salvage operation took place over the following days and *Skagern* was successfully unloaded and refloated, whereupon the full extent of the damage could be surveyed (**Figures 11a, b and c**).

Skagern after salvage operation

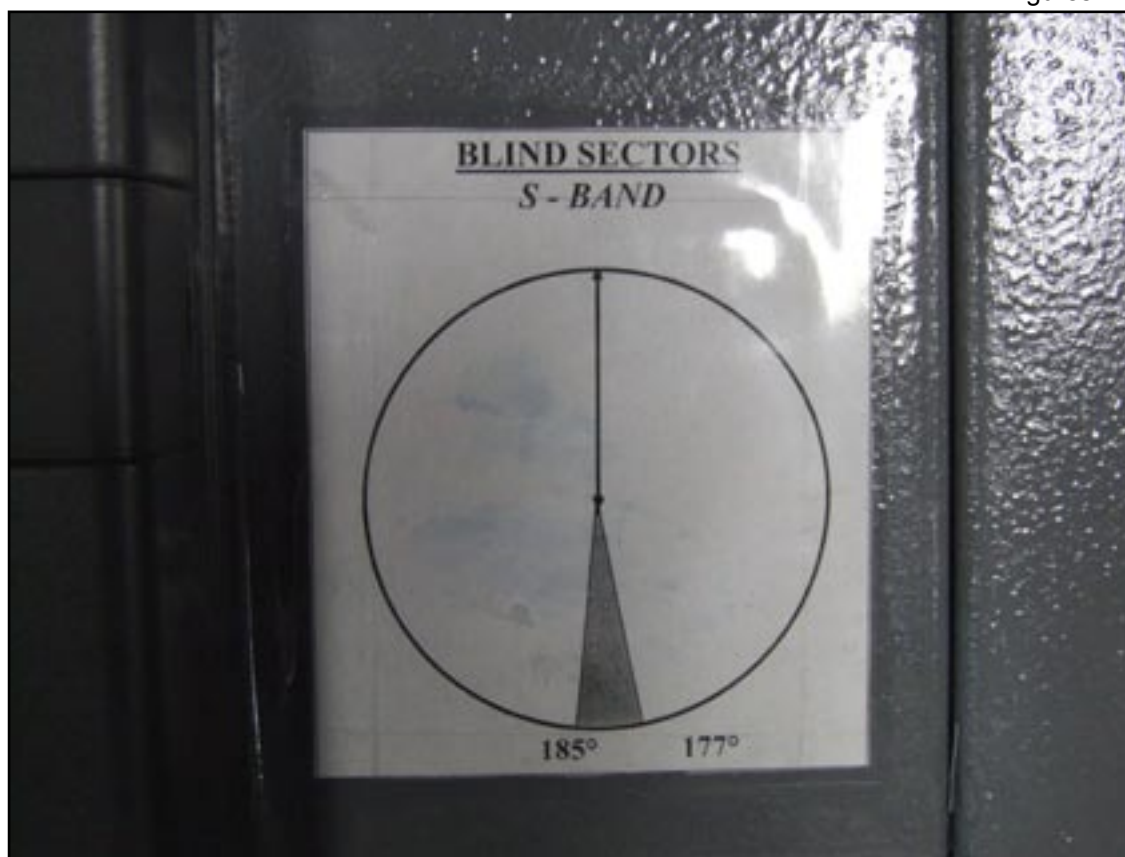
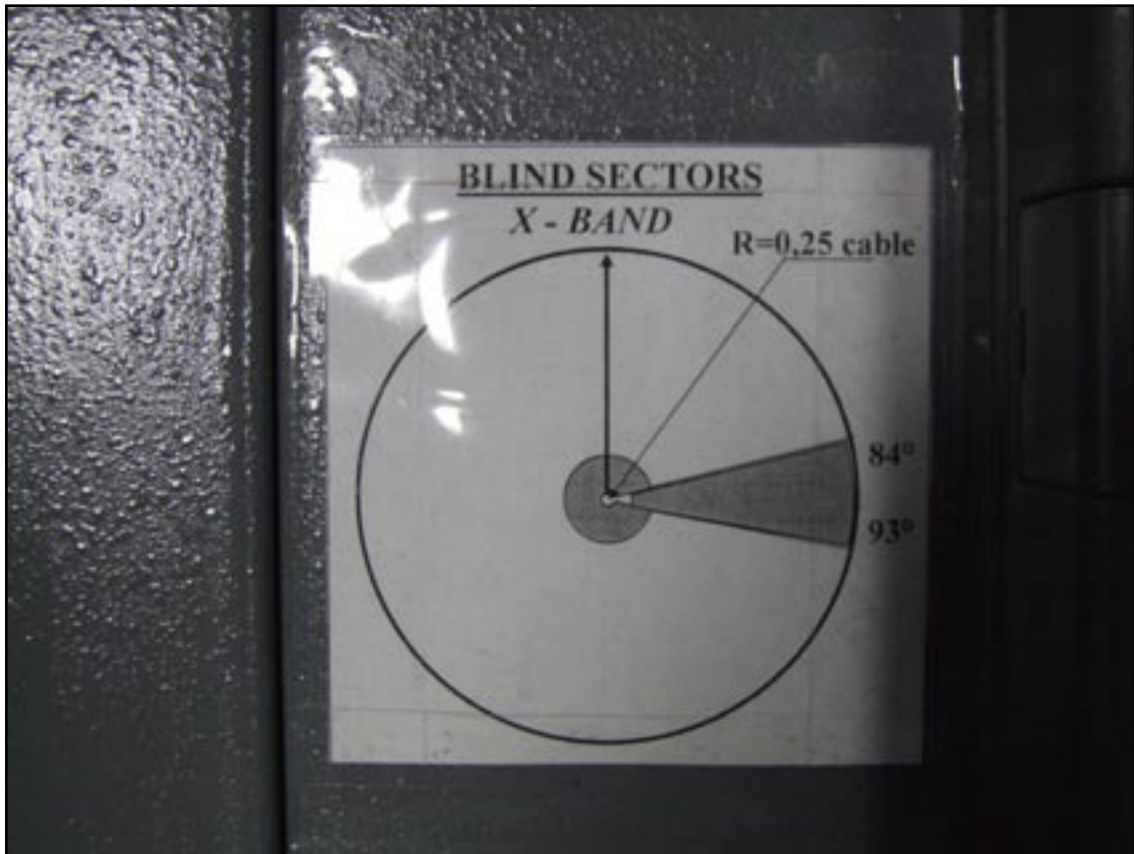
Figures 21b

Details of blind sectors
