MARINE ACCIDENT INVESTIGATION BRANCH

FLYER TO SHIPPING INDUSTRY

SPRUCE:

INTER-DEPARTMENTAL FLEXIBILITY – ENSURE THE CREW ARE PROPERLY TRAINED

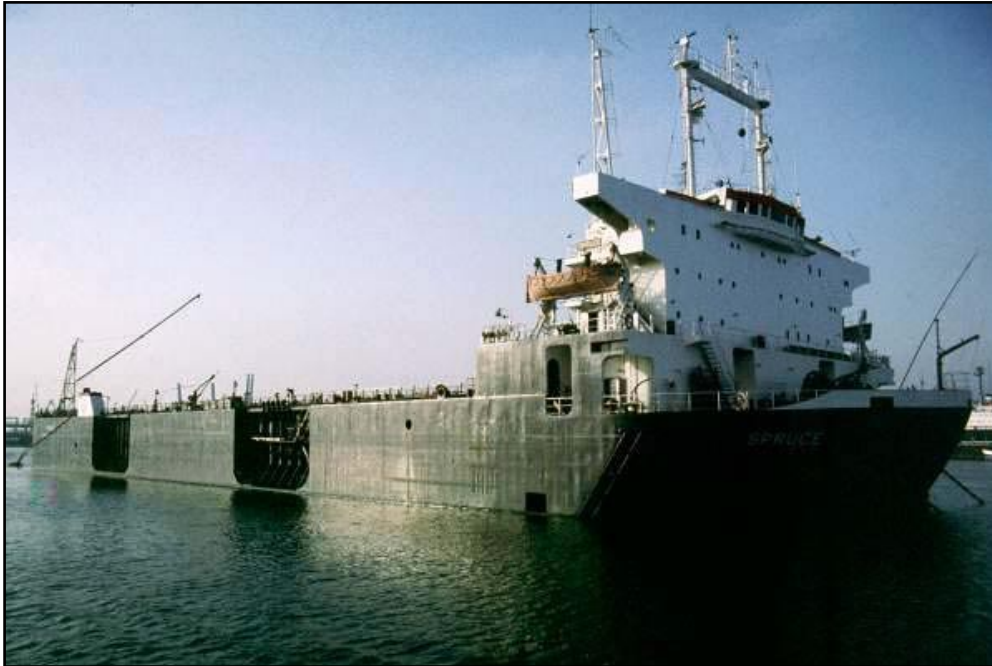
At 1718 UTC, on 06 March 2006, the cook of the LASH vessel *Spruce* sustained serious injuries to his left leg and left pelvis as the result of a fall of 6m from the ship's deck into the empty barge hold. These injuries required several operations and it was 6 weeks before he was fit enough to be repatriated. It was estimated that it would be an additional 6 months before he would be fit to return to work onboard ship.

The incident occurred at mooring standby while some of the crew were recovering the portable gangway prior to letting go. The cook was assisting in this operation, after which he had been tasked to assist with unmooring operations on the forecastle even though he was not trained for working on deck and he had little experience of doing so.

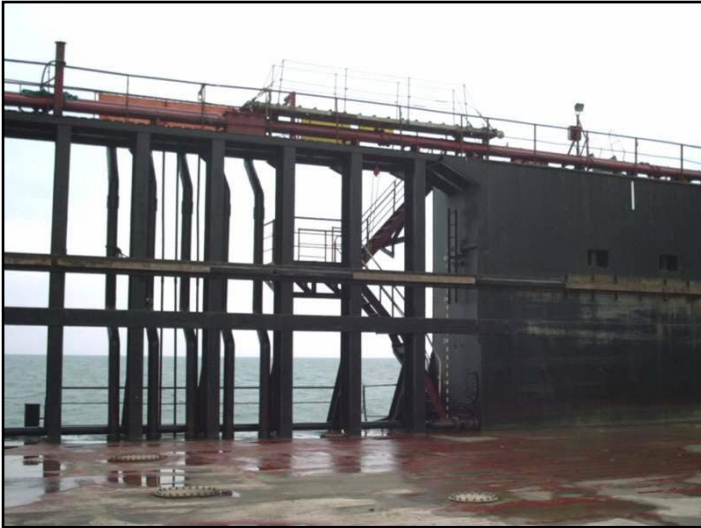
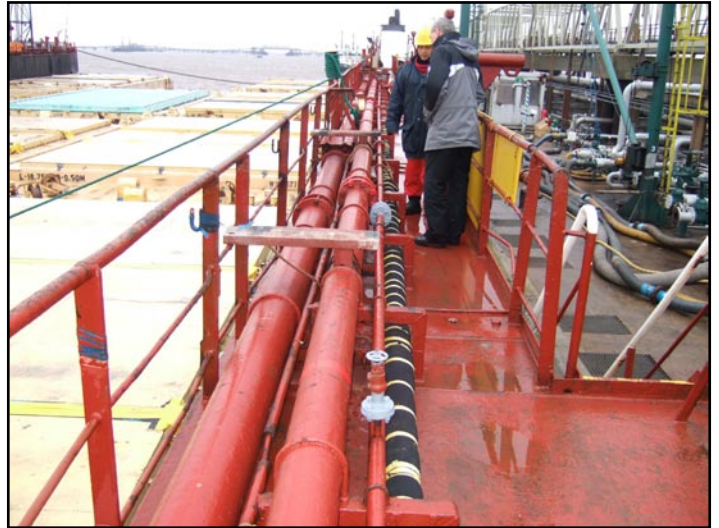
The operation to recover the gangway was labour intensive; five members of crew were used to manhandle the gangway up the side of the vessel to the main deck where the stowage position was located. The vessel was originally fitted with a method of retrieval for a fixed gangway, but this had been cropped and removed a number of years previously for an unknown reason.

- Whenever changes are made that affect the vessel's working procedures, as in this case when the fitted gangway retrieval system was removed, a new assessment should be conducted to ensure unacceptable risk has not been created.
