Report on the investigation
of the failure of a mooring bollard from the
Class V passenger vessel
Star Clipper
resulting in a fatal accident at
St Katharine's Pier, River Thames, London
on
2 May 2004

Marine Accident Investigation Branch
Carlton House
Carlton Place
Southampton
United Kingdom
SO15 2DZ

Report No 3/2005
February 2005

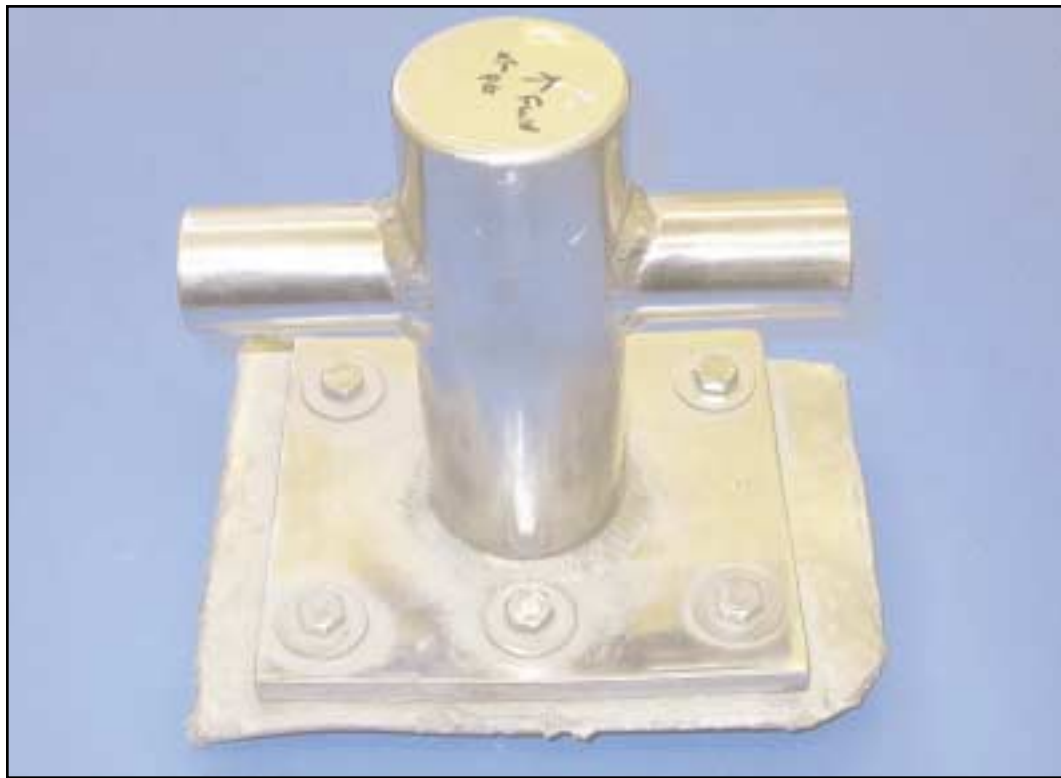
Figure 6

At 1300, when *Star Clipper* was just under 1m from the pier edge, the mooring bollard and supporting insert plate (**Figure 6**) were ripped from the deck and catapulted over the 1.1m safety fence, into a group of waiting passengers. The mooring rope, having become detached from both the pier and vessel's mooring bollards, was reported to have "snaked" through the air, and landed among the passengers. At the same time, the mate looked down at the passenger access platform and saw a hole where the bollard had previously been (**Figure 7**). He then looked down the pier and saw a female passenger laying approximately 2.13m from the pier bollard position. She was surrounded by other waiting passengers. As the bollard failed, the vessel moved about 1m along the pier where the captain held her in position using her engines.

Displaced stainless steel mooring bollard and insert plate

Mkl bollard base plate remains

The stainless steel mooring bollard was recovered by the Metropolitan Police and was still connected to the 6mm aluminium insert plate by 6 x M10 stainless steel bolts and associated washers, nuts and lock nuts. The arrangement had been repaired, and the weld securing the insert plate to the supporting structure had failed. Weld material with signs of porosity was found on the edges of the insert plate.

There was also considerable distortion of the bollard stainless steel base plate and aluminium insert plate. The latter had suffered the greatest deformation. There did not appear to be any damage to the bolts, bollard, vertical and horizontal pins, or associated pin fillet welds. However, all but one of the washers had suffered severe deformation.

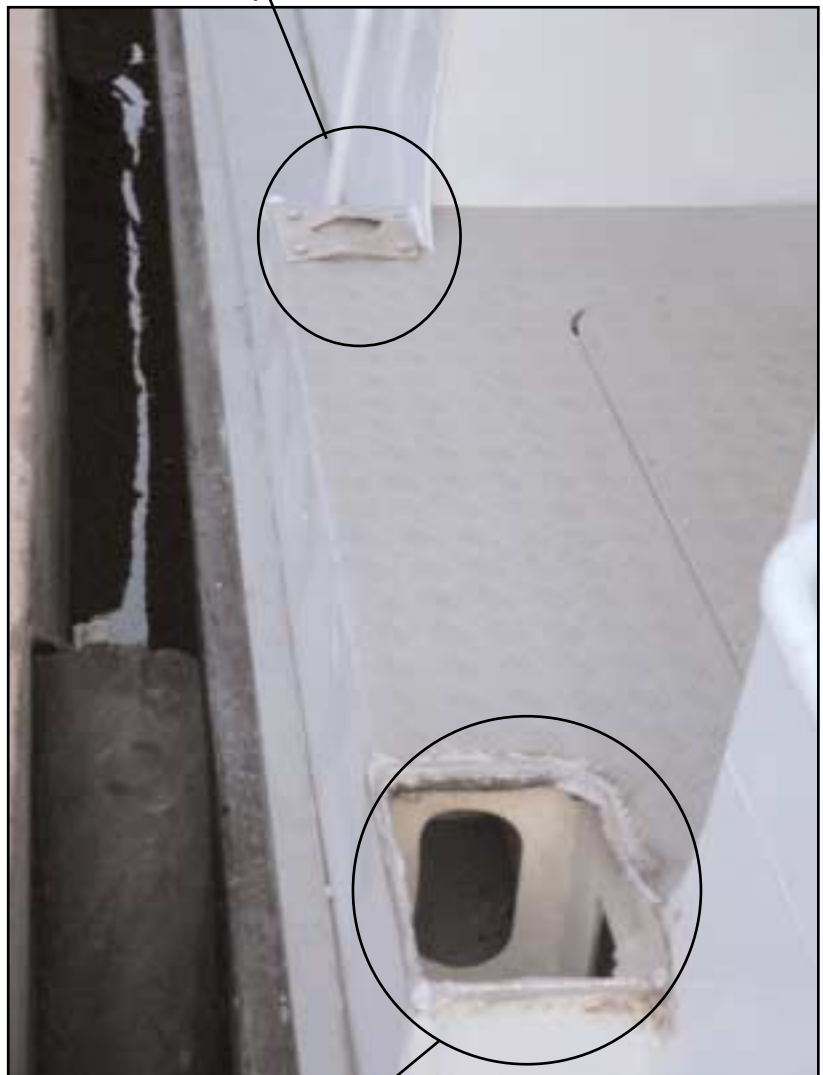
Figure 7

Position of displaced bollard

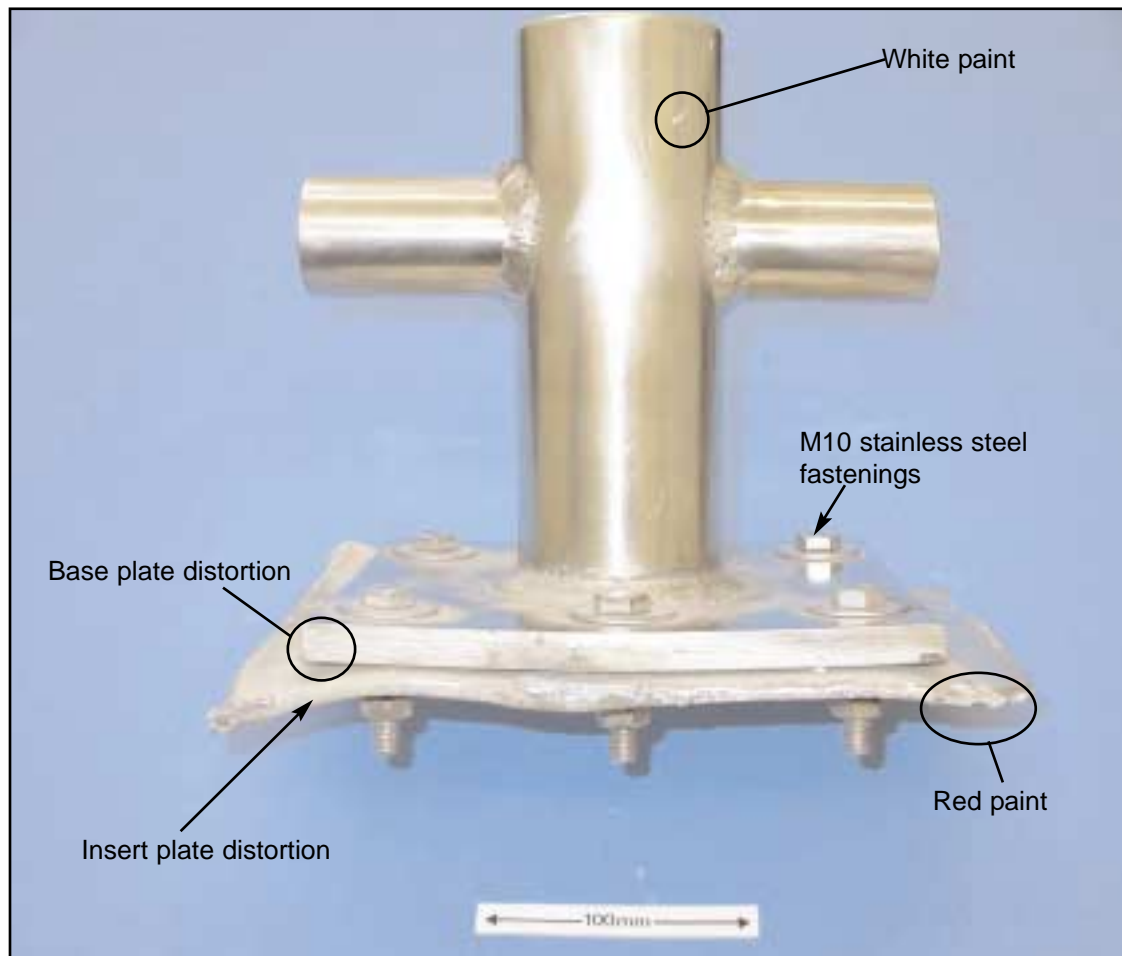
Figure 14

Location of red and white paint, fastenings and insert plate distortion

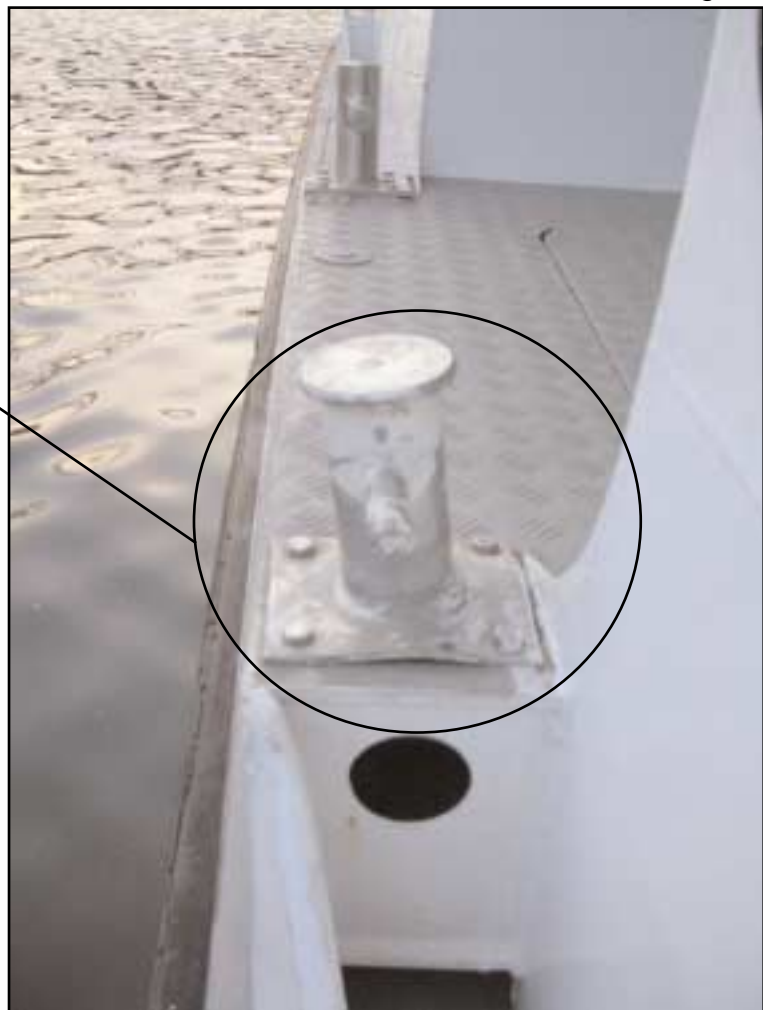
Figure 16

Aluminium bollard showing distortion to base plate and vertical pin

View of Mk1 hollow aluminium bollard

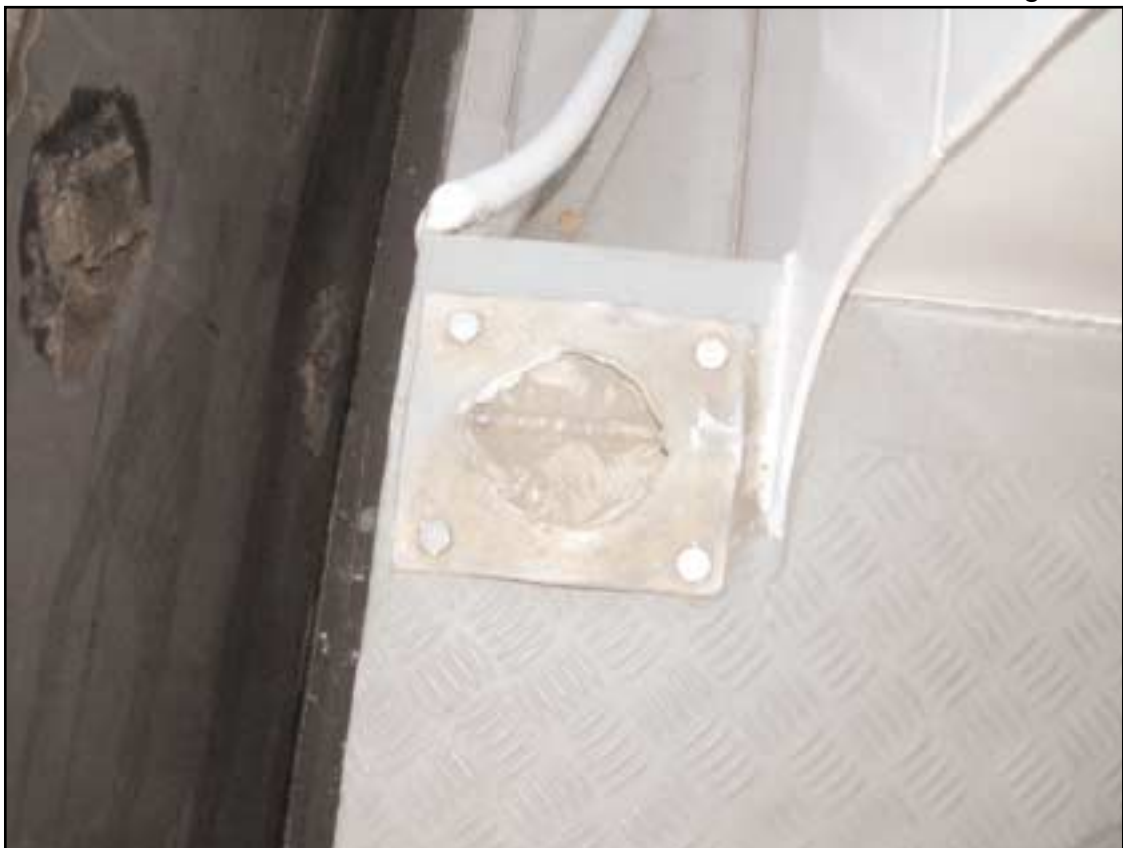
Figure 17

On taking ownership of *Sky Clipper*, CRE replaced the **Mk I** aluminium bollards fitted to the passenger access areas, some of which had already failed (**Figure 17**). Two **Mk II** bollards were fitted to the after end of the access as it was found that the forward two were not required for the River Thames operation. However, within 6 weeks of service, the weld at the base of the bollards' vertical pin began to fracture and the base plates deformed. The bollard design was subsequently changed, and the defective bollards were replaced with **Mk III** bollards. The increase in base plate thickness resolved the base plate distortion, but the bollard vertical pin still suffered deformation.

Failed Mk I bollard

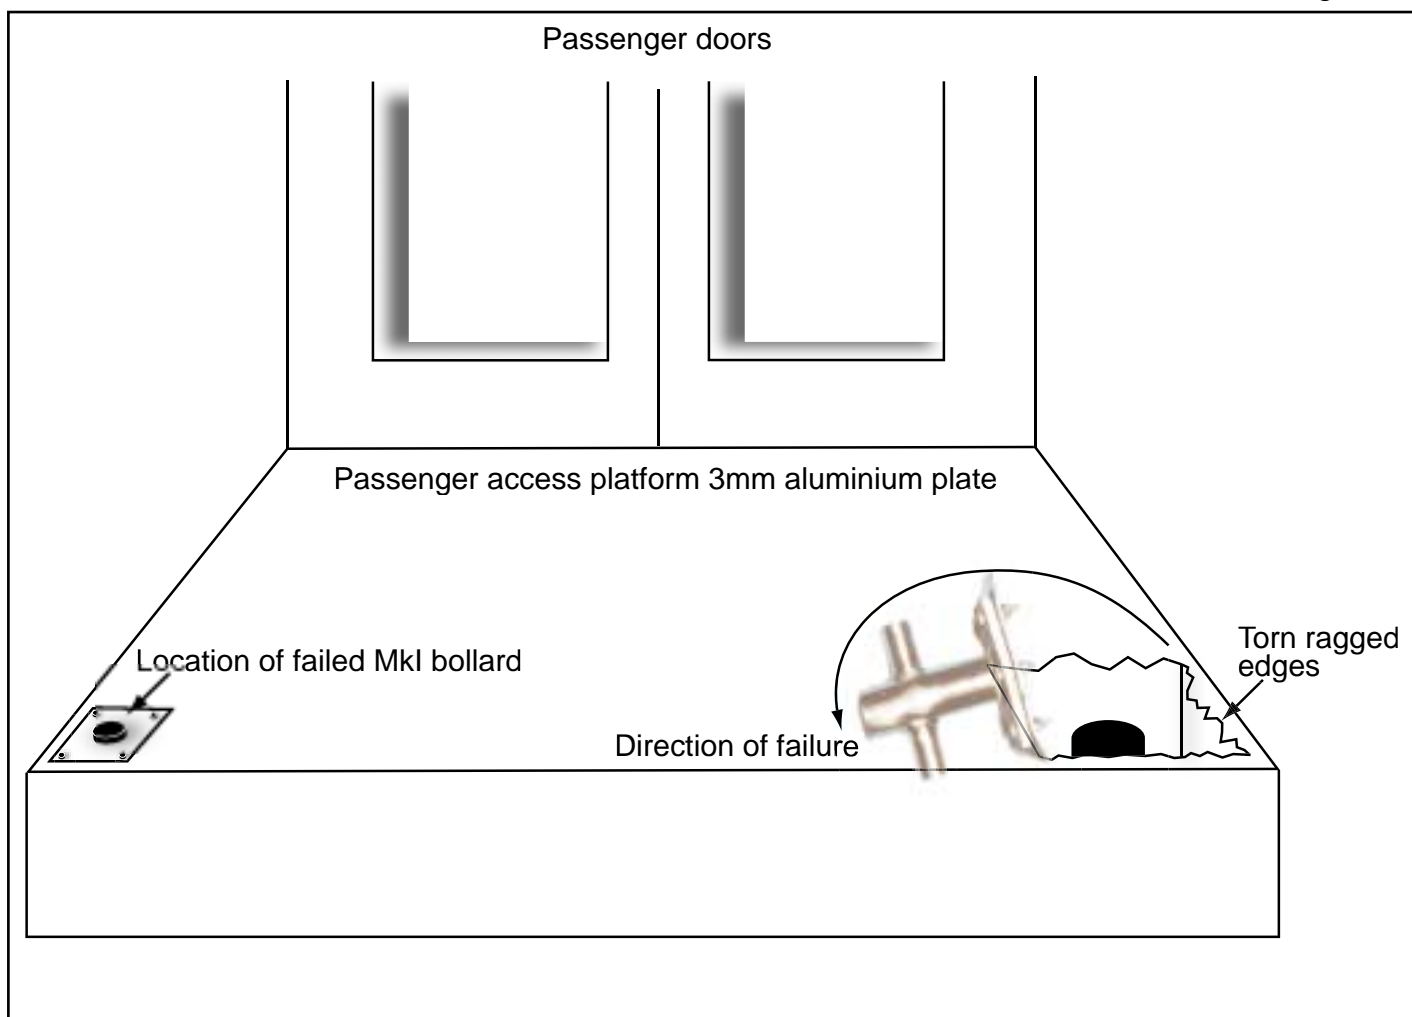
On 9 April 2004, the port after **Mk IV** type bollard in *Star Clipper's* passenger access was torn from the deck. Whilst leaving a pier, the eye of the mooring rope caught on both the pier bollard and the vessel's bollard. As the vessel went astern, force was exerted onto the after face of the vessel's bollard, tearing up three sides of the supporting 3mm aluminium deck checker plate (**Figure 18**).

Damage to bollard arrangement sustained on 9 April 2004

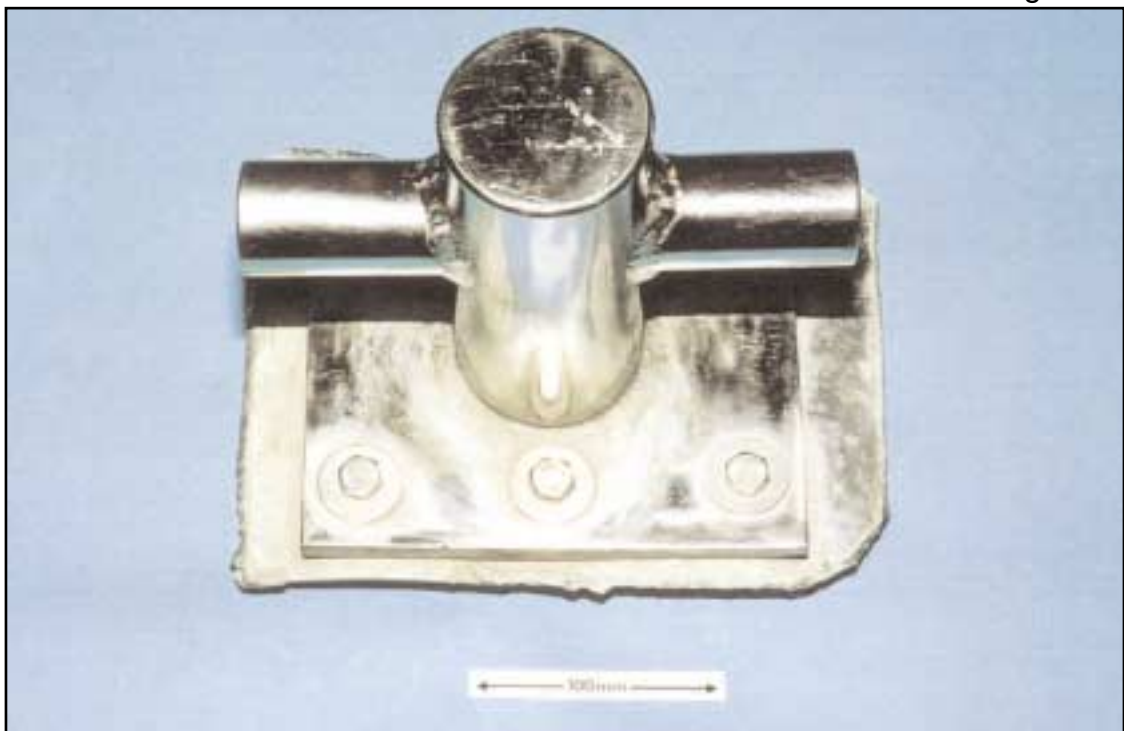
Figure 19

By the time the Alweld representative arrived on site, CRE engineers had already removed the bollard from the damaged 3mm aluminium deck plate and had hammered down the edges of the torn deck section. The Alweld employee fitted the bollard to a thicker, 6mm aluminium mounting plate, which was drilled and secured to the bollard base plate with 6 x M10, 316 stainless steel bolts with washers, nuts and locking nuts (**Figure 19**). The damaged deck area was dressed to facilitate fitting of the insert/doubler plate, which was cut to size on site.

Bollard and insert plate fastening arrangements viewed from inboard side

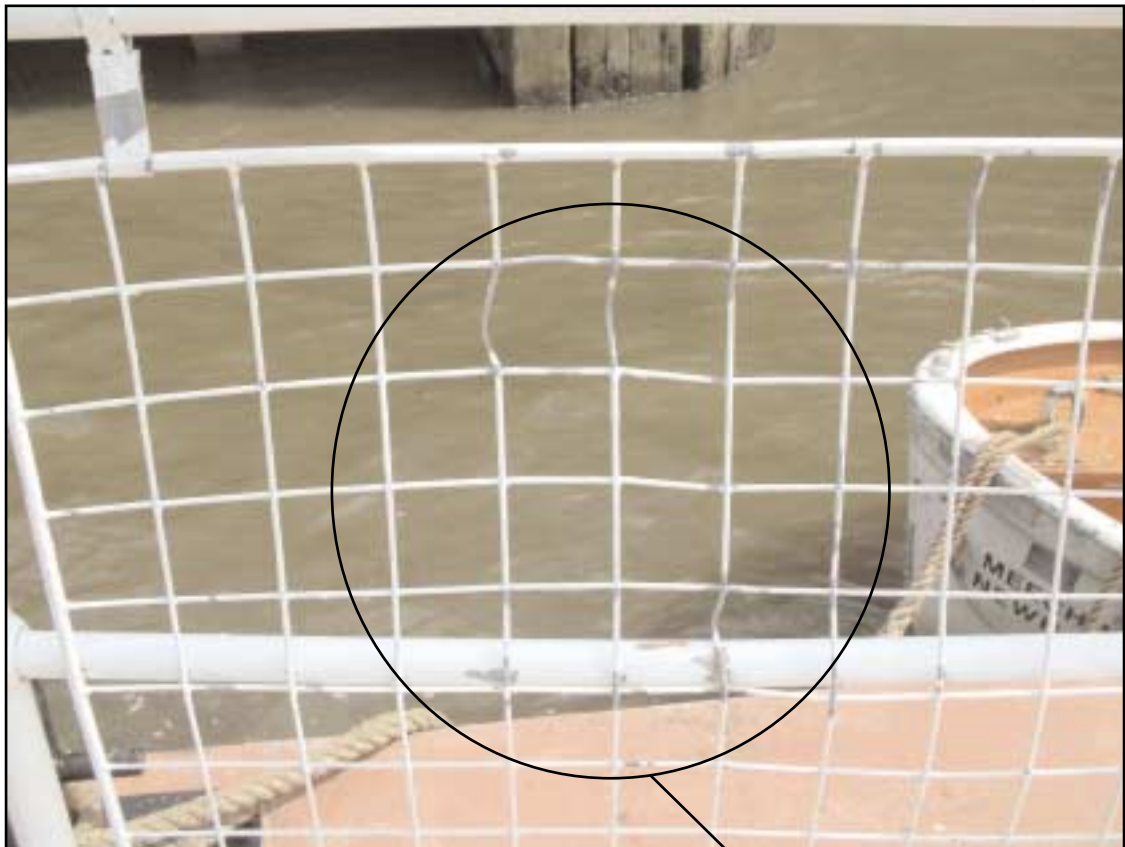
Figure 23

The results of the independent study suggest the most likely scenario was that the vessel bollard hit the pier bollard and was deflected over the riverside safety fencing. It hit the lady and then the bankside safety fence (**Figure 23**), before landing on the pier.

Damage to bankside safety fencing
