Marine
Accident
Report

the fire onboard

Star Princess

**Report No 28/2006
October 2006**

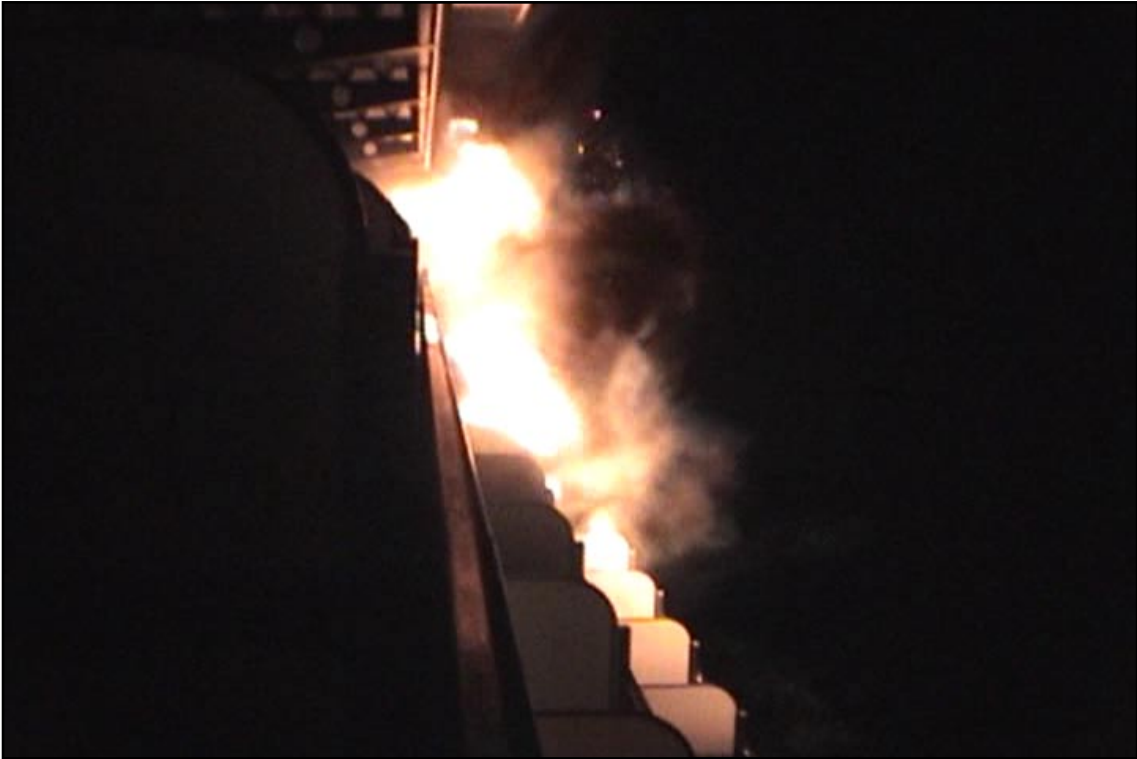
Figure 2

Still from video taken at 0311

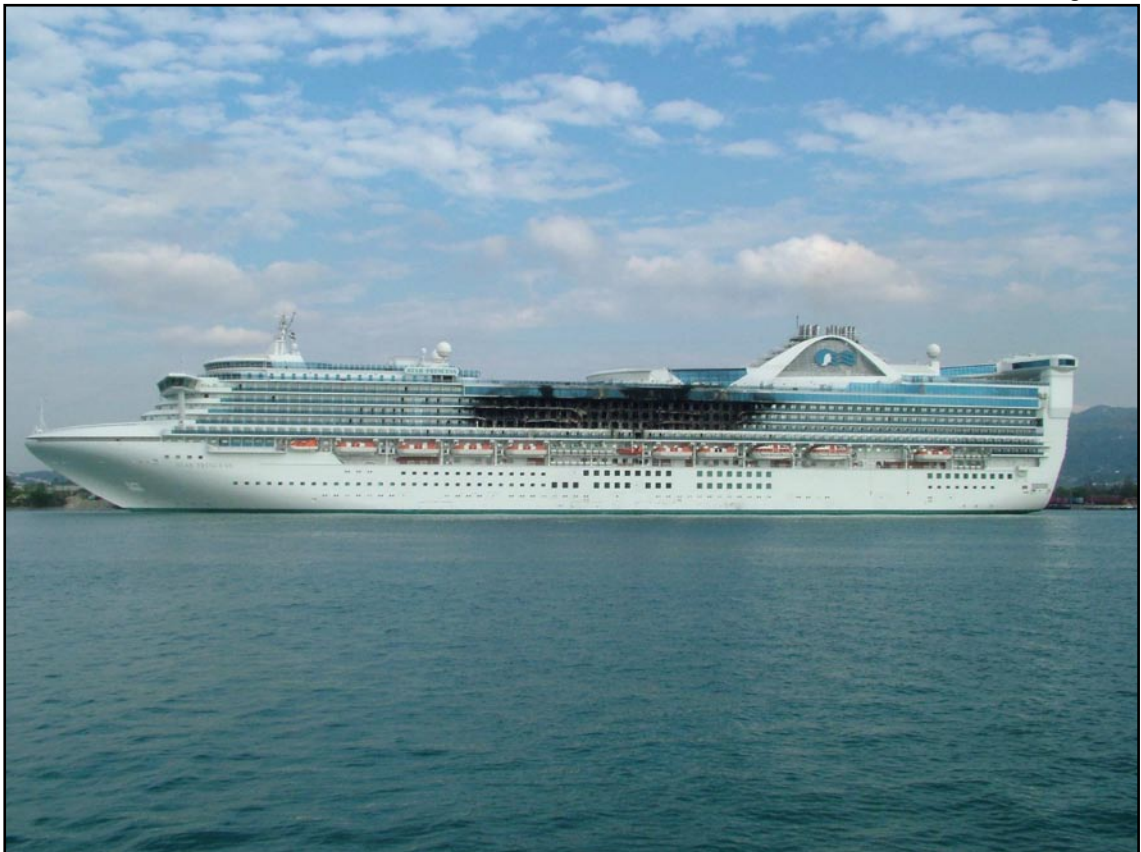
Figure 9

Fire damage extended over the balconies and outboard staterooms in the central third of the ship's length, in Fire Zones 3, 4 and 5 on the port side (**Figure 9**). The most severe damage was on decks 10, 11 and 12 (**Figure 10**) in which 79 outside staterooms were seriously damaged by fire. A further 218 were damaged by fire, smoke, or water. One balcony on deck 9 was seriously damaged by fire, and numerous others sustained minor damage caused by falling debris. Semi enclosed public areas on the port side of deck 14 were damaged by heat and smoke (**Figure 11**). Minor smoke damage and debris of the products of combustion was evident on deck 15.

Extent of damage on ship's port side

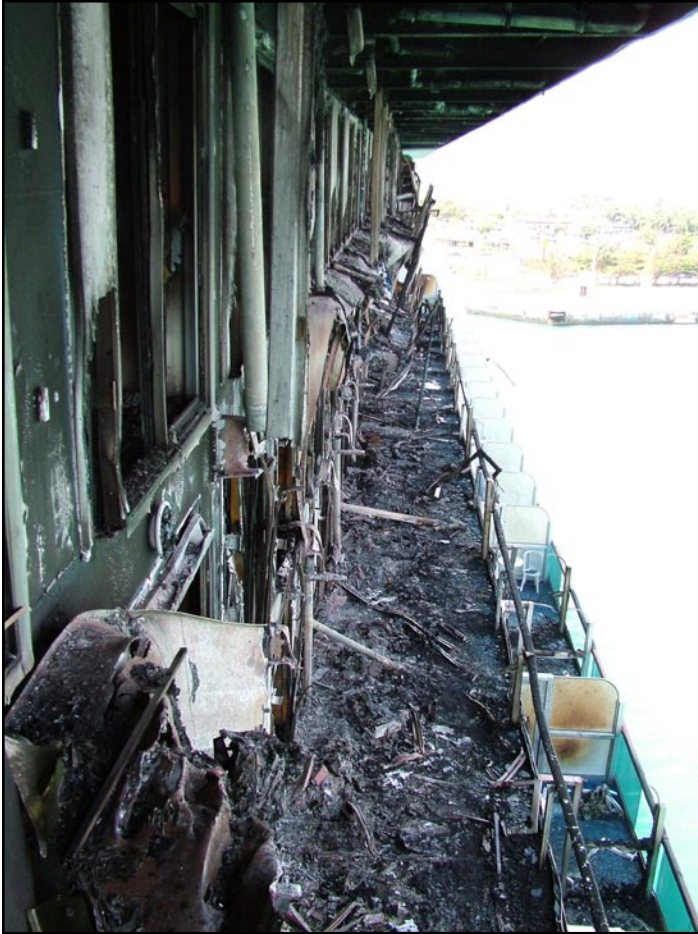
Figure 10

Damage to balconies

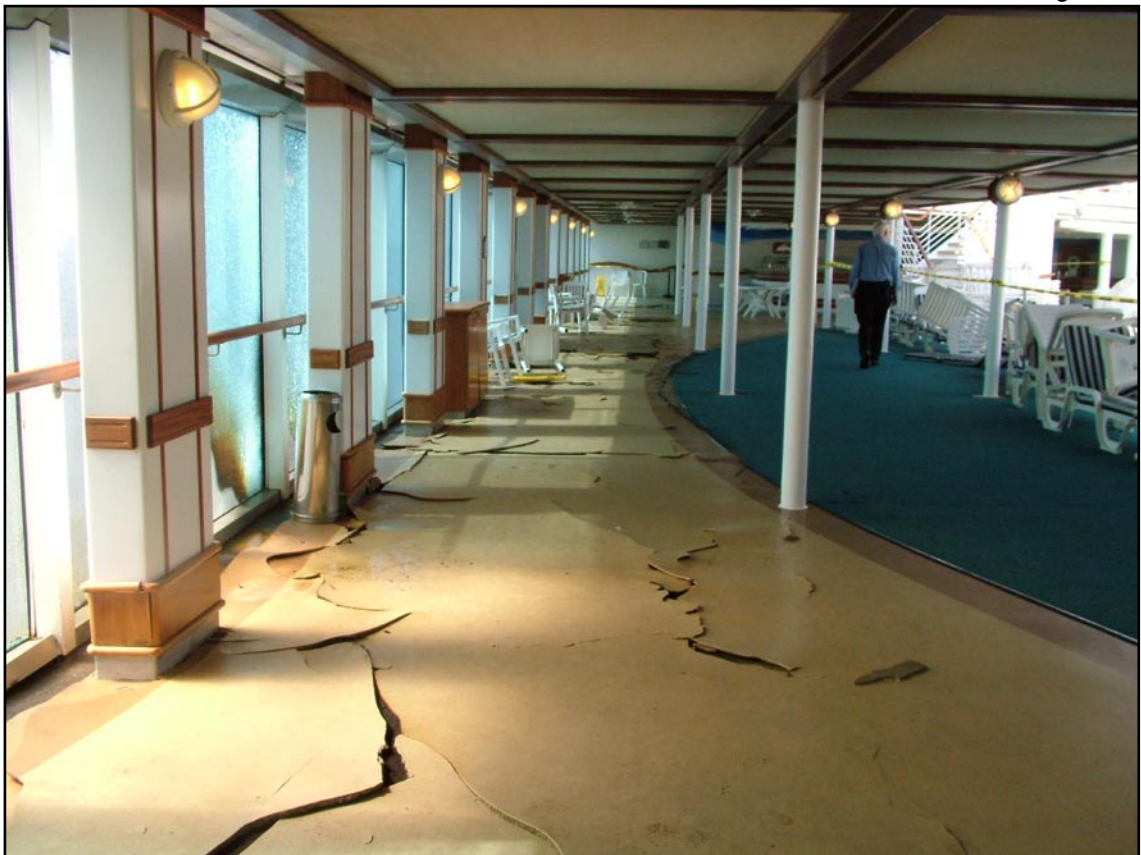
Figure 11

Damage to deck 14

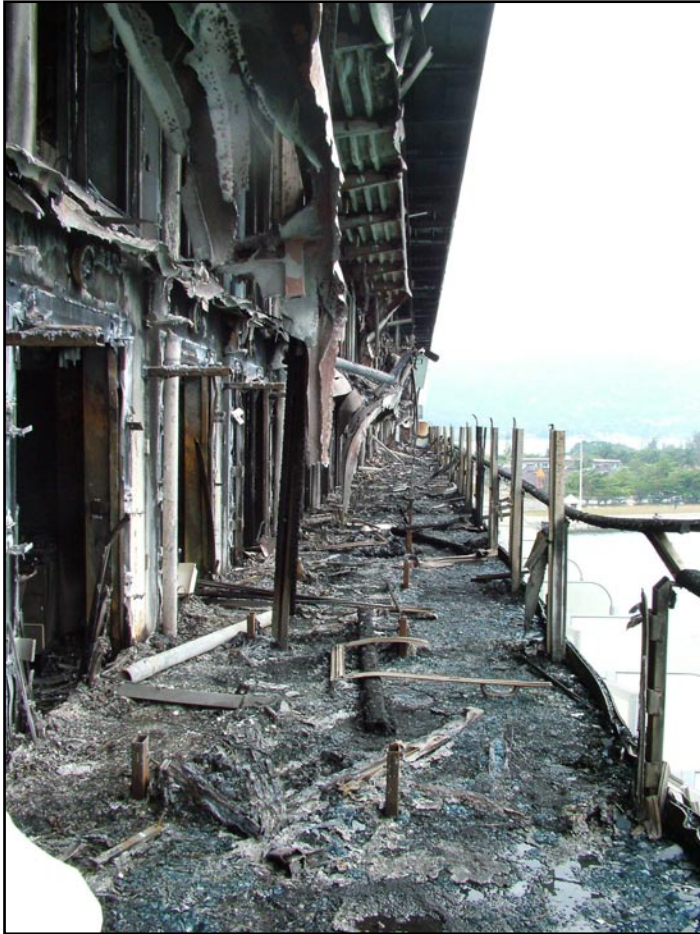
Figure 12

The fire generated sufficient heat to melt the aluminium structure of decks 11 and 12 (**Figure 12**). The heat also caused glass in the balcony balustrades and doors to shatter, which allowed the fire to penetrate into the outside staterooms (**Figure 13**).

Melted aluminium structure

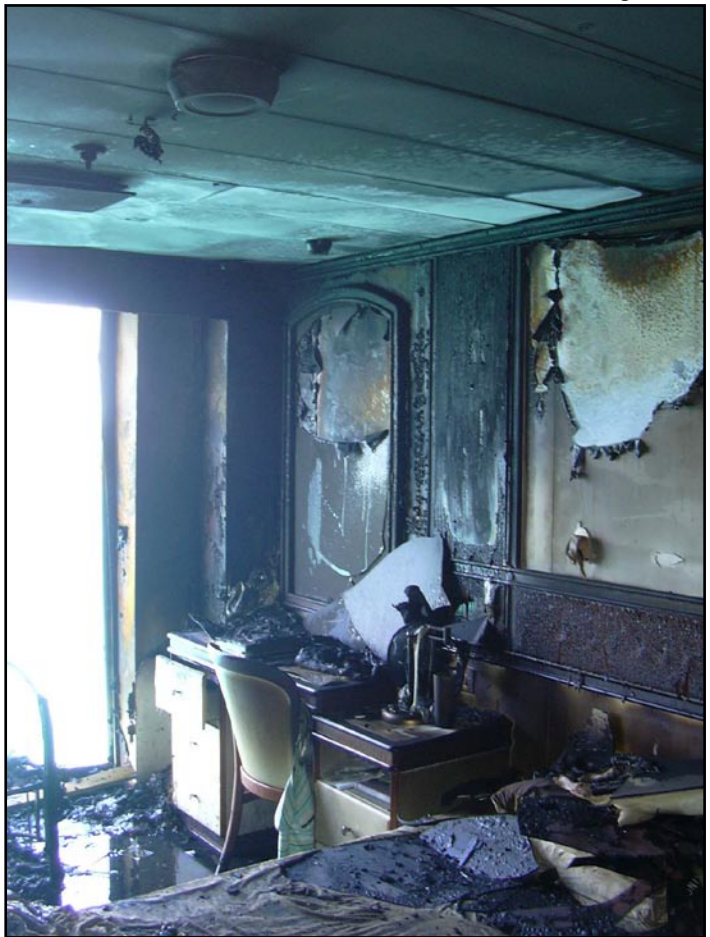
Figure 13

Damage to stateroom

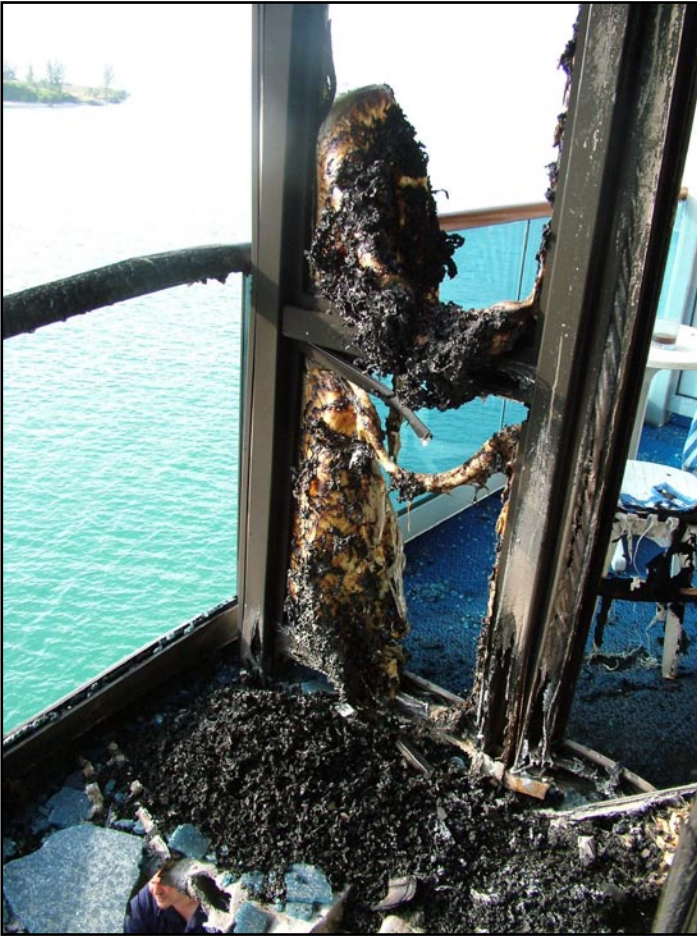
Figure 14

At the outer boundaries of the damaged areas, the balcony partitions were charred and melted, and sagged under their own weight (**Figure 14**). Where this occurred, it was possible to see that the partitions had burned before their aluminium frames distorted. In all other places, the partitions were reduced to ash and their frames partially or totally melted. The plastic furniture and deck tiles were mostly reduced to ash within the fire affected area, and were melted and scorched at its outer boundaries (**Figure 15**). The only electrical fitting provided on each of the balconies was an exterior light sited over the balcony doors. There was no evidence of any electrical failure or arcing on these fittings.

Melted polycarbonate partition

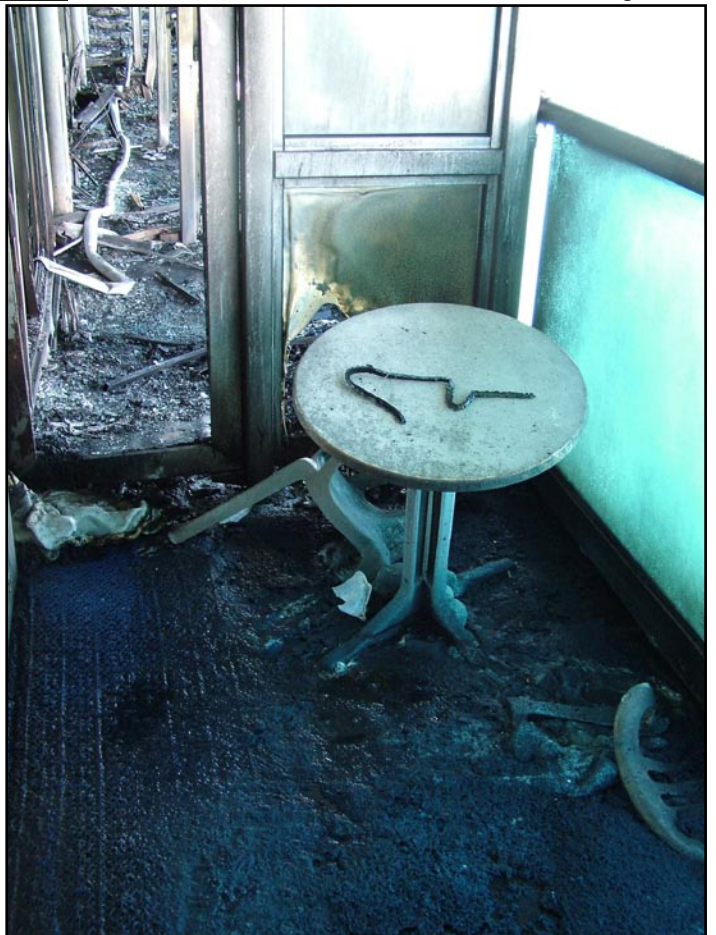
Figure 15

Partially melted balcony furniture

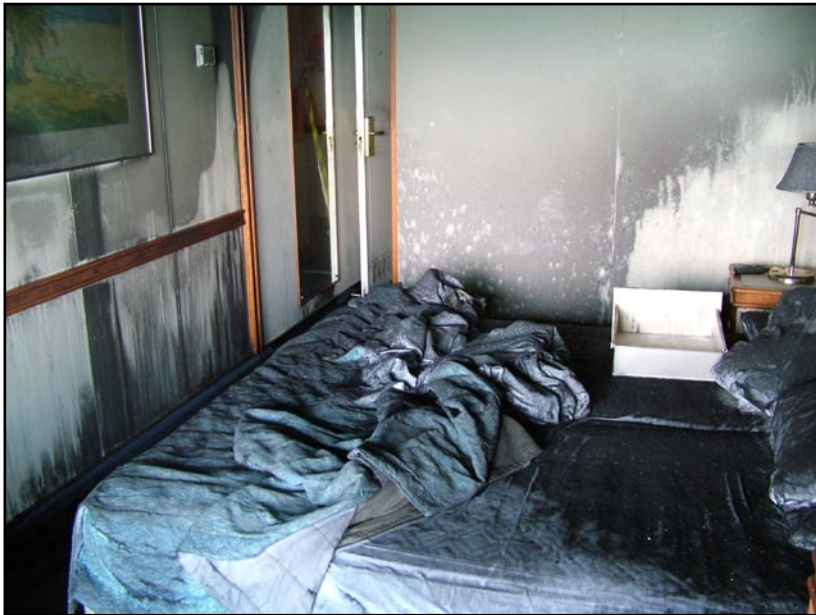
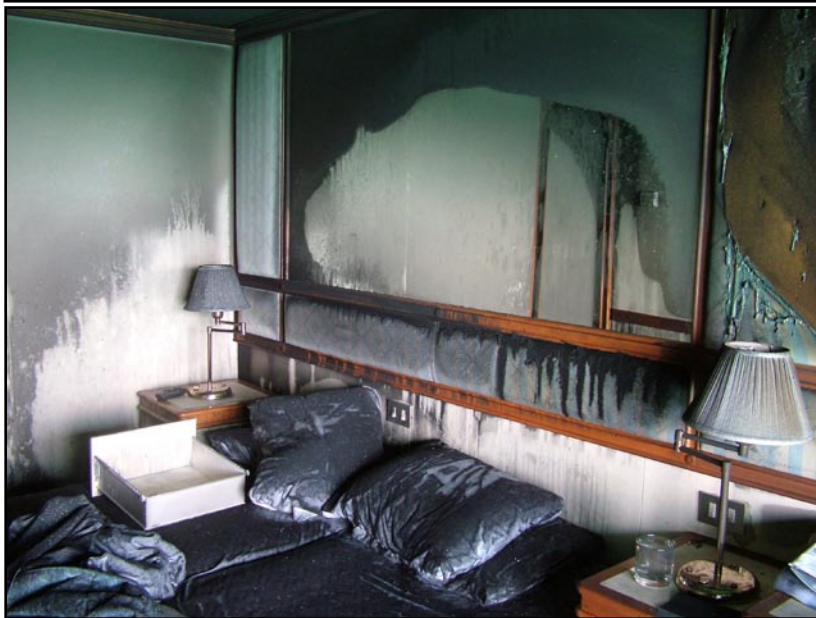
Fire damage in the staterooms was worst immediately inside their balcony doors, and reduced towards their interior. A rapid reduction in temperature was shown by undamaged chocolates found on many bedside tables, and bedding and furnishings, which looked charred (**Figures 16 and 17**), but were in many cases only stained with heavy soot washed from the smoke by the water mist.

Figure 16 and 17
Soot in stateroom interior

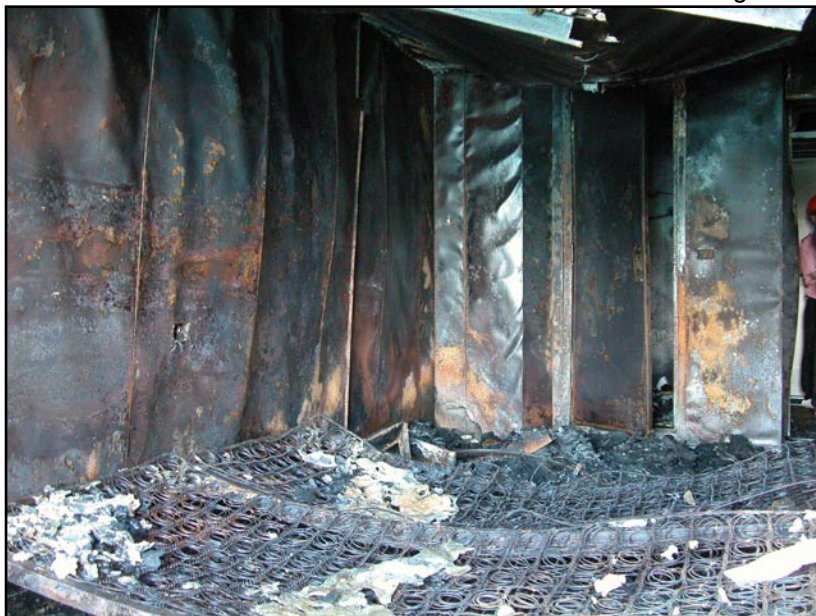
Figure 18

The most severe damage to a stateroom was in C510 (**Figure 18**), where the water mist head was found on the deck, having failed to activate. The heat generated had buckled the stateroom's deckhead panels, and its door to the alleyway was also badly buckled and very nearly breached.

Stateroom C510

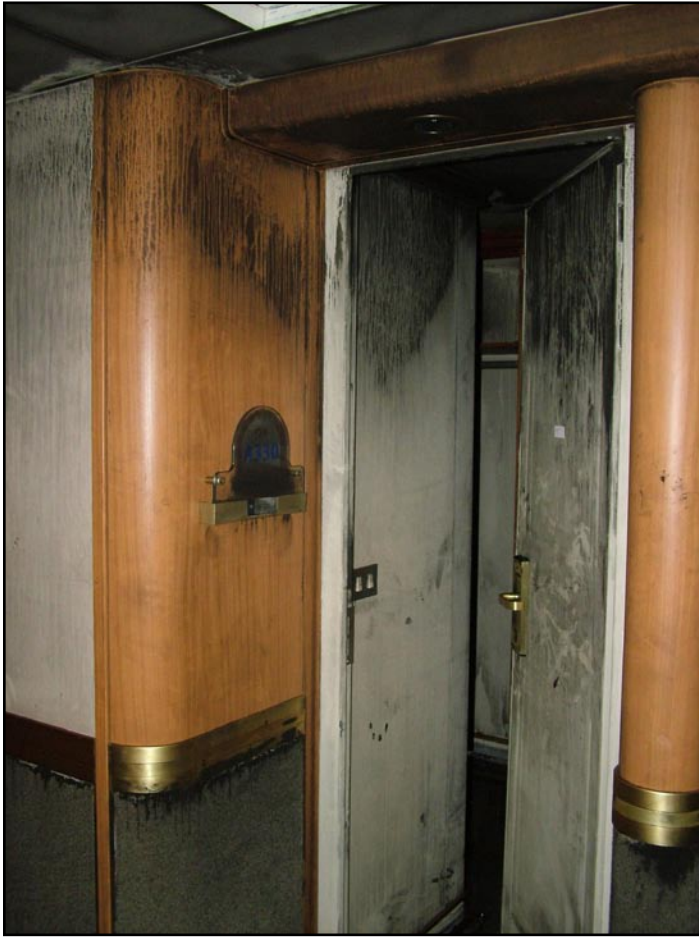
Figure 19

Soot deposits indicated that smoke entered the ship and reached internal alleyways in accommodation spaces through staterooms via open balcony doors. **Figures 19 and 20** show the soot deposits outside the entrance to staterooms of A330 and A338. The stateroom door of the latter was held open due to the insertion of a wedge in its self-closing mechanism. Although soot stains were evident in zone 3 on deck 12, they were less evident in zone 4 (**Figure 21**).

Door to A330

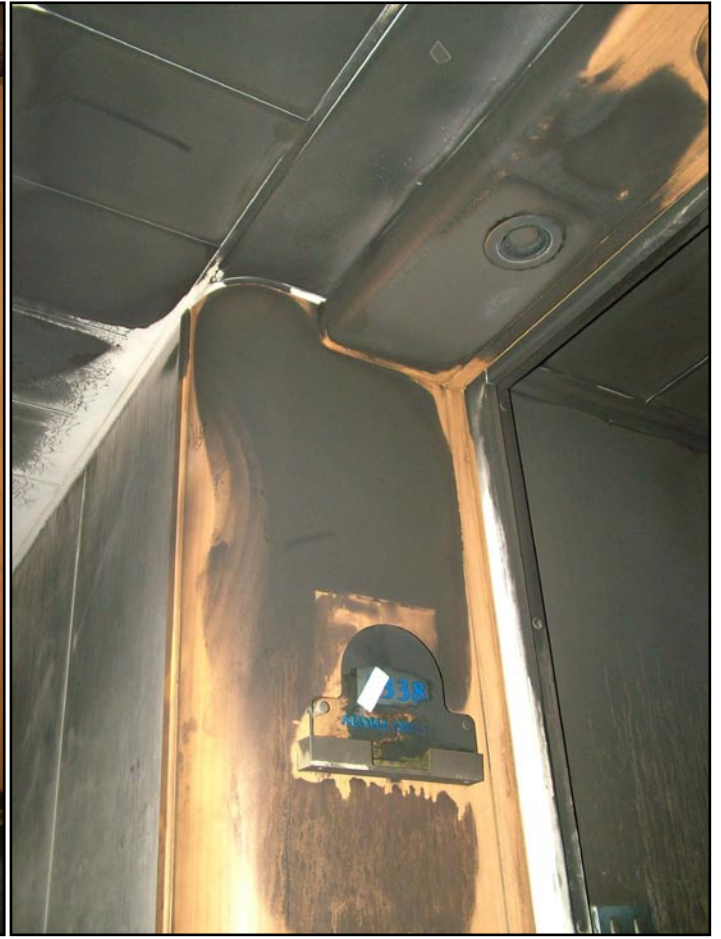
Figure 20

Door to A338

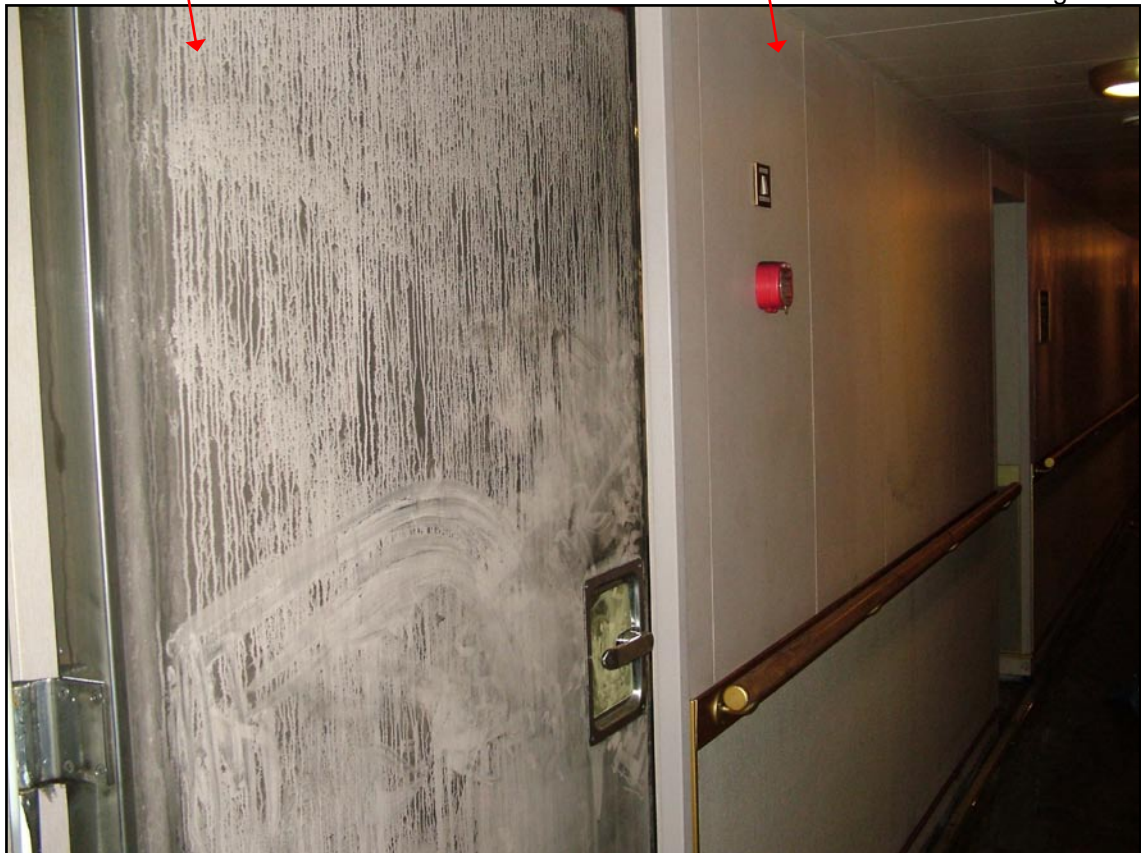
Figure 21

'A' class fire door between zones 3 and 4 on deck 12, port side
