Report on the investigation of  
the catastrophic failure of a windlass hydraulic motor  
on board  
***Stellar Voyager***  
off Tees Bay  
resulting in a major injury on  
23 March 2009

**Report No 25/2009**  
**December 2009**

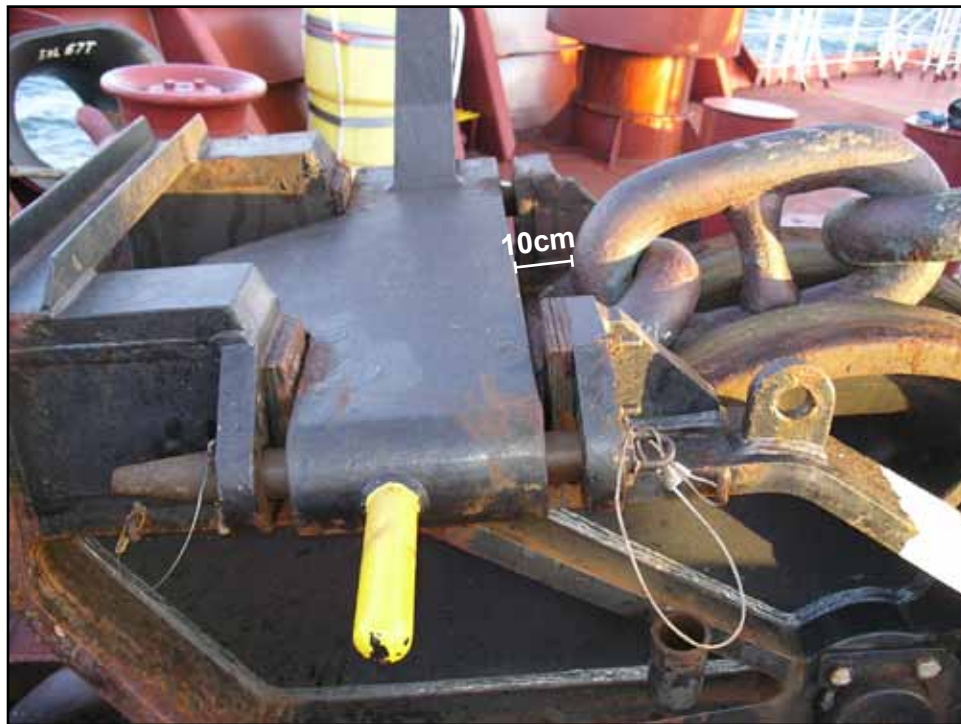
Figure 3

At 2230, the duty AB heard the chain cable suddenly tension on the windlass. On investigation, he found that the gap between the chain stopper and the link had closed, and immediately informed the bridge. The second officer checked that the vessel was not dragging her anchor and also alerted the master. The master arrived on the bridge at 2240 and ordered the duty AB to start the windlass hydraulic system; he also called anchor stations.

Gap between chain link and stopper

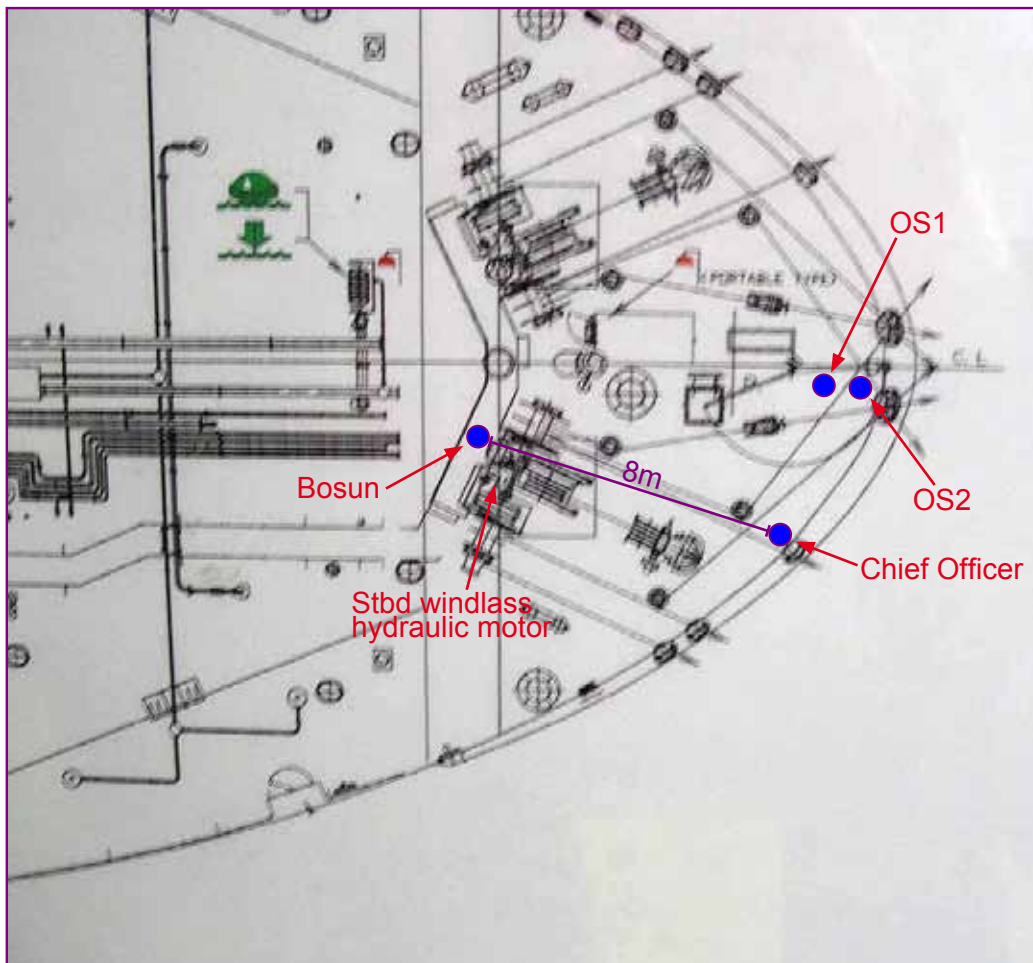
The chief officer soon joined the AB on the focsle, which was well lit, and told him to engage the windlass gear. The bosun and two ordinary seamen (OS) also arrived on the focsle. Communication between the master and the chief officer was via UHF radio but, because the master had difficulty hearing the chief officer due to the background noise caused by the wind, he often repeated what he had heard and asked the chief officer to confirm its accuracy. The positions of the anchor party on the focsle are shown in **Figure 3**.

Positions of crew members at the time of the accident

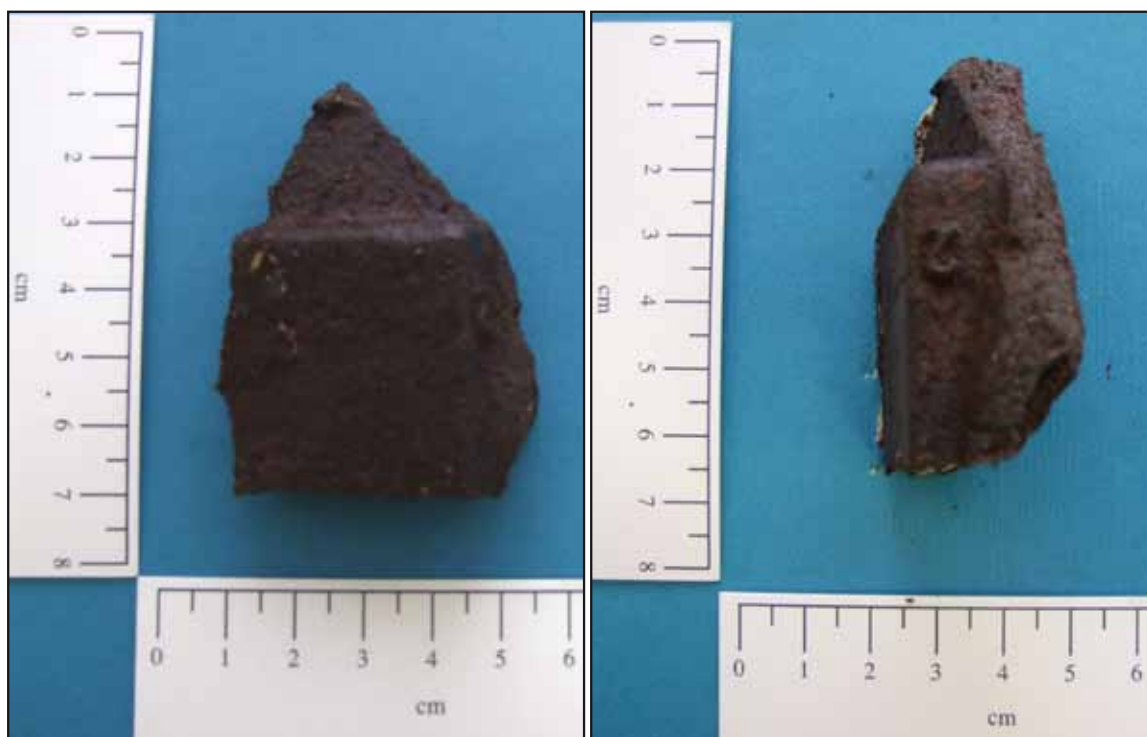
Fragments of the motor's cast iron casing were blown with considerable force away from the windlass, some of which struck and seriously injured the bosun, who immediately fell to the deck. One fragment (**Figure 4**) measuring 5.7cm x 4.4cm, with a maximum thickness of 1.8cm and weighing 148g, was found on the deck 40m aft of the windlass.

Fragment of hydraulic motor casing found 40m aft of the starboard windlass

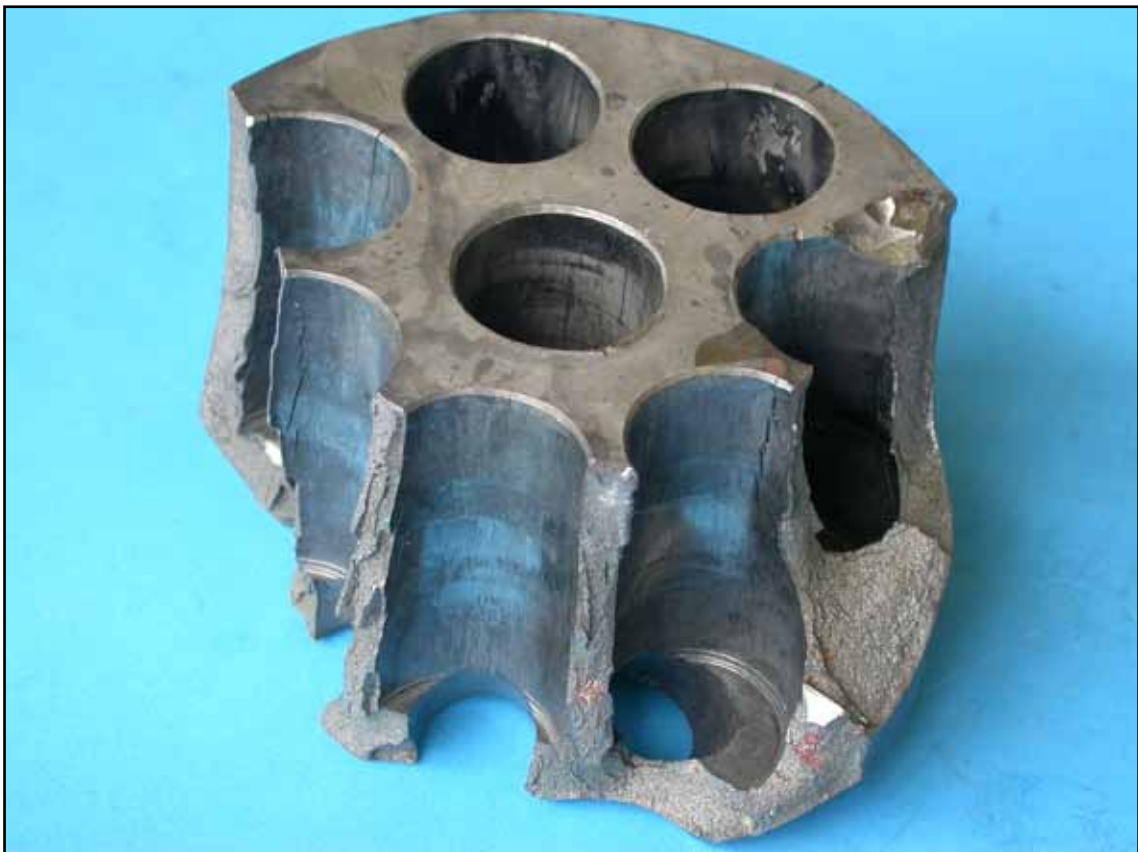
Figure 10

Preliminary onboard examination of the damaged hydraulic motor revealed very little evidence of torsional failure of its components. The majority of the damage was local to the hydraulic motor and its casing. The centre drive pin had sheared at its mid point where its bore increased substantially and, although three of the seven pistons were found intact, the remaining four were missing. The three pistons showed signs of hard contact between the ball heads and drive shaft, and the bodies of the pistons showed what appeared to be incipient service wear or spalling type damage (**Annex B, Figure 42**). Of the seven bores in the cylinder block, five adjacent bores had disintegrated (**Figure 10**). Except for the damage to the first roller bearing on the motor output shaft, a seized drive gear on the planetary gear train and overheating of the disc brake plates, no other damage was observed beyond the hydraulic motor.

Cylinder block

The laboratory tests did not find any evidence of manufacturing or metallurgical defects including pre-incident fatigue cracks. The failed cylinder block appeared to have experienced brittle fracture along the longitudinal axis of the cylinder bores, and there was very little evidence of plastic deformation of the material, although the cylinder block was constructed of *engineering type steel that had entered service in a normalised type condition.*

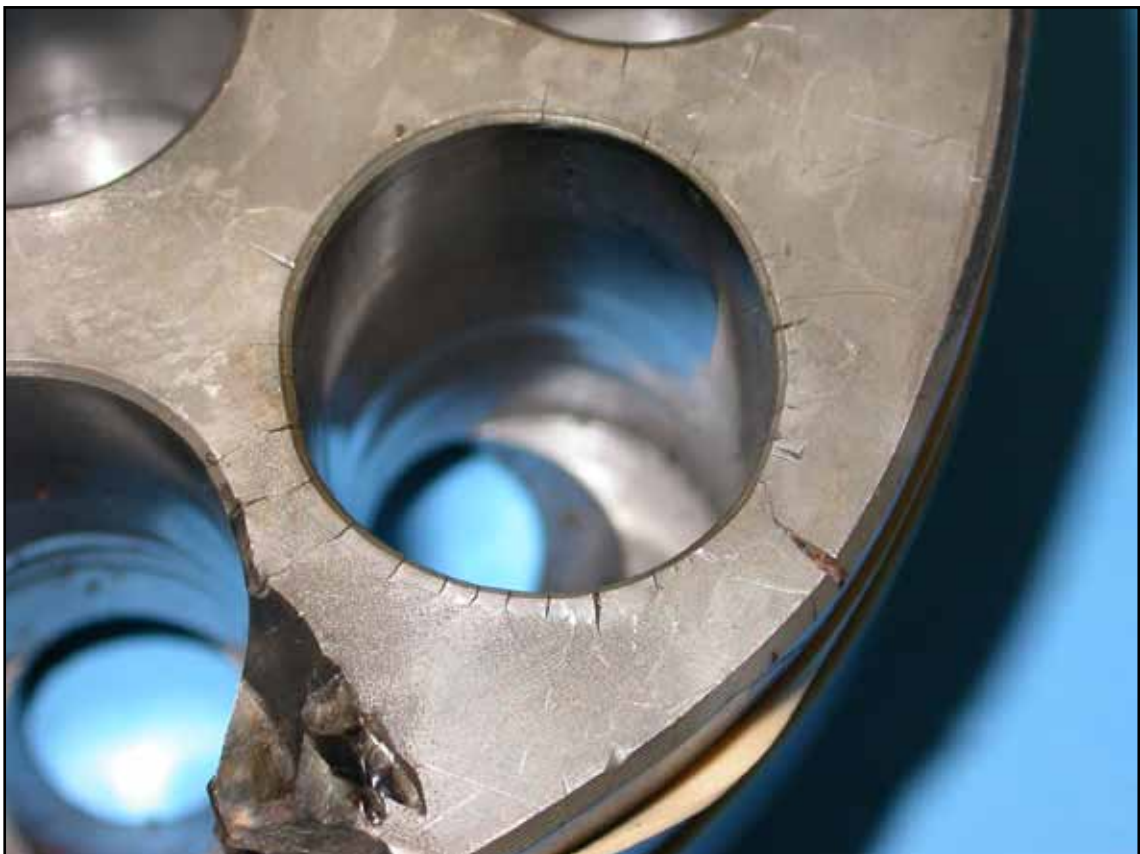
Figure 11

The findings of the metallurgy tests (paragraph 1.6.3 and **Annex B**) conclude that the explosion of the windlass hydraulic motor was the result of the brittle fracture of the motor cylinder caused by its over-pressurisation. As the results of the tensile test carried out on an undamaged section of the cylinder block ruled out material degradation leading to embrittlement, the load applied to the cylinder block must have been so rapid that the steel reached its yield point without plastic deformation, eventually surpassing its UTS and leading to fracture. The almost instantaneous nature of the fracture, the failure of the cylinder block along its longitudinal axis, and the secondary cracking on the cylinder bores (**Figure 11**) indicates that the cylinder block was subject to a very high hoop stress caused by the rapid and uncontrolled rise of pressure in the system. This is further supported by the predominant damage to one side of the cylinder (**Figure 12**), which was most likely to have been the pressurised side.

Secondary cracks on a cylinder bore

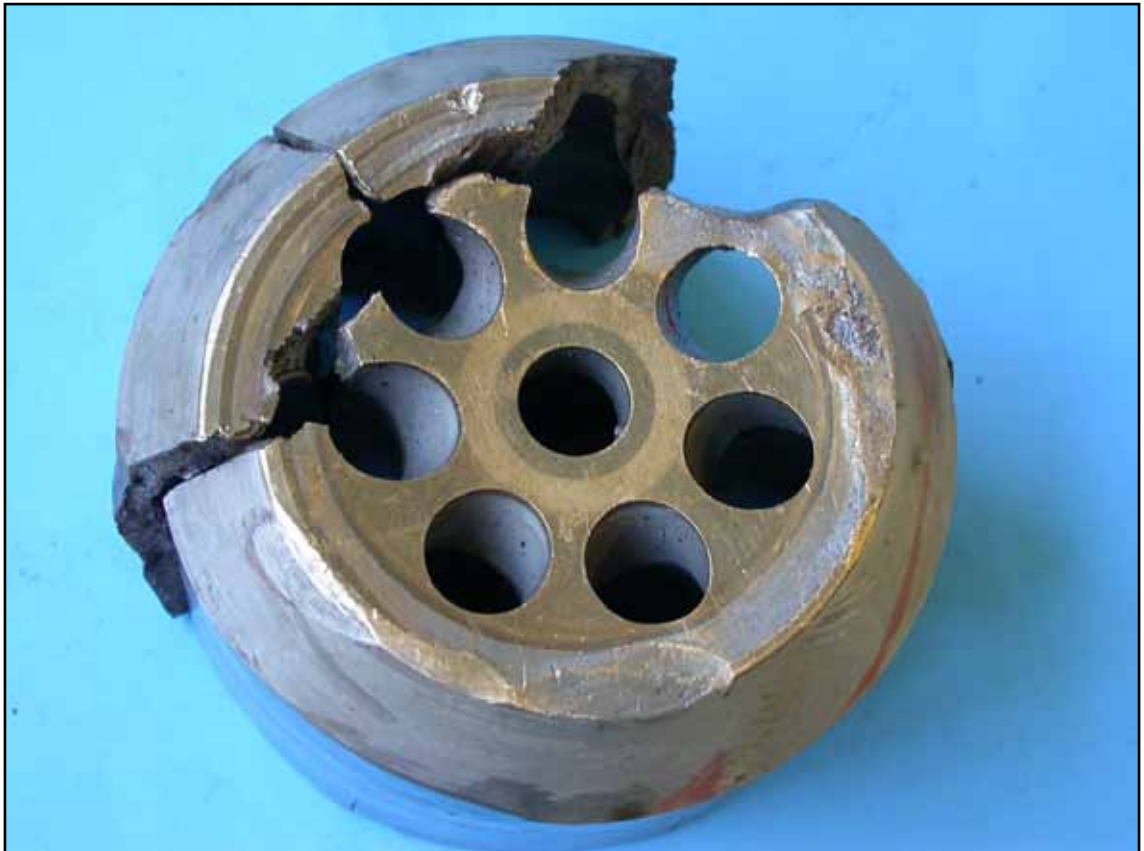
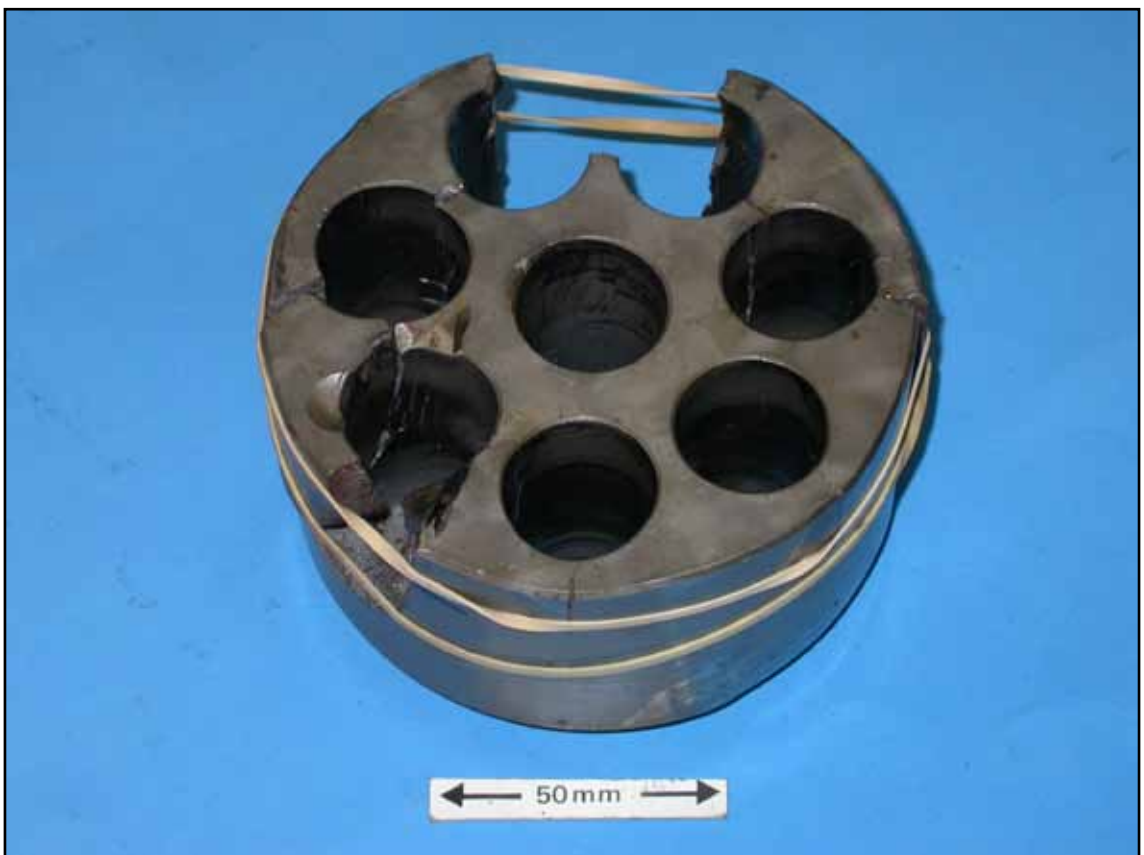
Predominant damage on one side of the cylinder housing

The over-pressurisation of the motor was possibly due to the ineffectiveness of the pressure relief valve. As the cable rendered, the flow of oil into the heaving line resulting from the motor turning in the opposite direction to that intended would have caused the motor to act as a positive displacement pump. With the operating lever set to maximum displacement, the position of the lens plate would have caused the pumping action to deliver the maximum throughput possible. Consequently, the pressure developed must have exceeded the 245 bars produced by the power pack, otherwise the motor would have stopped turning.

As the relief valve was only capable of relieving instantaneous peaks of pressure, it would not have been capable of handling the rapid and continuous pressure rise in the system which became a closed loop when the motor reversed. Together with the severely constricted pipes on the outlet side of the relief valve, which would have further hampered the flow of oil, and continuous supply of fresh oil through the replenishment circuit, this would have led to a very rapid rise of pressure in the motor, sufficient to cause its catastrophic failure.
