Report on the investigation of
the engine room fire on board
the passenger cruise vessel

The Calypso

6 May 2006

**Report No 8/2007
April 2007**

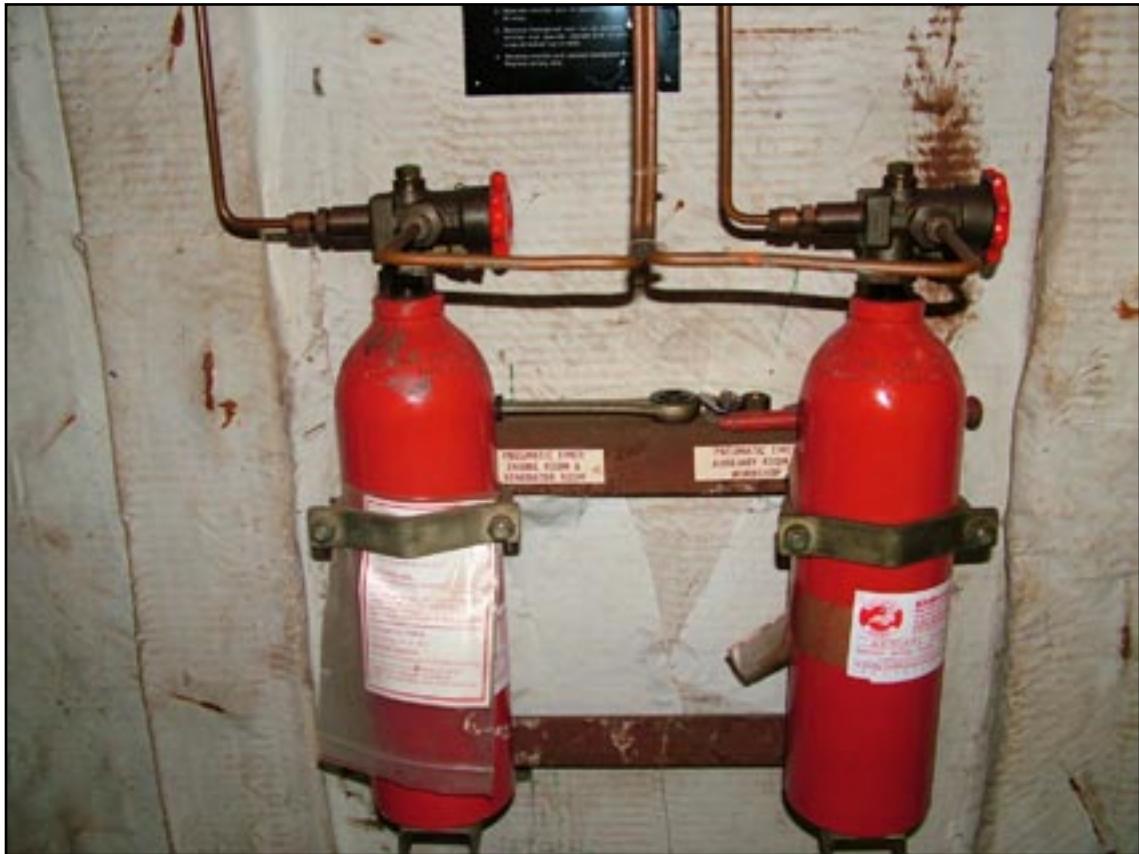
Figure 4

The chief electrician opened the valves on two small bottles on the aft bulkhead, which he believed were the pilot cylinders (**Figure 4**). He then operated the control levers for the engine and boiler room gas supply lines (**Figure 5**), as directed by the posted instructions, and manually opened the distribution valves to the engine room and boiler room (**Figure 6a/6b**). He left the CO₂ room within a few minutes and informed the chief engineer that the CO₂ system had been operated. At 0350, the safety officer contacted the bridge and confirmed that the CO₂ had been released. At about this time, an electrical blackout occurred and the emergency diesel generator started.

Timer cylinders

Below the control levers were two red pneumatic timer bottles linked to the control switches through small bore copper pipes. Timer devices are used to delay the opening of main or distributing valves until a short period after the CO₂ alarm has sounded. This is a common method of meeting the SOLAS requirement to provide a delay between the CO₂ release alarm and the release of the extinguishing medium (**Figure 4**).

In most circumstances, the timer bottles need not be touched, their operation being completely automatic. The timer bottles each have a capacity of 2.68 litres and work on a pressure differential between the inlet pressure and that achieved within the bottle. When the ratio between the two exceeds 1:0.66, a spring-loaded piston within the valve handle opens the bottle outlet valve, allowing the operating gas to pass through, and open the distribution valve to the space. A calibrated nozzle in the time delay valve could be changed to provide varying time delays between either 20 – 30 seconds or 60 – 90 seconds. If the delay valve failed to operate, or a shorter delay was required, the valve handle on the top of the bottle could be opened and the timer bypassed. The timers on *The Calypso* were set for a 90 second delay. The wooden support brackets for the bottles were labelled, however the stickers for attachment to the bottles were still in plastic wallets cable tied to the bottles.

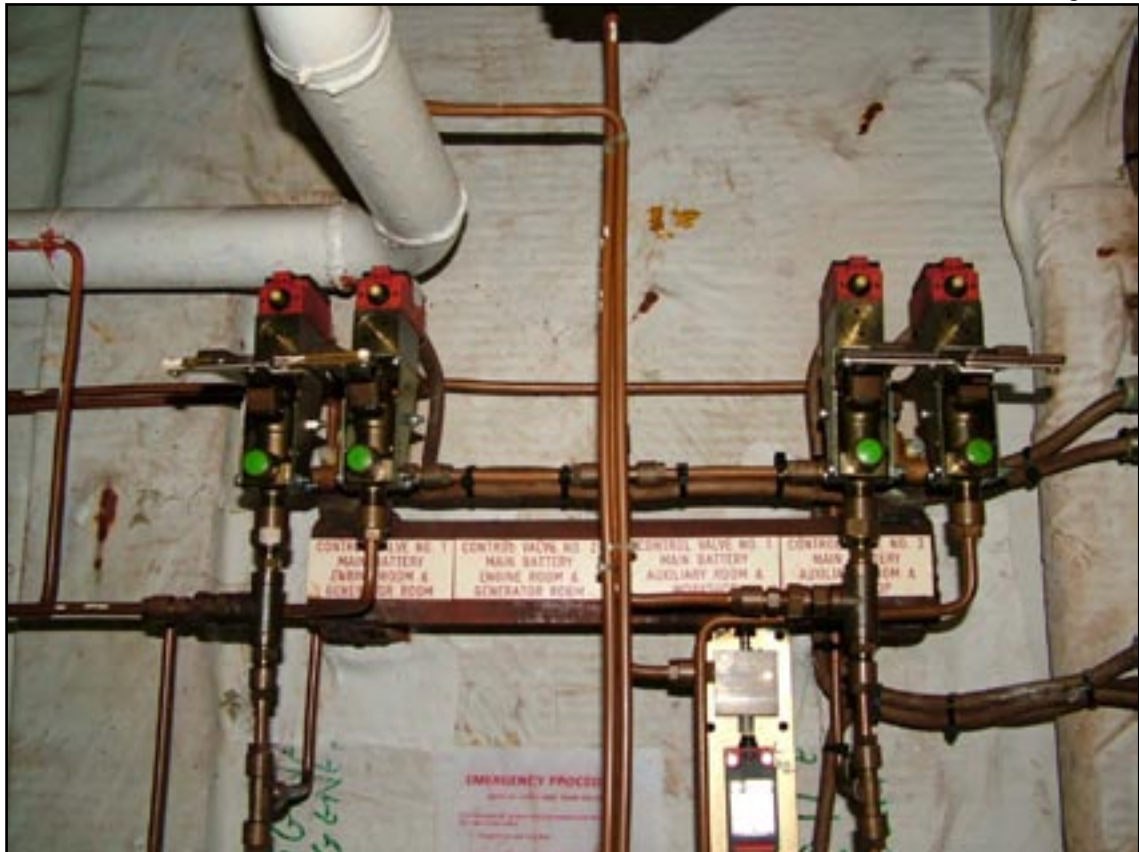
Figure 5

Control levers - in released condition

On the aft bulkhead of the CO₂ room were the manual/pneumatically operated levers for the release of the CO₂ from the bank cylinders into the manifold and for the operation of the relevant distribution valve. In manual mode, these levers (two per protected space) were pulled down to allow the pilot CO₂ from the manually operated pilot cylinders, to pass through internal orifices in the switch body and external small bore copper pipework to charge the system. The pilot gas also operated electrical switches for the CO₂ alarms and for ventilation shutdown of the protected space. In pneumatic mode, the pull down levers were automatically pushed open by small pistons behind each switch, pressurised by CO₂ gas from the remote pilot cylinders. Labels identified the levers (**Figure 5**).

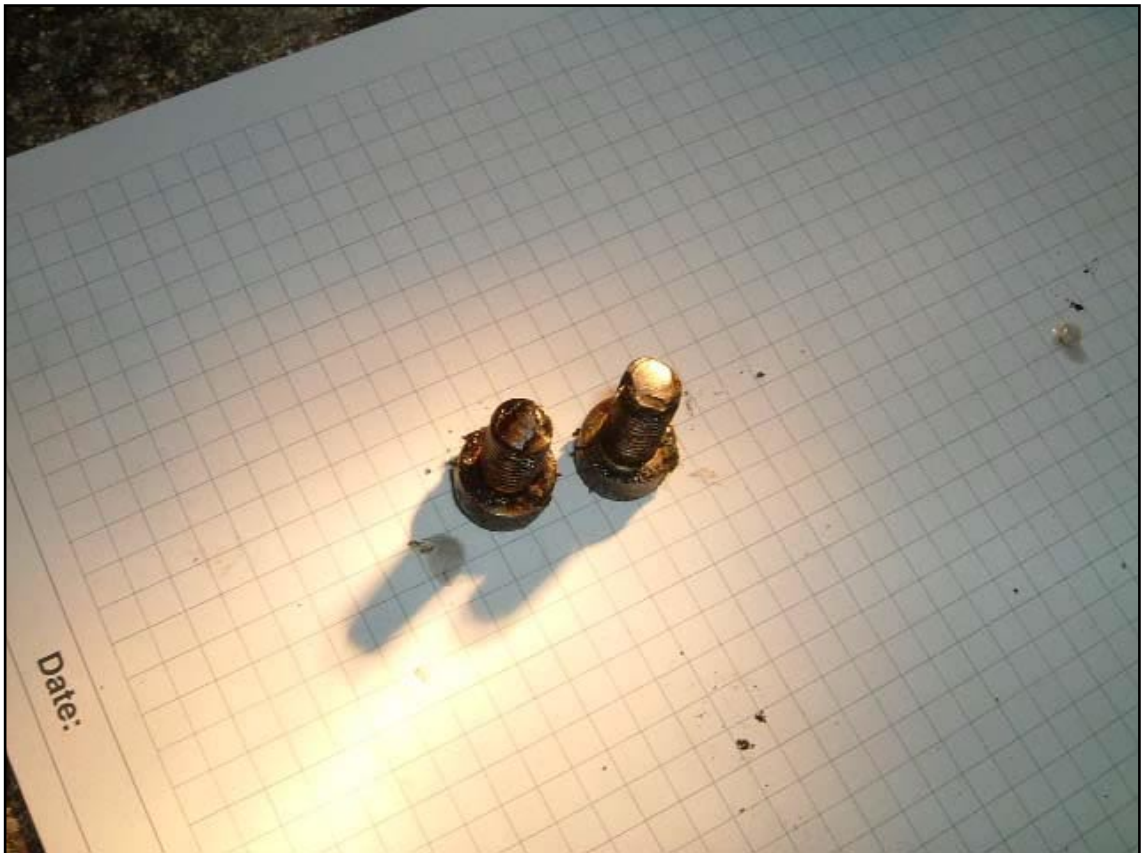
Figure 22

The flanges had separated because the two, 10mm, socket headed flange bolts had failed. Their failure allowed the flanges to separate slightly, thus causing the "O" ring seal to become dislodged and fuel, at a pressure of up to 10 bar, to spray through the gap in the flanges (**Figures 22, 23a/23b**).

A qualified metallurgist carried out a preliminary metallurgical analysis of the failed 10mm socket headed flange bolts. Both bolts were marked as 8.8 indicating the grade of steel used in their manufacture. This was the required grade specified by Wartsila in their operating manual.

The analysis indicated that the fracture surfaces were very fine and difficult to resolve using stereo-optical microscopy. Nevertheless, one bolt showed some evidence of failure by fatigue. No evidence was found of over-tightening and the conclusion was, therefore, that they failed due to fatigue.

Fatigue is a long term metallurgical process which results in the development of a crack under oscillating loads, although the ultimate failure is likely to be sudden. The precise initiation of the fatigue failure was not identified during the analysis but can arise from a number of potential origins, such as localised material defects, manufacturing defects, localised areas of damage, normal engine vibration or pressure pulses from the fuel injection pumps.

Failed bolts

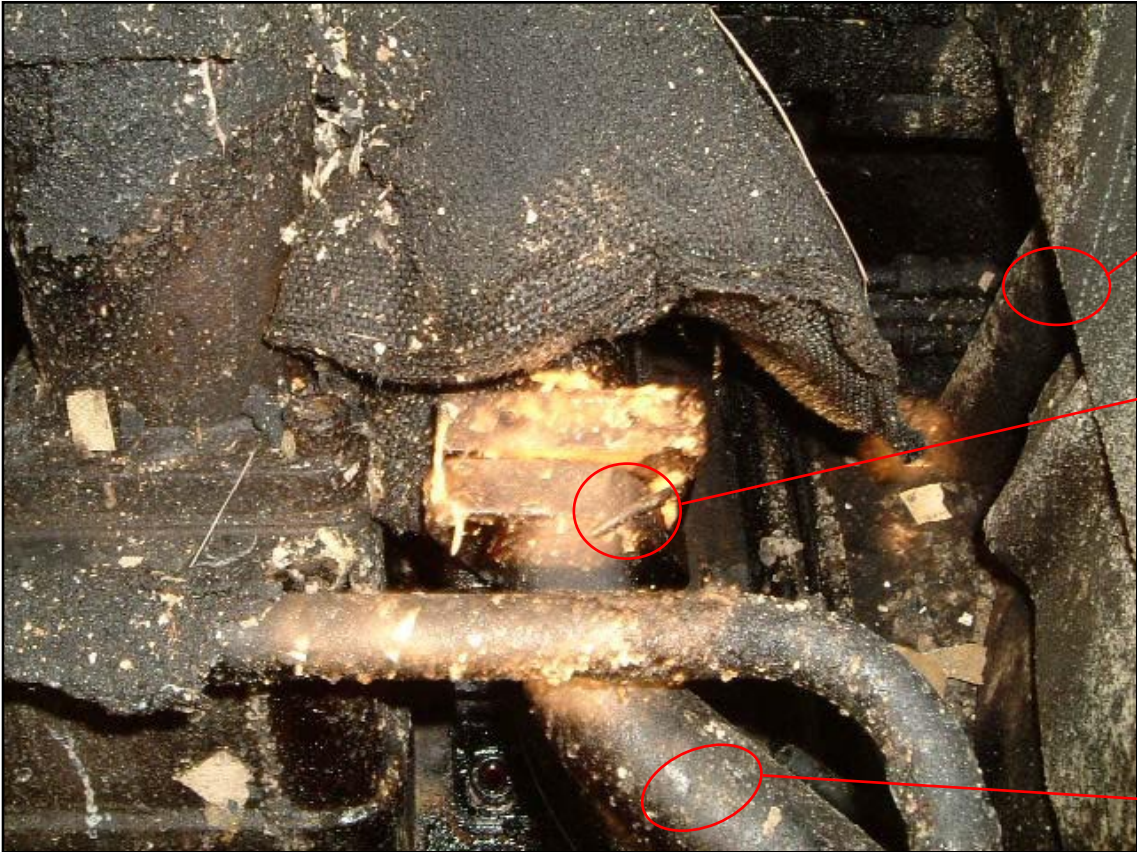
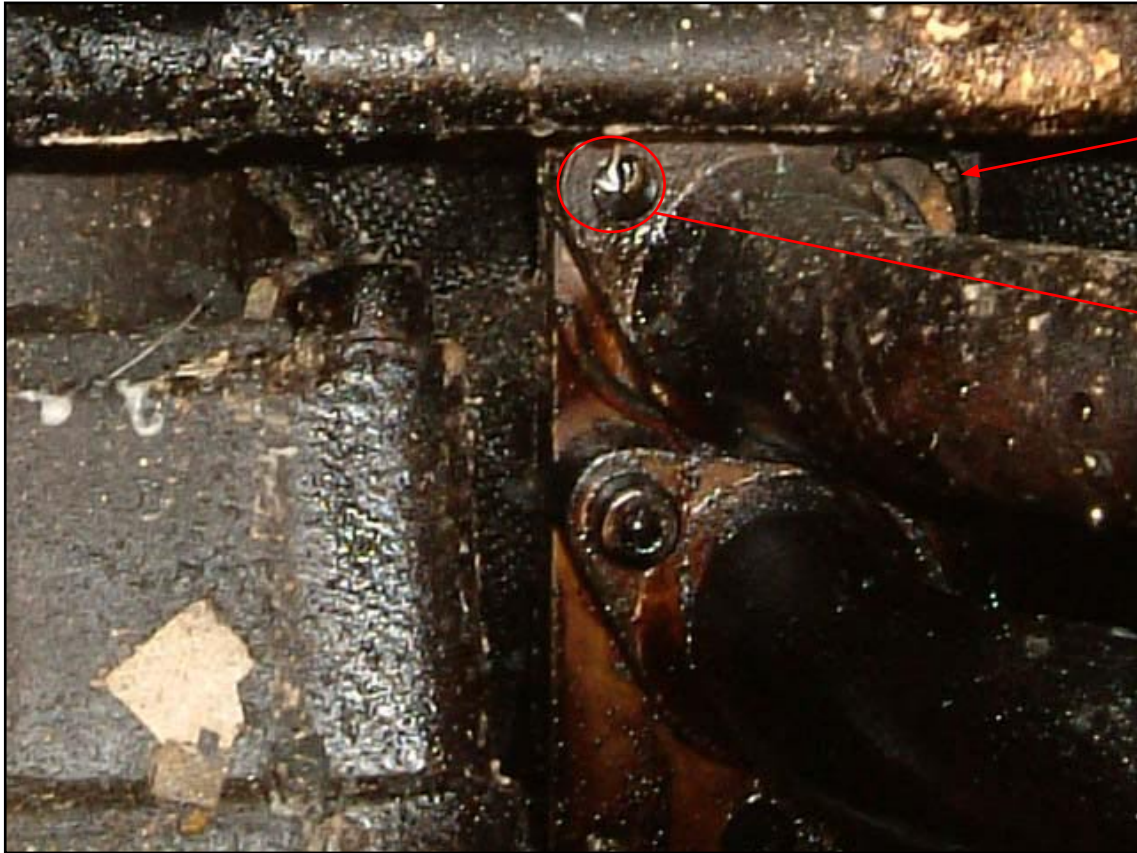
Figure 23a and b

After the fire, an inspection of the starboard main engine quickly established that the cause of the fire was due to a loose flange connection on the LP fuel return line from the inboard cylinder bank.

Fuel pipe flange and "O" ring seal

The Wartsila technical bulletins 3217T011Gb and 3217T044GB(01) (see Sections 1.10 and 2.8 and **Annex 4**) provided relevant comprehensive advice including the replacement of two bolt flanges with four bolt flanges and other modifications aimed at dampening pressure pulses and vibrations in the fuel supply system. The recommended modifications had not been carried on *The Calypso*.

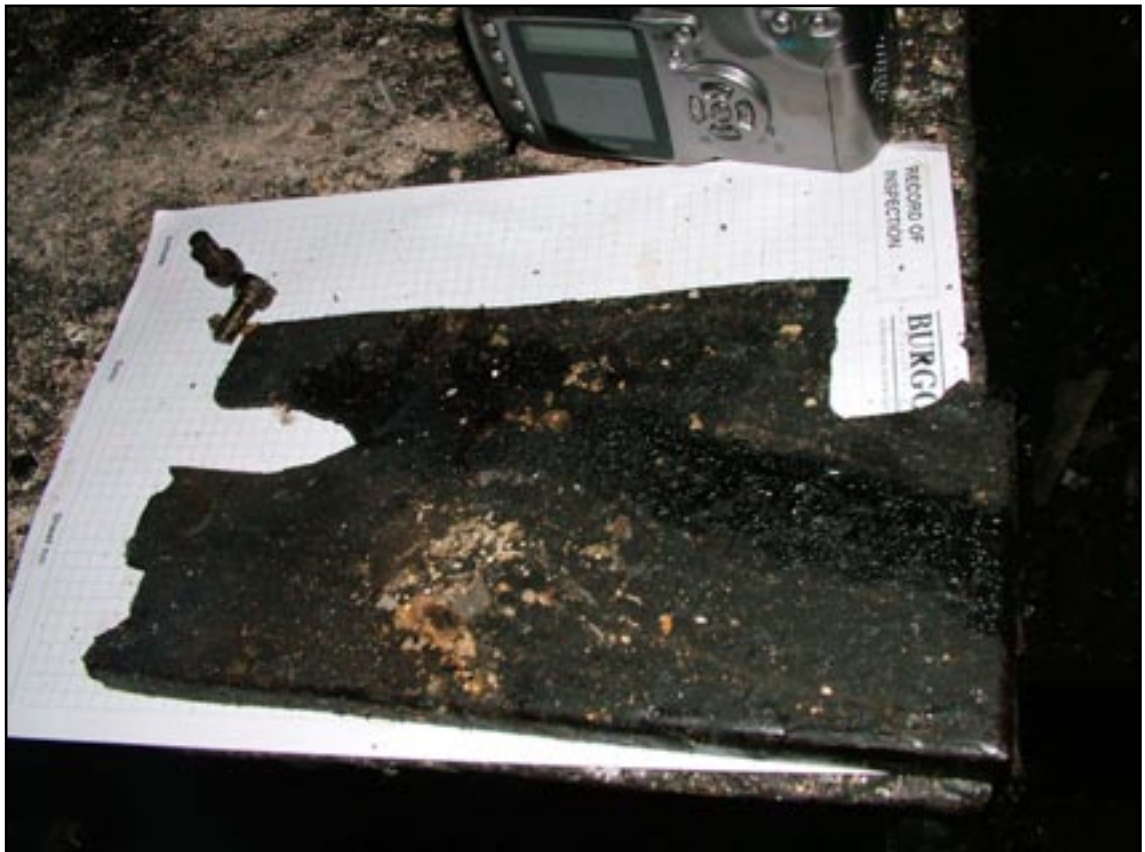
Figure 24

A sprayguard, above the failed flange had, at some time previously, been modified so that it was no longer able to be retained securely in position. The guard was intended to meet SOLAS requirements to prevent fuel from coming into contact with hot surfaces. The sprayguard was found a short distance away from the failed flange. However, it is not known whether the cover had become dislodged before, during or after the fire (when water from the fire-fighting might have dislodged it). It is considered probable that, even if it had been resting in position, it would have been ineffective in preventing fuel, under pressure, from spraying beyond the cover (**Figure 24**).

It is concluded that a combination of factors, primarily the fatigue failure of the securing bolts on an LP fuel pipe flange and including a poorly fitting or loose sprayguard and the close proximity of hot spots to cause ignition, caused the fire. If the advice contained within the Wartsila technical bulletins had been followed, it is likely that this fire would have been avoided.

Spray guard

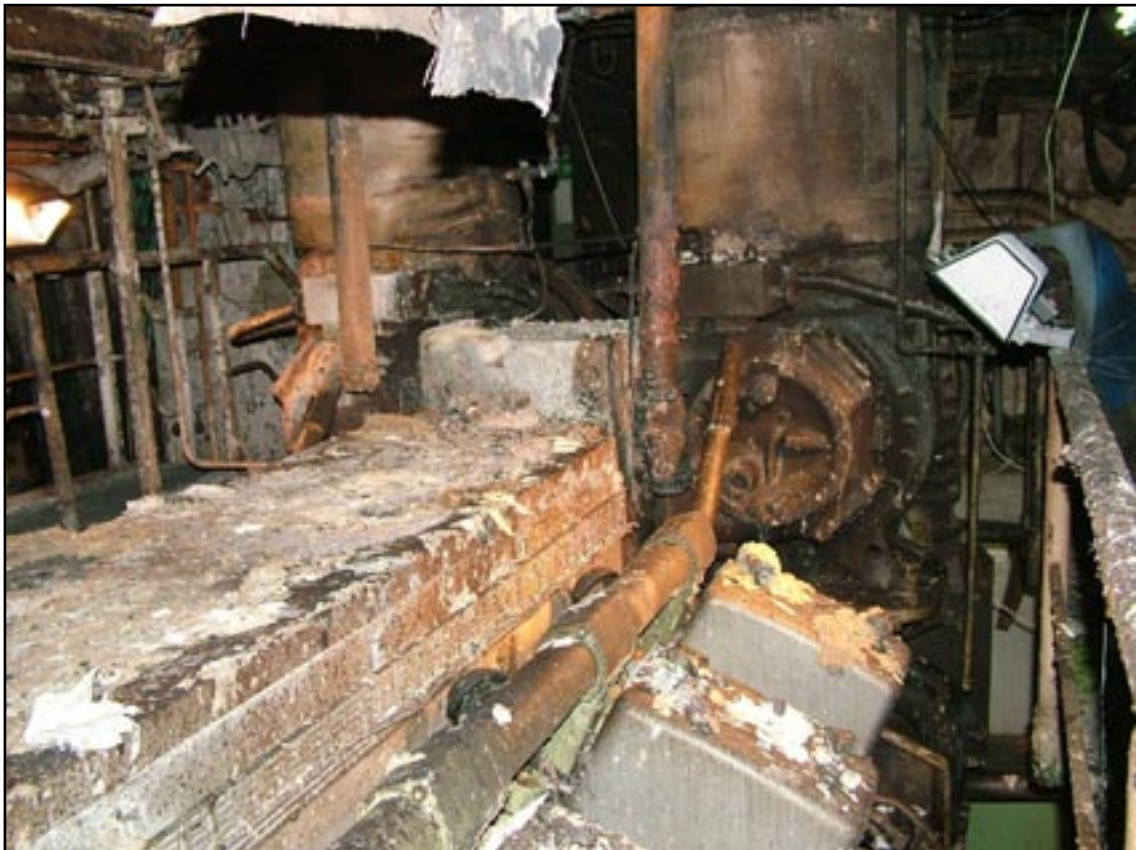
Figure 25

Fire damaged turbo chargers

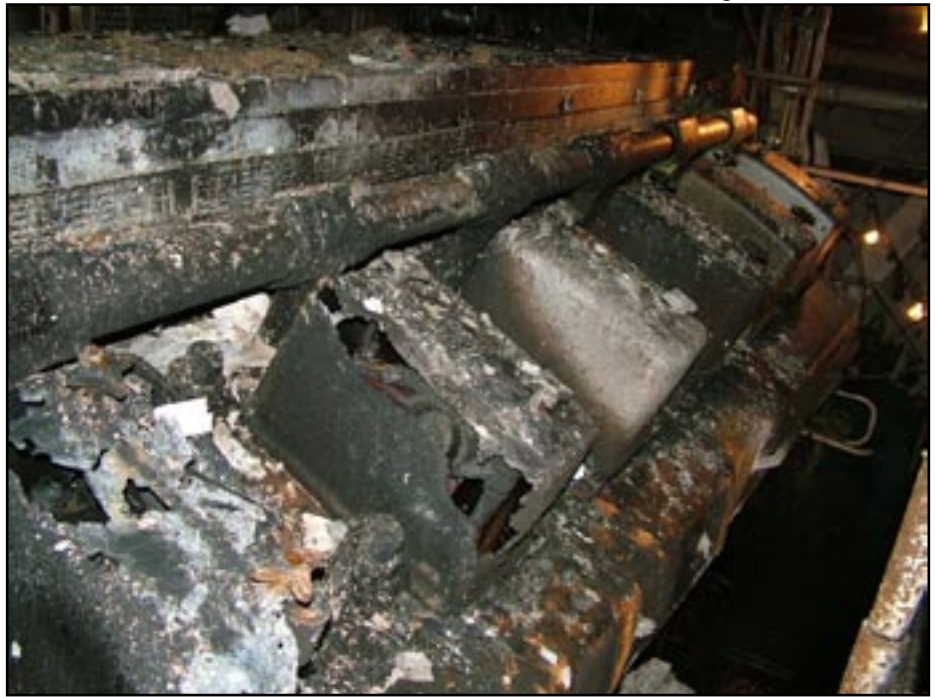
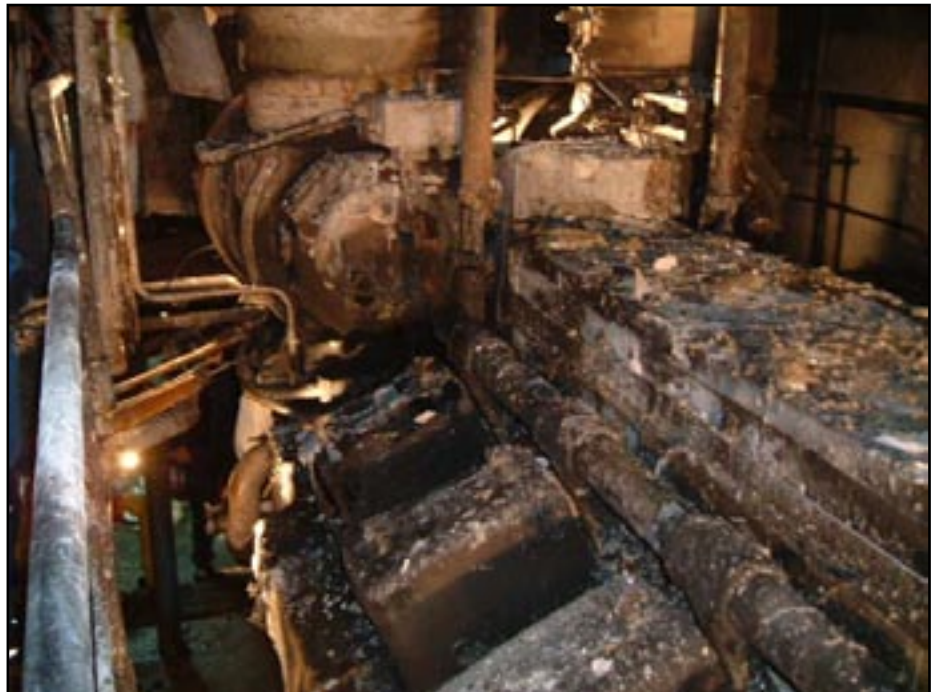
Damaged rocker covers, camshaft and crankcase doors

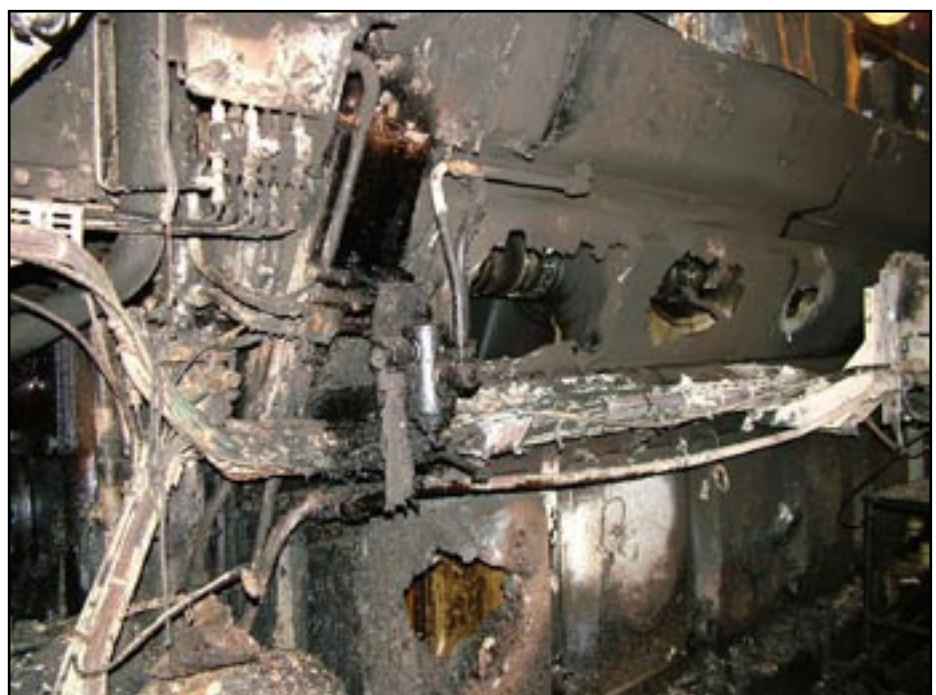
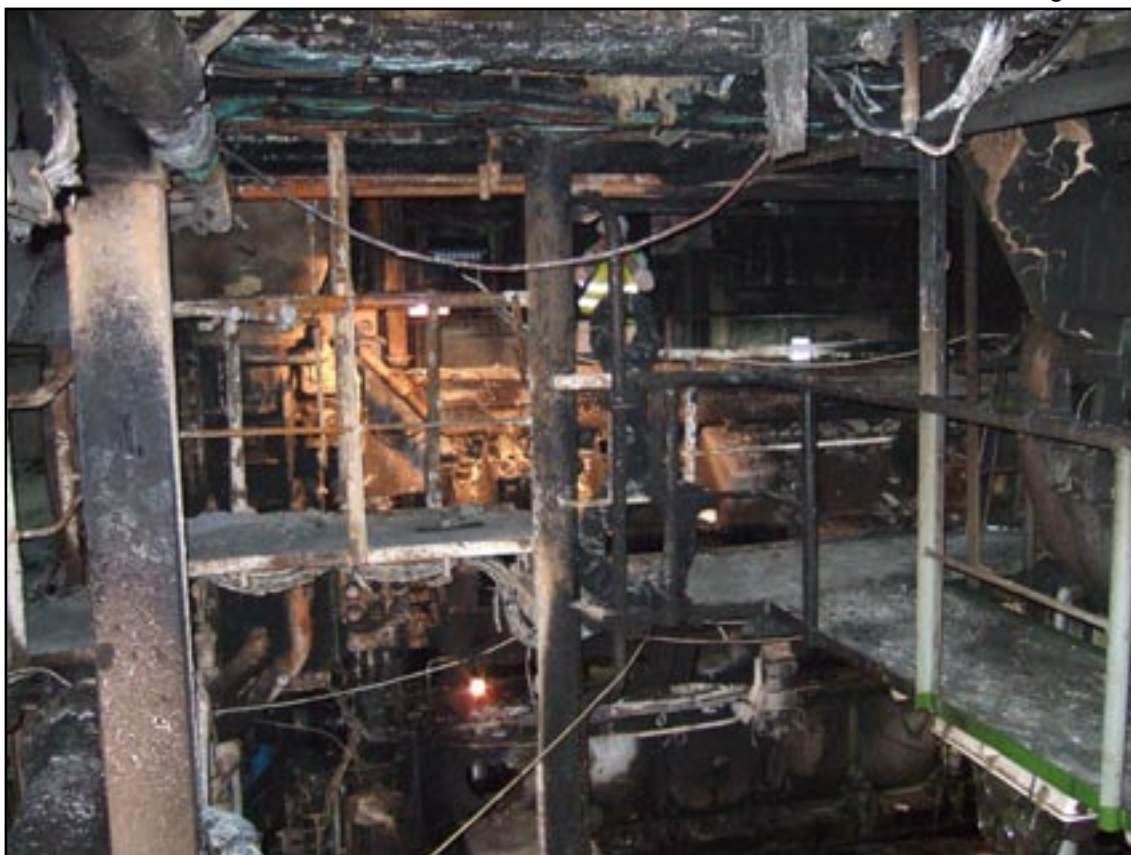
Damaged upper areas
