Report on the investigation of
the fatal accident to person on board

Thomson Celebration

Tender 15

**Report No 11/2007
June 2007**

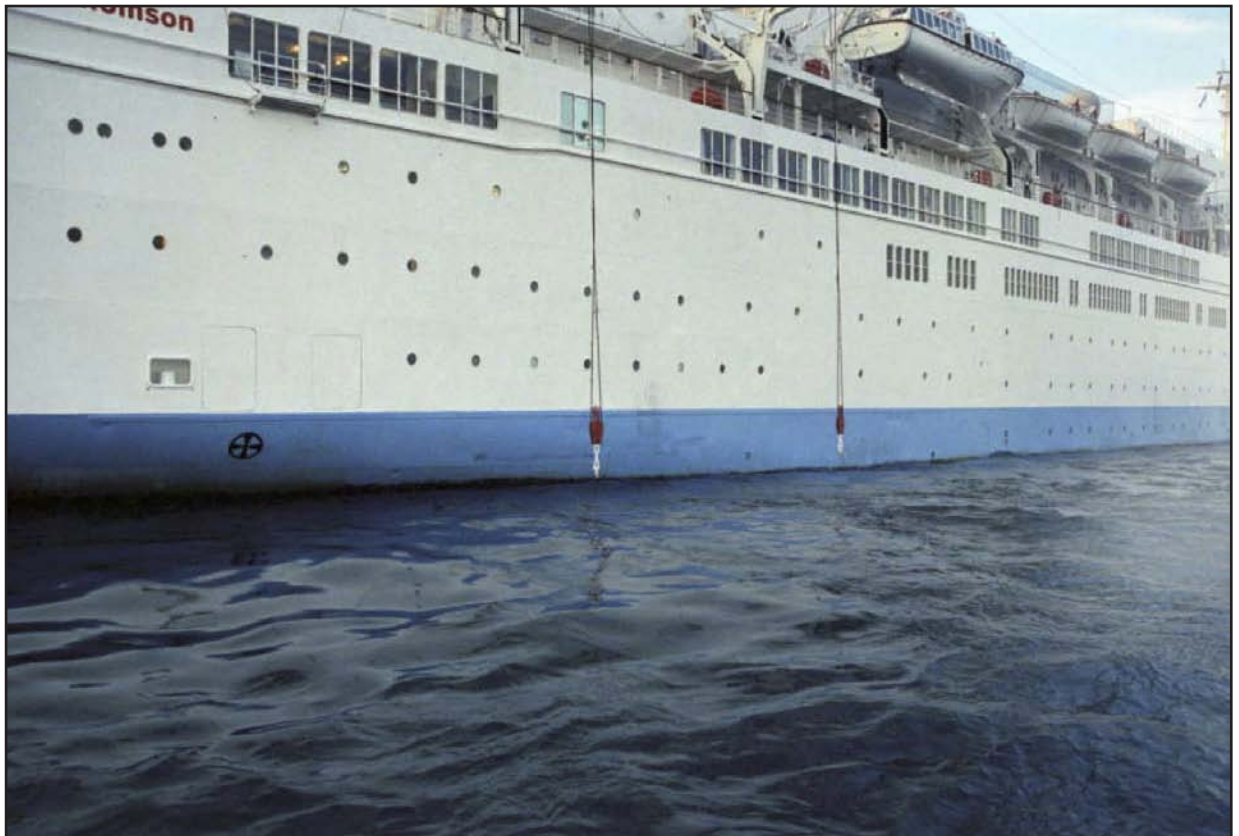
Figure 3

Tender operations commenced soon after *Thomson Celebration* had been anchored. Three of the vessel's four tenders were launched and then used to transport the passengers. The fourth tender was out of service with a mechanical fault on one of its two engines. After the tenders were clear of the ship's side, the davit fall blocks were left hanging close to the water (**Figure 3**).

Davit fall blocks

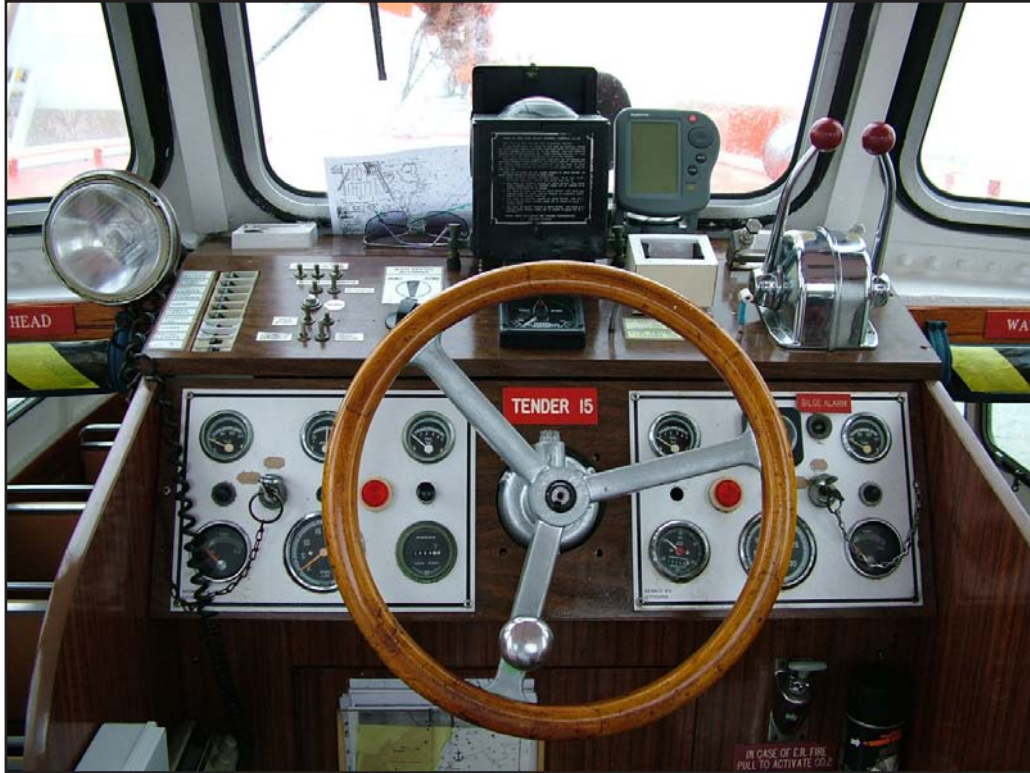
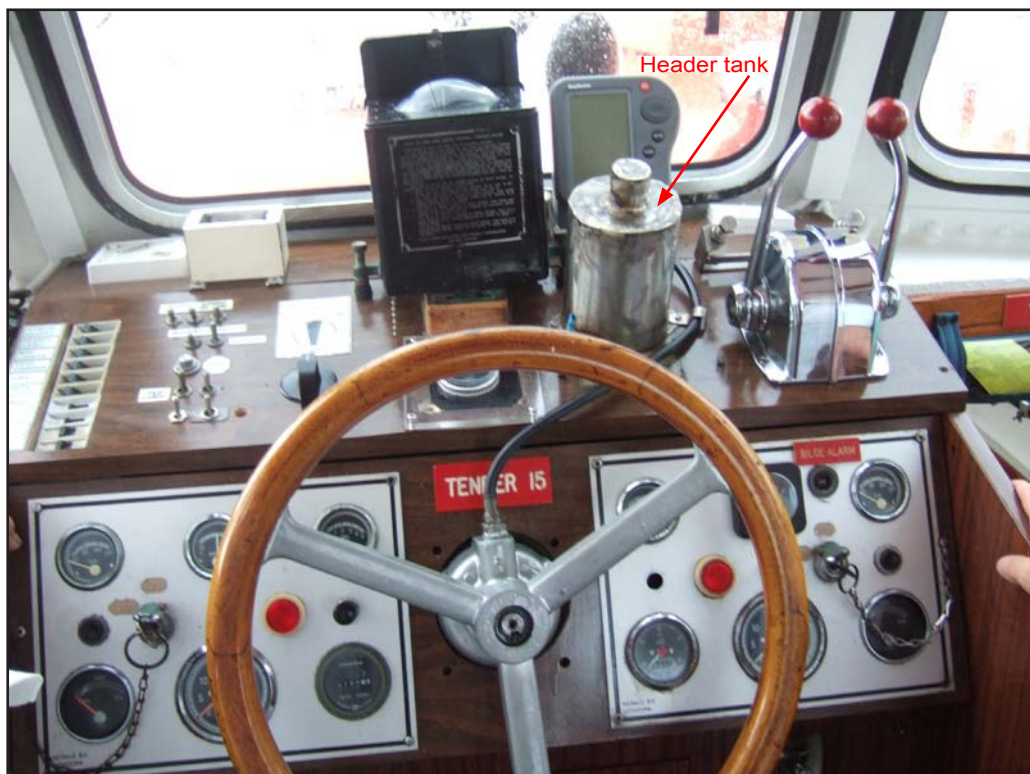
Figures 7 and 8

Tender 15 remained in operation with an oil leak from the steering system that caused progressively poorer rudder response. Before the accident, the steering was reported to be 'loose' and required an excessive amount of turns for the rudder to respond. This was noted at the coxswain's handover, as was the fact that the rudder indicator was inoperative. The accepted procedure to inform *Thomson Celebration's* bridge of any mechanical problems affecting the passenger tenders when in service, was not followed, and the bridge was therefore unaware of these problems.

loss of oil from the *Tender 15* steering system. His records indicate that the initial fault finding traced the leak to a drain plug. After the accident, the piping system was fully

inspected and the leak was found to be at a weld. The size of the weld fracture had probably increased over time, leading to more oil loss and leading to the need for more frequent topping up of the system.

After the accident, the fitter developed his own solution to the oil loss by manufacturing and fitting a header tank in the tender wheelhouse. The officer responsible for the maintenance of the tenders was unaware of this modification (**Figures 7 and 8**).

Controls, Tender 15

Controls, Tender 15 - with oil header tank fitted

- 2007/152 **Lloyd's Register of Shipping** is recommended to:
Propose and develop within IACS agreed standards for the issuing of lifeboat/passenger tender certificates.
- 2007/153 **The Maritime and Coastguard Agency (MCA)** is recommended to:
Recognising the need for additional training, to achieve a level of competence appropriate to operating large capacity passenger tenders, develop and take forward to IMO, through the most appropriate channels, competency requirements for passenger ship tender coxswains and crew.
- 2007/154 **Columbia Ship Management Ltd** is recommended to:
Put in place and enforce procedures that will prevent unauthorised maintenance being carried out on passenger tenders.

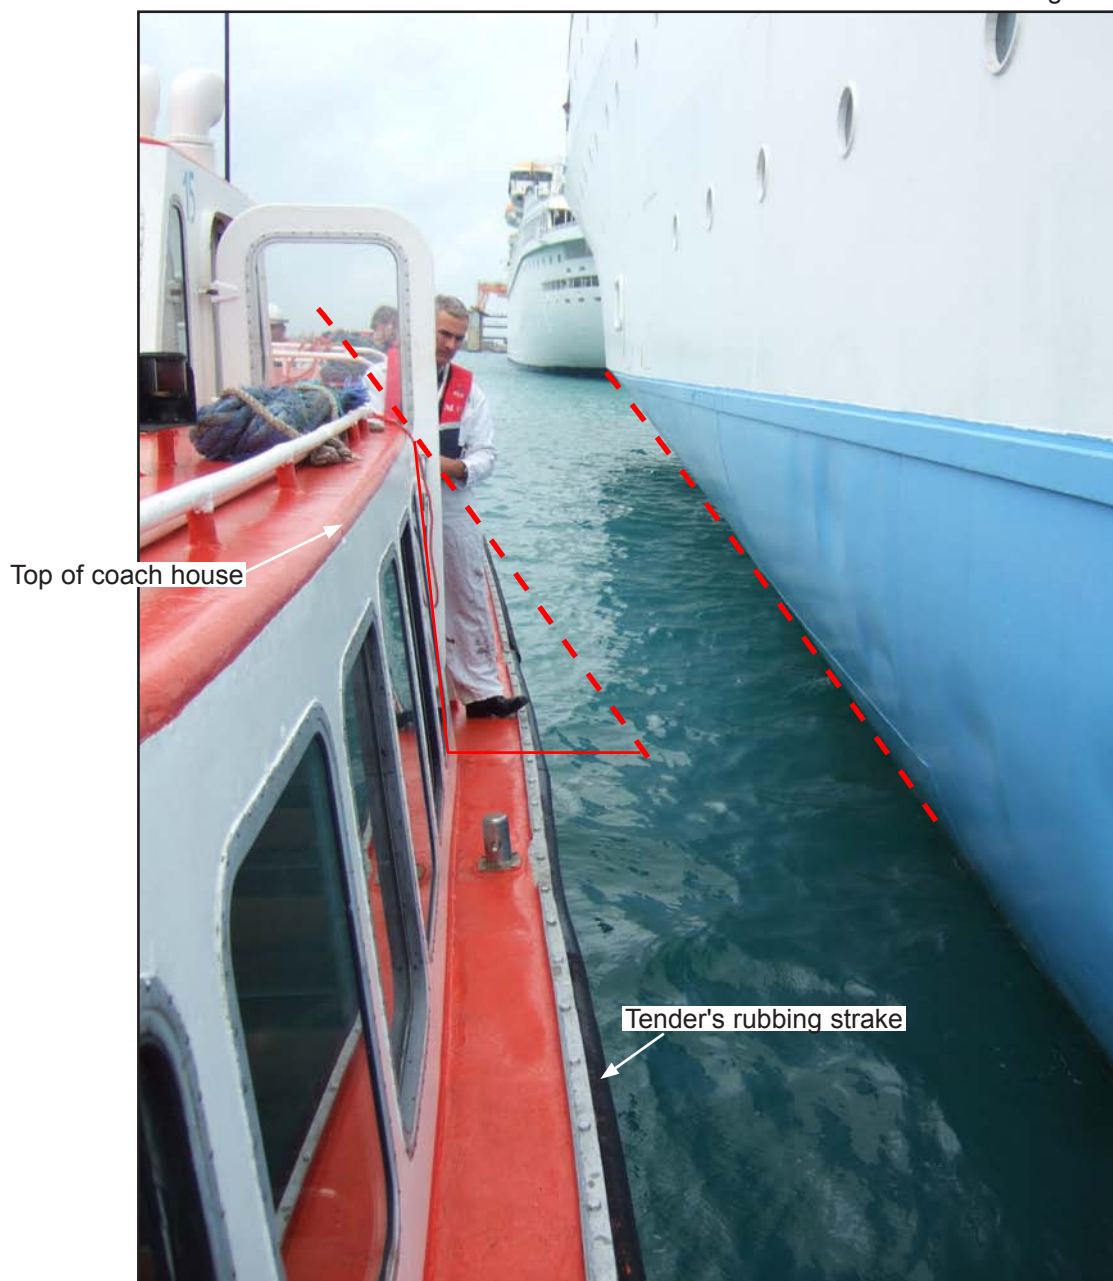
Figure 9

If *Tender 15* had been located further forward, where there was no curvature of the hull at the waterline, it is probable that the accident would not have occurred. Given the frequent use made of passenger tenders on *Thomson Celebration*, manoeuvring of the boats to the falls during recovery operations would be significantly easier in such a position, especially in tidal conditions.

Photograph showing the curve of the ship's side at the position of the accident (dotted parallel lines indicate the coach house will strike the vessel's hull before the tender's rubbing strake)

- Given the frequent use made of passenger tenders on *Thomson Celebration*, manoeuvring of the boats to the falls during recovery operations would be significantly easier for the coxswains of the passenger tenders, especially in tidal conditions, if *Tender 15* had been located further forward. At this location there was no curvature of the hull at the waterline, and it is probable the accident would not have occurred. [2.7]
