Report on the investigation of the grounding of

mv Thunder

at the approaches to the Dee Estuary

**Report No 12/2007
June 2007**

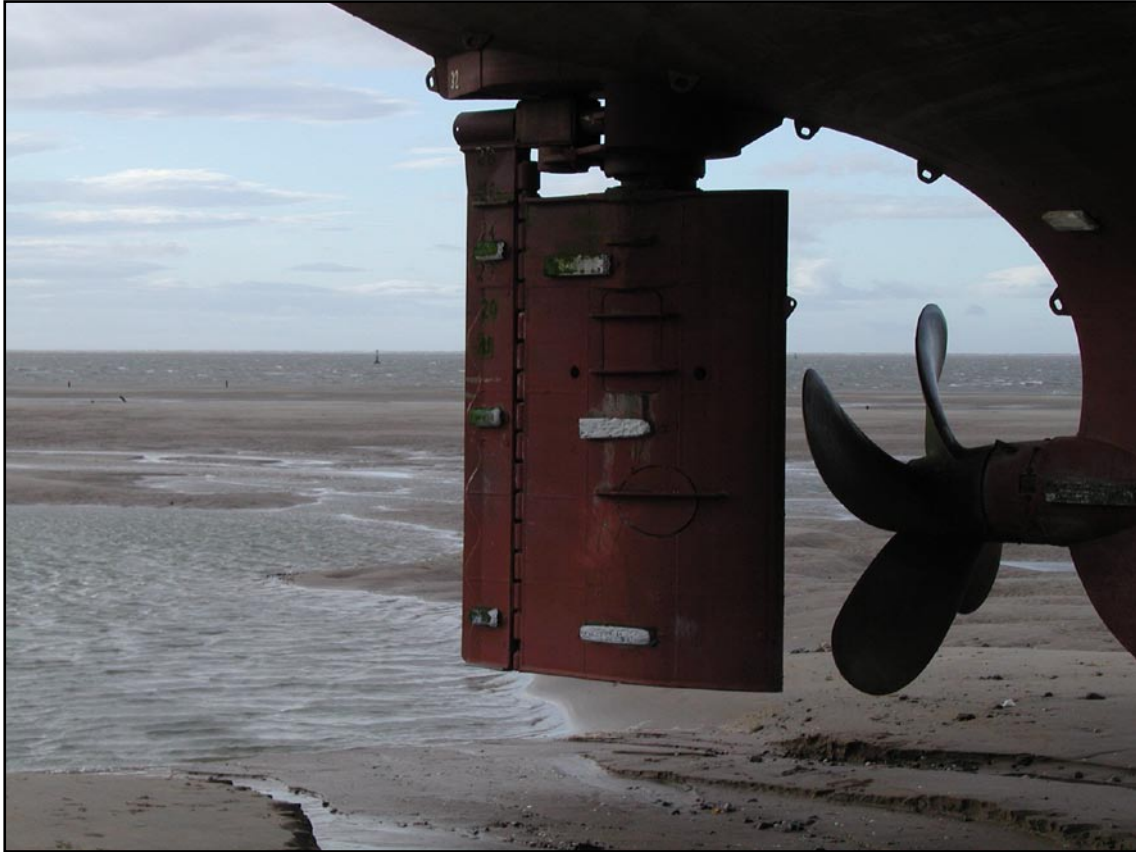
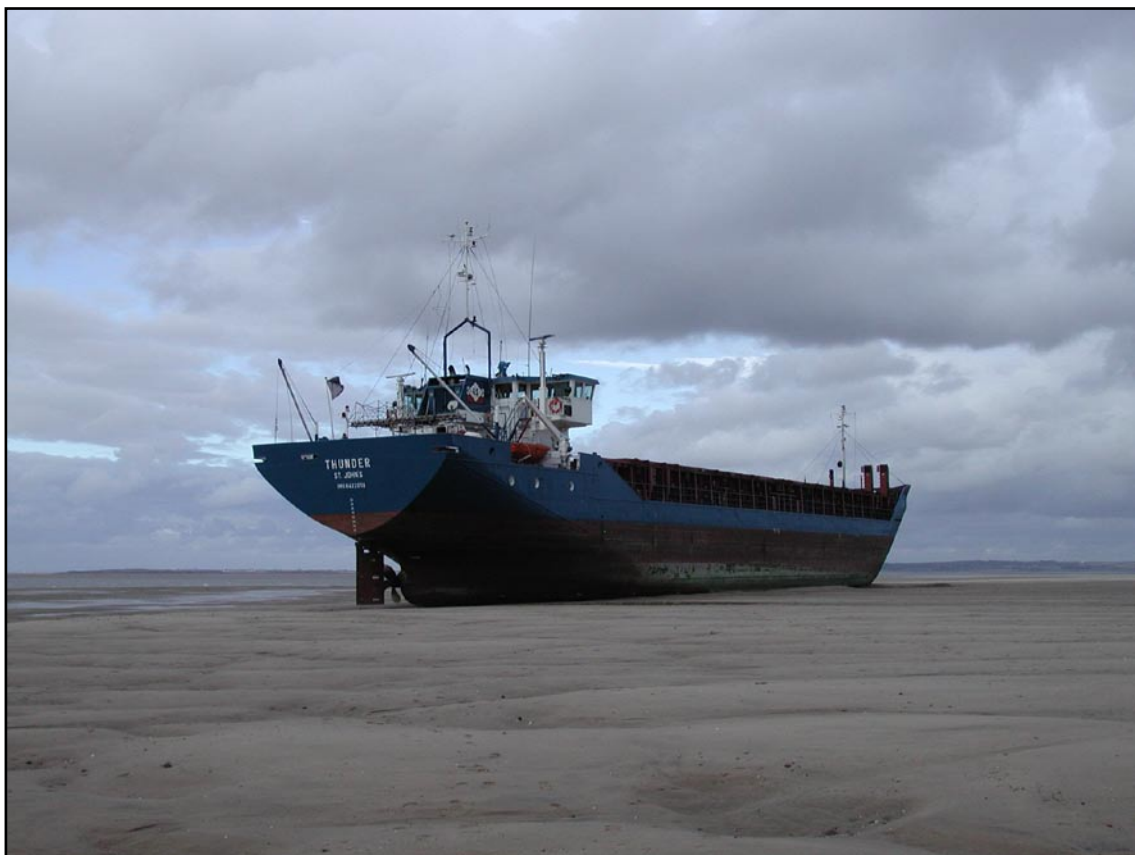
Thunder aground pm 10 August on the Mostyn Bank

In fact, *Thunder* was not making good the course given due to extremely poor manoeuvrability caused by the exposure of the majority of the propeller and rudder above the waterline, a consequence of the earlier de-ballasting operation. The master reported a maximum attainable speed of 2 knots.

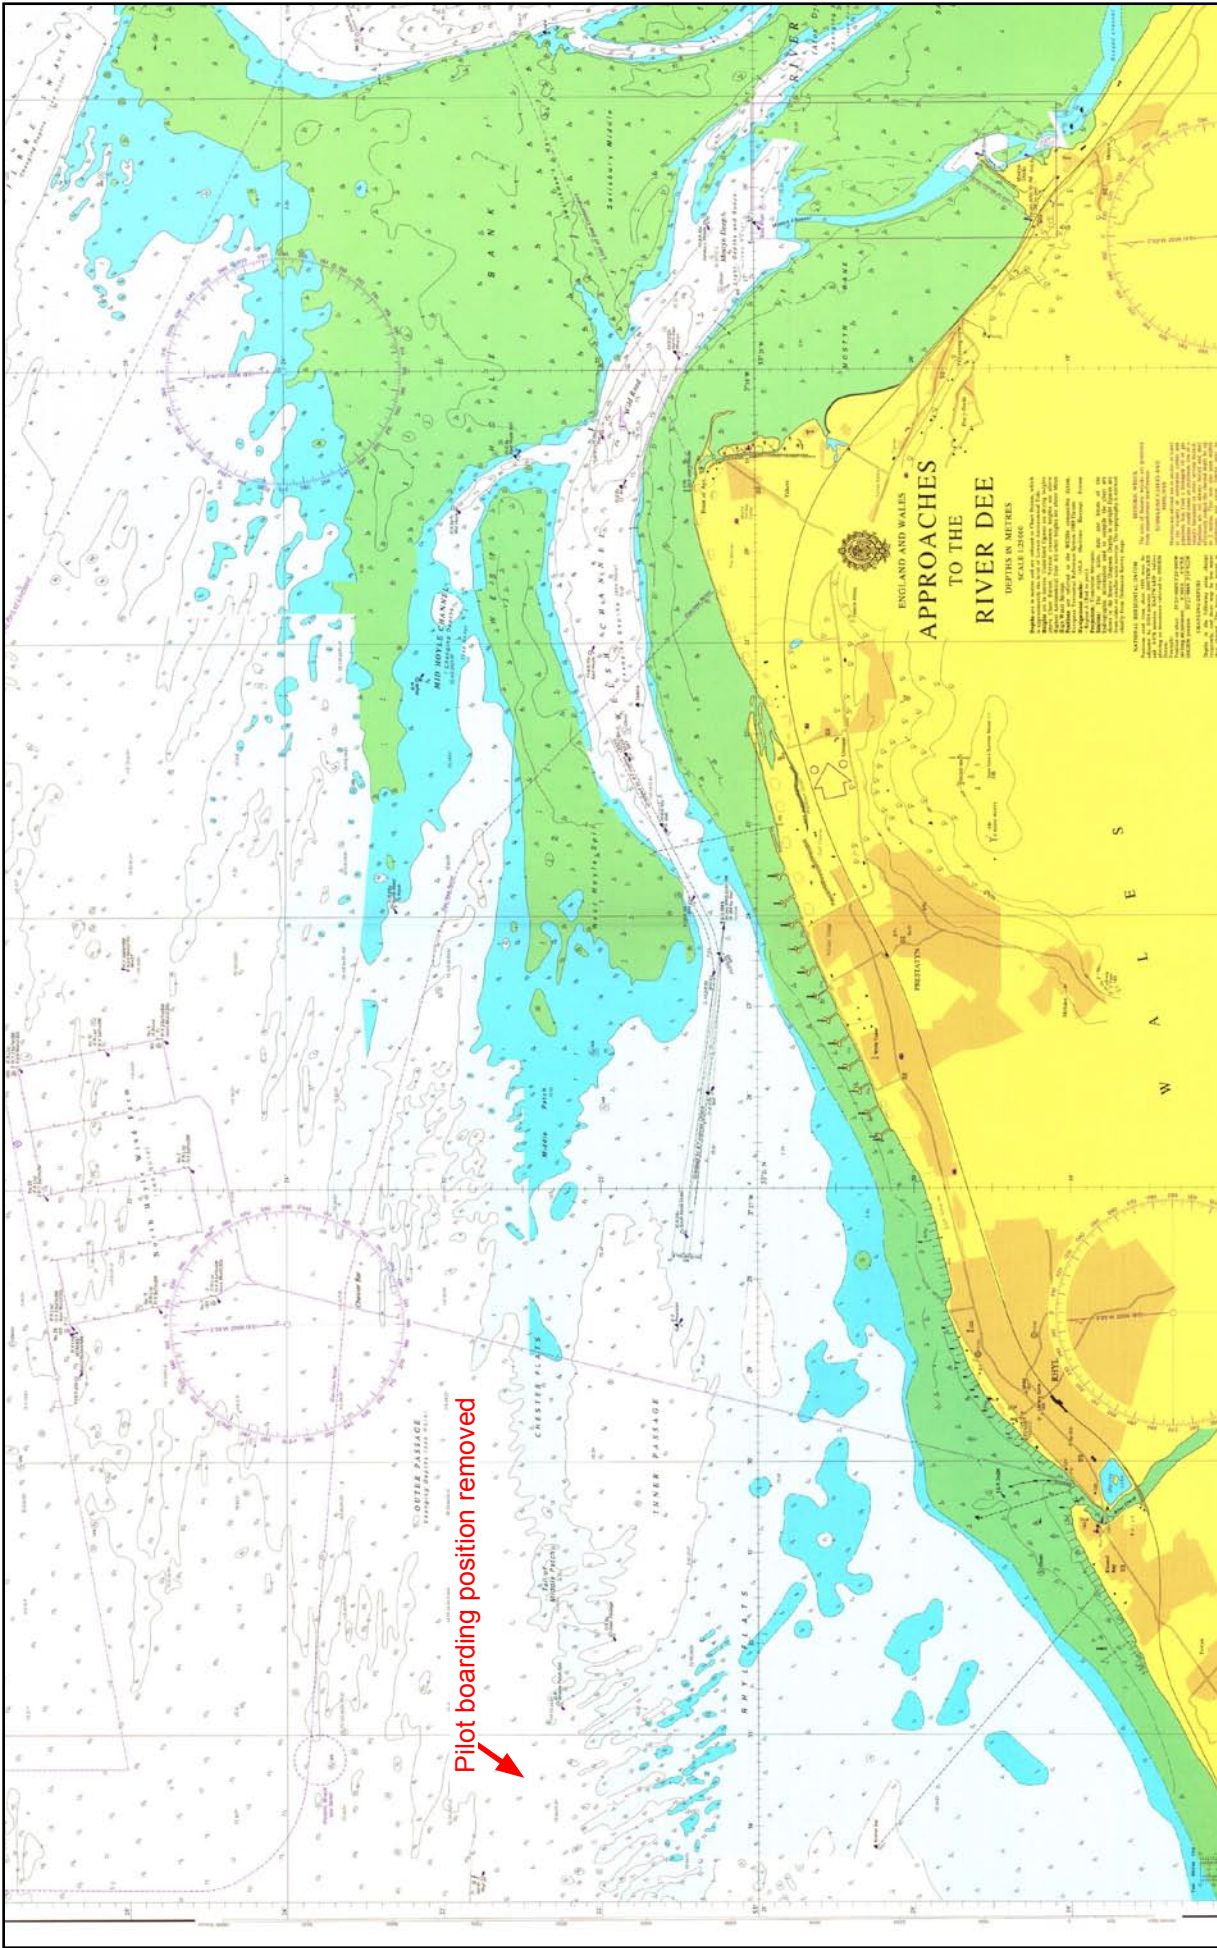
Figure 3

BA Chart 1953 Edition No 6

Had the master been in possession of BA chart 1953 he would have noted the only pilot symbol laid close to the Dee buoy.

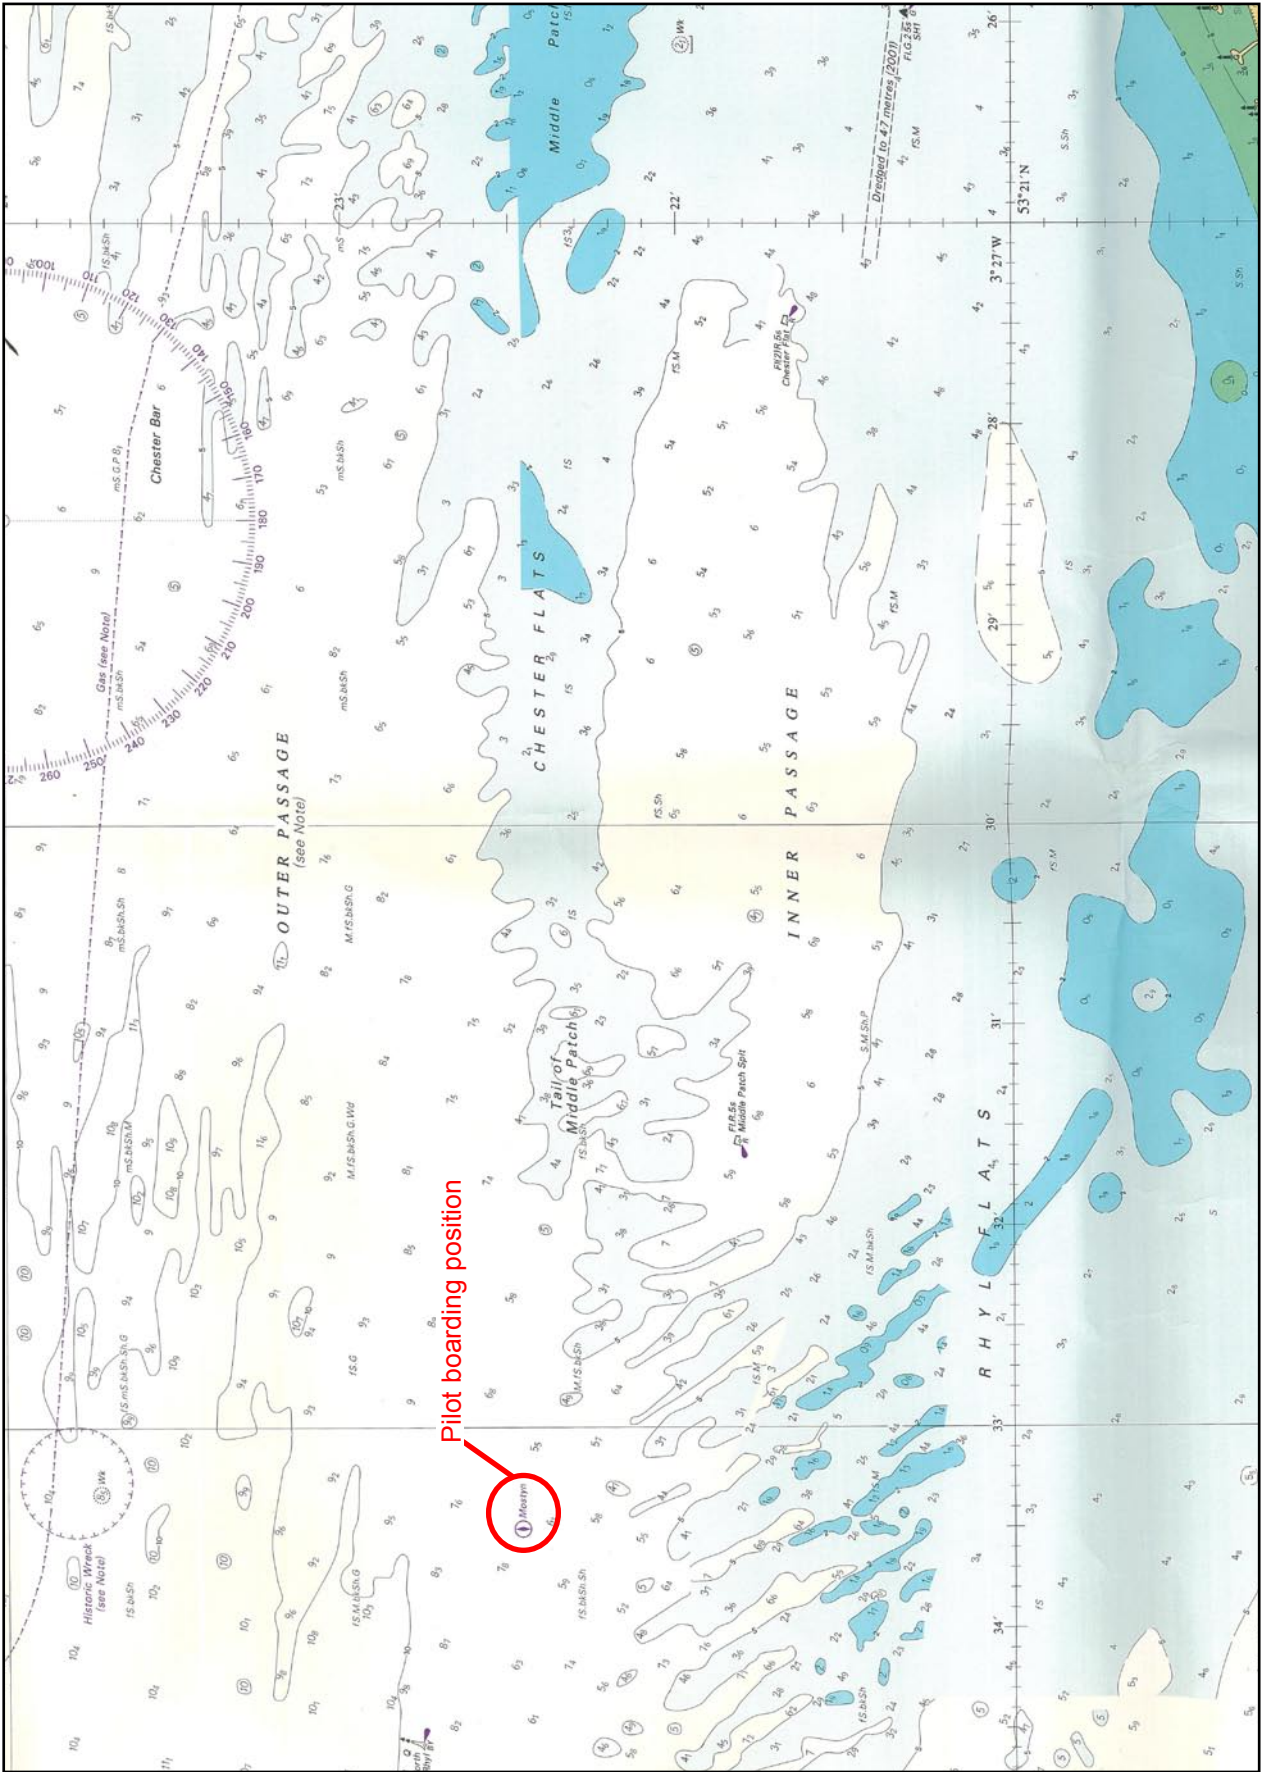
Figure 4

The previous edition of BA chart 1953 – edition number 5 (**Figure 4**), was published on 25 October 2001. This chart displayed pilot boarding points for Mostyn in the centre of the channel at Wild Road, and seven cables south east of the North Rhyl buoy. On edition 6, the pilot boarding position near the North Rhyl buoy had been removed, and two directional lights had been added: the West Hoyle Spit (Earwig) light beacon (perch pile)³, and a second light located ashore 4.5 cables southwest of Mostyn Docks. On edition 6, the recommended anchorage at Wild Road remained in the same position, while the recommended anchorage in the Mostyn Deep had been moved 4 cables west to the south side of the channel.

Extract of BA Chart 1953 Edition No 5

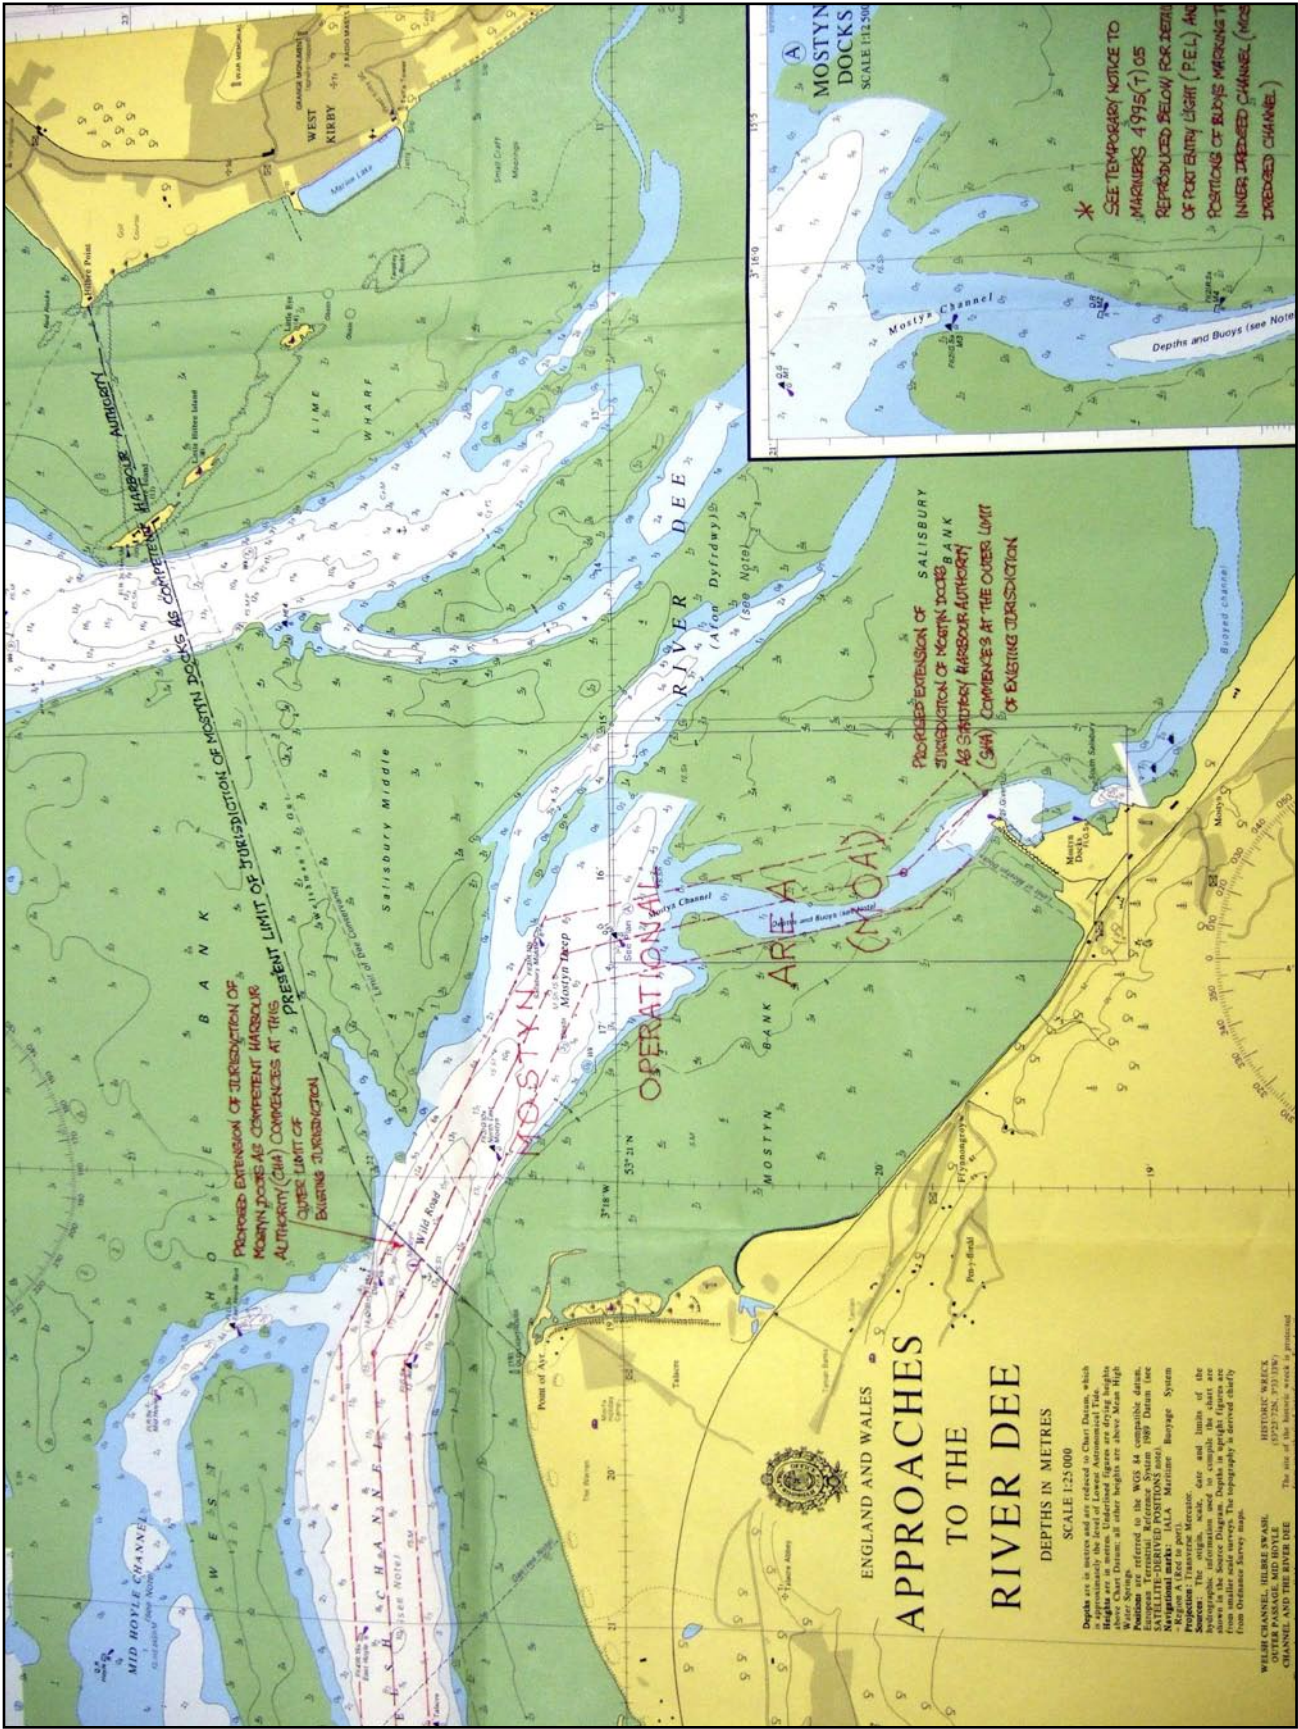
Figure 6

Chart showing the Mostyn Operational Area and the present limits of jurisdiction as the competent harbour authority
