**A report on the investigation of the capsizing and
foundering of the workboat/tug
Trijnie
with the loss of one life
in the approach channel to Milford Docks,
Milford Haven, on 8 September 1998**

Marine Accident Investigation Branch
First Floor Carlton House
Carlton Place
Southampton
SO15 2DZ

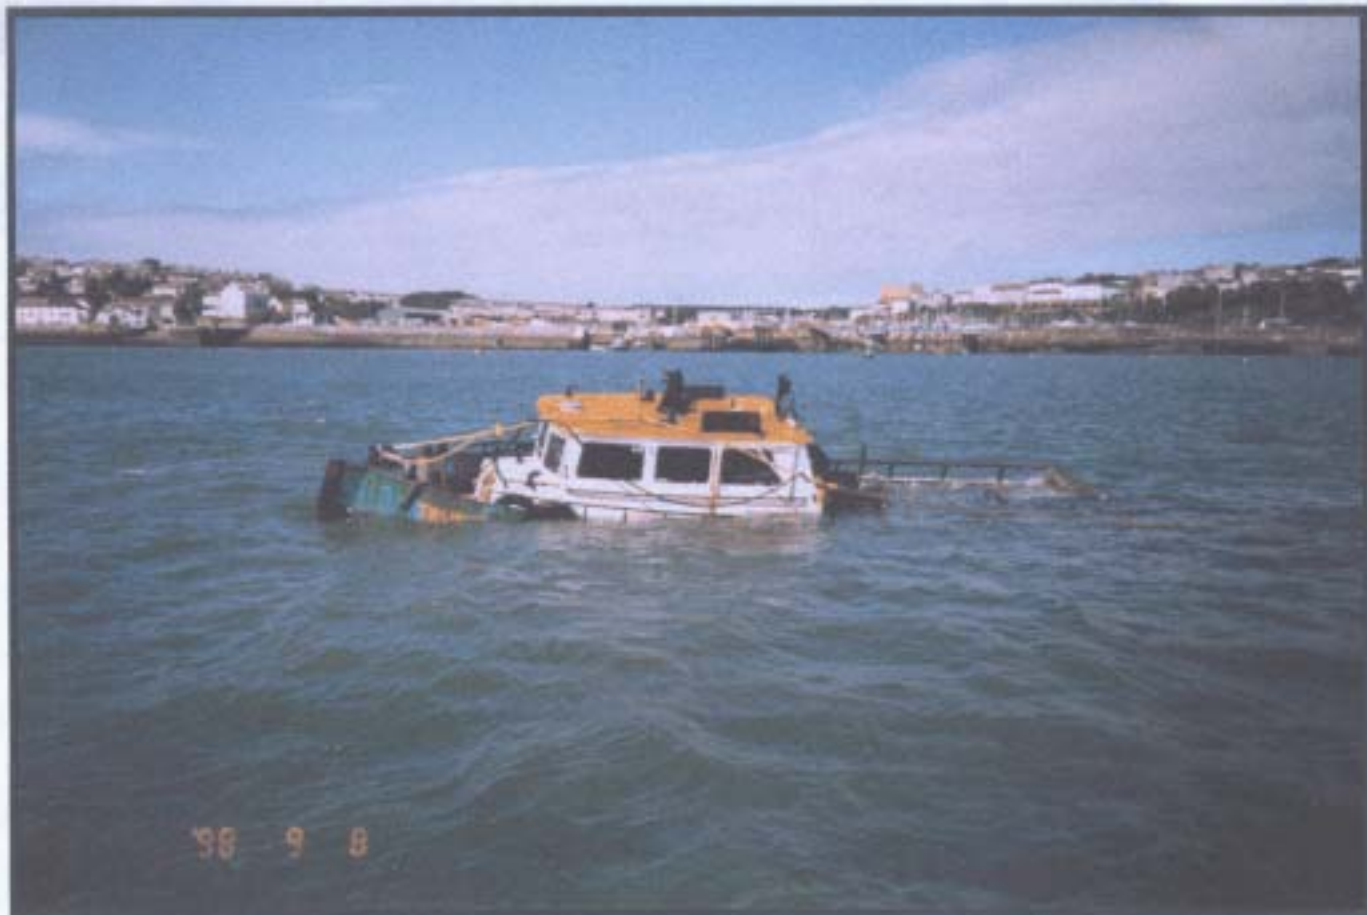
*Trijn*ie partially submerged at low water, prior to her salvage

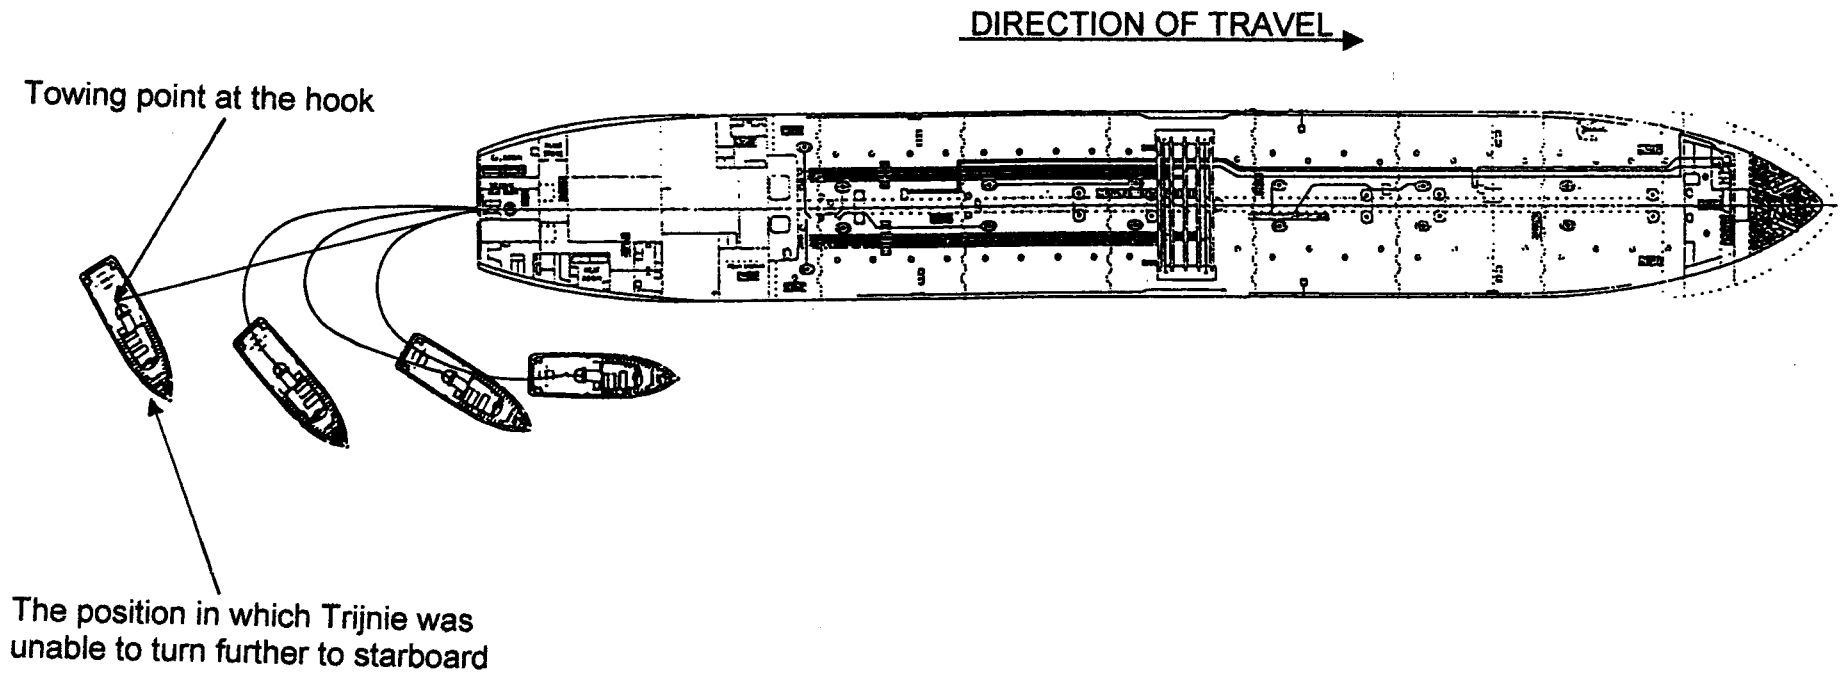
Approximate positions of *Trijnie* in relation to *Tillerman*
(Tug and ship to scale)

Trijnie making her peel-off manoeuvre to starboard without a gog rope
(Tug and ship to scale)

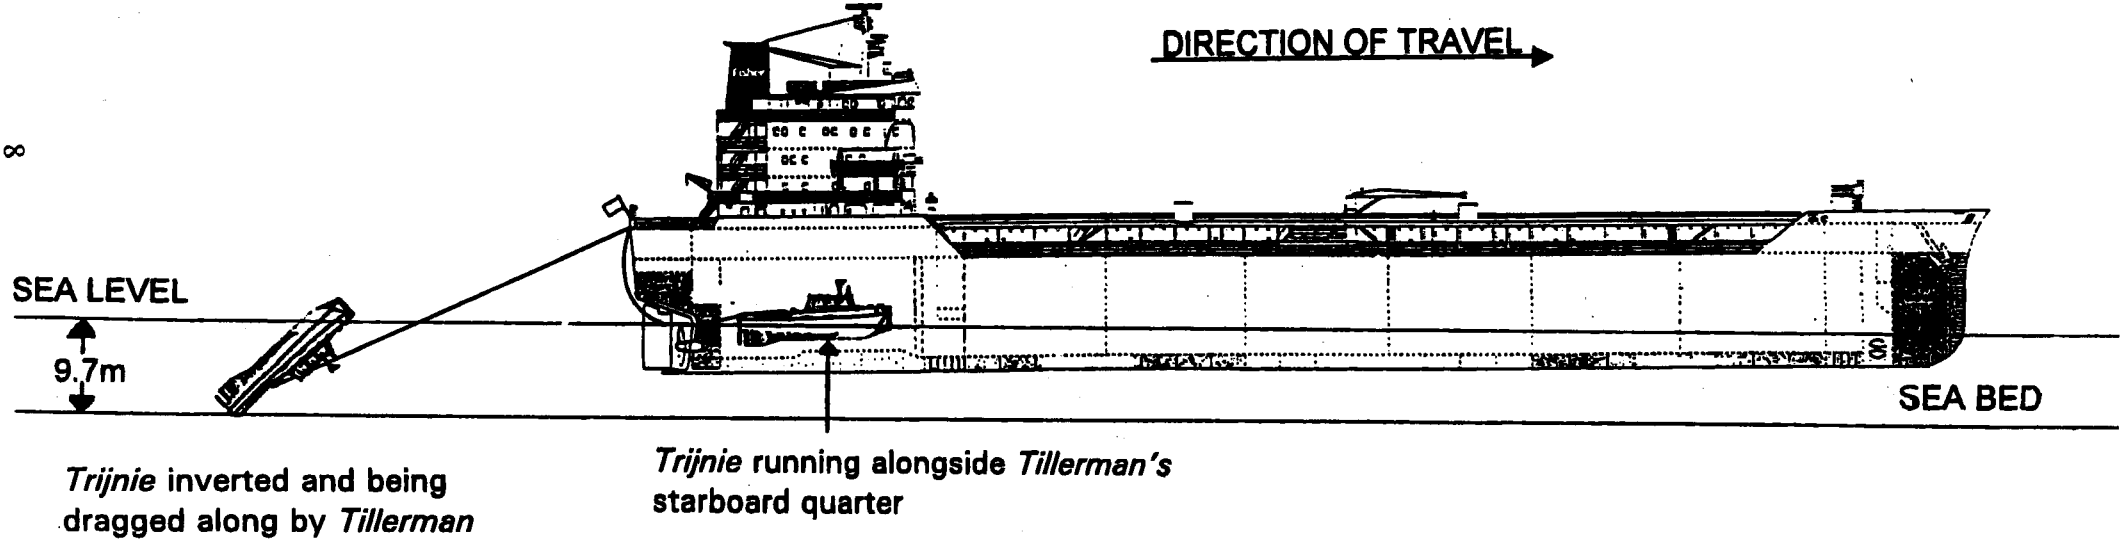
Profiles of *Trijnie* and *Tillerman*
(Tug and ship to scale)

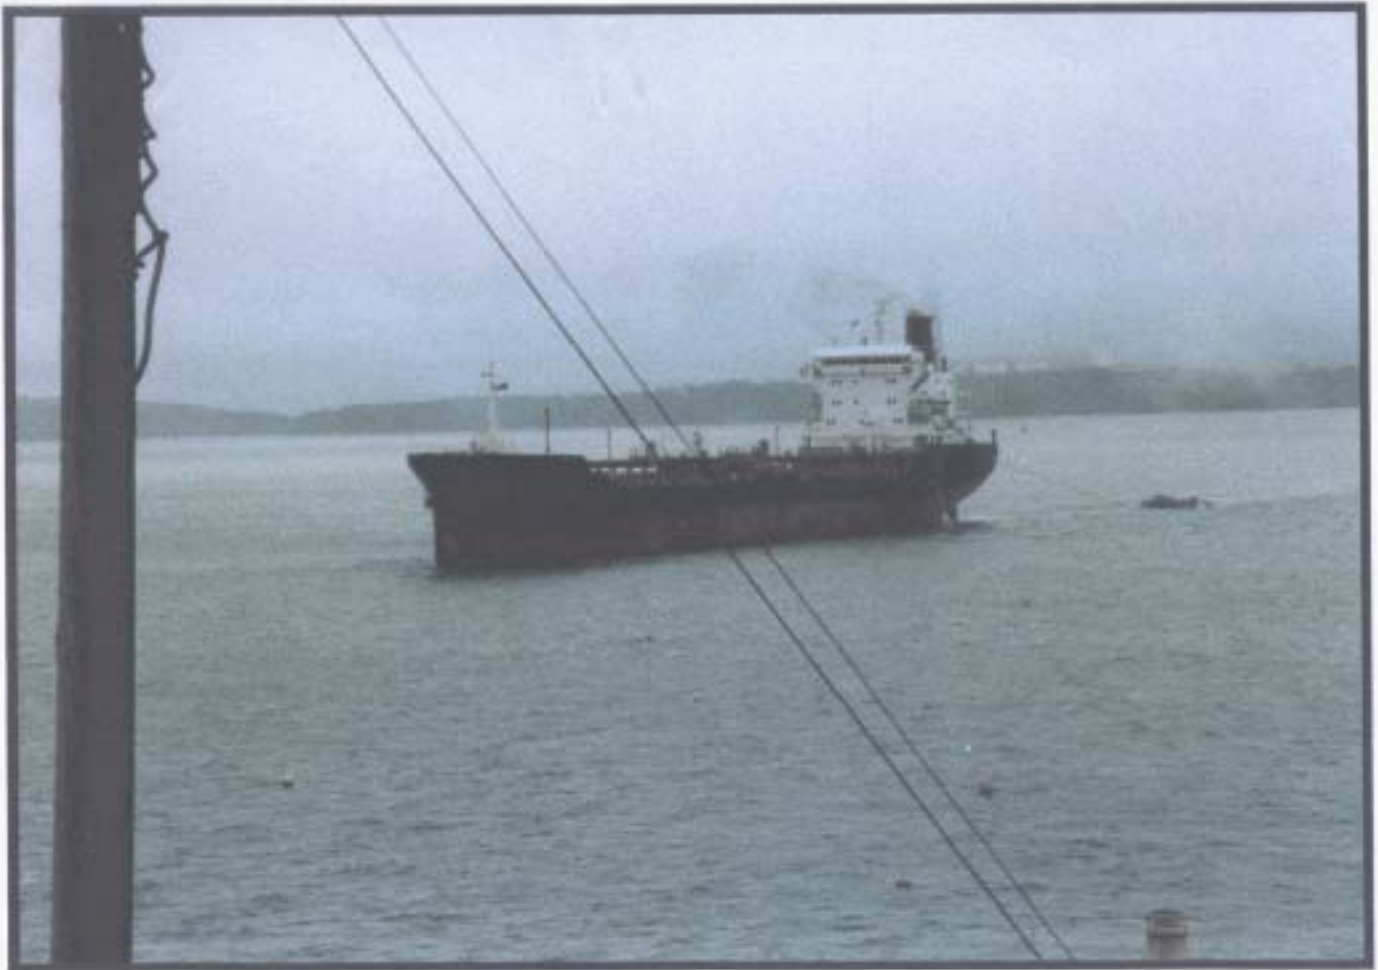
1. *Tillerman* and *Trijnie*, with the latter in the capsized position

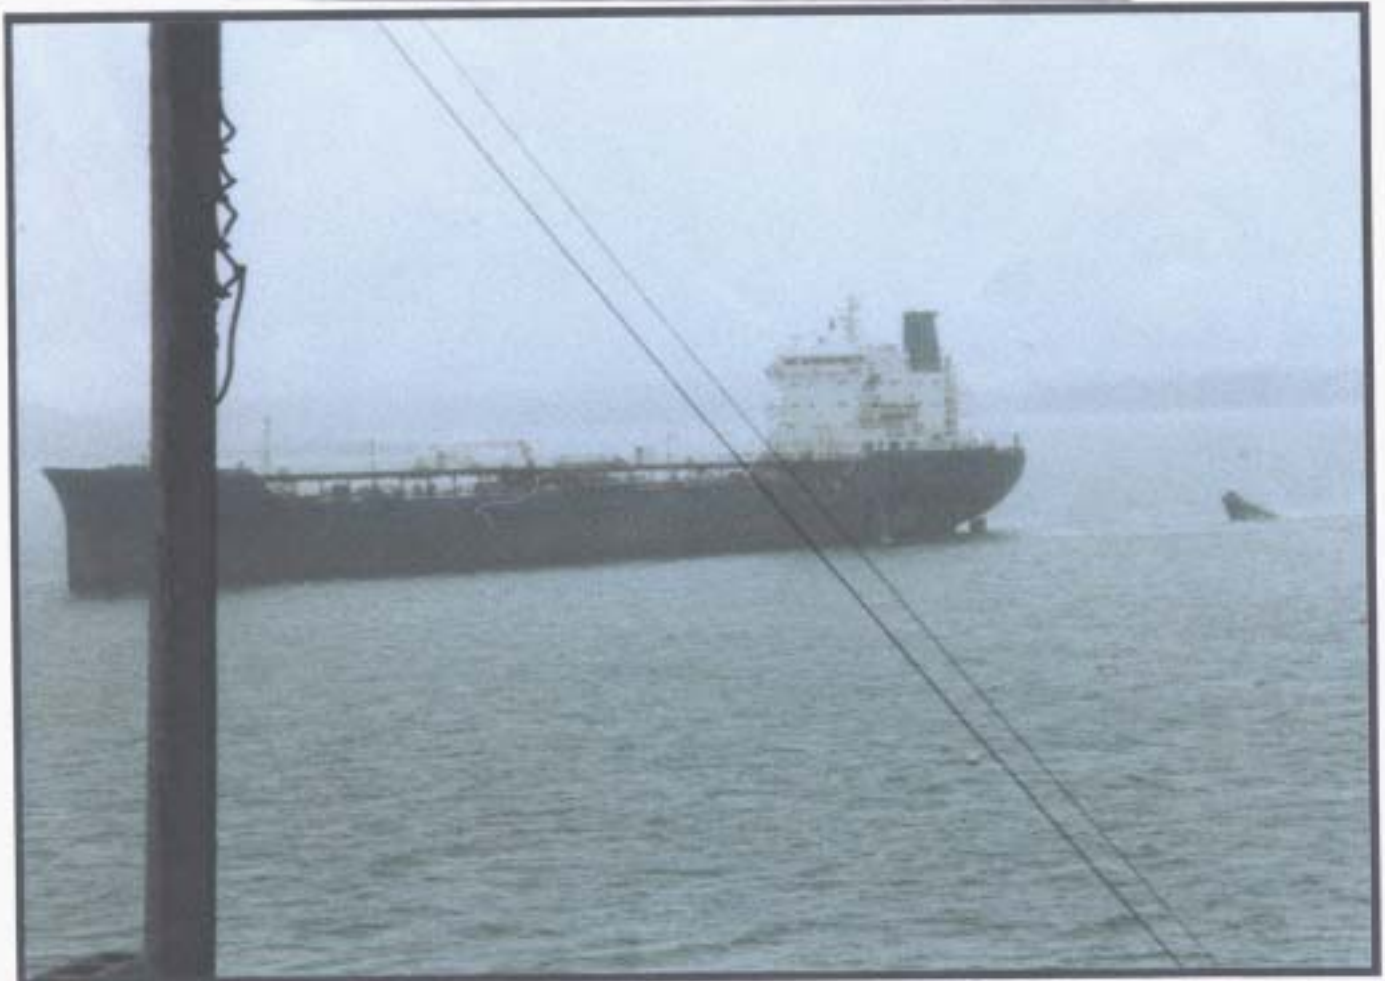
Following her capsize, *Trijnie* had taken up an inverted bows-up attitude. The mooring line, on which there was a lot of weight, was still attached to the ship (**Figure 3 and Photographs 1 and 2**). The pilot and Port Control discussed the implication of letting go the mooring line and whether the tug would sink. By this time fire brigade divers had been called to the scene to search the tug for the missing crewman. It was then suggested that *Anglegarth* could take over from *Tillerman* to keep *Trijnie*'s bow above water pending the arrival of the divers.

2. *Trijnie* in the inverted bows-up position

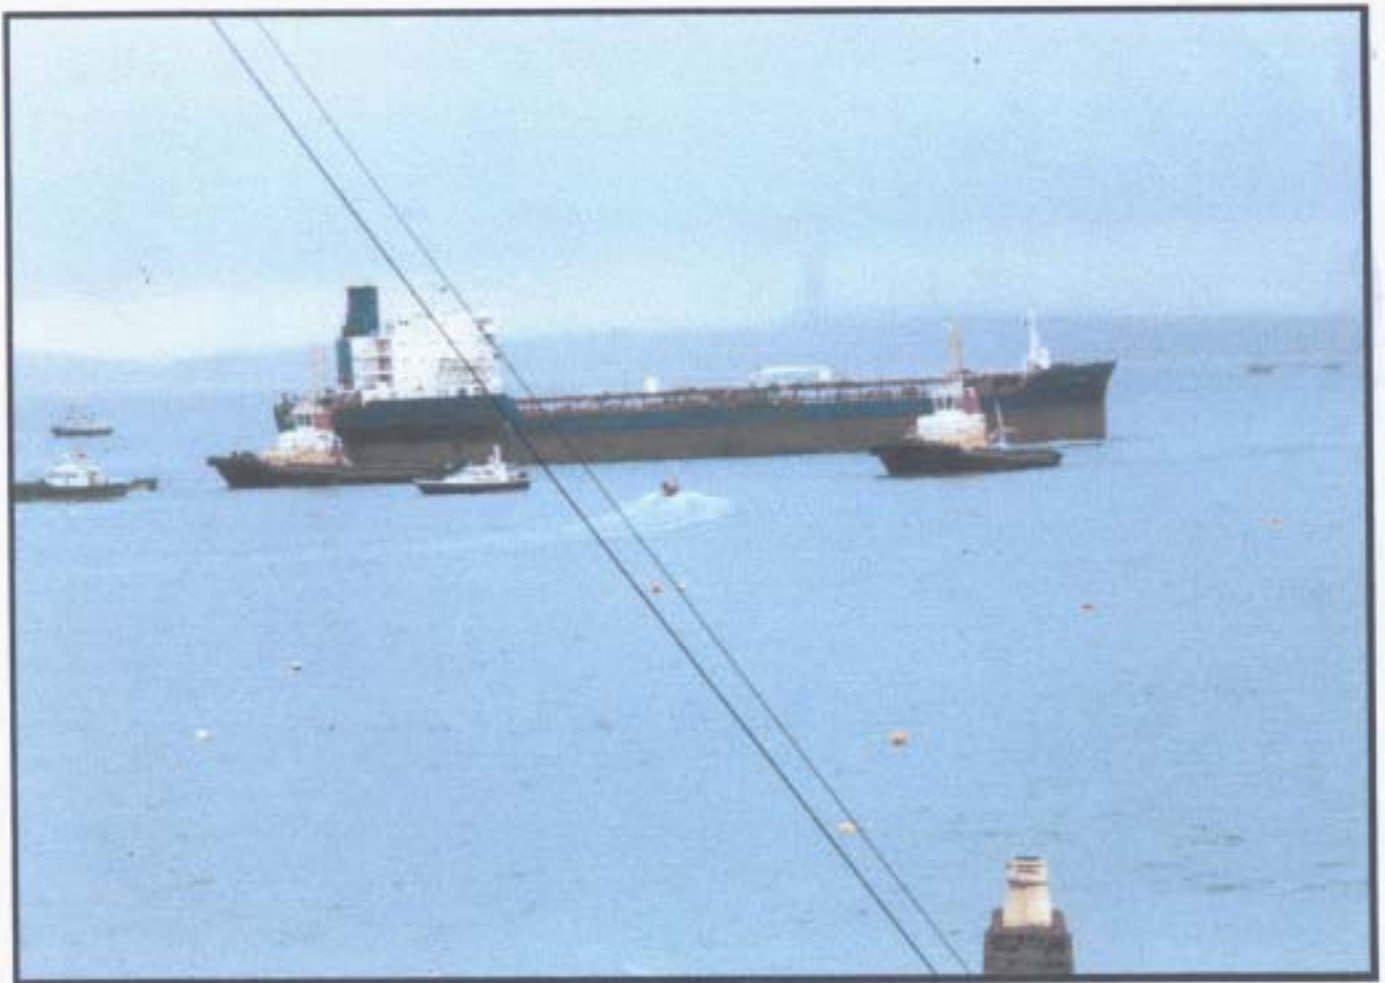
At 0825, when a second rope from *Anglegarth* was being made fast to the tug, the first one parted. The divers, who were on board *Anglegarth* would not dive on *Trijnje* until a second rope had been made fast. This was achieved at 0832 (Photograph 3).

3. *Anglegarth*, close to the stern of *Tillerman*, with a line fast to *Trijnje*

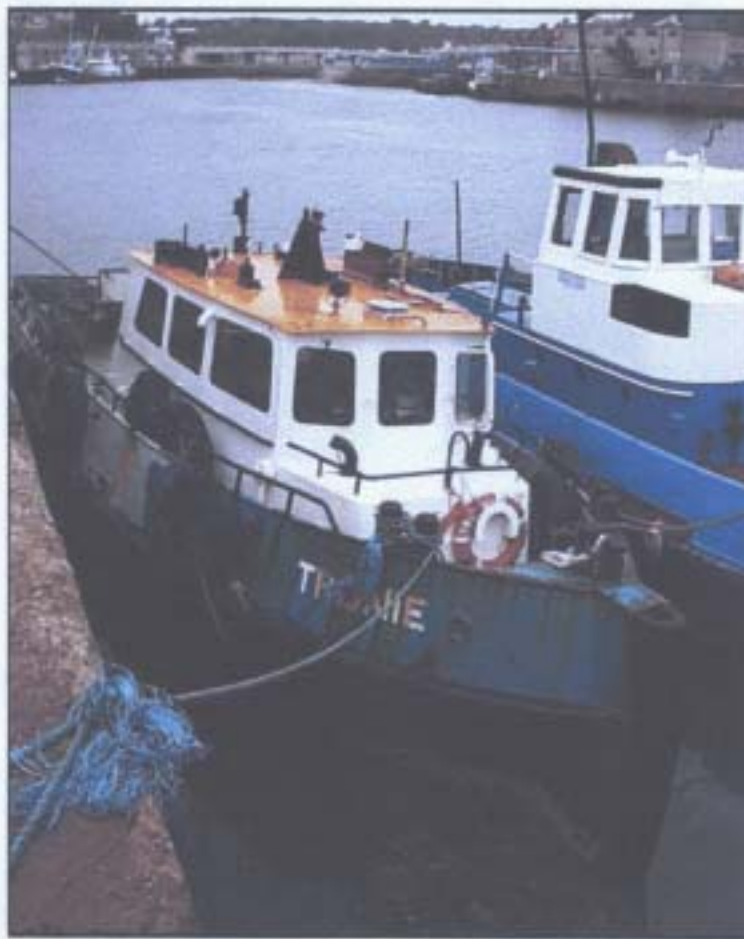
4. A general view of the fore part of *Trijnie*

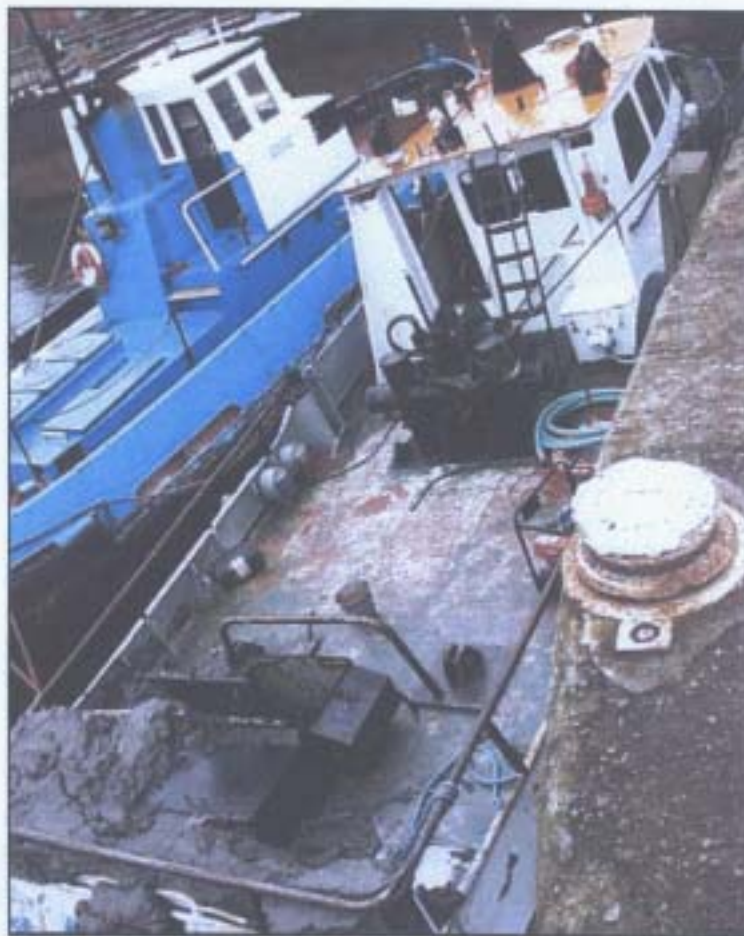
5. A general view of the after deck of *Trijnie*

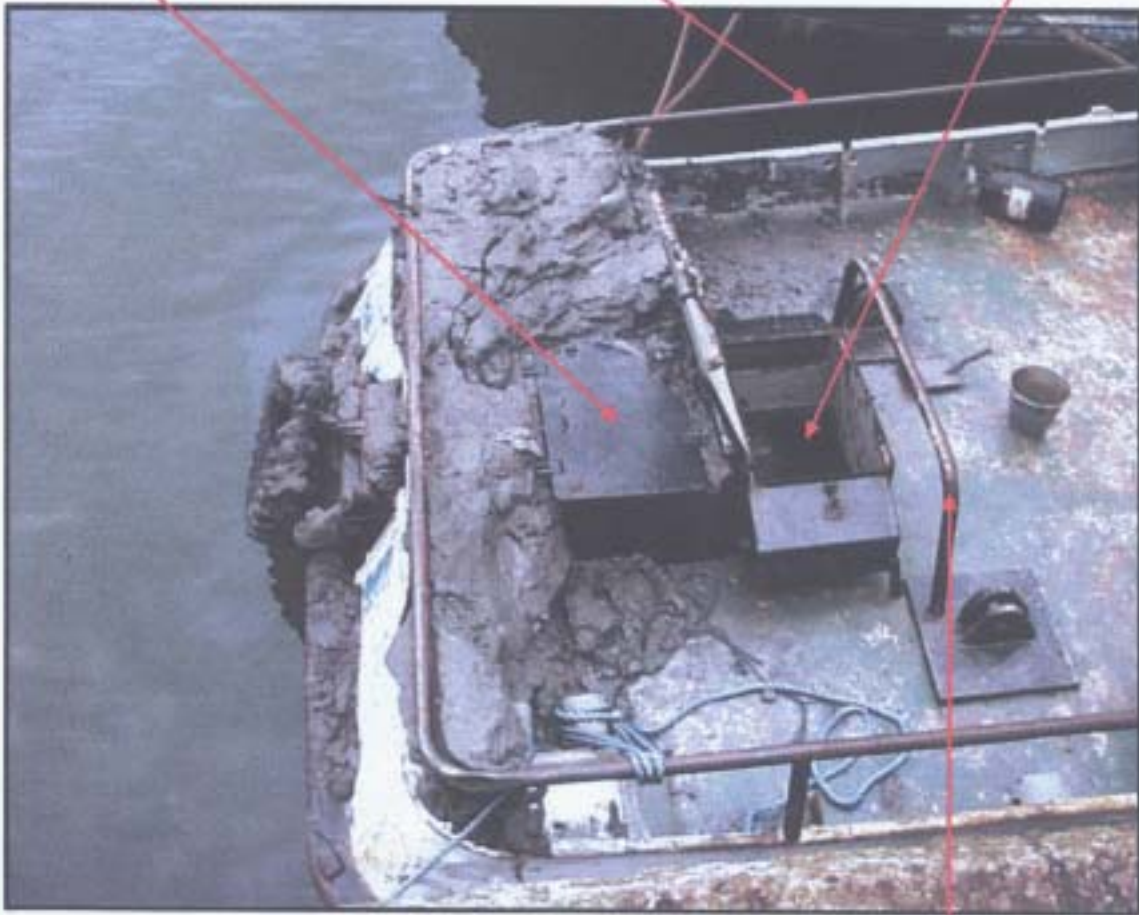
6. A closer view of the stern

New 'U' shaped rail

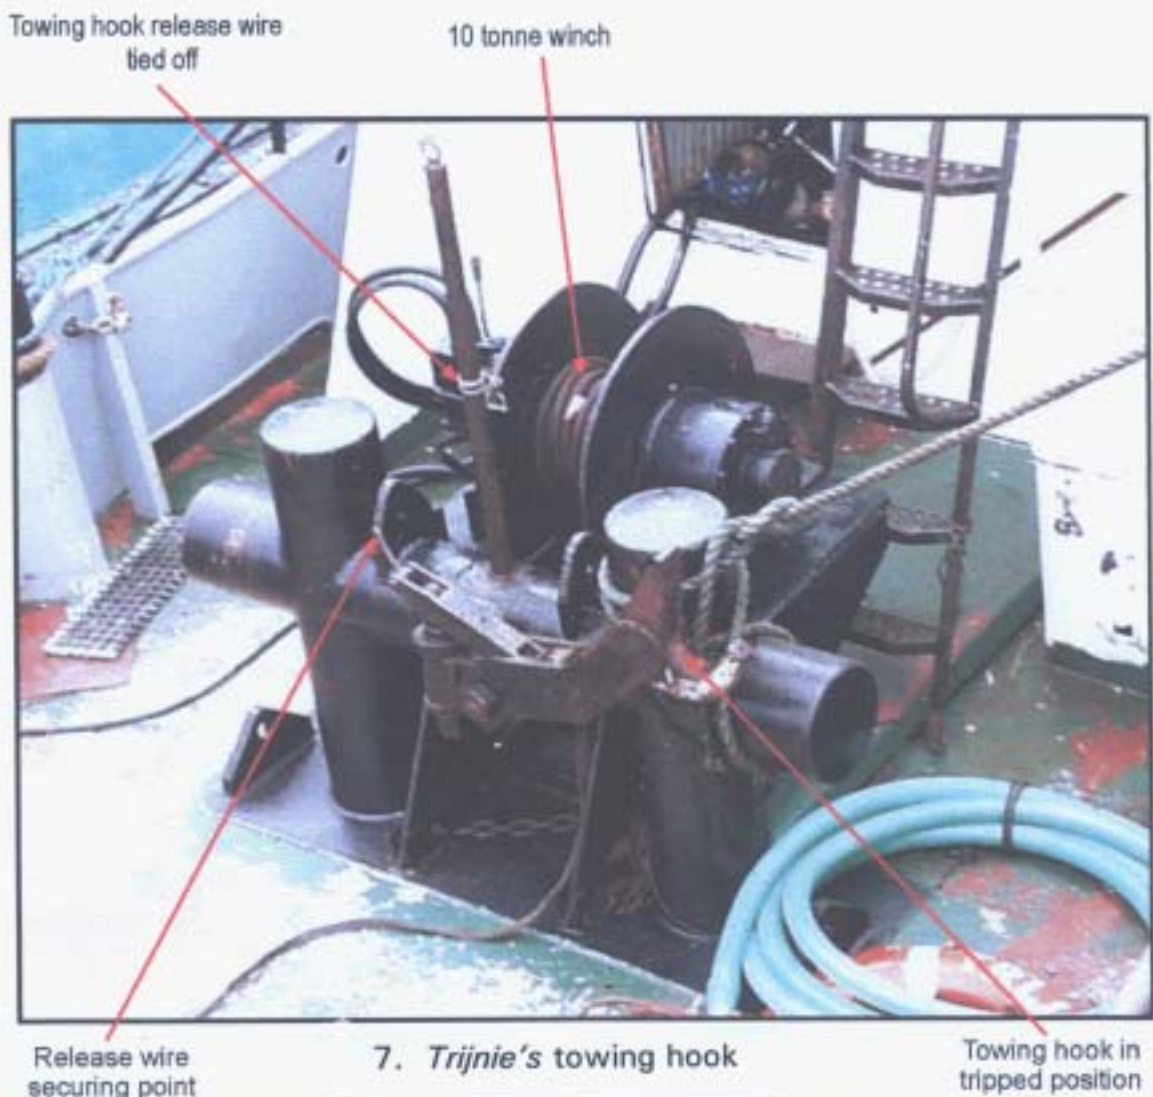
When *Trijnie* was raised following the accident, it was found that the tow hook release wire **was** not secured to the hook but tied **off** on the vertical stanchion (**Photograph 7**). It was confirmed that none of the divers had touched the wire at any time. The investigation revealed that the wire had been tied **off** when working at the Texaco berths. The crews found heaving lines fell on the release wire when being thrown from ships and tripped the hook, which was inconvenient when running mooring lines.

After the accident, the release wire was untied from the stanchion and secured to the hook. In attempting to trip the hook from the helm position, the system would not work. However the hook was found to be have been displaced to about 30° above the horizontal, and probably occurred during the incident. During later tests, the hook was found to release satisfactorily when using the wire.

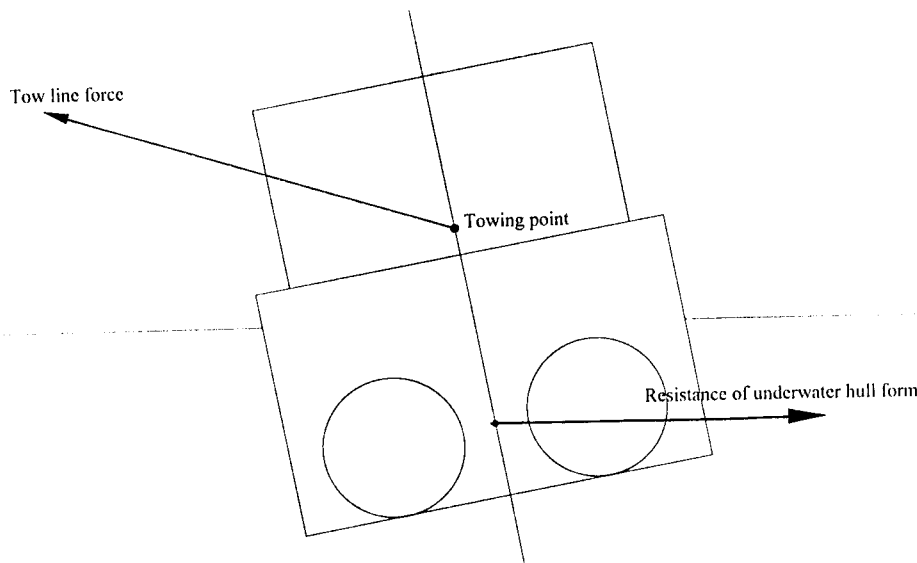
Another effect is that a heeling moment is created by the vertical distance between the towing point and the point of resistance to movement on the tug's hull form, together with the magnitude of the opposing forces. This is known as girting and can cause a tug to capsize (**Figure 4**).

Figure 4 - A sketch showing the opposing forces on a tug in the girting position

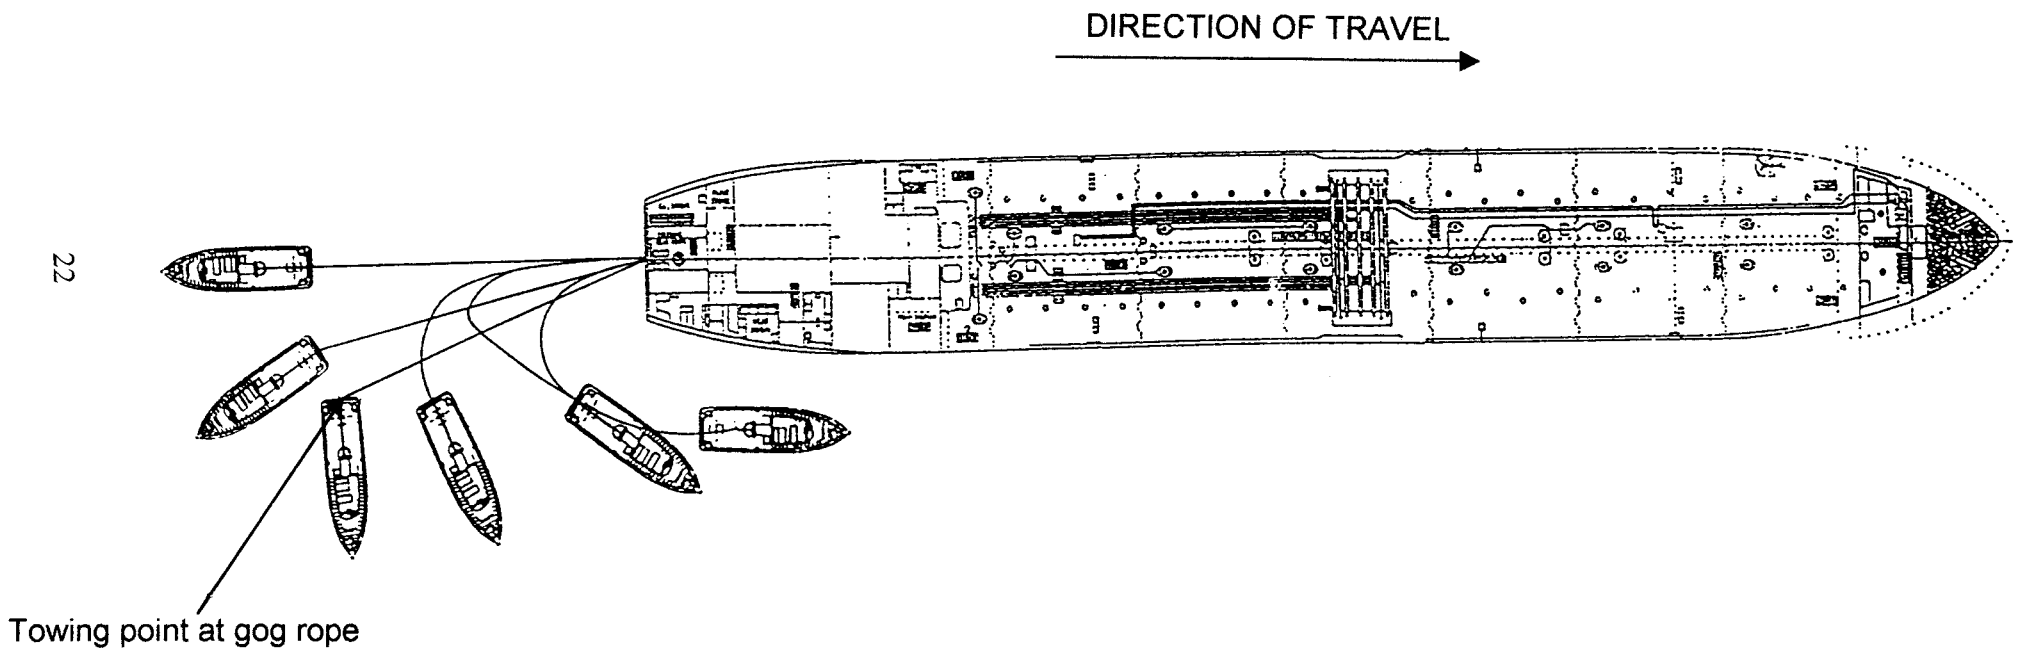
By using a gog rope, the horizontal distance between the towing point and the centre of pressure is increased, which increases the horizontal turning moment. This enhances the tug's ability to steer. Being able to manoeuvre out of a beam-on situation means that the tow line can be brought into the fore and aft centreline of the tug and dangerous heeling moments can be prevented (**Figure 5**).

The peel-off manoeuvre using a gog rope
(Tug and ship to scale)

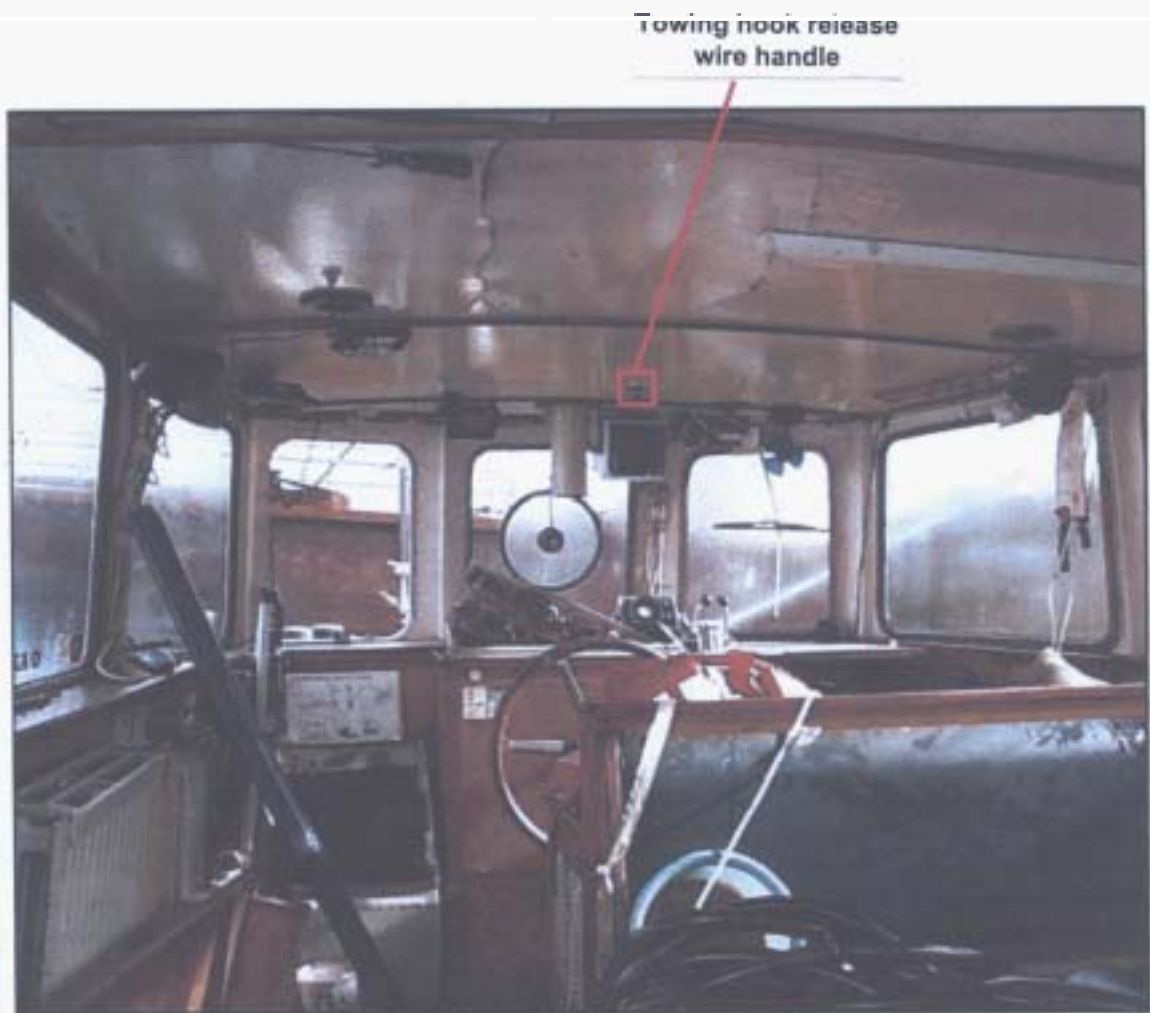
In the release mode, the hook is designed to open or swing down to allow the tow line to slip. The release mechanism can be hydraulic, pneumatic or a cable. Early hooks were released simply by striking a mechanism on the hook with a hammer. Modern tug release mechanisms are now remotely controlled as well, to give greater safety (**Photograph 8**).

8. A view of the interior of *Trijnie's* wheelhouse, looking forward from aft door

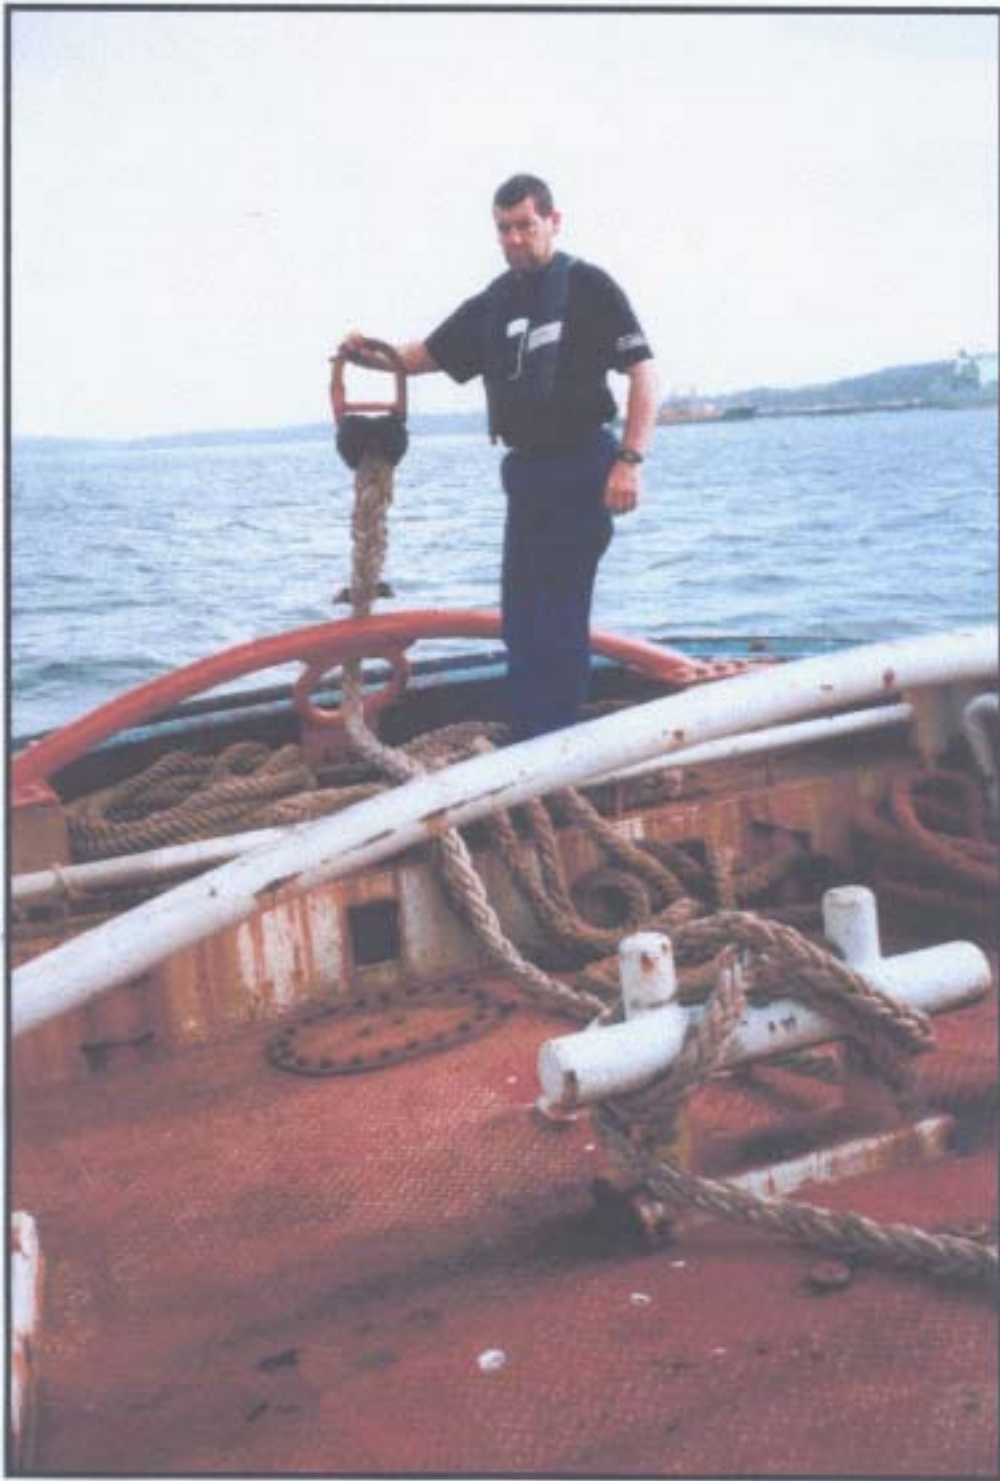
9. A crewman on *Seamaid* holding up the gog rope eye through which the tow line passed

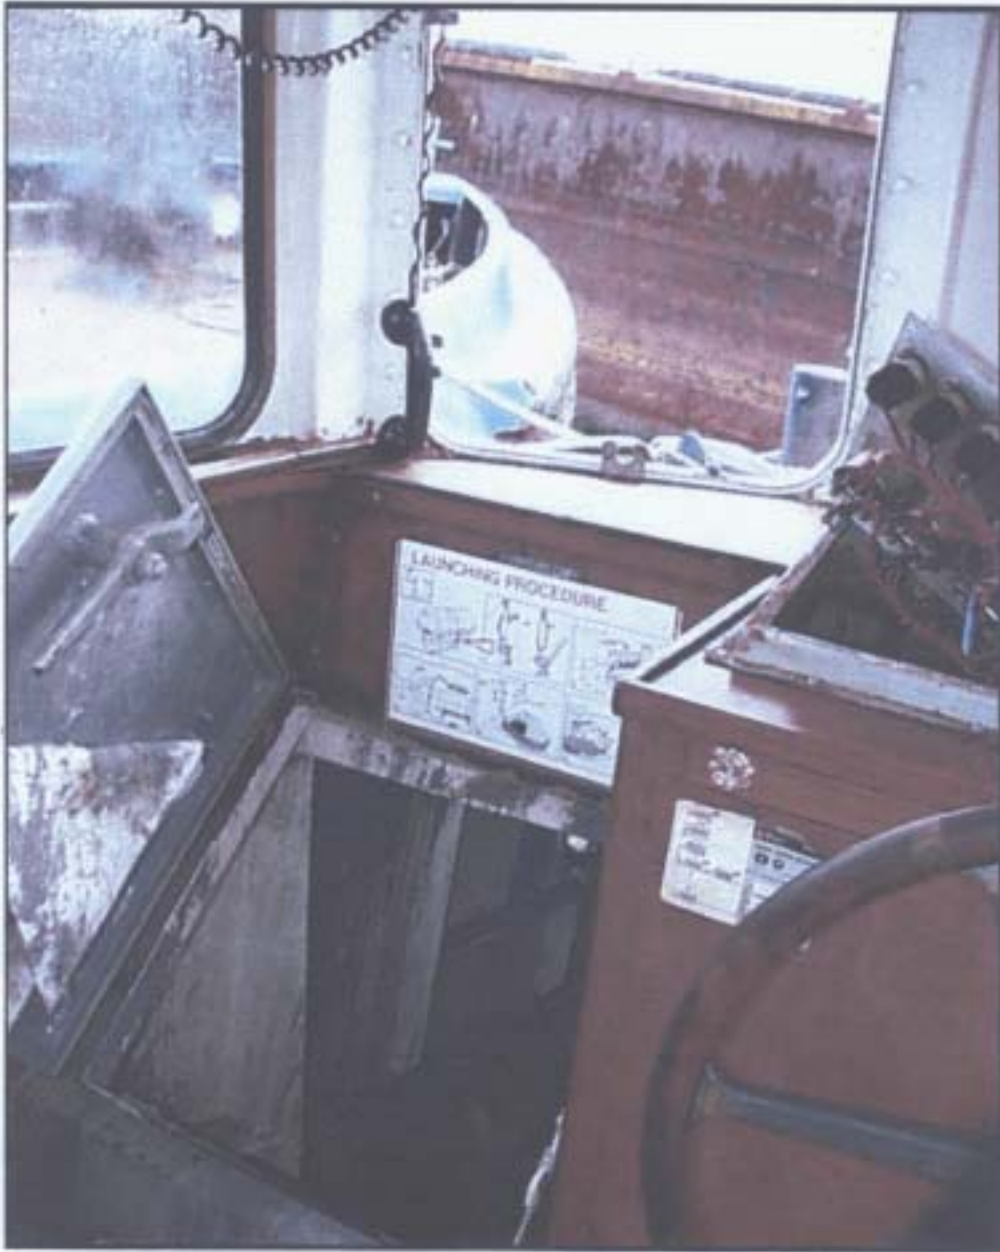
10. This access hatch to the lower deck was closed during the incident
