MAIB TRILOGY REPORT

Korenbloem

Osprey III

Optik

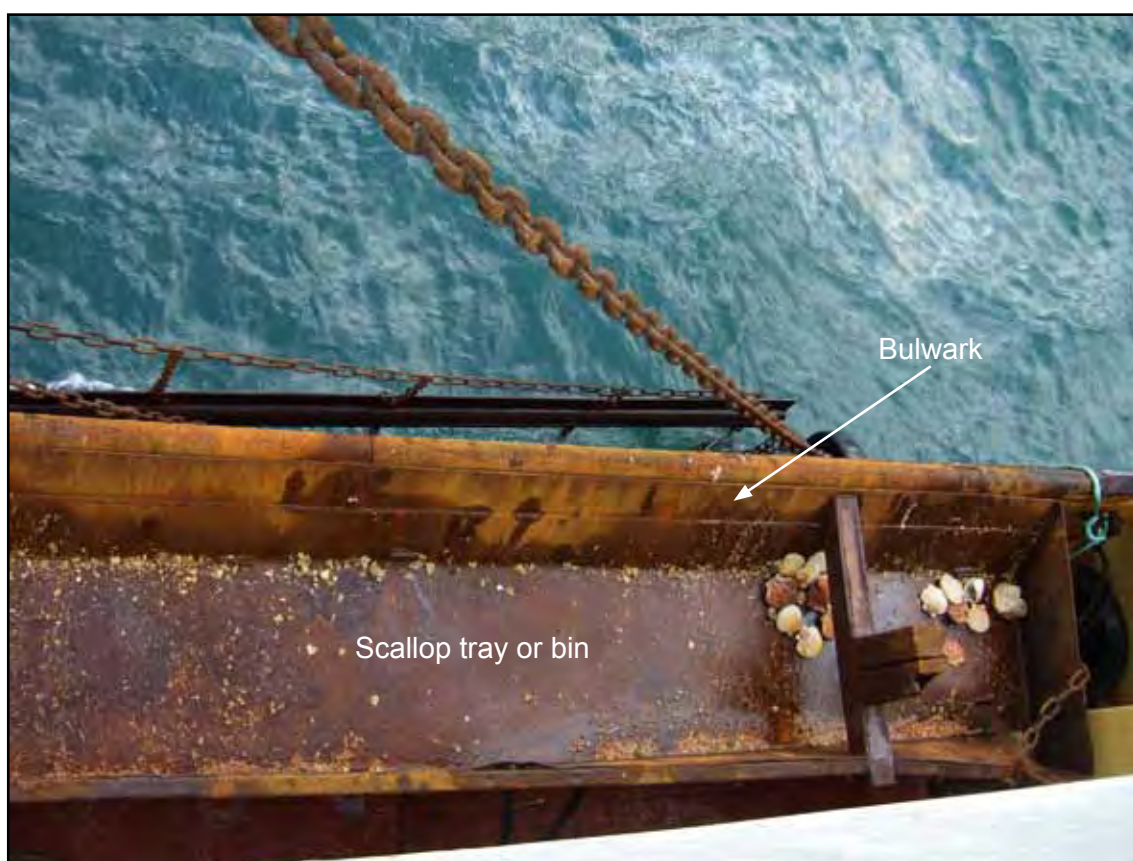
Figure 1

Korenbloem is a beam trawler with the ability to carry out either white fishing or scallop dredging depending on the fishing gear fitted. At the time of the accident she was working as a scallop dredger, operating 12 dredge bags on either side. At the end of each haul the dredge bags, which were suspended between the towing beams and tipping bars, were emptied into long trays (bins) adjacent to the bulwarks by lifting the tipping bar using the gilson winch. During hauling and shooting the gear, deckhands had to climb on top of the bins to attach or detach the gilson clips. The top edges of the bins were nearly at the same height as the bulwarks (**Figure 1**).

Scallop trays or bins adjacent to the bulwark

Korenbloem was surveyed twice in 4 years, and inspected once annually. However, the potential hazard posed by fitting the scallop bins flush with the bulwark was not identified during these surveys.

In practice, the bins extended the bulwark inboard and, as such, did not pose a hazard until anyone climbed on top of them to operate the gilson clips. As the bins are removed during the surveys, it is understandable that the danger of falling into the sea from the bins was not readily apparent to the attending

In order to appreciate the implications of fitting additional equipment, such as bins, it is necessary for the surveyor to see them in place. Therefore, it would be prudent for surveyors to insist on seeing the vessel in the 'ready to sail' condition during surveys and inspections.

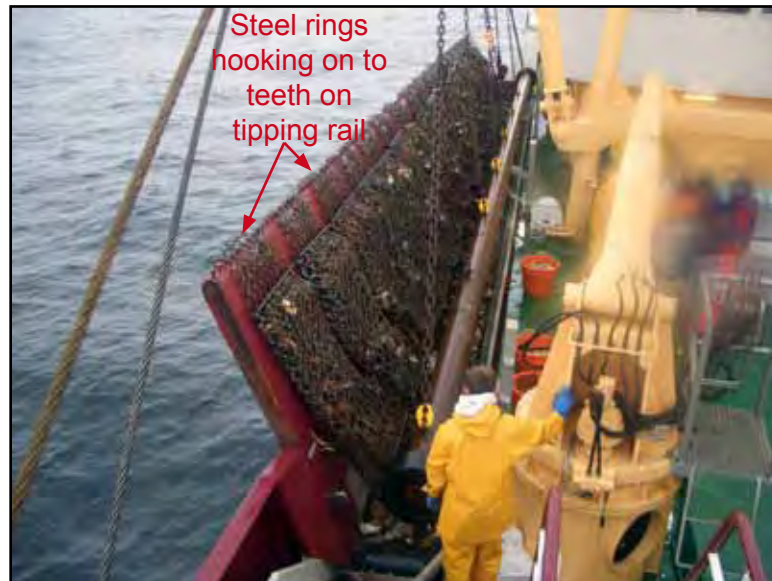
The tipping rail system is a recent innovation implemented in several of the larger Scottish scallop dredgers, which eliminates the need for a tipping bar and gilson to invert the dredge bags. The tipping rail is, effectively, a second movable bulwark which rotates to lift the dredge bags. Steel rings attached to skirts at the bottom of the dredge bags hook on to teeth protruding from the tipping rail as it is raised, inverting the bags over the bins. The tipping rail is hydraulically rotated and is controlled from the bridge so the crew can remain clear of the moving equipment (**Figures 8a, 8b, 8c**). Some fishing vessel owners have tried other means of tipping the dredges, but none of them have achieved the same level of safety as the tipping rail system.

Tipping rail mechanism

The tipping rail system is a recent innovation, and it is possible that as the industry gains experience of its use it will find new hazards which have not yet been identified. However, at present the tipping rail system appears to significantly improve crew safety compared with existing systems.

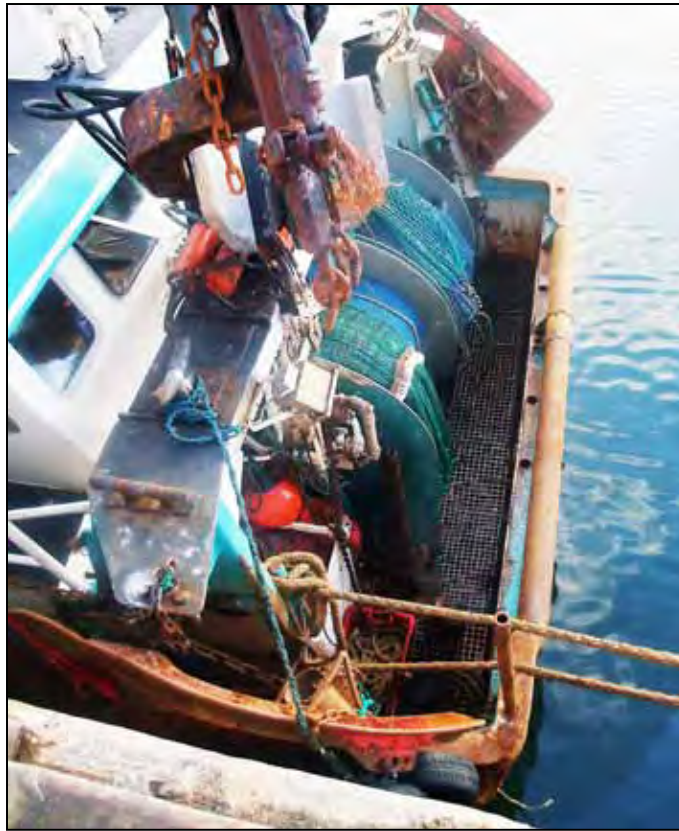
Figure 13

Photograph of the aft deck
