Report on the investigation of

the contact between

***Ursine***

***Pride of Bruges***

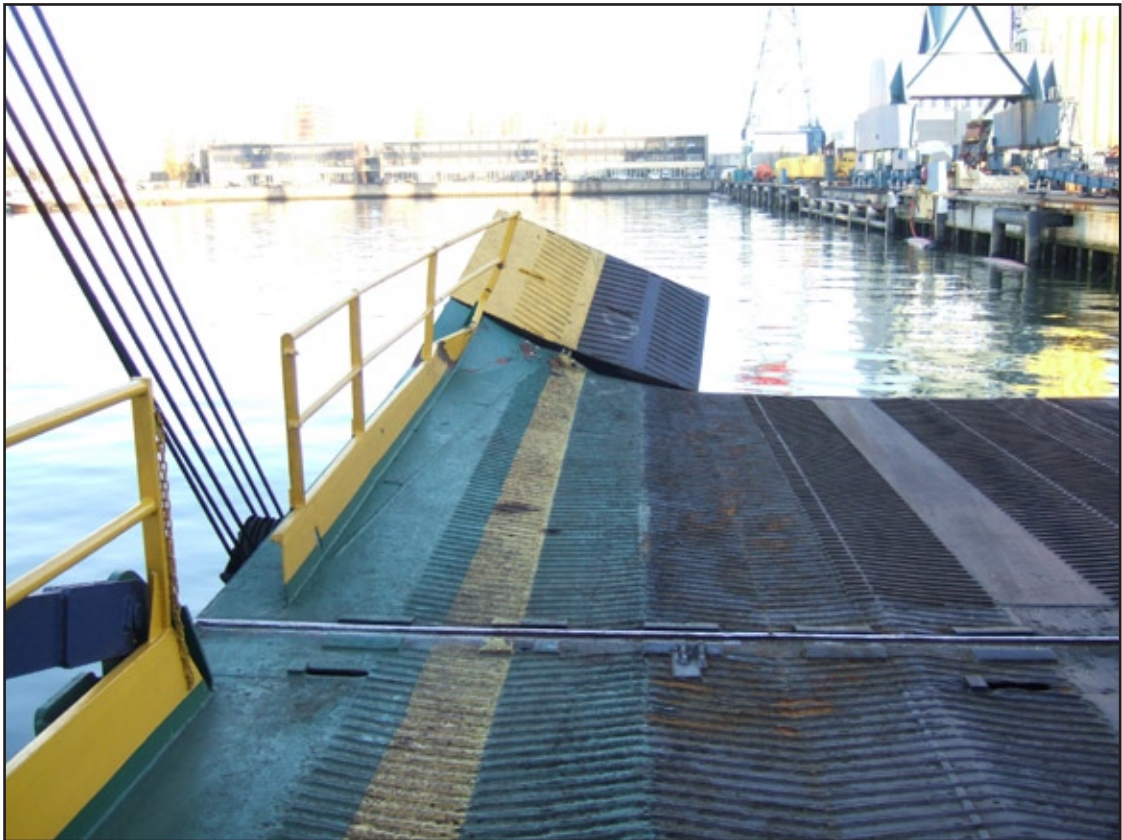
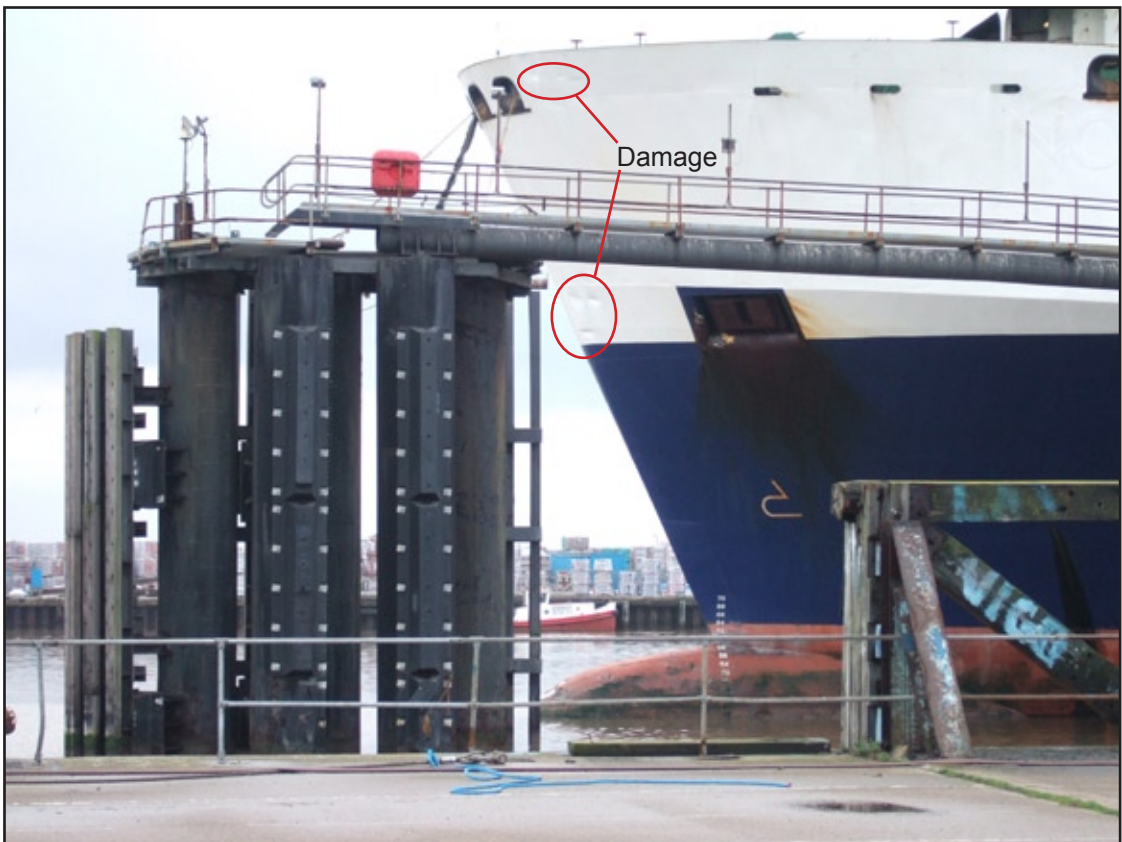
Figure 4

*Pride of Bruges*, which was not embarking passengers at the time of the contact with *Ursine*, was pushed astern by some two metres, causing three mooring lines to part and resulting in minor damage to the steelwork of her bow and stern ramp. The force of the impact was sufficient for the master to sound the general alarm. After an inspection, the vessel was determined to be safe to remain in service, with repairs being scheduled for her next refit.

*Ursine*’s stern ramp was damaged as a result of the impact, which required her to be taken out of service to allow the ramp to be repaired to the satisfaction of her classification society. A condition of class was subsequently issued to enable the vessel to undertake a single voyage to a repair port. The vessel’s stern light and associated supporting steelwork were also damaged by the contact (**Figure 4**).

Damage to *Ursine* (top) and *Pride of Bruges* (bottom)
