Report on the investigation into the contact
made by the tanker
Vallermosa,
with the tankers
Navion Fennia and ***BW Orinoco***
at the Fawley Marine Terminal
on 25 February 2009

Marine Accident Investigation Branch
Mountbatten House
Grosvenor Square
Southampton
United Kingdom
SO15 2JU
Report No 23/2009
November 2009

On 25 February 2009, the oil product and chemical tanker, *Vallermosa*, loaded with a full cargo of 35,000t of jet fuel and bound for the BP Hamble Terminal in Southampton Water, made contact with two oil tankers which were discharging alongside at Fawley Marine Terminal. The accident caused structural damage to all three vessels, minor damage to the jetty and minor pollution.

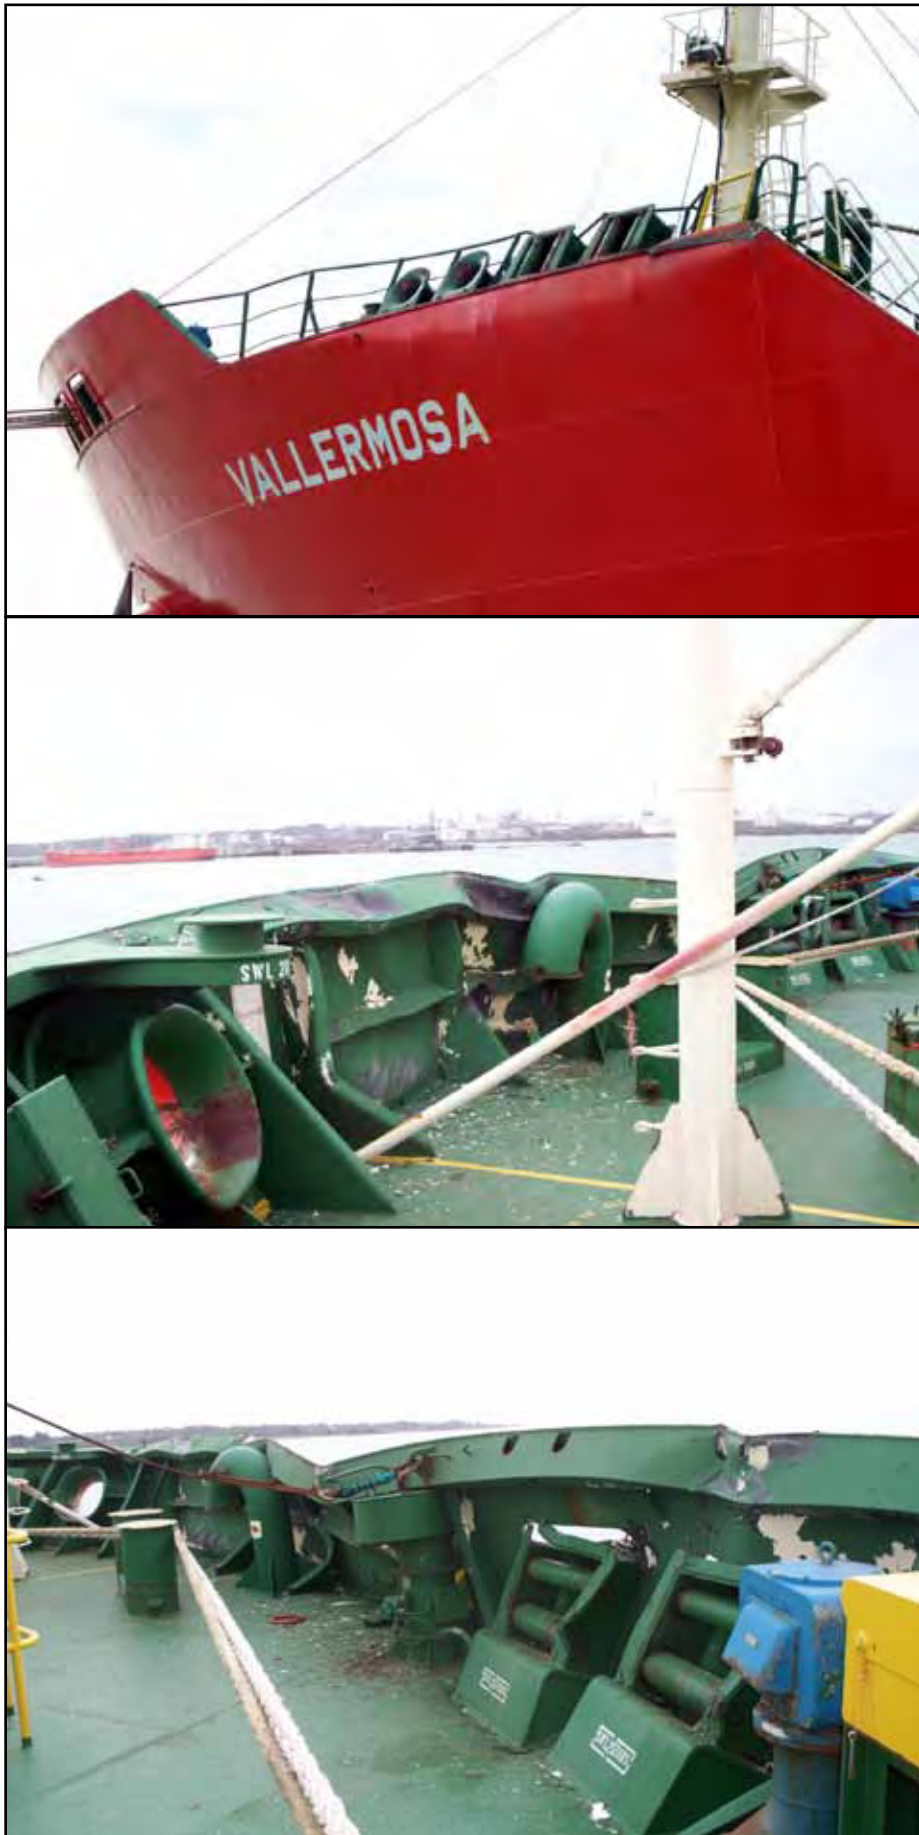
Figure 6

Vallermosa sustained damage (**Figure 6**) to the port and starboard side forecastle bulwark and connecting brackets, the forecastle deck was heavily buckled over a 15m length. Two fairleads on the port side and two on the starboard side were damaged along with the ventilation trunking to the forward store. Following discharge of her cargo, the vessel proceeded to Portland, where temporary repairs were effected. Permanent repairs were subsequently carried out in Flushing (**Figure 7**).

Damage sustained by *Vallermosa*

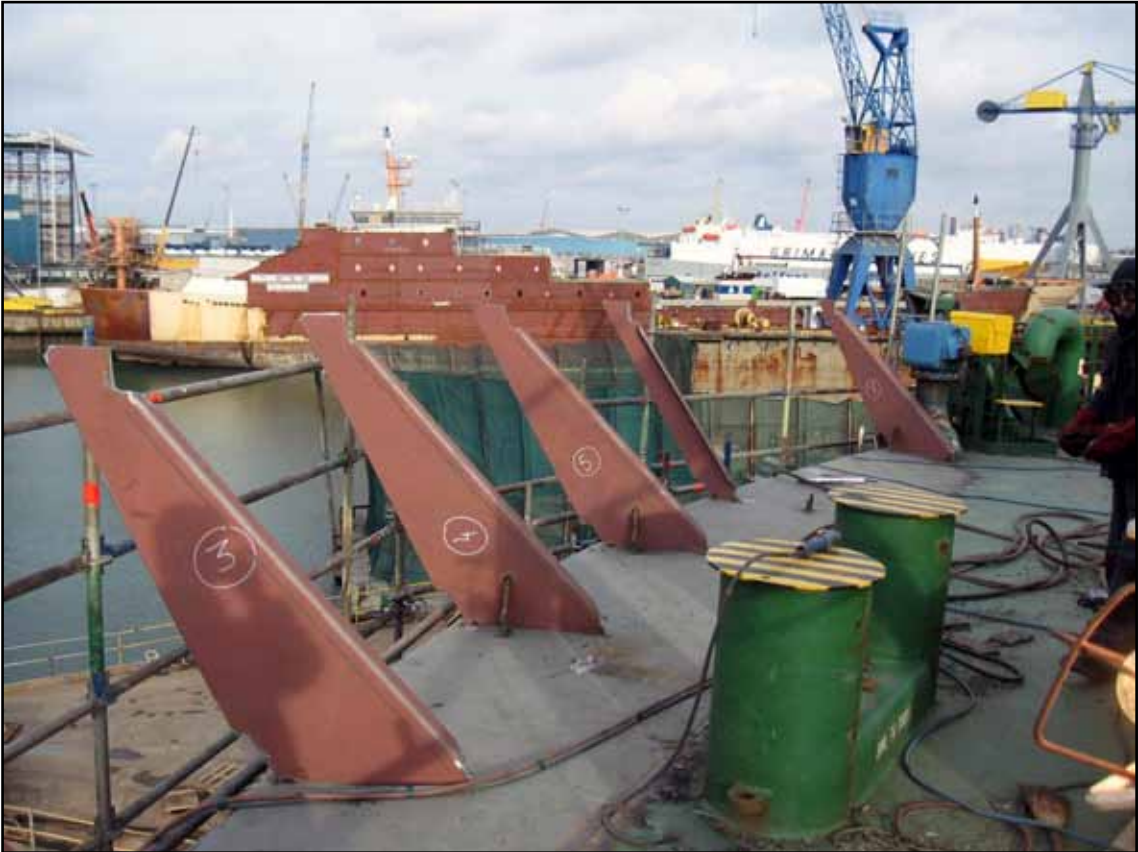
Figure 7

Vallermosa undergoing repairs in Flushing

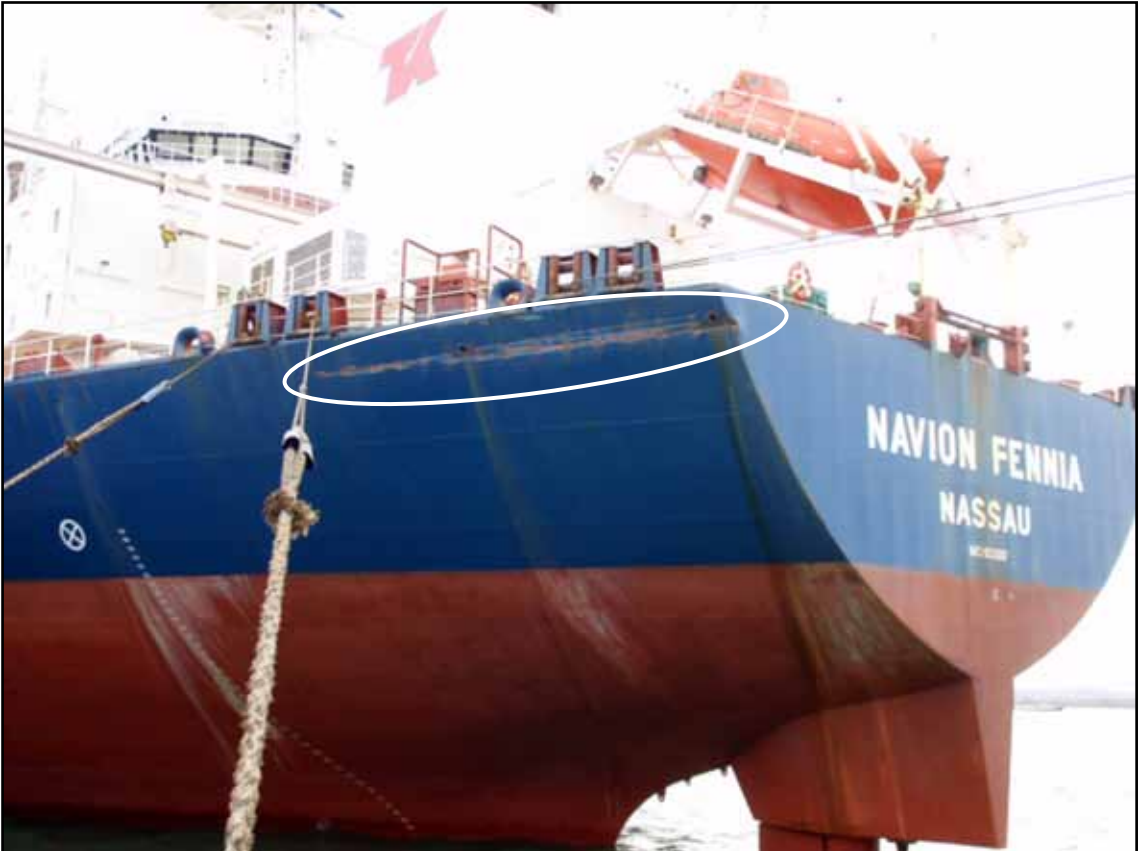
Figure 8

Navion Fennia, which was starboard side alongside Fawley Marine Terminal berth 5, sustained damage to her port quarter (**Figure 8**). This consisted of torn and indented plating with buckling of associated stiffeners. Temporary repairs were effected before the vessel left the Solent, allowing permanent repairs to be deferred until her next docking period.

Damage sustained by Navion Fennia

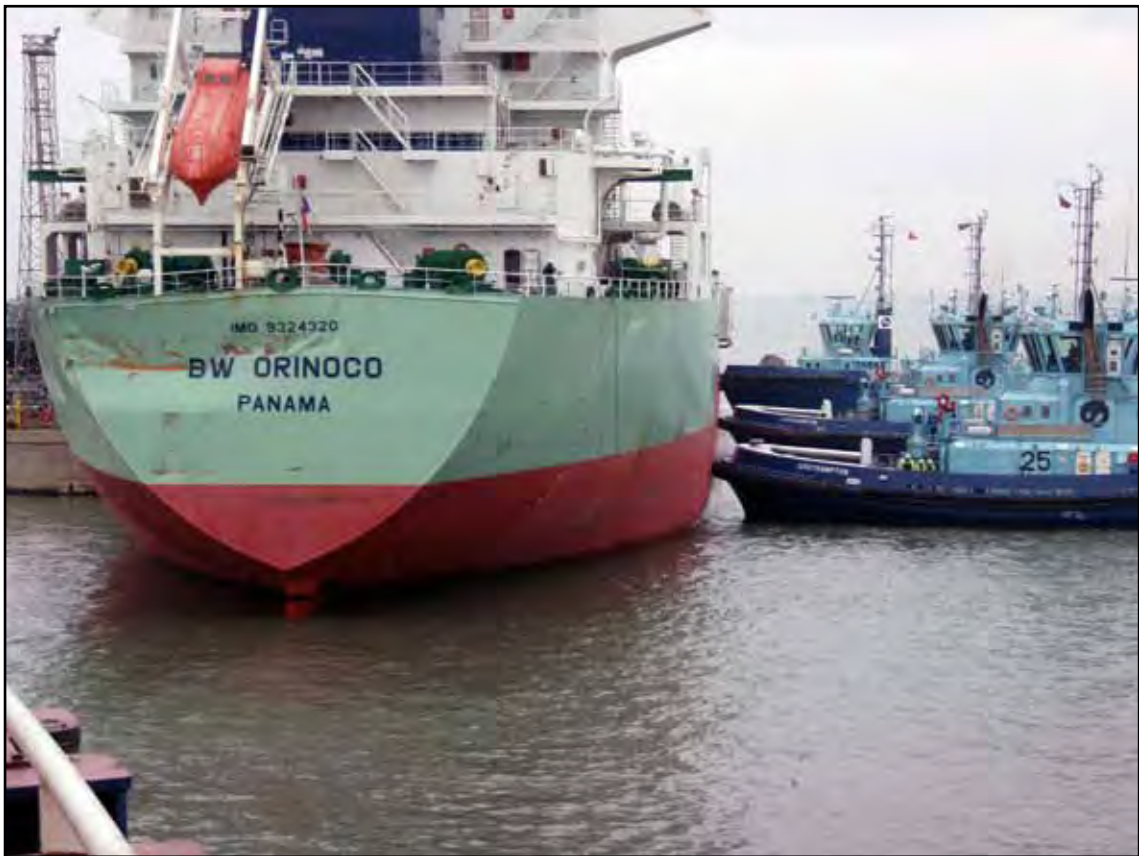
Figure 9

BW Orinoco, port side alongside Fawley Marine Terminal berth 4, sustained extensive damage to her port quarter, stern structure, poop deck and steering gear (**Figure 9**). The vessel required steelwork replacement (**Figure 10**), and repairs were also required to the freefall lifeboat davit before she could leave the Solent.

Damage sustained by *BW Orinoco*

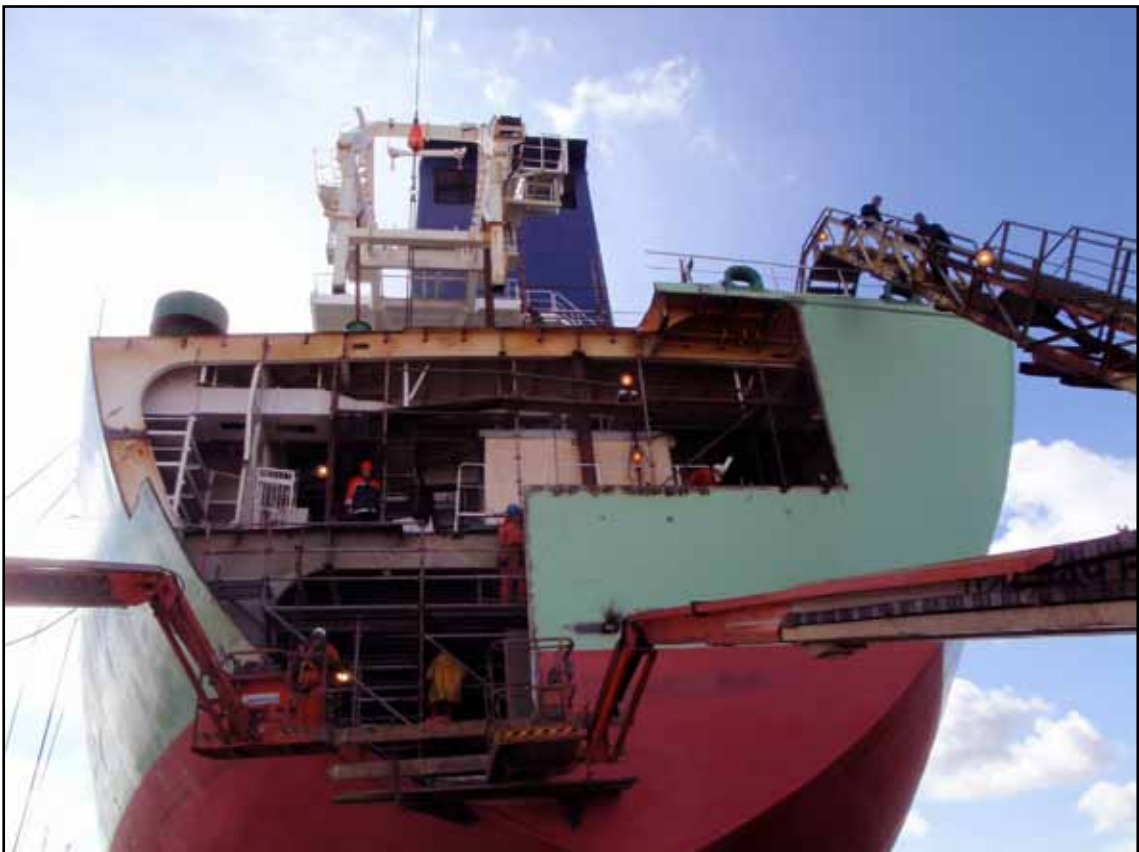
Figure 10

Repair work to *BW Orinoco*

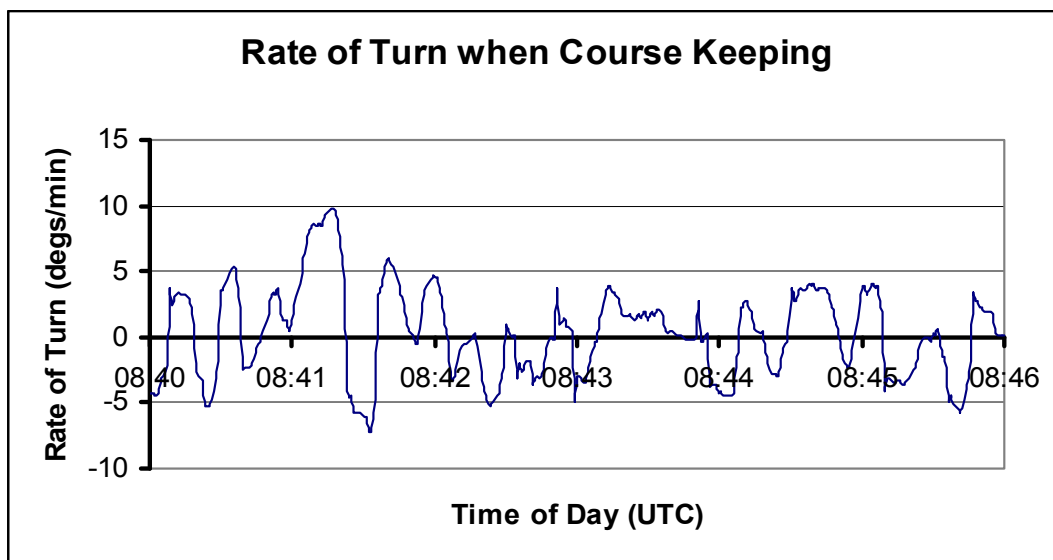
Figure 4: Vallermosa Measured Rate of Turn while on a Steady Course

It is seen that the rate of turn is hardly ever steady or close to zero, as one might have expected on a day when the winds were light and the sea slight. The plot in Figure 4 was made from data sampled every second, so the undulations, whose periodicity is well in excess of the sampling period, cannot be ascribed to noise in

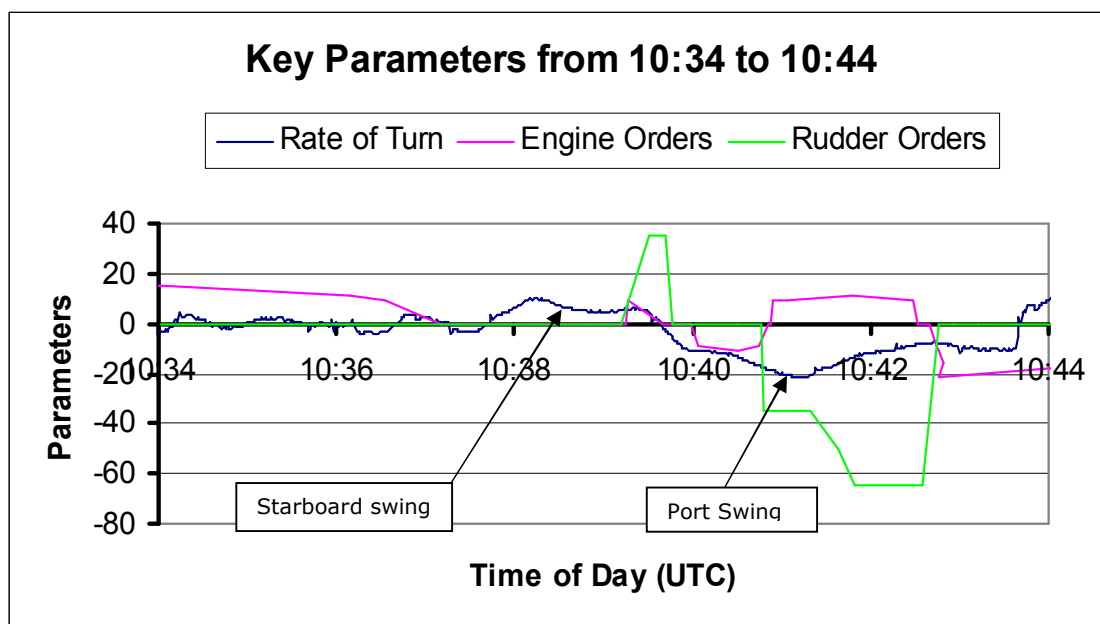
At 10:34 the ship was making about 11.5 knots over the ground with the engines on half ahead, having been reduced from full ahead. Figure 8 indicates the turn rate, rudder commands and engine orders over this last period.

Figure 8: Measured Parameters in Period Leading to Collision
