Report on the investigation of
the fatality of a chief officer in a ballast tank
on board the container ship

Ville de Mars

28 January 2009

Report No 20/2009
September 2009

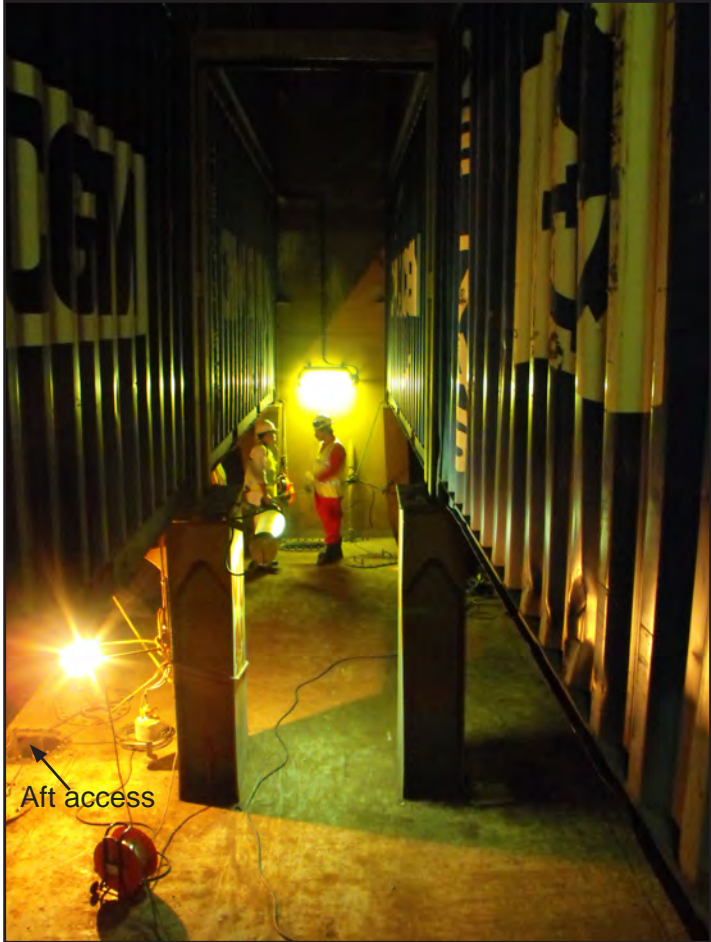
Figure 1

The party entered cargo hold No 1 and made their way to the forward access of WBT 1F (**Figure 1**). At 1030, the chief officer informed the third officer, who was the officer of the watch on the bridge, that he was about to enter the tank. He then took a reading of the tank's atmosphere by kneeling and reaching inside the access hatch with the gas analyser. The oxygen content was 20.9%¹. He put the analyser back in his boiler suit pocket and descended through the open manhole into the darkened tank, holding the lit torch in one hand. The bosun stood at the tank access monitoring the chief officer's progress; the AB stood about 0.5m behind the bosun.

Access to WBT 1F in cargo hold No 1

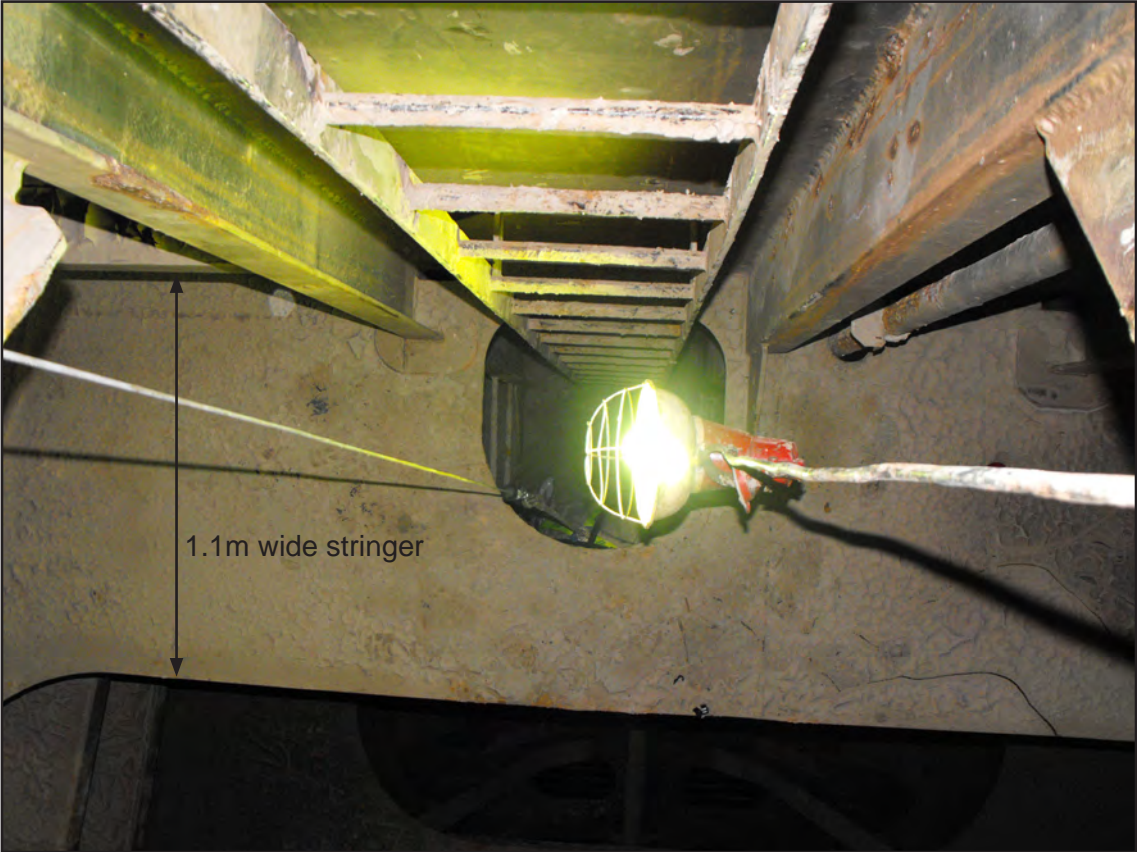
Figure 2

The chief officer stopped at the fifth or sixth rung of the vertical ladder, almost level with a transverse stringer (**Figure 2**) through which the ladder continued. He then took another reading from the gas analyser and informed the bosun that the oxygen level was between 20.8% and 20.9%. The chief officer then stepped to his left onto the stringer.

Upper transverse stringer

Although the location of the stringer made it easy to step onto when descending the ladder, it was not a means of access, and there was no requirement for the chief officer to use the stringer in order to get to the tank bottom. WTBT 1F was a potentially hazardous space protected by manhole covers. The removal of

these covers should have initiated a permit to work system requiring the space to be lit and the persons entering to wear fall arrestors or harnesses. Had these precautions been taken, the possibility of falling from the stringer to the tank bottom would have been eliminated.

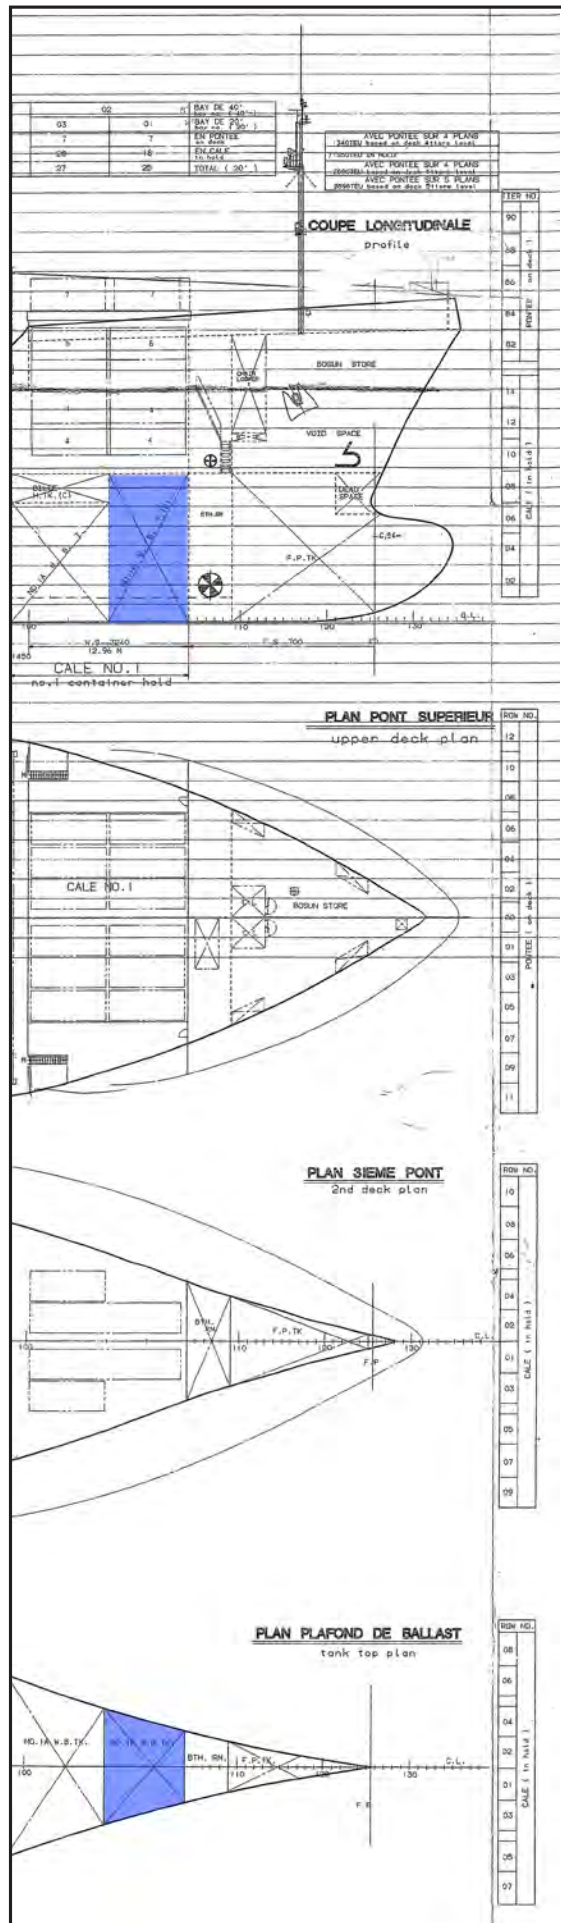
Figure 3

WBT 1F (**Figure 3**) had a capacity of 406 cubic meters and was 12.2m deep. Access to the tank was via two manholes located in the deck of cargo hold No 1. The forward manhole opened to a vertical ladder attached to the tank's forward bulkhead which was strengthened by vertical stiffeners and by three transverse stringers. The transverse stringers extended along the width of the tank and were 1.1m deep; the drop from the top stringer to the tank bottom was 7.74m. The ladder was continuous as it passed through a hole cut into the top stringer and terminated at the middle stringer. A second ladder provided access from the middle stringer to the tank bottom via a hole cut into the bottom stringer. The outer edge of the area between the ladders on the middle stringer was protected by guardrails (**Figure 4**). No protection was fitted on the outer edge of the top and bottom stringers

General arrangement showing the location of WBT 1F

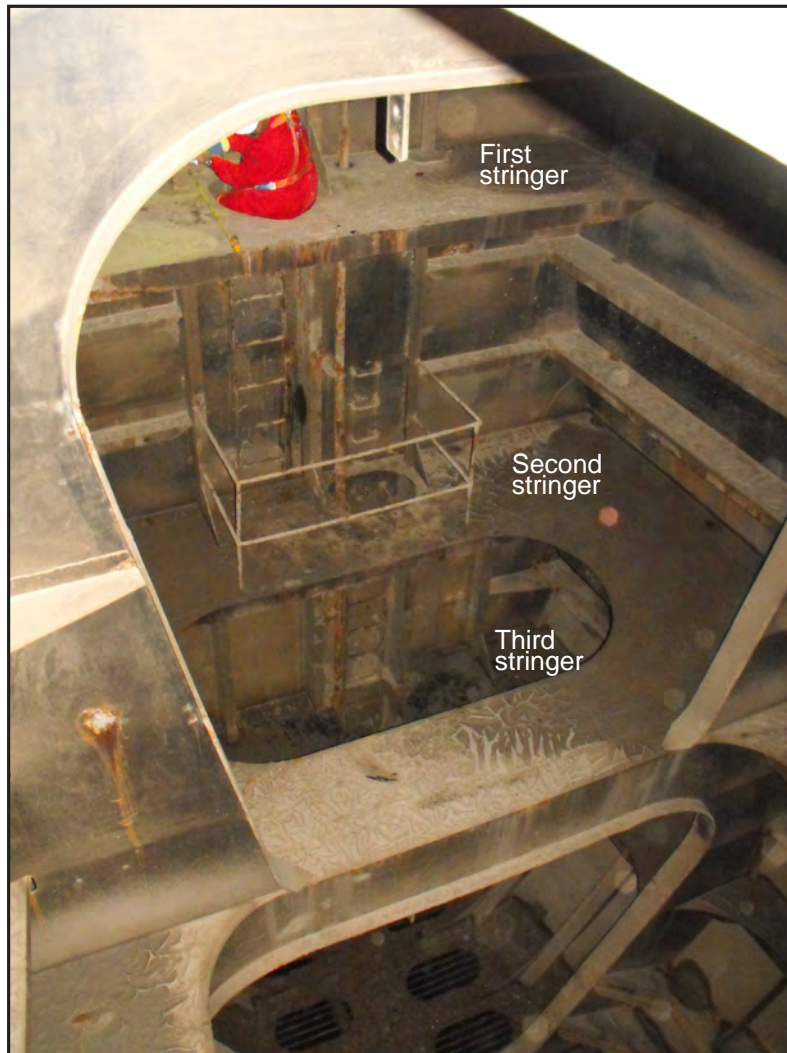
Figure 4

Forward bulkhead with stringers, ladders and guardrails
