**MICRON EAGLE HYDRAULICS LIMITED
THOERY OF OPERATION
INSTALLATION OF CURSOR WINCH ON FWD BELL SYSTEM
CSO WELLSERVICER**

Project: Installation and commissioning of Cursor Winch on Fwd Bell Handling System on the CSO Wellservicer

Extract from Aberdeen Hydraulics Report to the MAIB

FLYER TO THE SHIPPING INDUSTRY Fatality on the diving support vessel *Wellservicer*

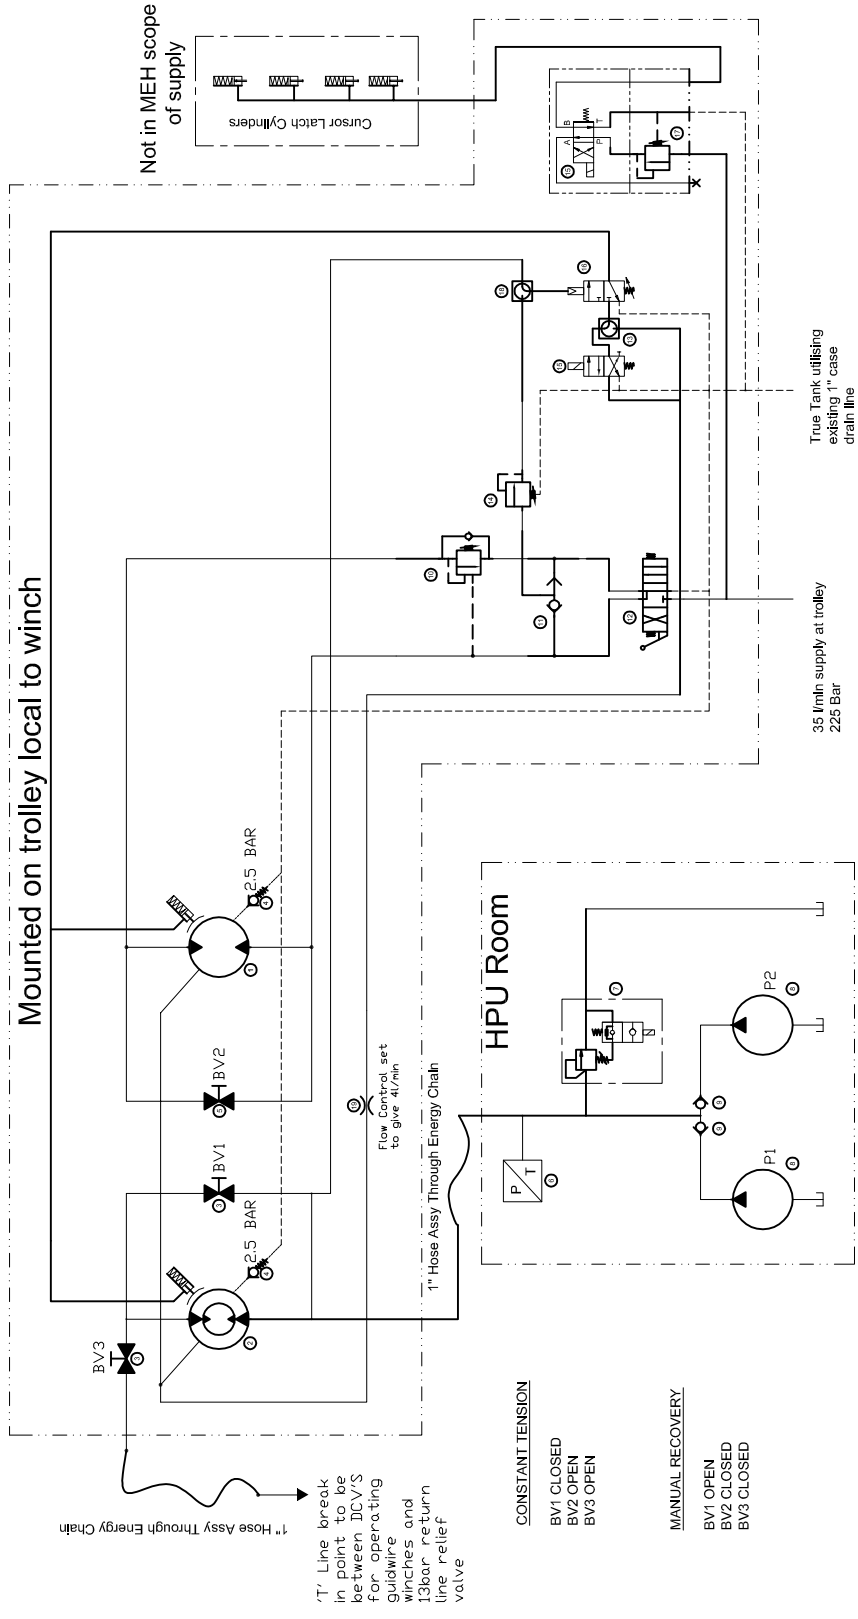
CUSTOMER	Technip UK Ltd
TITLE	Fwd Cursor Winch Circuit for Wellservber including Ball Hooks
DATE	28.01.09
SCALE	N.T.S.
DRAWING No.	ME24213-001

There are two electric motor / hydraulic pump sets (item 8) provided to drive the winch in constant tension mode. Only one is required for constant tension mode the second being a standby unit. At all times when the Cursor is moving one pump set must be running. These will deliver a constant flow to the raise port of the dual speed winch motor (item 2). The constant tension pressure will be set by means of an unloading relief valve (item 7) which will be located in the HPU room local to the pumps. This will need to be set during commissioning. The unloading part of the relief valve is controlled by a 24v DC solenoid valve which needs to be energised to build constant tension pressure. This would be best controlled by a timer so that the motor can start on no load and after a set time the system is 'loaded up' to the constant tension pressure. The lower port on the motor will be connected back into the 13 bar return line of the existing system at the most convenient break in point. Isolation Ball Valve BV3 (item 3) will be open for constant tension mode and closed for emergency mode. Isolation Ball Valve BV1 (item 3) will be closed for constant tension mode and open for emergency mode.

There is a failsafe on the brake circuit facilitated by the pilot operated DCV (item 16) which will only allow the brakes to be released when the constant tension system is healthy.

1. Pressure reducing valve (14) traps pressure on to the pilot of variable pilot valve (16), thus allowing pressure through to release the brakes.
2. Pressure reducing valve (14) delays the pilot venting from variable pilot valve (16), thus causing a delay in the brakes applying.
3. Variable pilot valve (16) sticks in the operated position due to contamination, thus allowing pressure through to release the brakes.
4. Very high tank pressure in excess of 16 Barg, thus allowing the brakes to release via the "T" port of variable pilot valve (16).

5. Obstruction in the brake line between the brake and variable pilot valve (16), thus preventing the brake actuators from venting when the variable pilot valve (16) is in the spring offset position.
6. Obstruction in the "T" line from variable pilot valve (16), thus preventing the brake actuators from venting when the variable pilot valve (16) is in the spring offset position.

Dynamic braking in this circuit is achieved by counterbalance valve (10) even without the brakes applied in a correctly configured circuit with the power pack running the winch should not lower off uncontrolled. The winch however would creep due to internal leakage.

8.3 The utilisation of the Hagglunds motor and the failure to adhere to the manufacturers recommendations in respect to supplying sufficient charge pressure directly impacts on the load holding capabilities of the motor when used in a lifting application.

- The design of the hydraulic circuit for the new cursor winch meant that the two brakes fitted to the winch did not operate independently, as they were required to do, since a single, defective, pilot valve was common to both brake circuits.

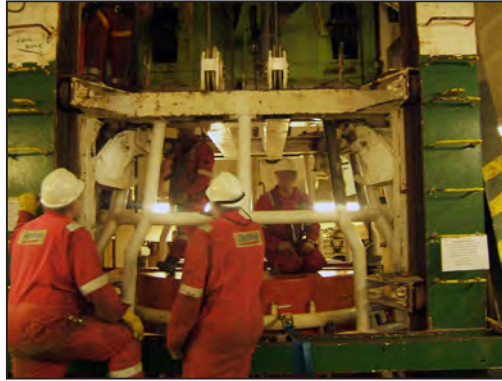
A crew member suffered fatal injuries while carrying out modification work on the diving bell recovery system of the diving support vessel *Wellservicer*.

The cause of the winch failure was attributed to a faulty pilot valve in the cursor's winch control system, which prevented the winch brakes from applying once hydraulic power was removed.
