Report on the investigation of  
a fatal accident on  
***Wellservicer***  
3 miles SE of Aberdeen, Scotland  
1 April 2009

Marine Accident Investigation Branch  
Mountbatten House  
Grosvenor Square  
Southampton  
United Kingdom  
SO15 2JU

**Report No 1/2010**  
**January 2010**

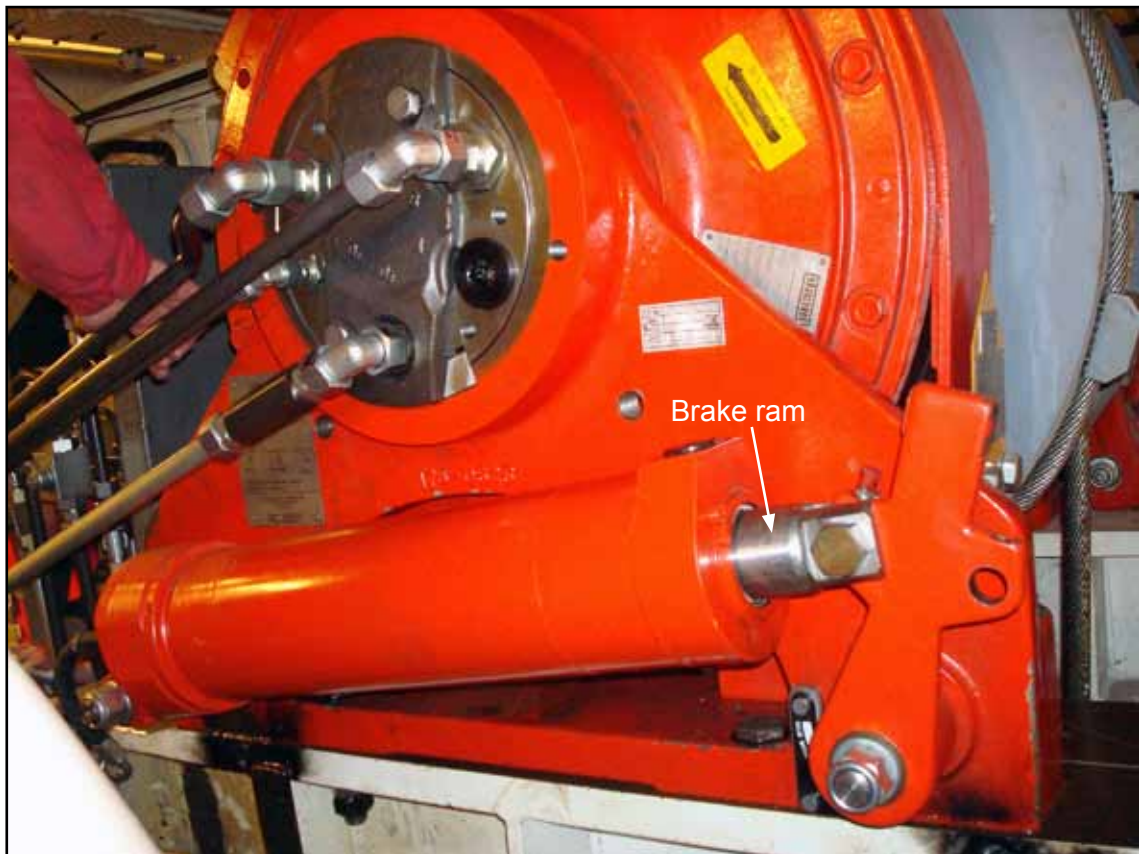
On 31 March, with the bell in the moonpool suspended from its normal winch wires and the cursor suspended by strops from the trolley, modification work continued, including the spooling of wire onto the new cursor winch sited on top of the bell trolley. The wire was then attached to the 4t cursor, enabling it to be independently supported by its own dedicated winch and wire. During the spooling of the winch wire, one of the Modification installation team noticed that, on one occasion, the winch brake ram (**Figure 8**) did not properly apply when

Cursor winch forward brake ram

the local winch control handle was released (**Figure 9**). This was remedied by the winch operator wiggling the control lever, and highlighted to him that the brakes would need some adjustment as part of the system's commissioning.

At one point during installation, a member of the installation team observed that the brakes did not fully apply. This was corrected by wiggling the control handle, and a mental note was made at the time to adjust the brakes later on. This was, in all probability, an early indication that the pilot valve was faulty and the “wiggle” was simply enough to release pressure from the system allowing the brakes to apply.

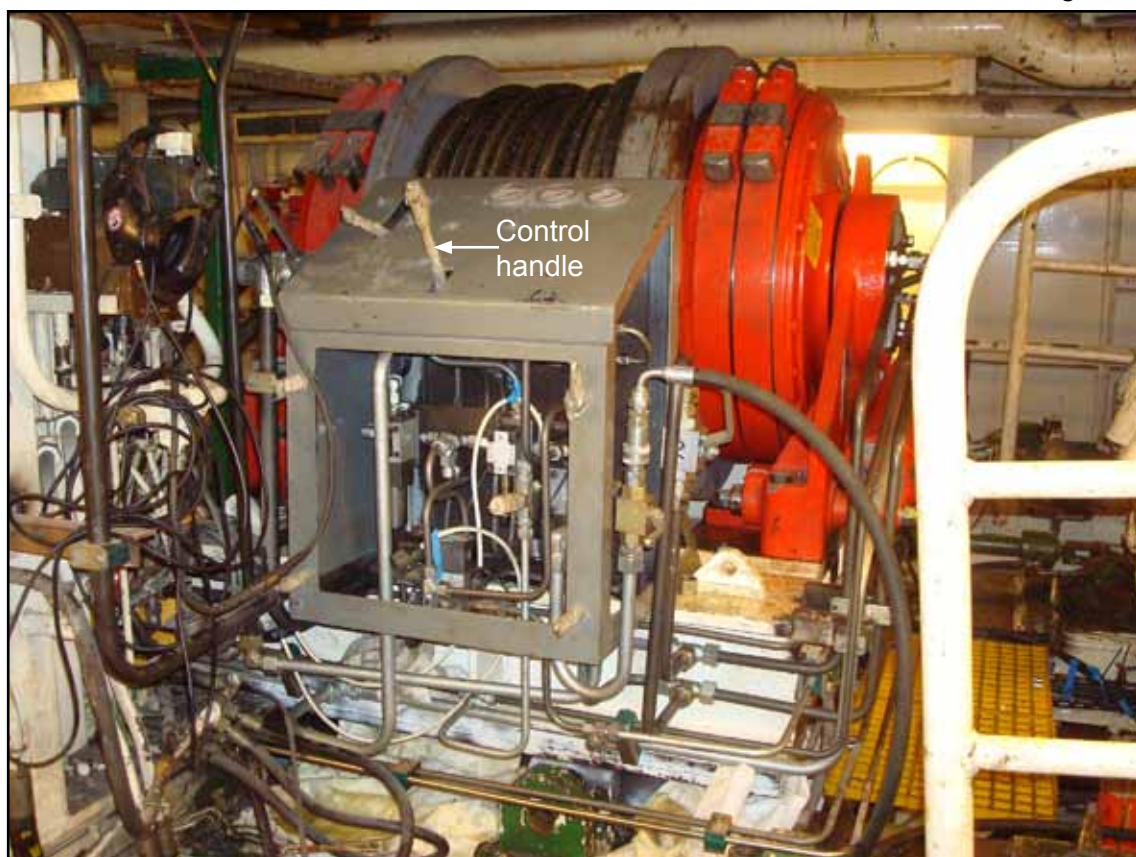
Figure 9

Cursor winch local control panel

In view of the function required to be carried out by the winch, i.e. emergency lifting or constant tension of the cursor wire in normal operations, the hydraulic lock, often found in winches to prevent them from veering, was not incorporated in the Hagglunds winch. This would have been acceptable provided the brakes were independently controlled. However, the design of the hydraulic circuit was such that the brakes were controlled through a single source (the defective pilot valve) and the independence of the brake operation was compromised. Consequently, on this occasion, when the control lever was released and the

power to the winch switched off, neither brake applied as hydraulic pressure was retained in circuits to both the brakes by the defective valve. The weight of the suspended cursor then caused the winch drum to creep back and go into freefall.

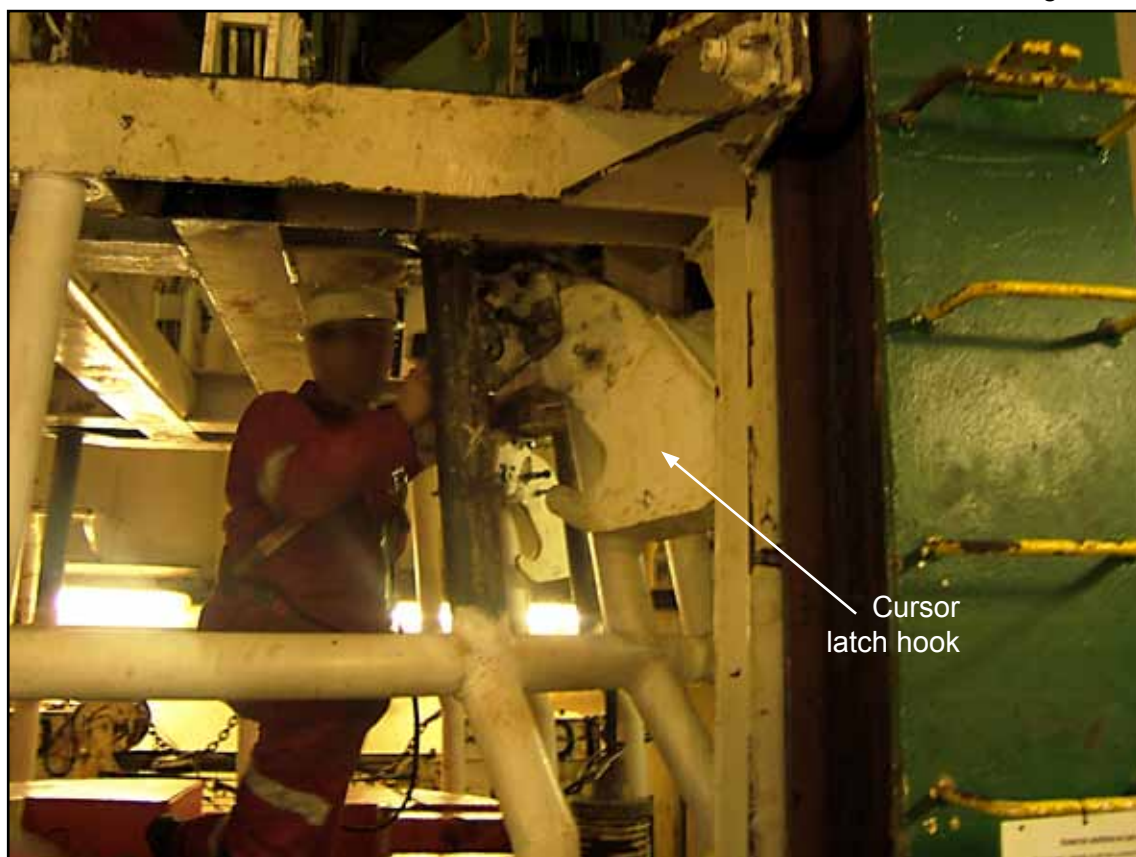
Figure 10

Rigger working on cursor latch hooks under suspended cursor

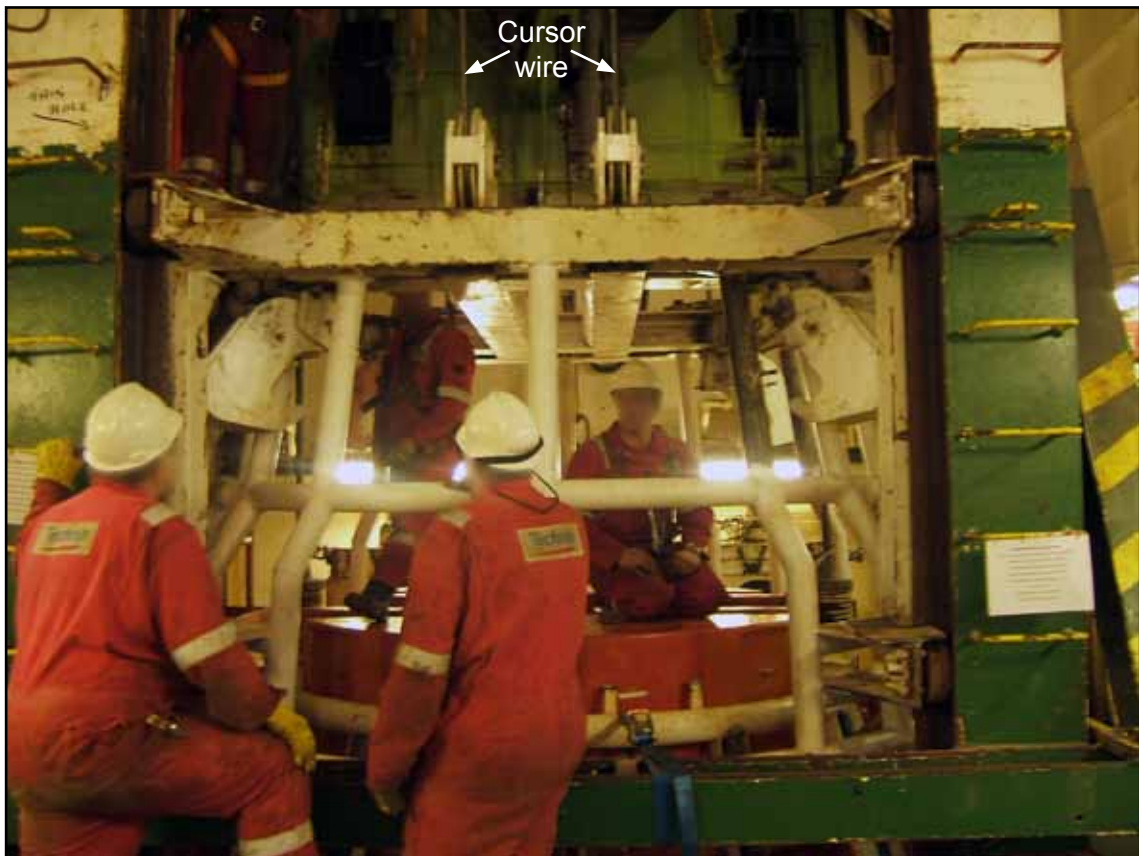
Figure 11

Riggers on top of the bell, under suspended cursor

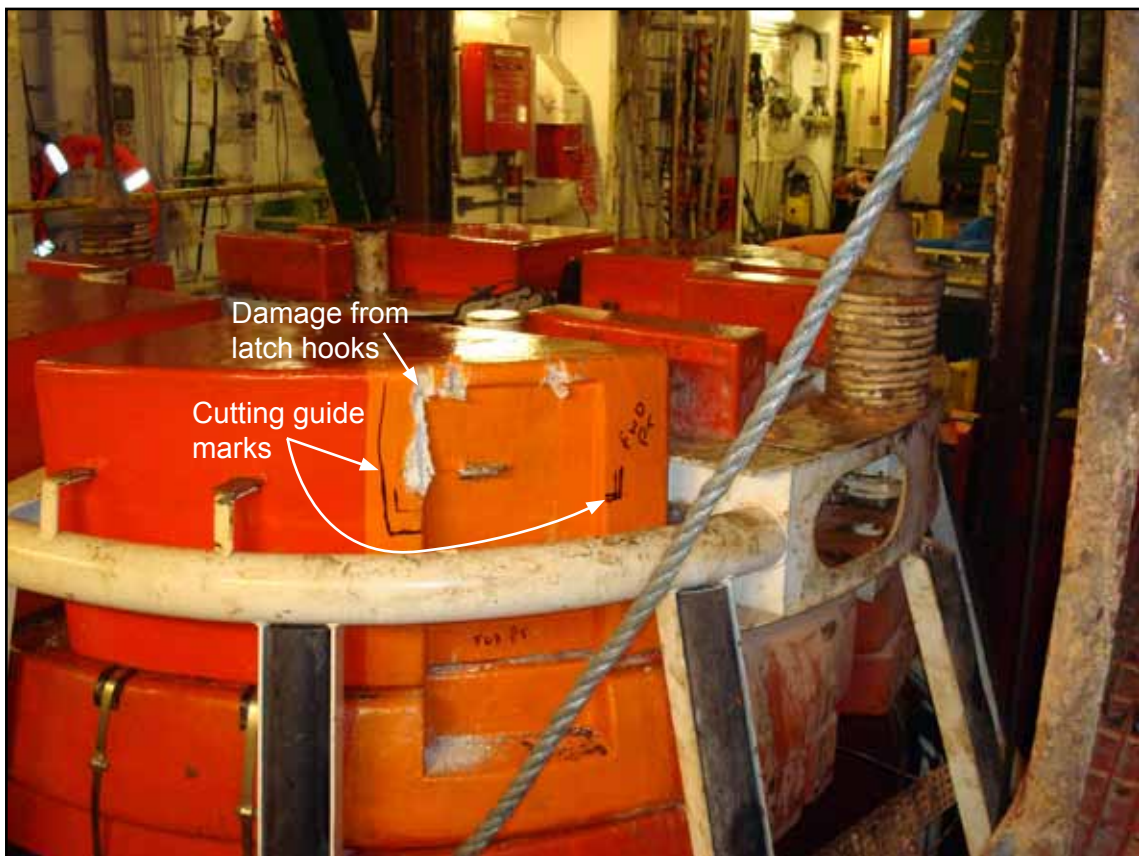
Figure 12

Damaged buoyancy blocks

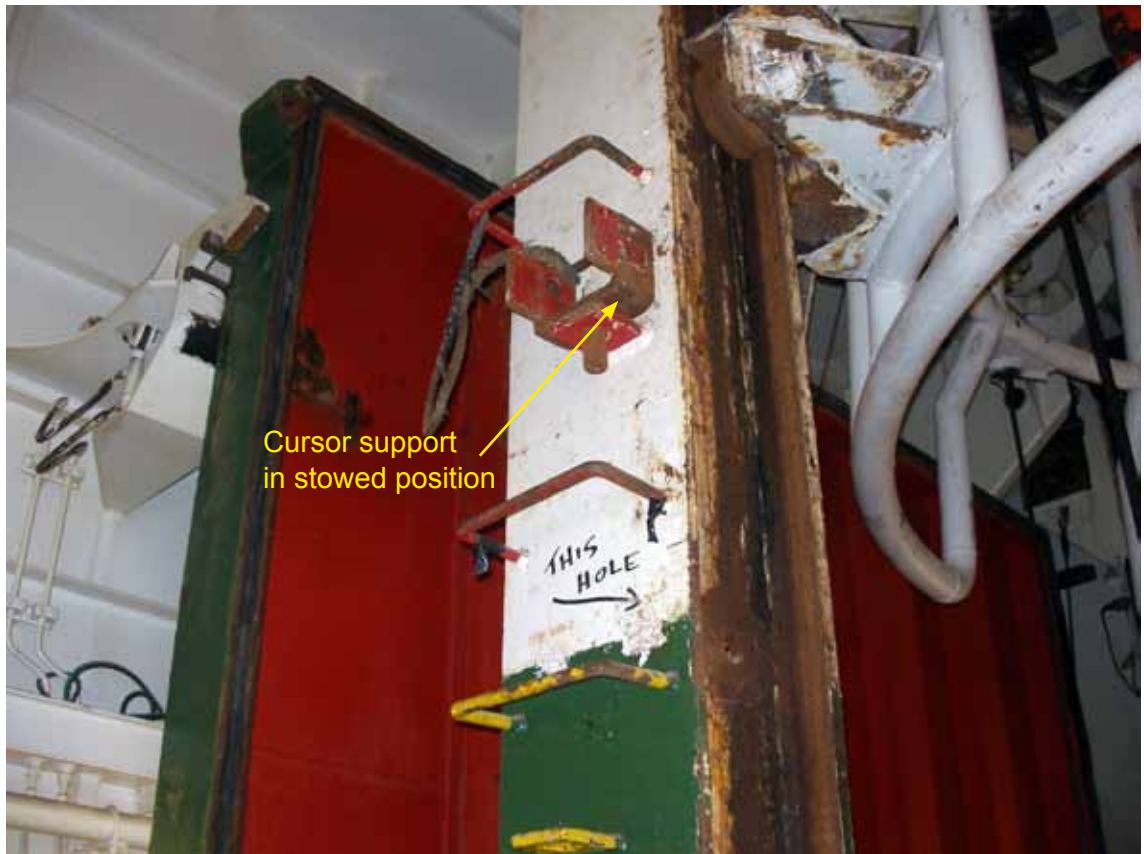
Cursor support  
in stowed position

Cursor support position at the time of accident

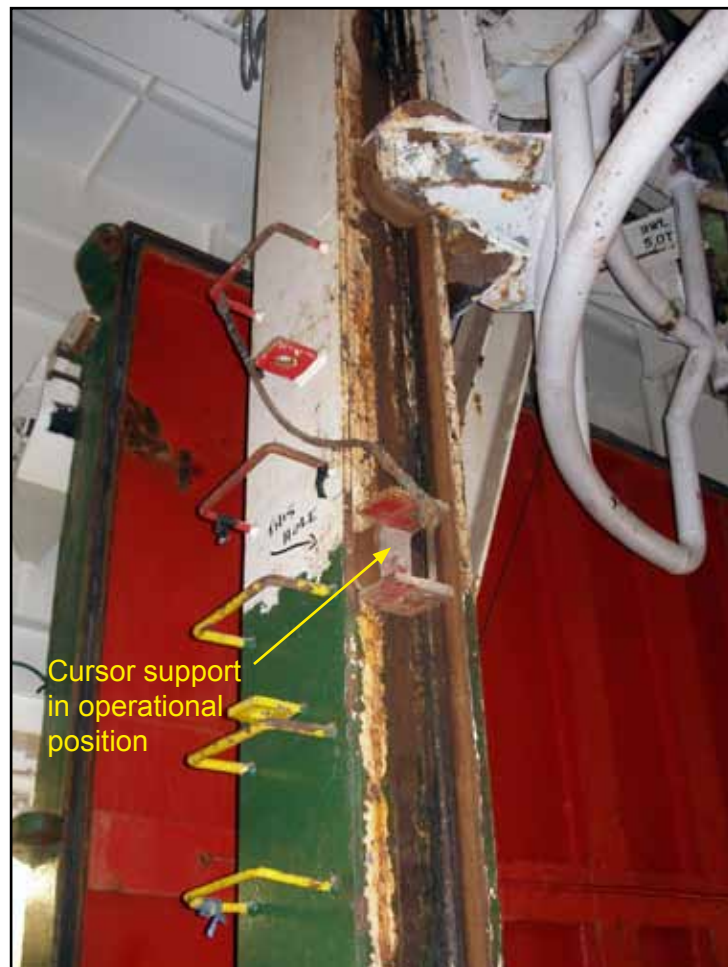
Figure 15b

Cursor support  
in operational  
position

Cursor support shown in operational position
