Report on the investigation of the collision between

Gas Monarch and Whispa

6 miles ESE of Lowestoft

**Report No 25/2007
December 2007**

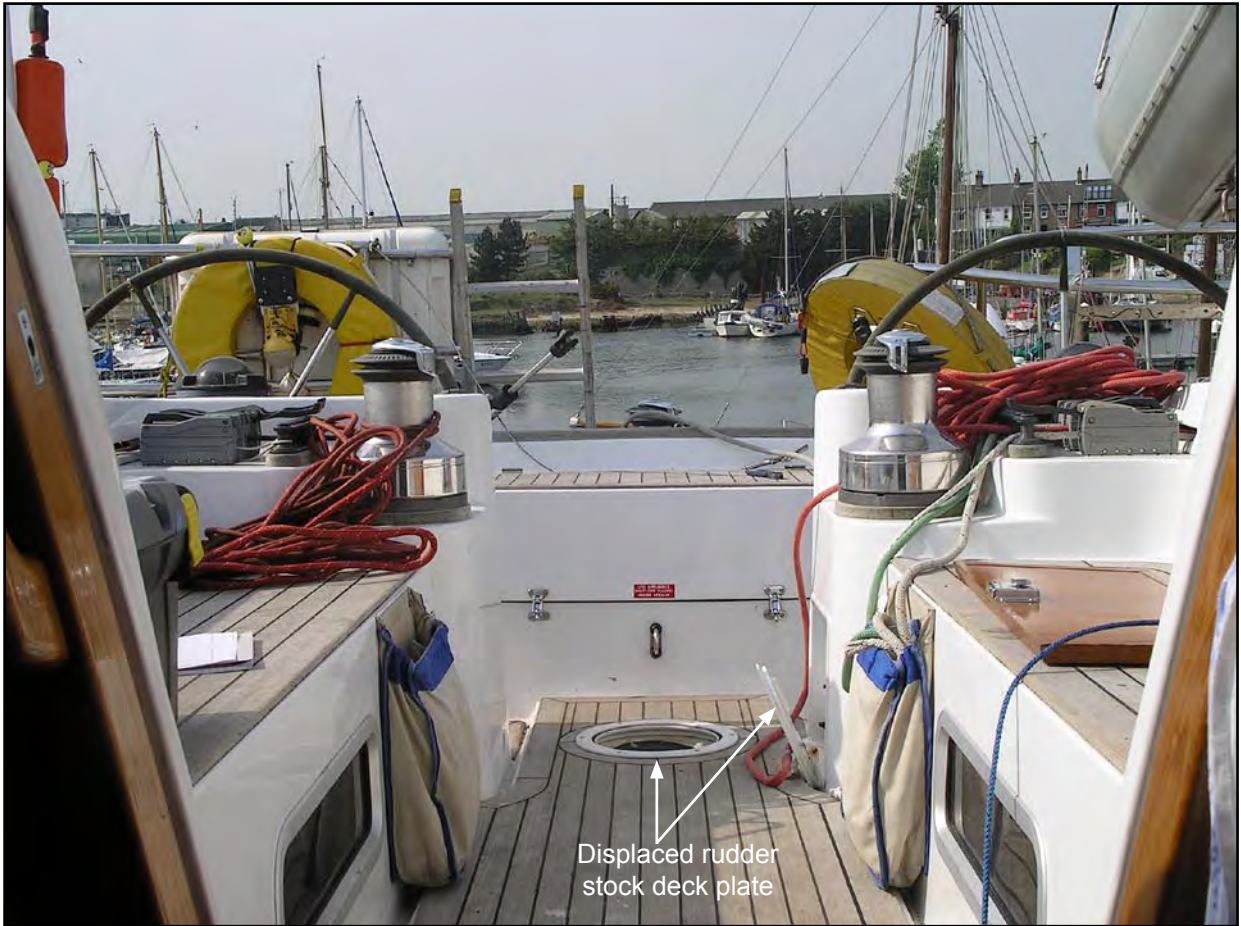
It took several minutes for the skipper of *Whispa* to compose himself but, once calm, he and his crew member carried out a check for damage. It was apparent that the rudder stock deck plate (**Figure 6**) was displaced, and on inspecting below deck they discovered that the vessel's lazarette had some 18 inches depth of the water in the space. On putting the vessel's engine into forward gear (the skipper had put the engine in neutral immediately after the collision), it was found that the steering was severely damaged. No other damage was evident below decks, and they were not unduly worried about the yacht sinking because she had a transverse watertight bulkhead forward of the lazarette, thus containing water ingress to that compartment.

Whispa's deck, showing the displaced rudder stock deck plate

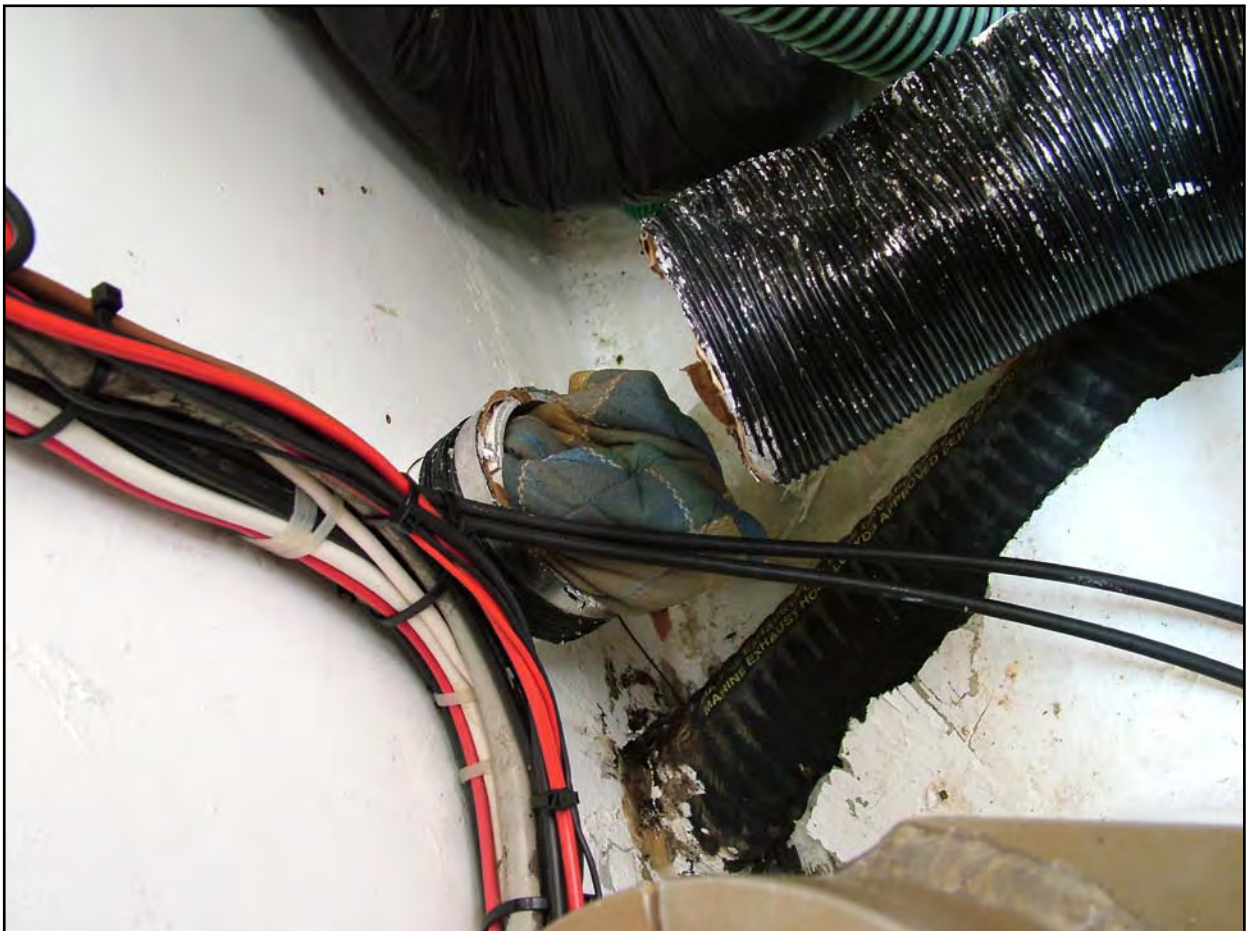
alongside *Whispa* to assist. Two crewmen from the lifeboat boarded *Whispa* with a portable salvage pump, and after several minutes succeeded in starting and priming the pump. Thereafter it took over an hour to contain the flooding to a level where the tow could be resumed. The flooding had been caused as a result of hot air conduit pipes passing through the watertight lazarette bulkhead becoming sheared by the damaged steering gear during the tow. Once the route of the flooding had been established, *Whispa*'s skipper was able to stuff rags into the sheared 4 inch bore pipes (**Figure 7**). This reduced the flooding significantly.

Sheared air conduit

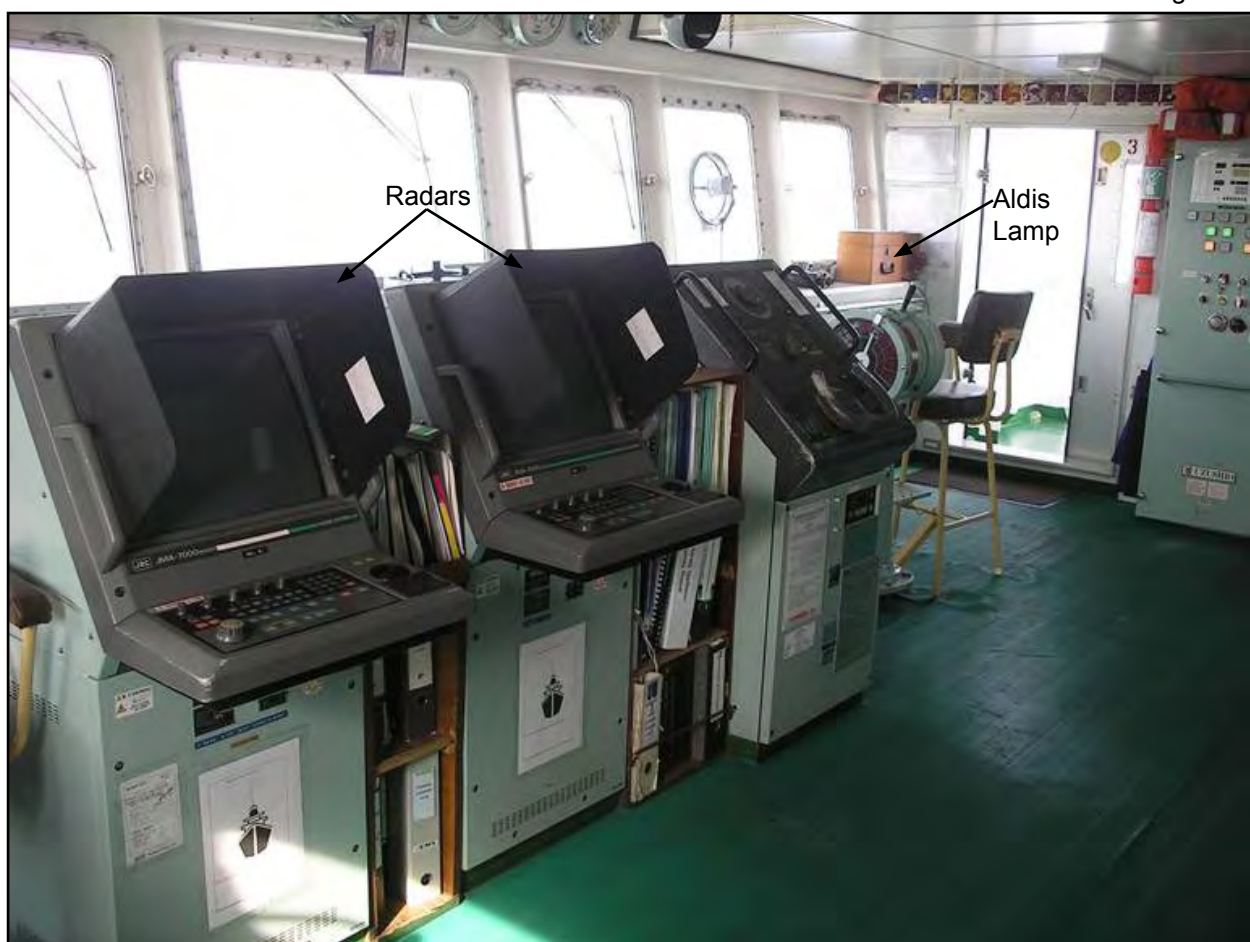
Gas Monarch's radars

Resulting from its own investigation, EMS requested ship's staff to conduct radar performance tests. These were carried out using the method advised in the radar operations manual (**Annex 2**). These tests revealed that neither radar was achieving 50% of optimum attenuation. On 10 May 2007, the vessel was attended by service technicians in the port of Antwerp, where it was established the magnetron on each radar had deteriorated to well below optimum capability. It was also found that the radar scanner bearings on the X band radar were worn to the extent that they were allowing vertical play of 2cm in the antenna.

Soon after the accident, the vessel's radars were inspected by service technicians in the port of Antwerp, where it was confirmed that the magnetron on each radar had deteriorated to well below optimum capability, and they were duly replaced. It was also found that the radar scanner bearings on the X band radar were worn to the extent that they allowed vertical play of 2cm in the antenna. A recommendation was made by the technicians to have this attended to as a matter of urgency.

Less than a year previously, the X band radar's magnetron had been replaced in Amsterdam. It is possible that the play in the radar scanner was contributory to the deterioration of the magnetron in such a short time span. The play in the scanner could also be responsible for deflecting some of the radar's energy from the wave guide and, thus, also contribute to poor performance.

- Following an appropriate performance check of the vessel's radars, the equipment was serviced and magnetrons replaced.
- Accelerated its programme to fit S-VDR across the fleet and implemented a regime whereby VDR data is used to assist masters and auditors when reviewing operational practices on board the vessels.

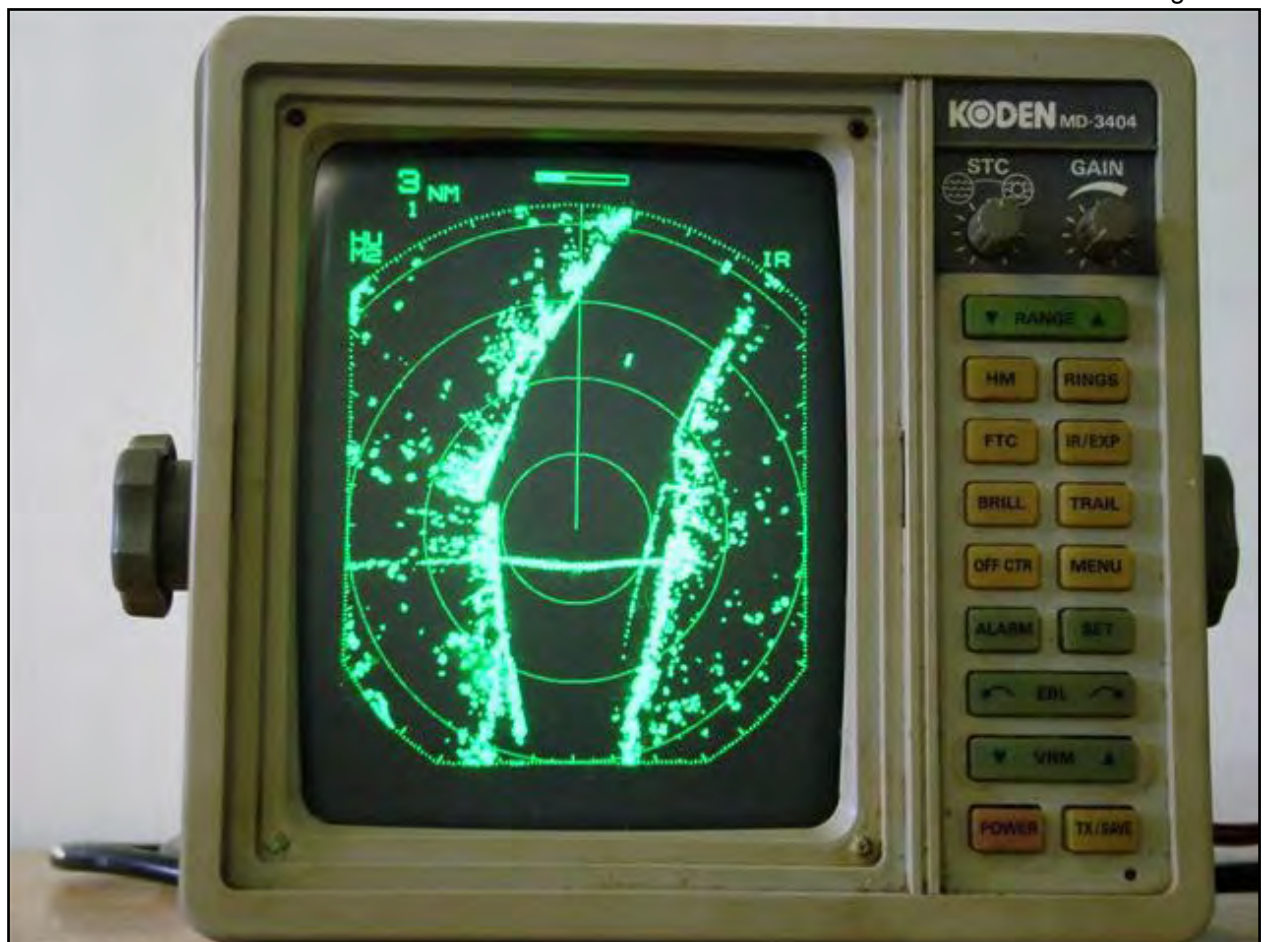
The skipper was unaware that his radar had a 24-mile range capability, and believed that the 6 and 3 mile scales had range ring spacing of 1 and 0.5 mile respectively (**Figures 14 and 15**). It was the skipper's perception that, when the radar was set on the 6-miles range, contacts coming onto the extremity of the screen directly in front of the yacht were 6 miles distant, when in fact they were actually about 8 miles away due to the oblong shape of the screen (**Figure 14**). On the 6-mile range, the radar screen was configured so that the last complete range ring was displayed at 6 miles; this screen configuration gave the effect of being continually off-centre, with additional off-centre options if required.

Whispa's radar screen showing 1 mile range rings on a 3 mile scale

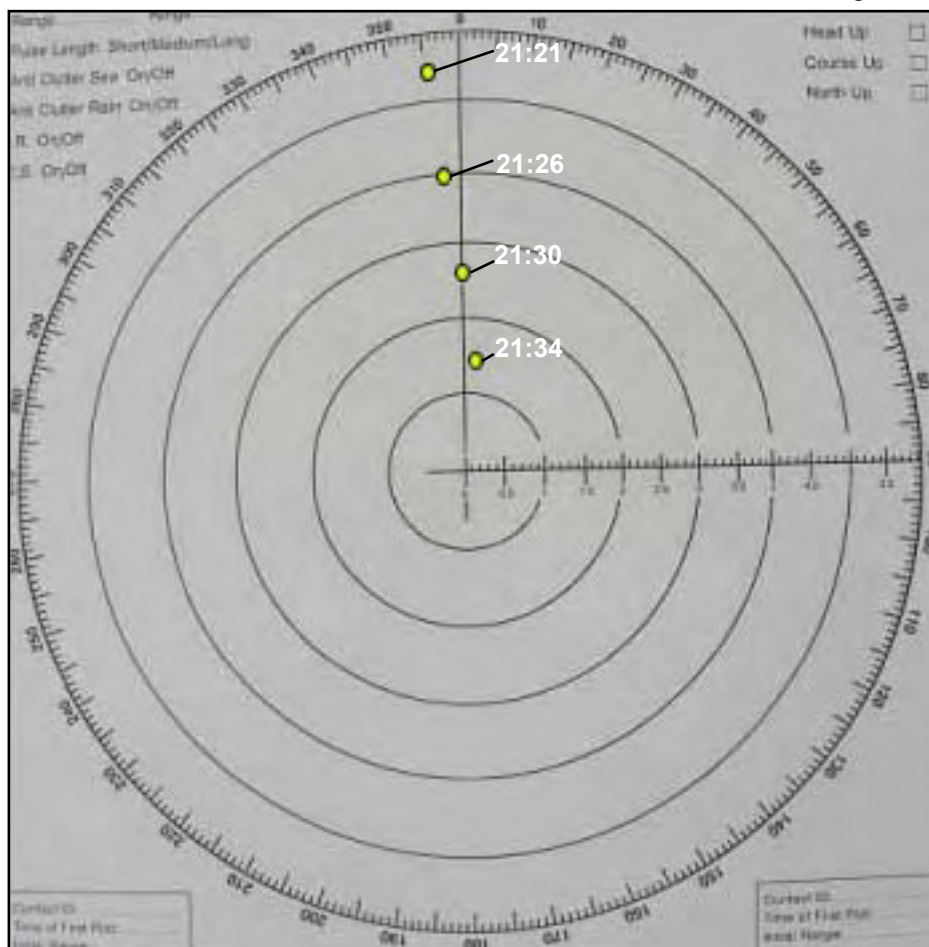
Figure 17

After the accident, when *Whispa* had been lifted ashore for repair, an experienced radar service technician visited the vessel and checked the validity of the radar's heading marker. The service technician found that the heading marker had a starboard error of no less than 2°, and thus the radar target of *Gas Monarch* would have been displayed on the radar screen slightly to port of her real bearing relative to *Whispa*. Due to *Whispa*'s navigation station being displaced some 5m from the steering wheels, it would be difficult for the skipper to compare the yacht's head with the radar heading

The foregoing issues would go some way to explaining the radar image displayed on *Whispa's* radar and her skipper's perception that the unidentified contact appeared to be on a collision course, encouraging his alteration across its stem. **Figure 17** shows a representation of how *Gas Monarch's* radar image might have appeared on a correctly aligned radar display without taking into account unstabilised display anomalies, heading marker error or enlargement of the image due to beam width expansion; all of these would have made accurate monitoring of a closing vessel very difficult even if the skipper had been aware of them. Also, due to the radar's heading marker misalignment, the contact did not appear on the starboard side of *Whispa's* heading marker at any time.

Representational radar plot of how *Gas Monarch* may have appeared on a correctly aligned display, not taking account of any beam width or unstabilised anomalies, prior to *Whispa's* alteration of course to starboard.
