**Report of the Inspector's Inquiry
into Three Fatalities and Injuries
to Six Crew Members on board
fv ATLANTIC PRINCESS
on 25 July 1996
off the Coast of Mauritania, West Africa**

Position of ATLANTIC PRINCESS
at time of accident

SYNOPSIS

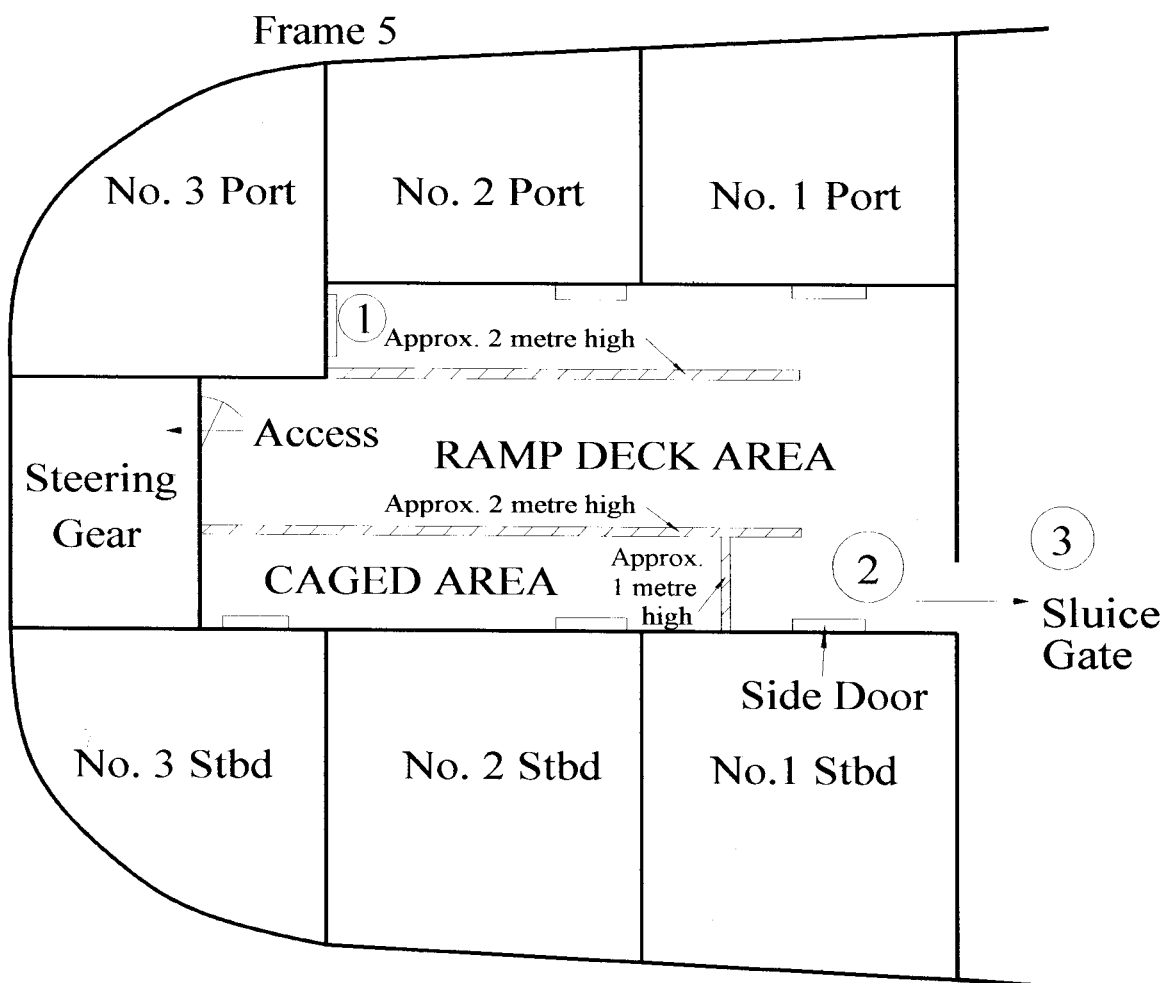
RAMP DECK AREA AND RSW TANKS
Not to Scale

- ① Mr Kurelus
- ② Mr van der Plas
- ③ Mr Fairbairn

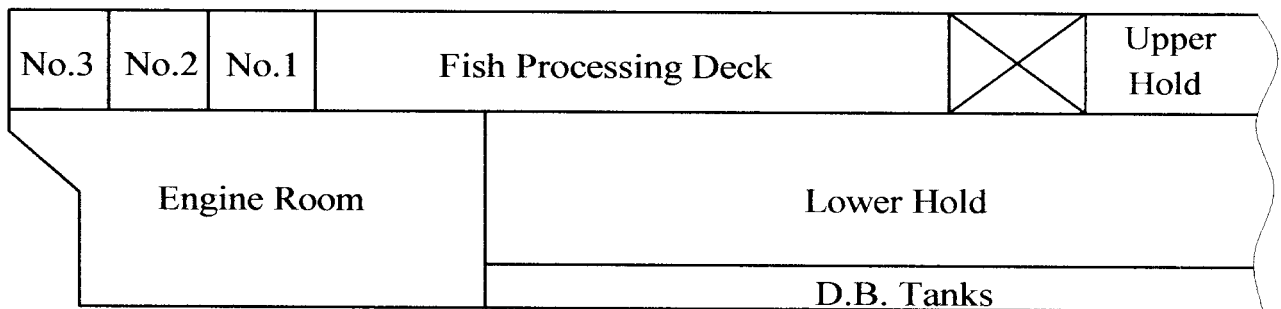
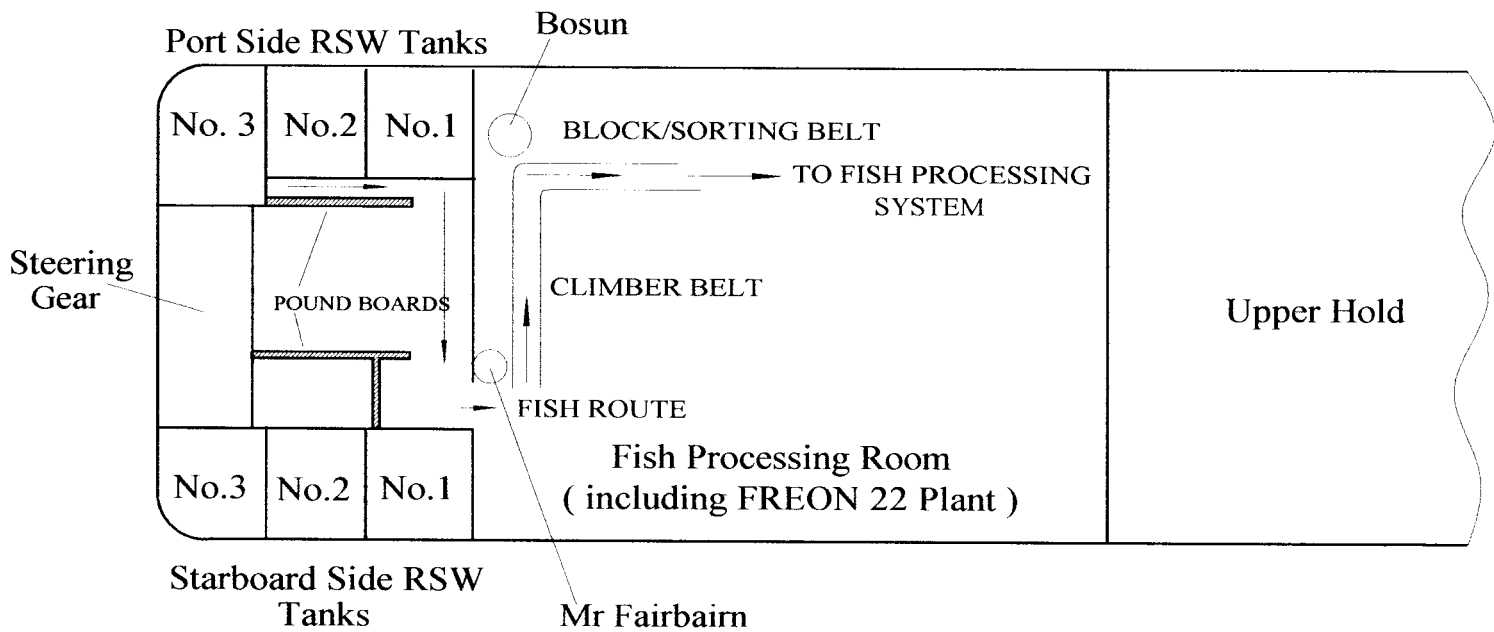
Figure 3

FISH HANDLING SYSTEM Not to Scale

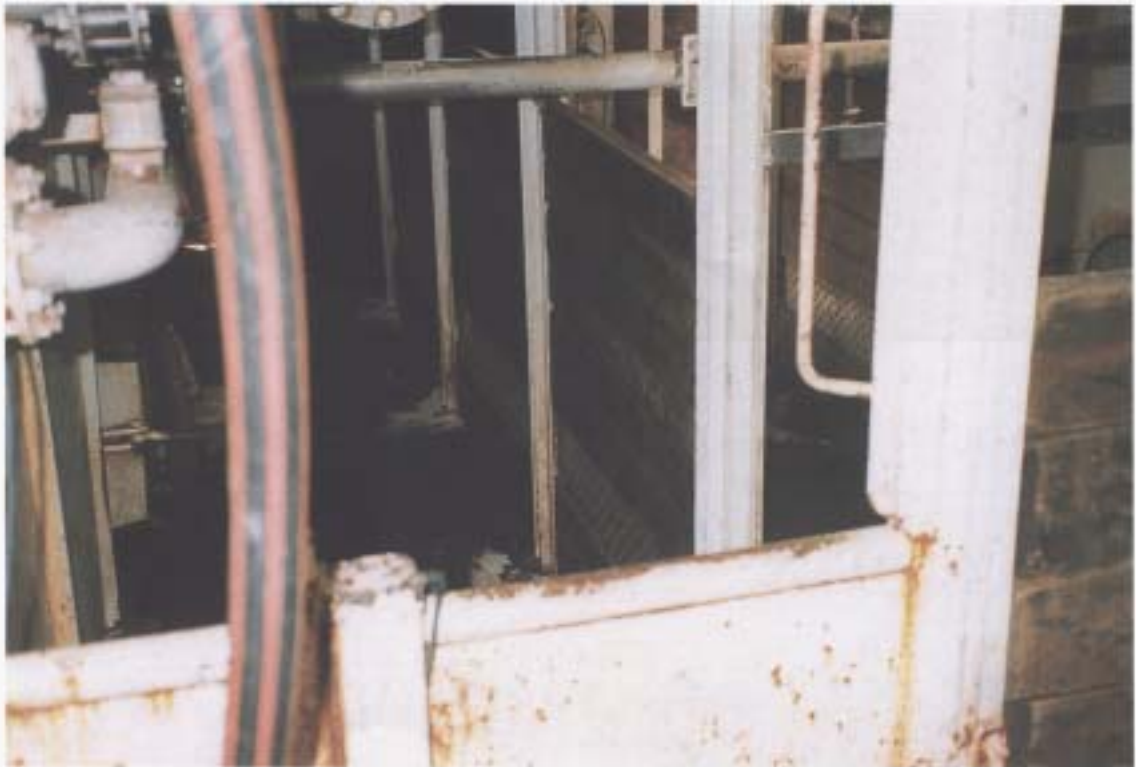
Figure 4

Starboard side of ramp deck in area of accident

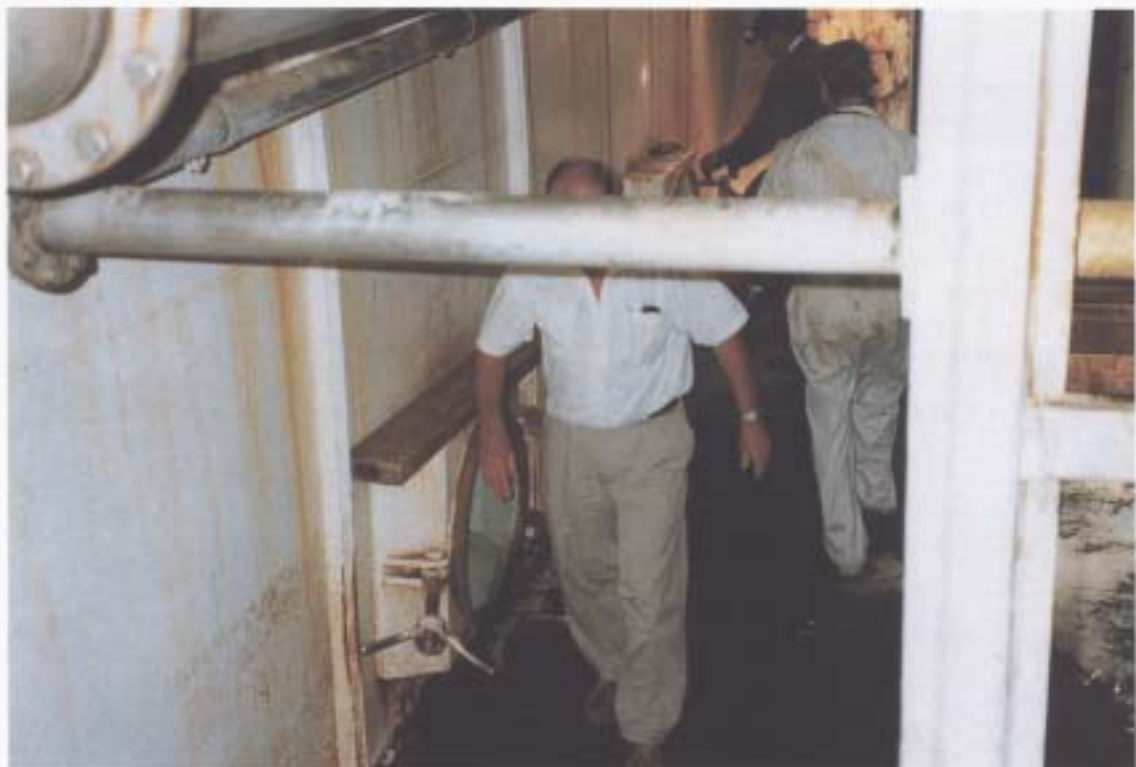
Figure 5

The Third Engineer on the 1800 to 2400 watch, Mr Bruin, took over the pumping operation which was expected to take about 20 to 25 minutes. He left the engine room and proceeded to the upper deck before going down to the ramp deck. He climbed over the low side of the pound boards and into the caged area (Figure 4) where he opened the door to No 3 starboard RSW tank (Figure 5) to release what was described later as grey/black water.

RSW tank side door: partly obscured door is that of No 3 starboard RSW tank

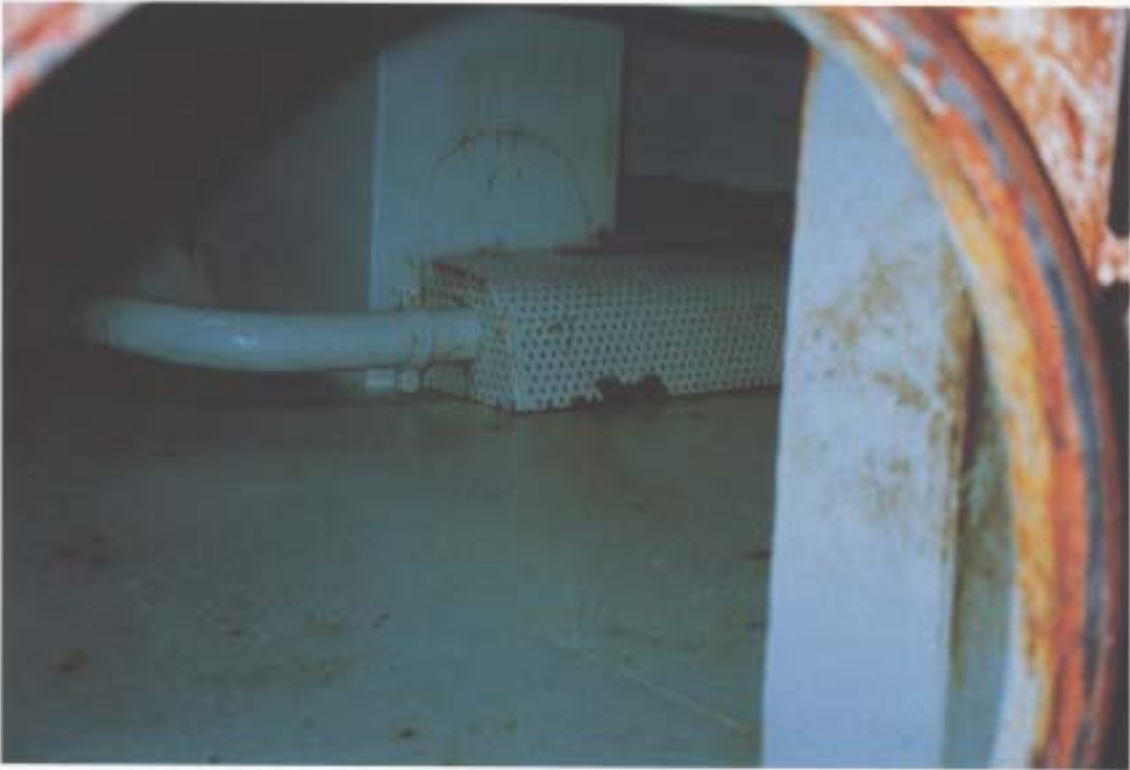
RSW circulating strainer in RSW tank

Manual which was supplied to the owners. The manual does not include information on how often the RSW system should be cleaned or maintained. The manufacturers advise that the system should be cleaned through with detergents every voyage, or at least once a month, not only to prevent accidents but to maintain the quality of the fish.

1. Ensure that all refrigerated processing and storage systems are thoroughly cleaned immediately after use so that no residual fish and sea water is left to decay.

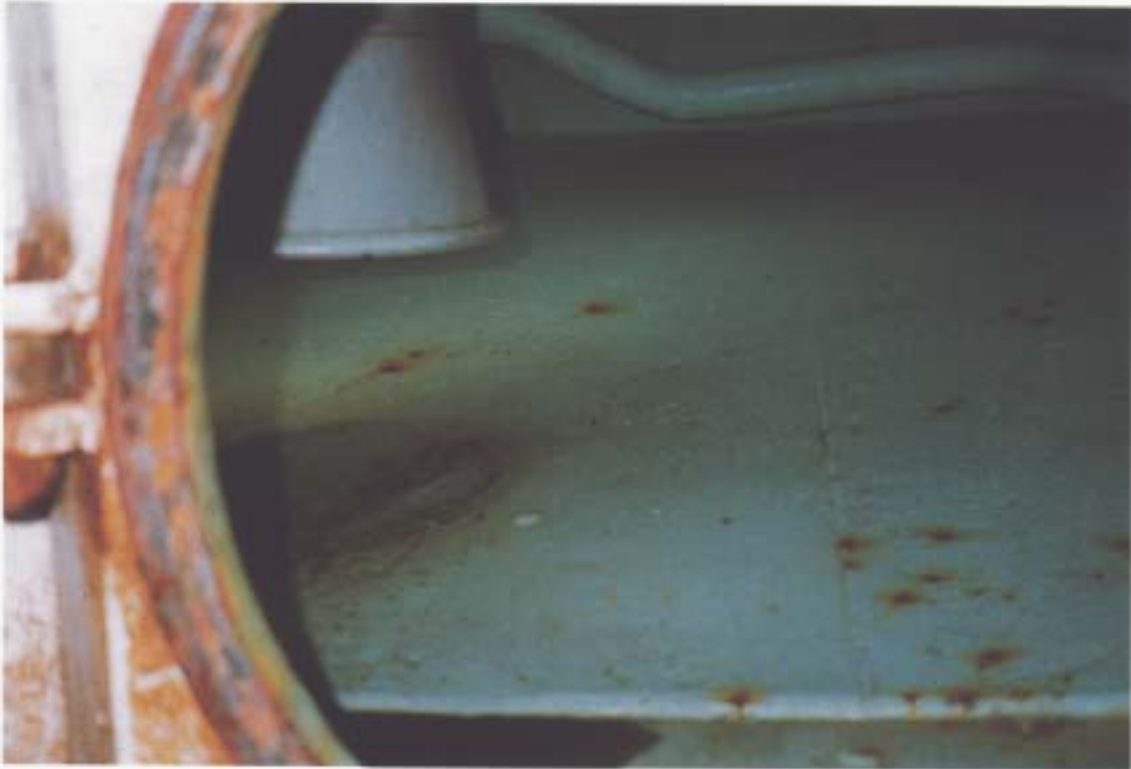
Figure 7

Although fish can be damaged in a number of ways, the most probable cause in this instance was the pumping action of the system pump and the crushing of fish in overfilled RSW tanks from earlier catches. Because the action of the cod end and RSW pumps damages fish over a certain size, the fish on 25 July 1996 were being bagged and transferred directly through the aft upper deck onto the ramp deck below.

End of fish suction pipe (elephant's foot) in RSW tank

When RSW tanks are emptied and cleaned, fish debris will be discharged from the tank. Some will remain in stagnant water held in the pipework, be circulated in other parts of the system under chilled conditions, or accumulate in the pump system strainers.
