**Report on the Investigation**  
**on the Capsize of the**  
**UK Registered Fishing Vessel**  
***CATRINA NNI94***  
**South of Newhaven**  
**on 13 October 1998**

*Catrina*, a dual purpose stern trawler/twin beam scallop dredger of 11.96 metre registered length, broached and capsized at about 1305 on 13 October 1998 about 8 cables south of Newhaven breakwater light. The crew of two were thrown into the water and rescued by the fishing vessel *Boy Antony*; none was injured. The vessel was returning from a fishing trip with a small catch of red mullet. The wind was south-south-westerly force 5 and a steep 2m sea was on *Catrina*'s port quarter.

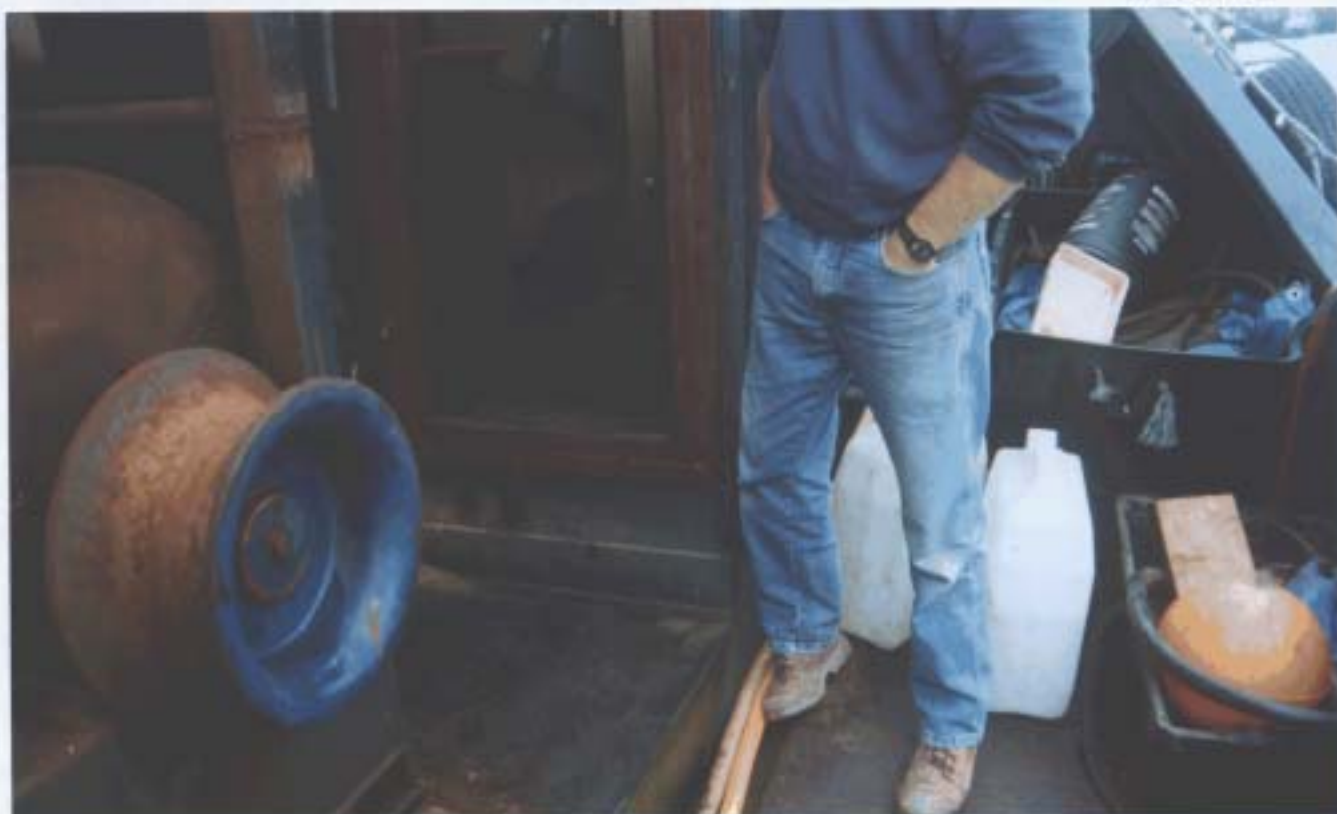
**FIGURE 3**

She was fitted with a forward wheelhouse (**Figure 2**). Access to the wheelhouse was through a wooden door in the starboard side of the aft bulkhead (**Figure 3**). Forward of the wheelhouse was the accommodation, which was connected to the wheelhouse by an opening in the bulkhead on the starboard side (**Figure 4**).

**Wheelhouse Door**

It is particularly important on small vessels that no openings are immersed before the angle of vanishing stability is reached. On *Catrina* two substantial openings were immersed, well before she had heeled to the 50° angle of vanishing stability. This caused rapid and extensive flooding of the interior of the vessel and possibly prevented her survival. At about 38° the door to the wheelhouse was immersed, flooding both the wheelhouse and forward cabin. At about 33° the starboard ventilator to the engine room was submerged, flooding that space (**Figure 10**).

Openings essential to the working of the vessel should be placed on the centre-line, wherever possible, to ensure that maximum advantage is taken of the available range of stability. For the same reason the locations and heights of ventilators should also be carefully considered.

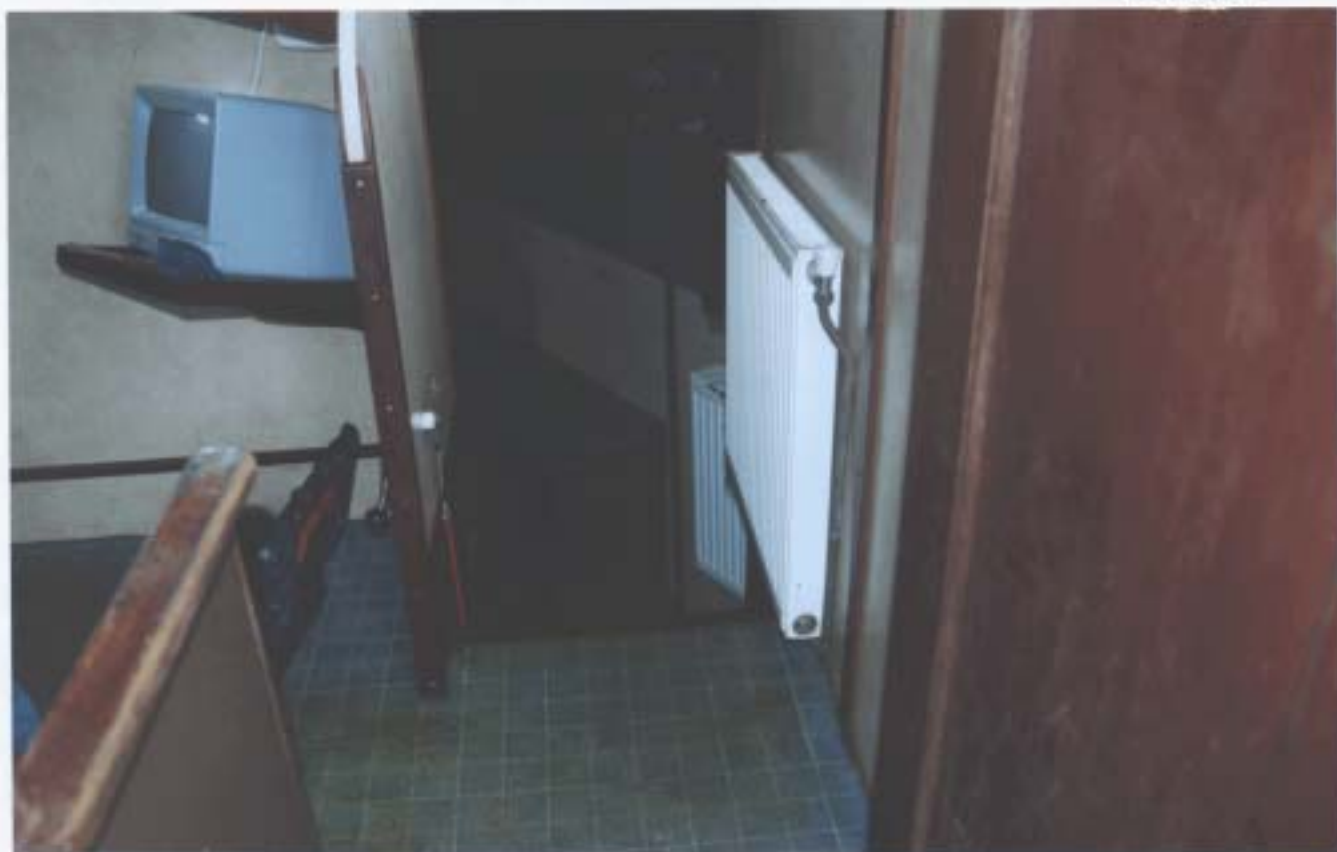
**FIGURE 4**

**Access to Forward Accommodation from Wheelhouse**

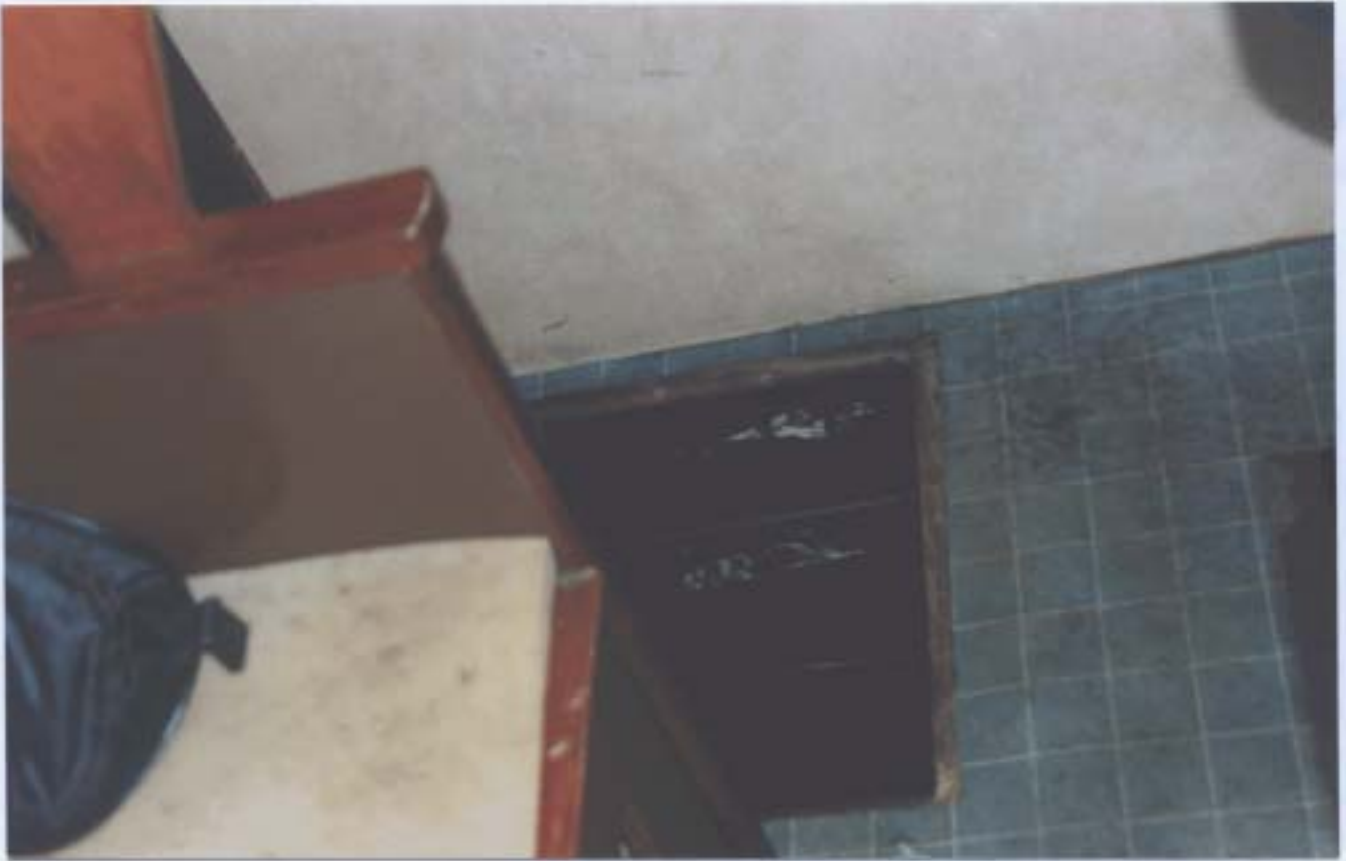
**FIGURE 5**

The fish hold was amidships between watertight bulkheads, and forward of this was the engine room. Access to the engine room was through a non-watertight hatch in the wheelhouse sole (**Figure 5**). Ventilators to the engine room were fitted on both sides just inboard of the bulwarks and against the aft face of the foc'sle bulkhead (**Figure 6**). The ventilators were 150mm x 200mm in section and stood 840mm above the weather deck.

**Engine Room Hatch in Wheelhouse**

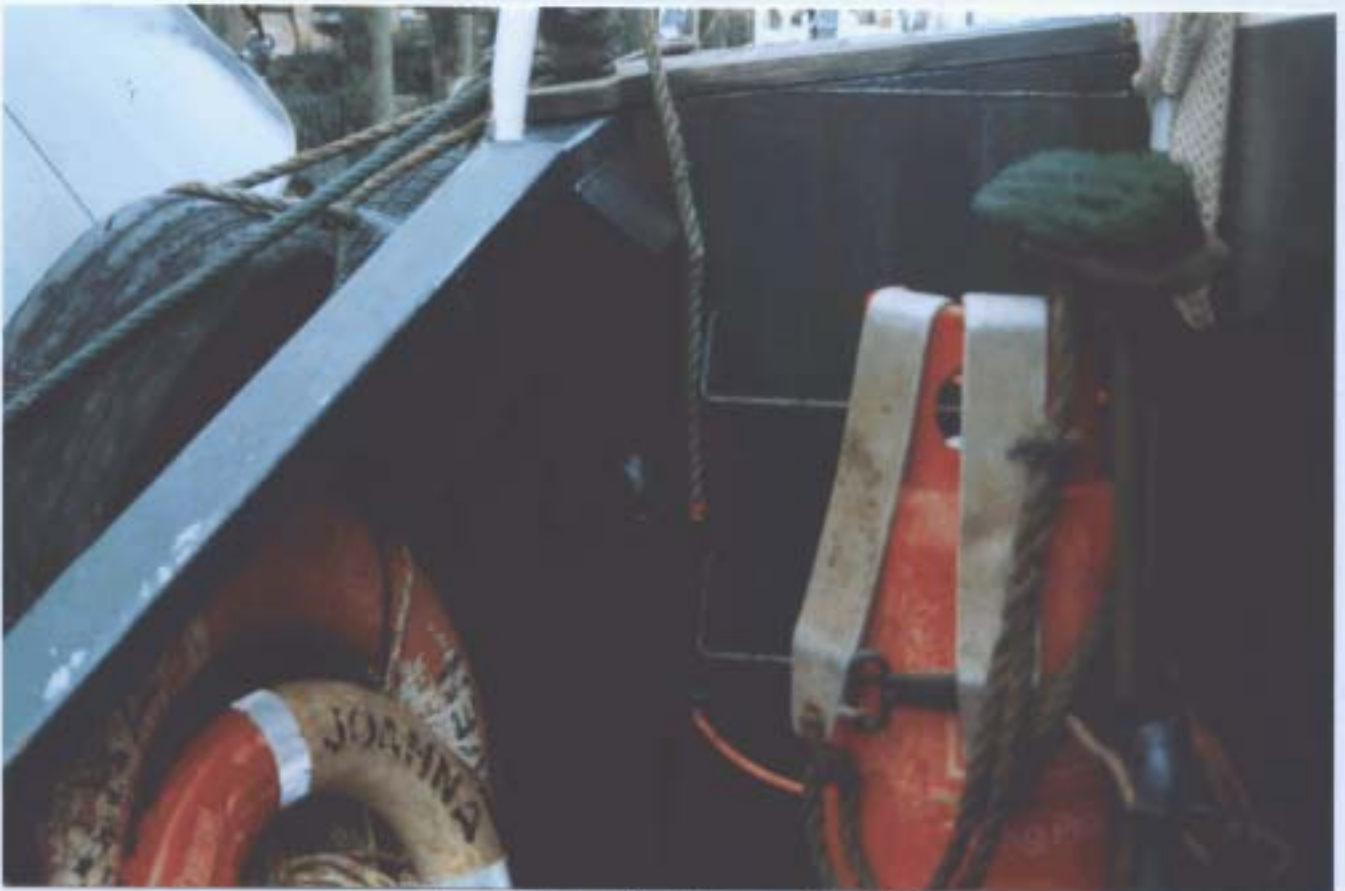
**FIGURE 6**

**Engine Room Ventilator on Port Side**

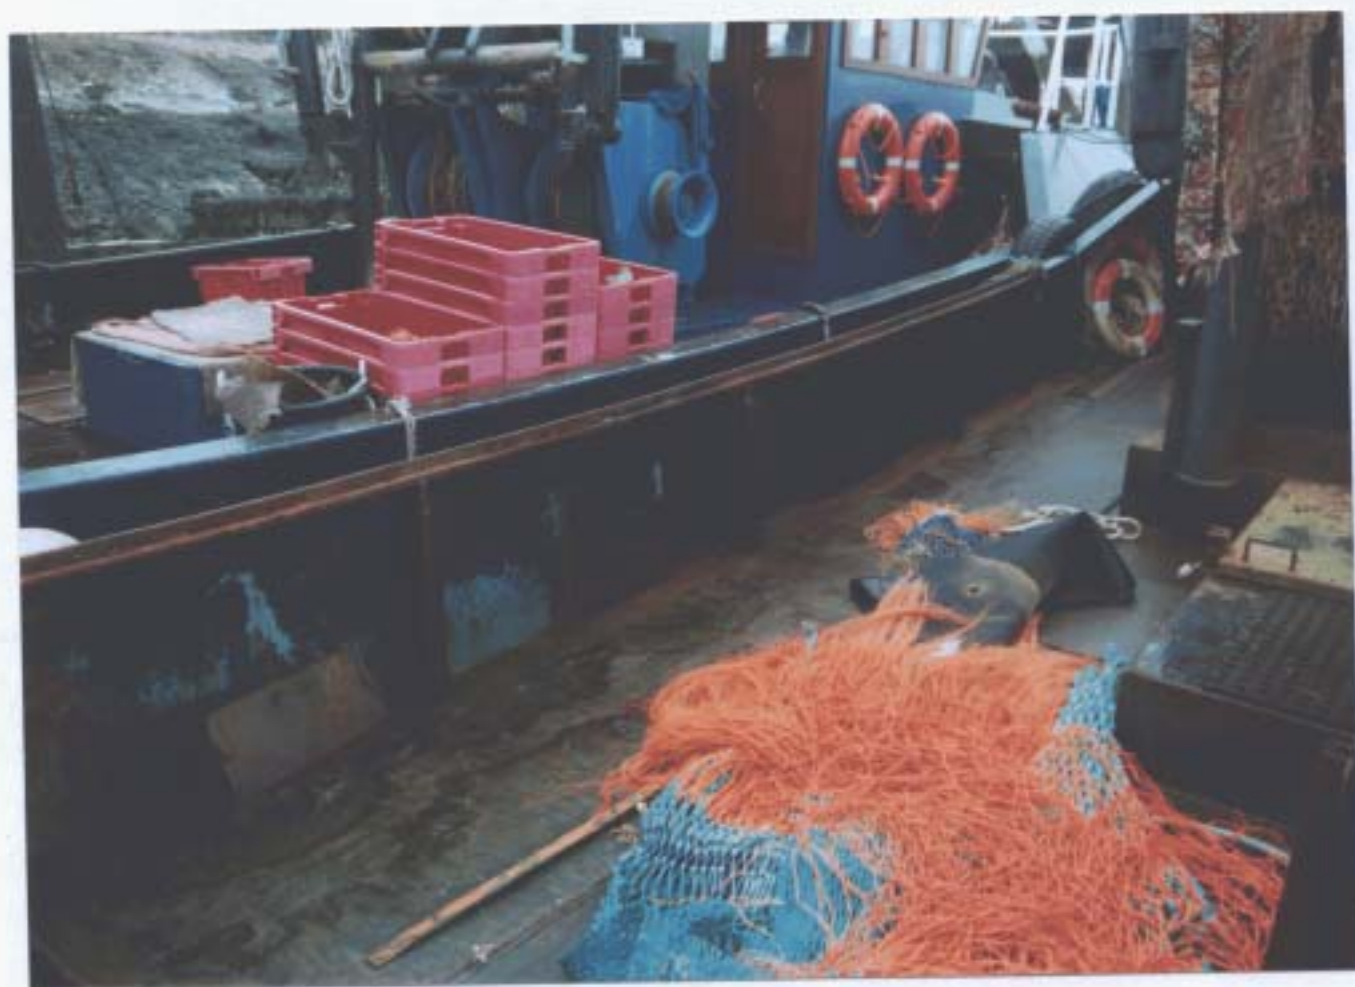
FIGURE 7

The working deck was bounded by bulwarks fitted with three freeing ports on each side and two across the transom. The total area of the freeing ports on each side was about 0.35 m<sup>2</sup>, some 30% greater than the area specified in the Sea Fish Industry Authority (SFIA) *Rules for the construction of steel fishing vessels of less than 24.4 metres registered length*. The freeing ports could be closed by vertical plates (**Figure 7**).

Freeing ports

She was well provided with freeing ports, the total area of which was well in excess of SFIA requirements. However, an inspection of the vessel showed that the freeing ports were concentrated amidships and there was a large area of the deck forward where water could be trapped inside the bulwarks. This could be improved by fitting an additional freeing port just aft of the foc'sle bulkhead.

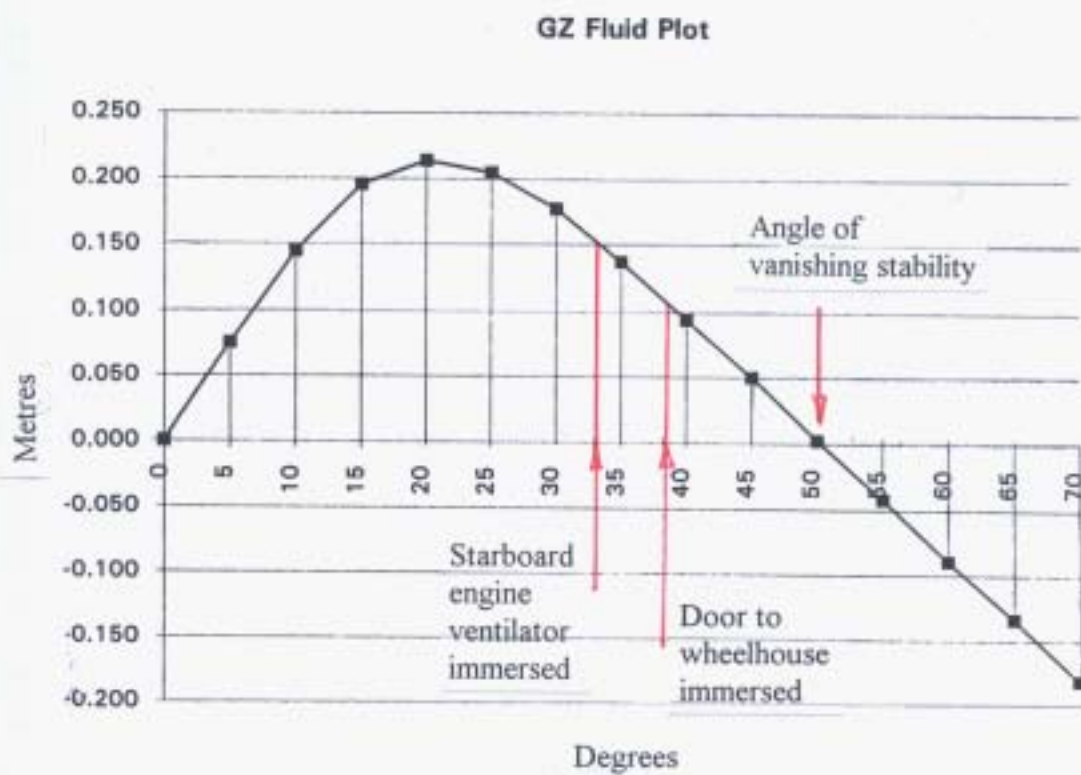
FIGURE 10

*Catrina's* Stability Curve Showing Downflooding Points

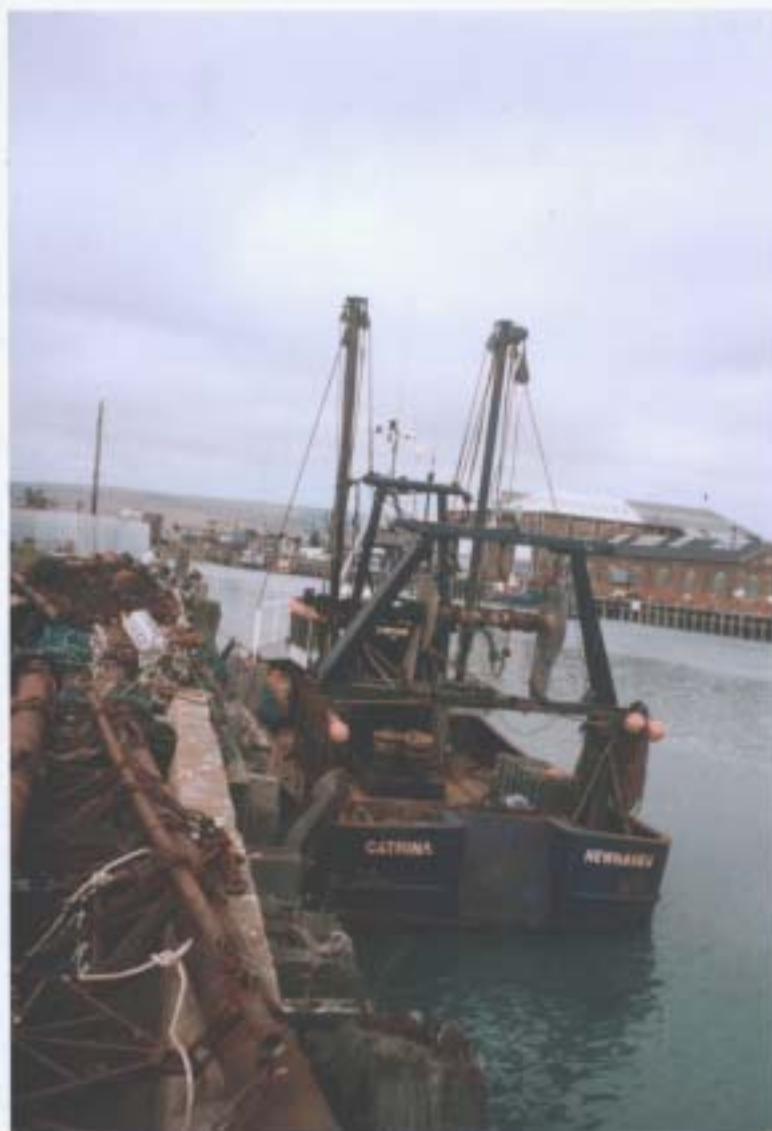
**FIGURE 11**

*Catrina* in Port, Showing Obstructions to Freeing Ports

The MAIB was also concerned that gear on deck, such as pound boards and stowed scallop bars, could have obstructed the freeing ports and prevented the deck from draining rapidly. Photographs of *Catrina* in harbour showed that pound boards were obstructing

the flow of water through the freeing ports in the transom, and fishing boxes were stowed in front of some of the freeing ports on the starboard side (**Figure 11**).

It is essential that freeing ports are unobstructed when the vessel is at sea. The owner is recommended to draw this important matter to the attention of his skippers.
