# Marine Accident Investigation Branch (MAIB) - Safety Digest - Fishing 2002

## Chief Inspector's Foreword

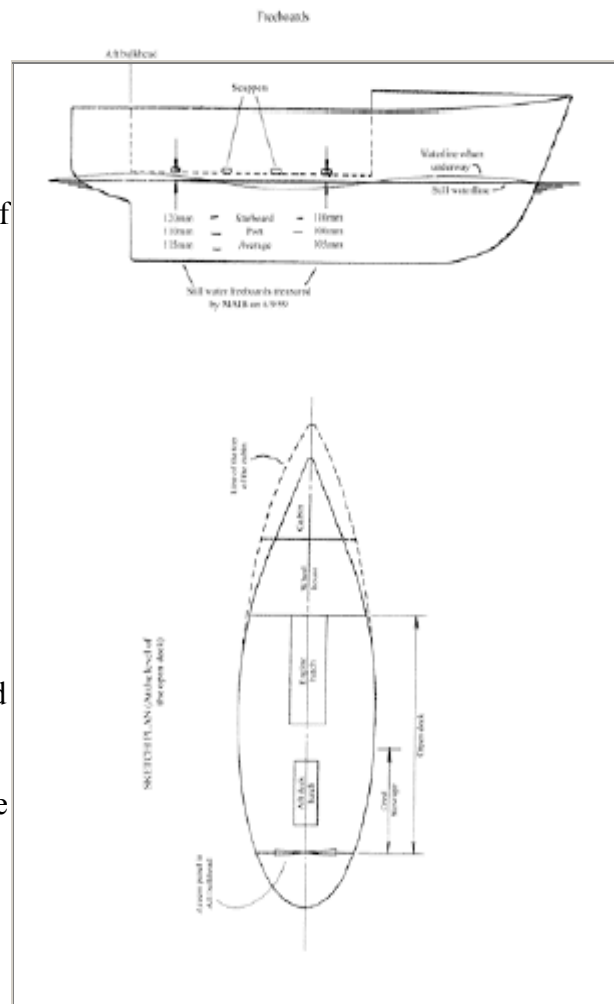
*Donna M*'s freeboard was very low at the aft end. Her skipper assumed the previous owner had carried a similar load of 50 pots, and that the low freeboard was normal. He was unaware that by carrying this many pots he had reduced the freeboard to an unsafe level.

This floodwater then built up to such an extent that it penetrated the wiring to the electric bilge pump. The wiring was in poor condition, and the effect was that it disabled the bilge pump.

It is possible the crew were unaware that the pump was disabled to start with and, when they switched it on, might have assumed there was no water in the bilges. They must have realised something was wrong eventually because they tried to rig the deck wash pump to pump out the bilges. Before this could be achieved, however, sufficient water had flooded into the vessel and *Donna M* capsized.

1. Skippers should ensure that their vessels have adequate freeboard when loaded. There are no statutory requirements regarding freeboard for fishing vessels under 12m, but the formula in the Workboat Code published by the MCA is a good guide.
2. A relatively high percentage of accidents occur in vessels that have just changed owners. New owners or skippers should, so far as possible, do their best to establish how the previous users operated the vessel, paying particular regard to stability considerations and weights embarked.
3. Lifejackets should be worn. Comfortable self-inflating lifejackets, suitable for constant use, are readily available. Further guidance is shown in MGN 155(F), provided free by the MCA.
4. Bilge pumping systems should be regularly inspected to ensure they are reliable. Further guidance is shown in MGN 49(F), provided free by the MCA.

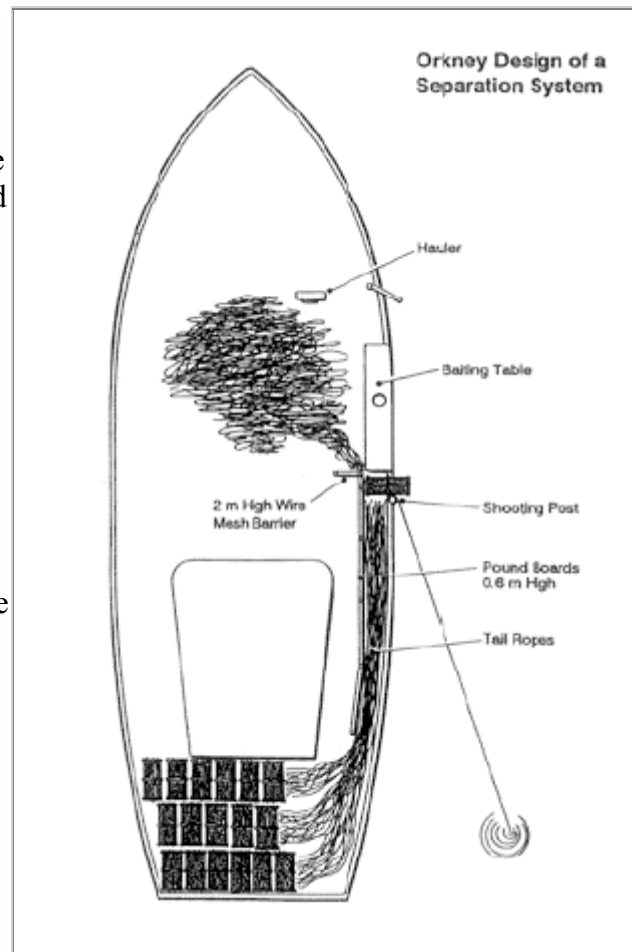
The 11.19m potting vessel *Dunan Star* was shooting for dog whelks 1.5 miles southwest of the Isle of Arran, when one of the two people on board became entangled in the back rope of a fleet of pots and was dragged over the side. He was not wearing a lifejacket.

Once again the skipper heaved on the hauler until the crewman reappeared, but by now the boat had drifted through the effects of the wind and tide and the victim was being pulled away from the boat. He also had some of the back rope around his chest and arms. The skipper, who could not reach the bight of rope around the crewman's leg, cut some of the rope around his chest in an effort to relieve the strain on his upper body. Having done so, however, the skipper was left holding the rope that led to the hauler. The deckhand was dragged underwater once again. He was not seen alive again.

The skipper contacted the coastguard immediately. A helicopter and lifeboat were tasked, and a short time later, with the help of the lifeboat crew the body of the deckhand was recovered. He was still entangled in the fleet of pots.

1. This is a horrific situation that no fisherman would ever wish to be in. The majority of potting vessel crews are well aware of the hazards involved when shooting pots, and take care to avoid them. Too often, however, accidents happen. By far the most common occurs when shooting pots, and involves somebody getting caught in a bight of back rope. Pay particular attention to keeping your feet out of the bights of back rope.

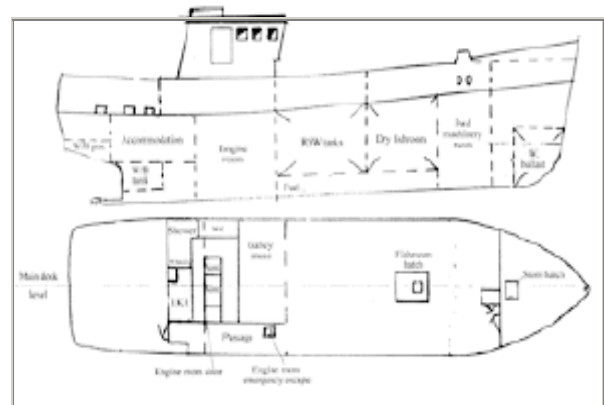
One crewman was ashore, the skipper was resting and the engineer was, among other things, pumping out the engine room bilges using a portable petrol-driven pump within the engine room. Its engine exhausted directly into it. Hoses on the pump led into the bilge for suction, and up through the engine room emergency escape hatch, for discharge. This pump was being used because the vessel's own power-driven bilge pumps were defective.

The pump had been running for well over an hour, without ventilation fans or any other machinery running, when the crewman returned from ashore. He went looking for the engineer 20 minutes later, and found him in the engine room, unconscious and slumped over the portable pump which was still running.

The engineer was found to have been poisoned by carbon monoxide.

1. Portable pumps may be very useful; particularly in an emergency. This is shown by the number of incidents where these pumps are supplied by the coastguard to vessels having flooding problems. However, they should always be used with their engine exhausting into a well-ventilated area.
2. Petrol gives off highly flammable fumes that are heavier than air. Therefore, using a petrol engine within an engine room runs the risk of explosive fumes accumulating in the bilges; particularly if ventilation is poor.
3. Carbon monoxide gas can be produced by any system which burns a fuel such as petrol or diesel. As it has no smell, it is a notoriously difficult gas to detect without instrumentation, and yet it is extremely poisonous. In this incident, even trained fire officers were unable to detect the presence of the gas without a meter.

4. Portable engine-driven pumps must be seen as for use in emergency conditions only. They should not be seen as a replacement for the vessel's own power pumps.
