Report on the investigation of  
a lifeboat accident on

**mv *Galateia***

Seaforth Docks, Liverpool

**Report No 25/2002**  
**July 2002**

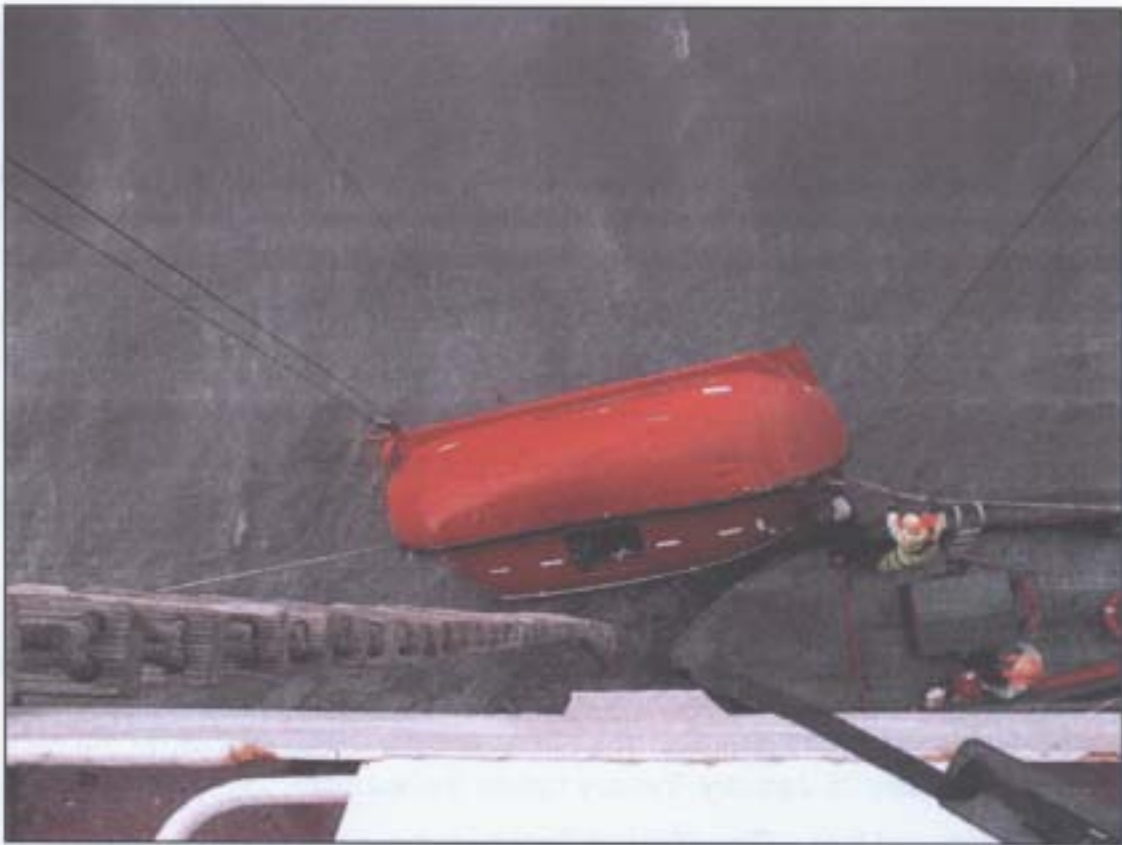
Port Authority launch alongside assisting in righting the lifeboat

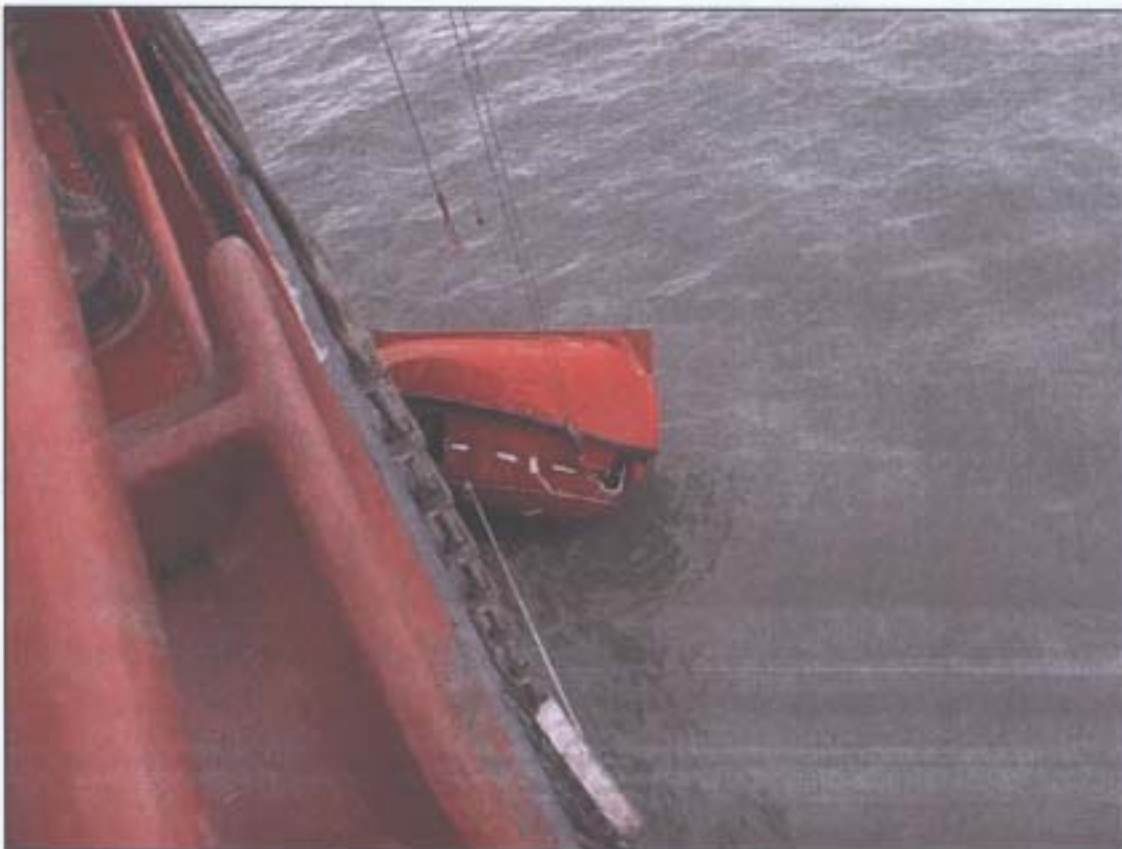
The partially capsized lifeboat - the falls had been lowered in preparation for righting the lifeboat

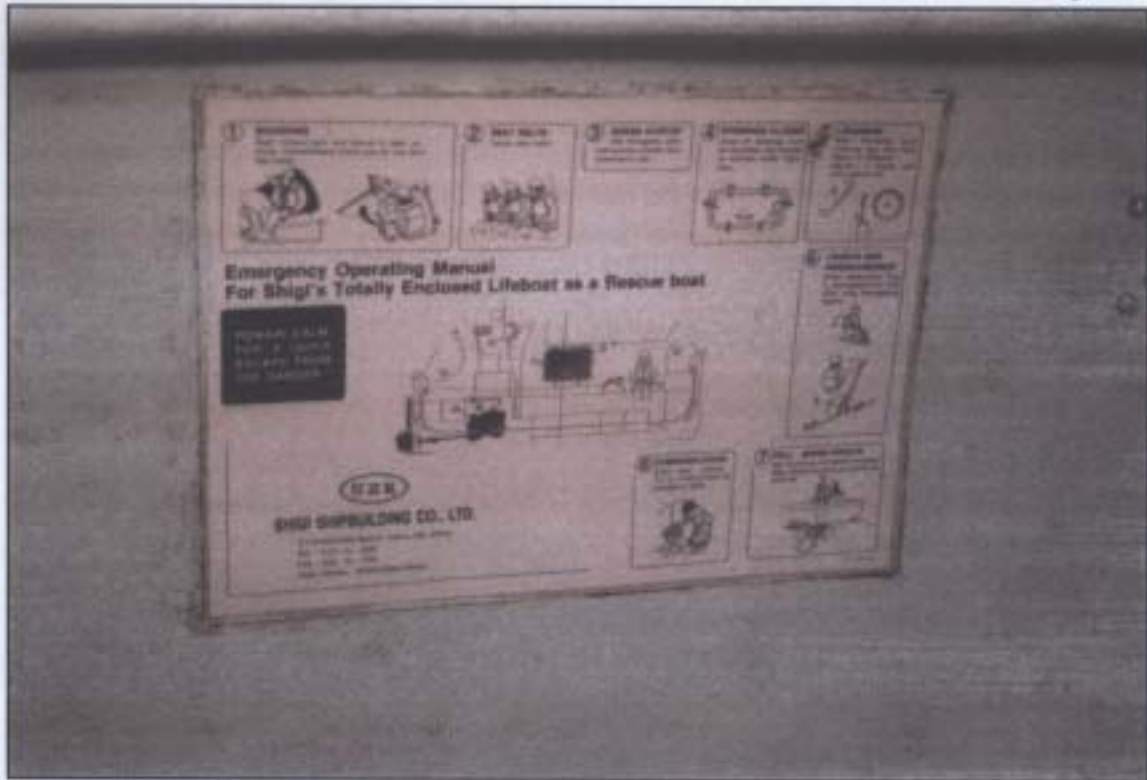
Figure 1

Operating instructions pasted on inside of lifeboat canopy

2.3.1 The lifeboat release instructions pasted on the inside of the lifeboat canopy were not very clear, nor were the item numbers clearly legible. In fact, some of the item numbers had completely worn off. As these are critical in identifying the order in which the procedure is to be followed, their loss greatly increased the chances of a mistake being made. The warning notice, which was part of the instructions supplied by the manufacturing company to the MAIB, was not included in the procedural notices pasted on the internal lifeboat canopy. That notice included a pictorial illustration of the correct cam plate position, as well as the correct position of the locking pin before lifting. The lifeboat manufacturers subsequently confirmed that this "Warning" notice was sent out in August 1997 to all users who could be identified. *Galateia's* owners could not be found at that time and, therefore, no notice reached them, hence the omission. That omission has since been rectified and "Warning" notices have been sent to the vessel for inclusion in the safety manual and to be pasted on the inside of the lifeboat canopies.

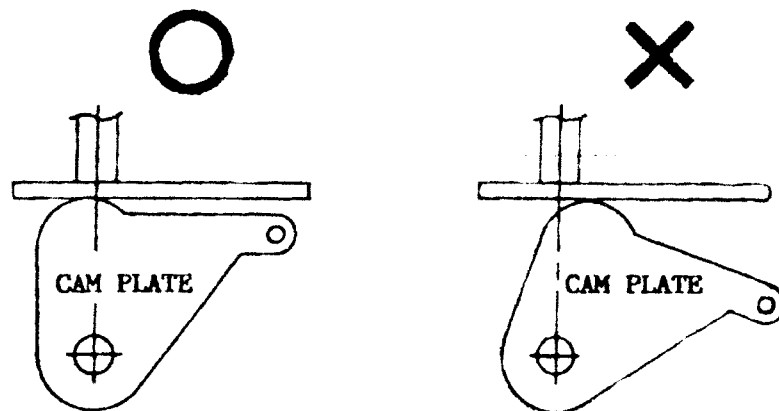
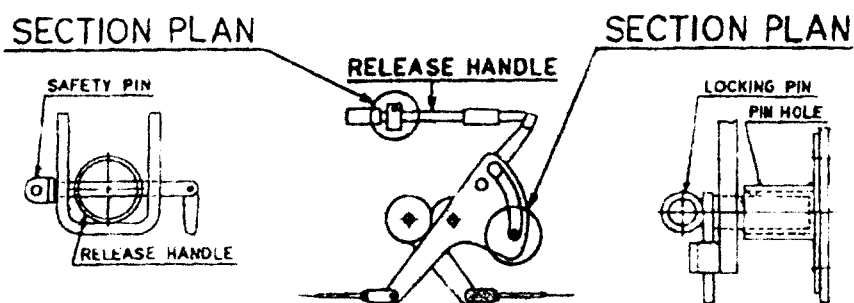
These latest guidance notes did not form part of the instructions pasted on the inside of the lifeboat canopies, nor were they seen in the safety manual.

Warning notice **not** issued to vessel until after accident

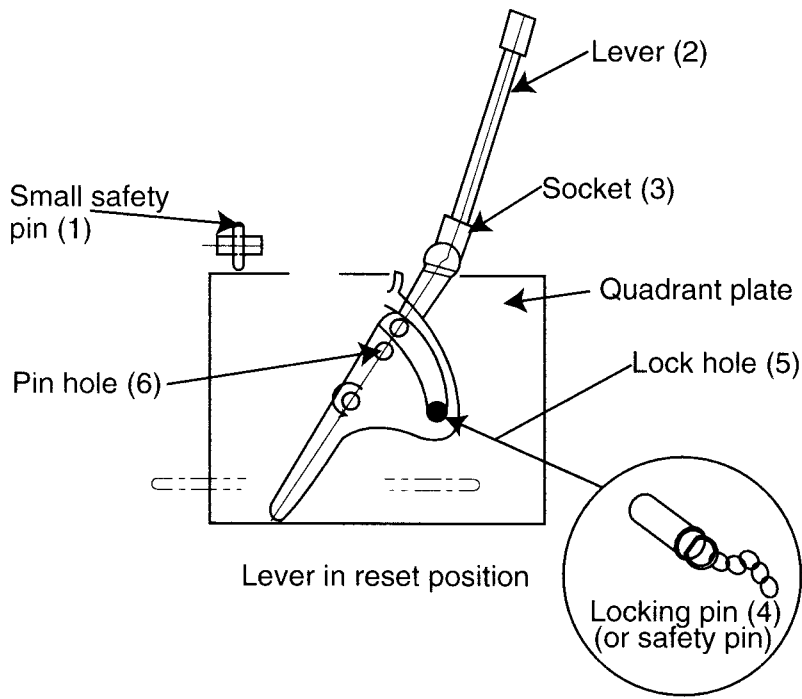
- 2.2.1 The primary cause of the simultaneous release of the hooks when at the davit head was the absence of the locking pin in the quadrant (**see Figure 4**) [lock hole (5)].

The central operating lever is placed adjacent to the coxswain's position, often in such a fashion that the gearing, quadrant and very important safety pin cannot be viewed easily. Indeed it is often impossible for the user to obtain the same view of the mechanism as it is shown on the instruction panel, he can see it only from above, making the important components difficult to identify. This problem is aggravated by these parts being below the bottom boards of the boat in an area of darkness.

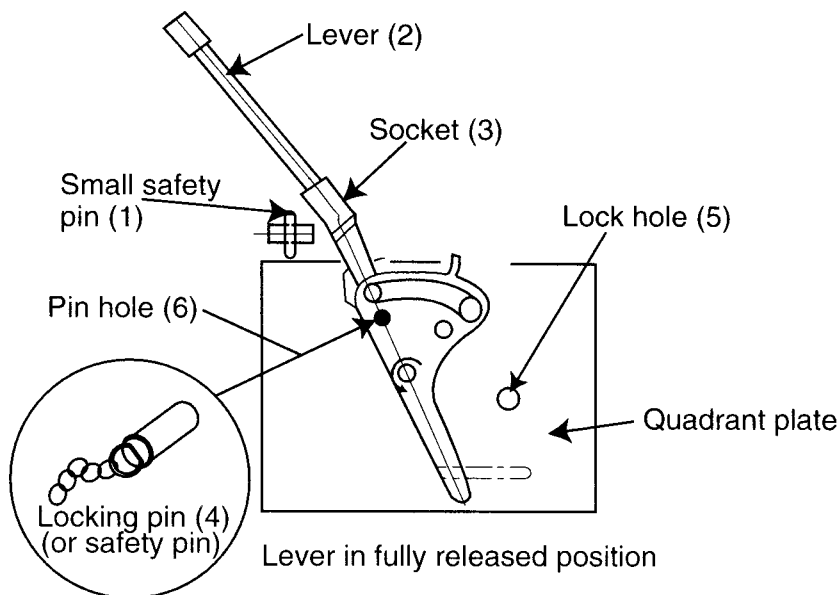
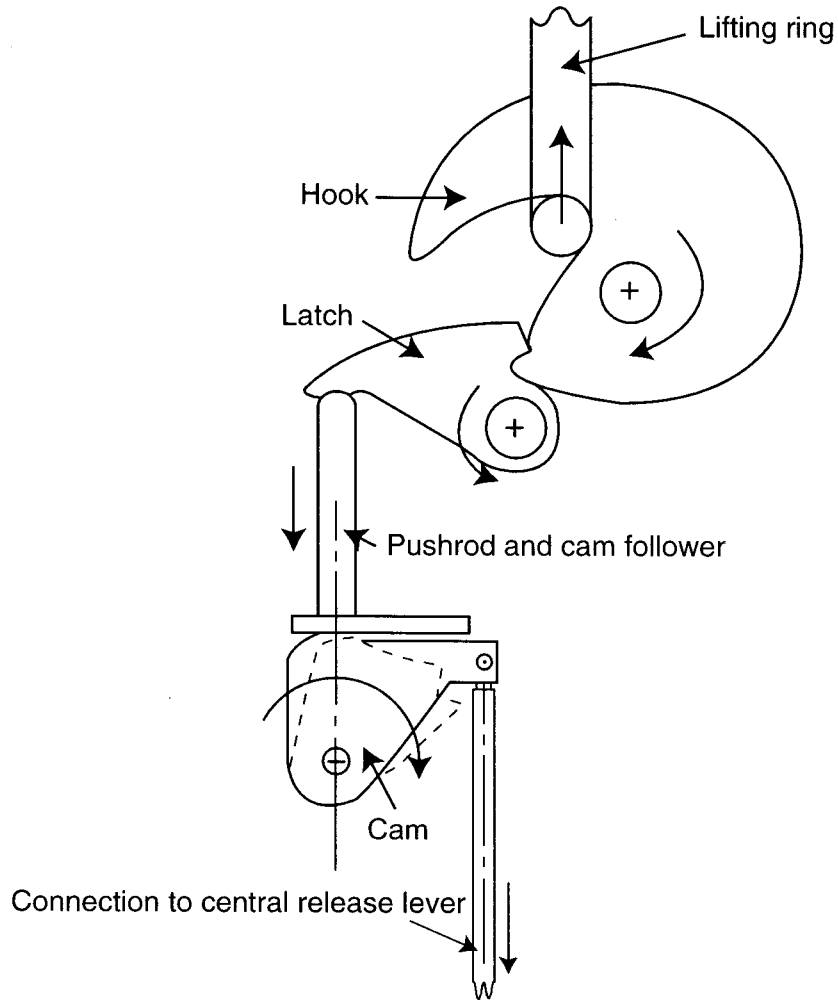
As both hooks released simultaneously, it suggests that the reset mechanism had not been pulled right back, thus leaving both cam plates slightly off the horizontal. Nothing would happen while the chief officer was holding the handle, but once he released it, lifeboat/crew movements could cause total release. If only one cam was slightly off the horizontal it is unlikely that both hooks would have released (**see Figures 5, 6 and 7**).

Diagrammatic arrangement of hook release mechanism and the direction of movement of its components during release. Improper resetting of the cam, as shown dotted, can induce an opening moment leading to inadvertent release.

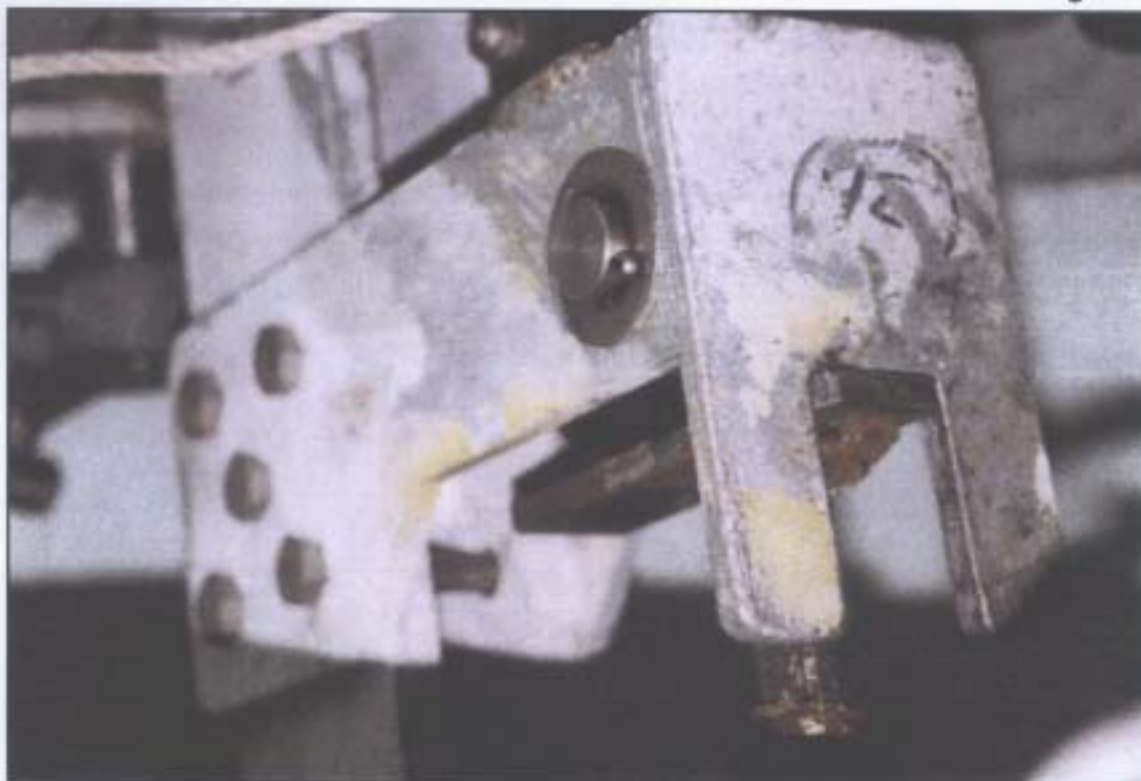
Figure 6

View of hook release gear in locked position

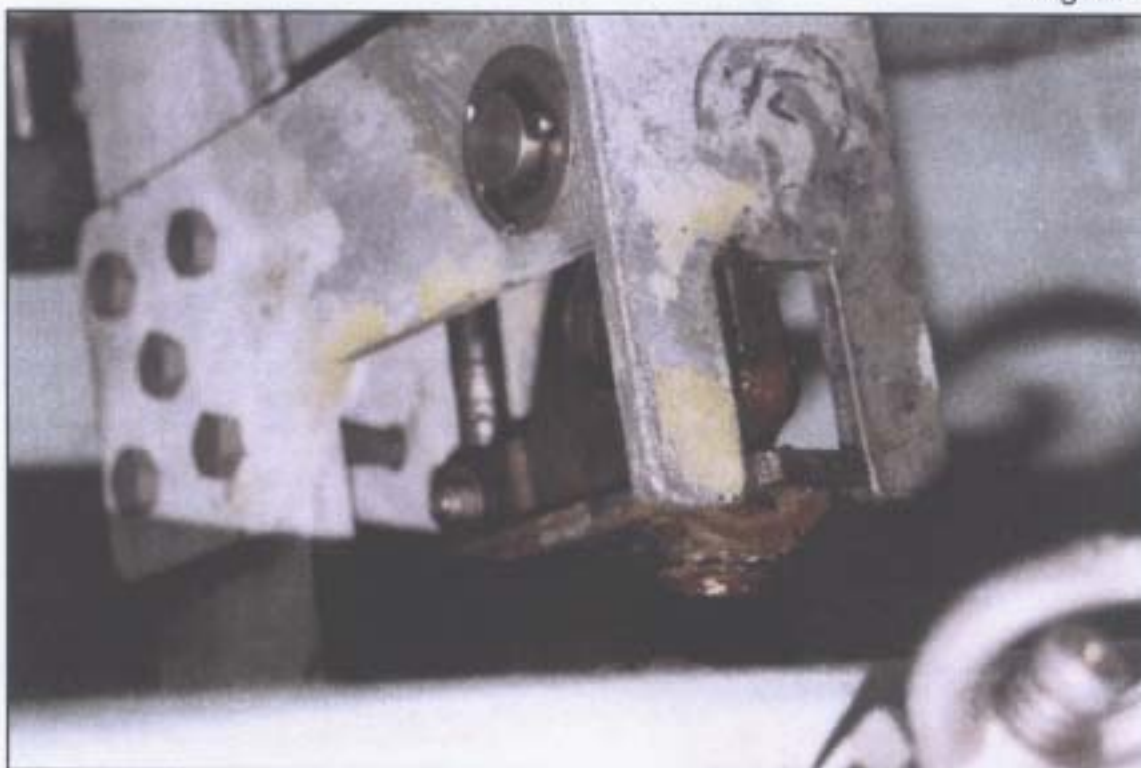
Figure 7

View of hook release gear in open position

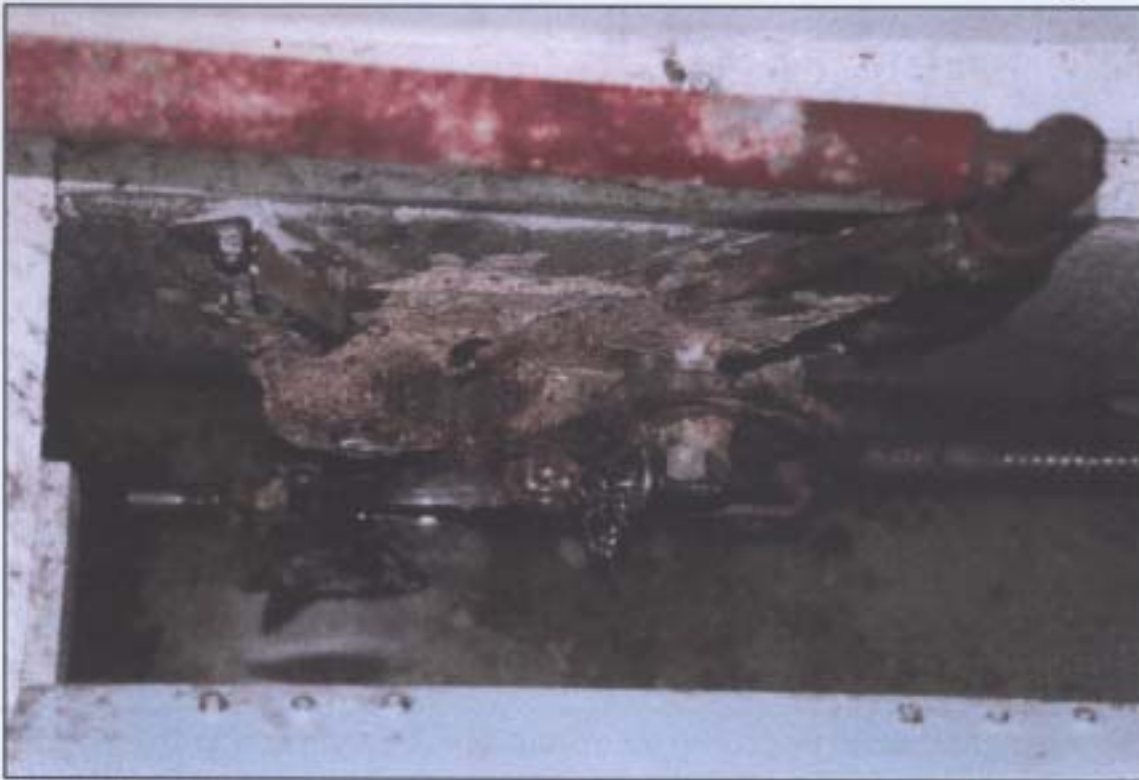
Figure 8

View of release gear with operating handle in stowed position  
Note: Locking pin still in operating position

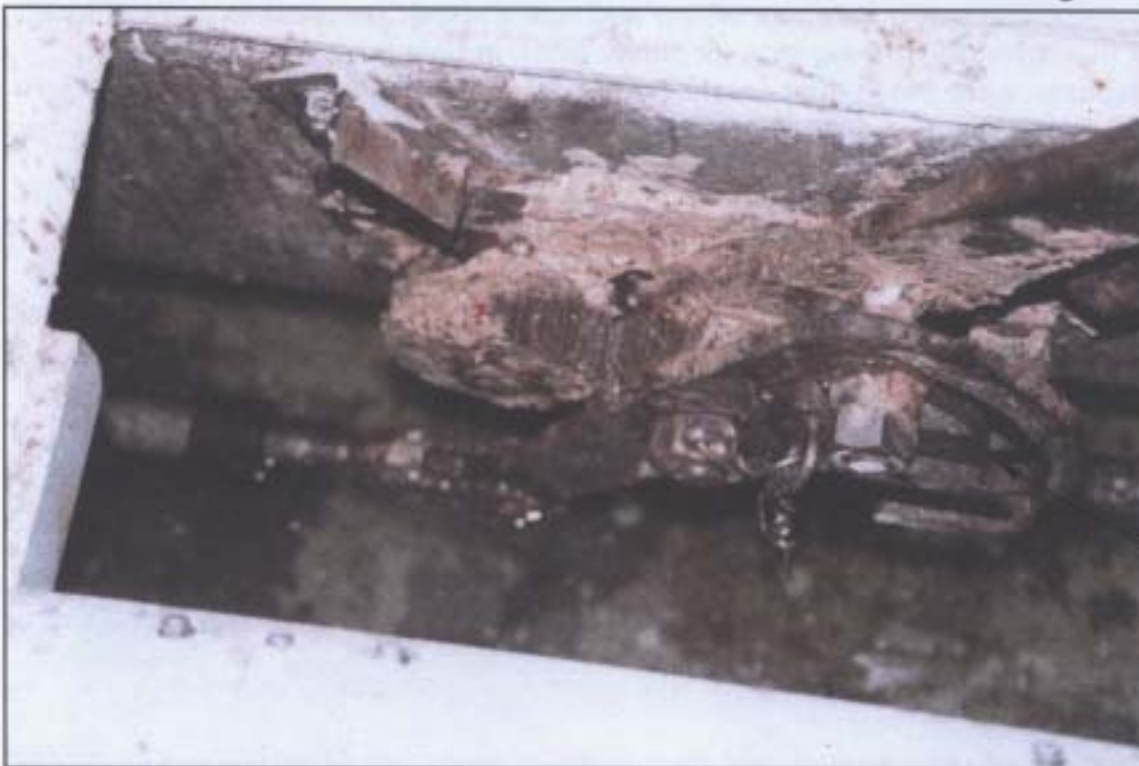
Figure 9

Close-up view of release gear showing quadrant in reset position **but** locking pin in released position

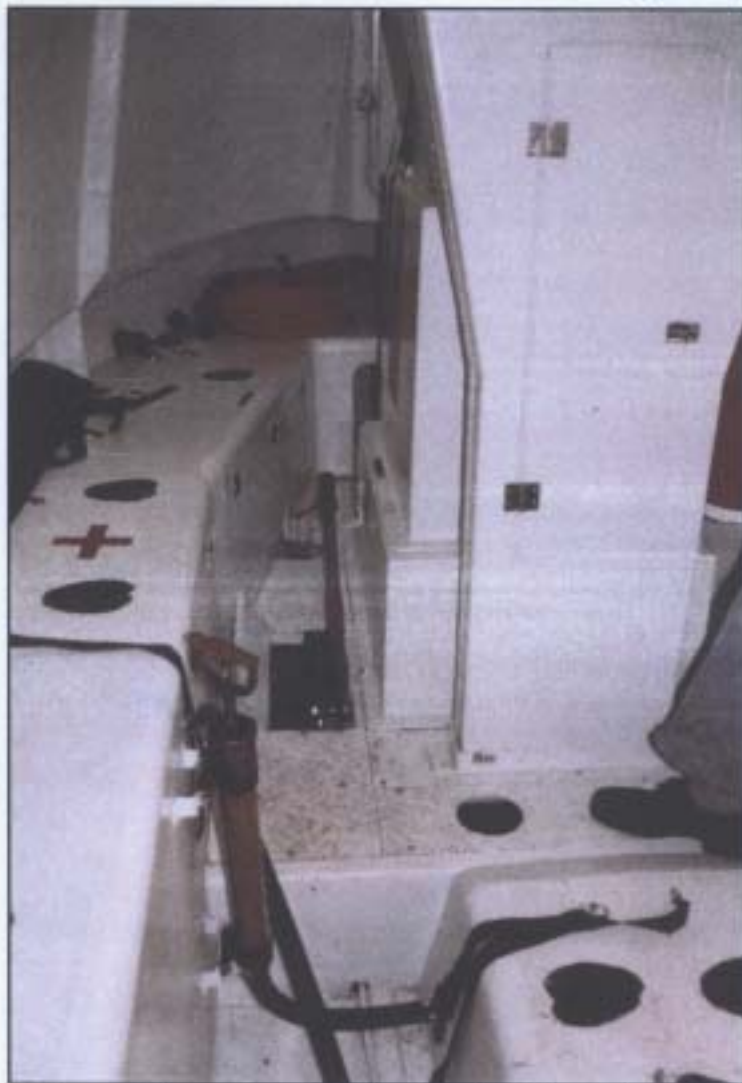
Figure 10

Furthermore, the release gear is positioned low down in the boat on the starboard side next to the control station and below the bottom boards. In this position, the operator is unable to get a clear view of the mechanism, or see the position of the locking pin. At night, without a torch, it would be impossible - it would have to be done by touch. Under emergency conditions this is not acceptable. With the operating mechanism in this position, access is difficult not only for visibility but also for maintenance. It is possible, however, for the crew to sight the operation of the hook mechanism at each end of the boat, and to check that the cam plate is in the correct horizontal position before hoisting.

General view of inside starboard lifeboat showing difficult access to operating gear

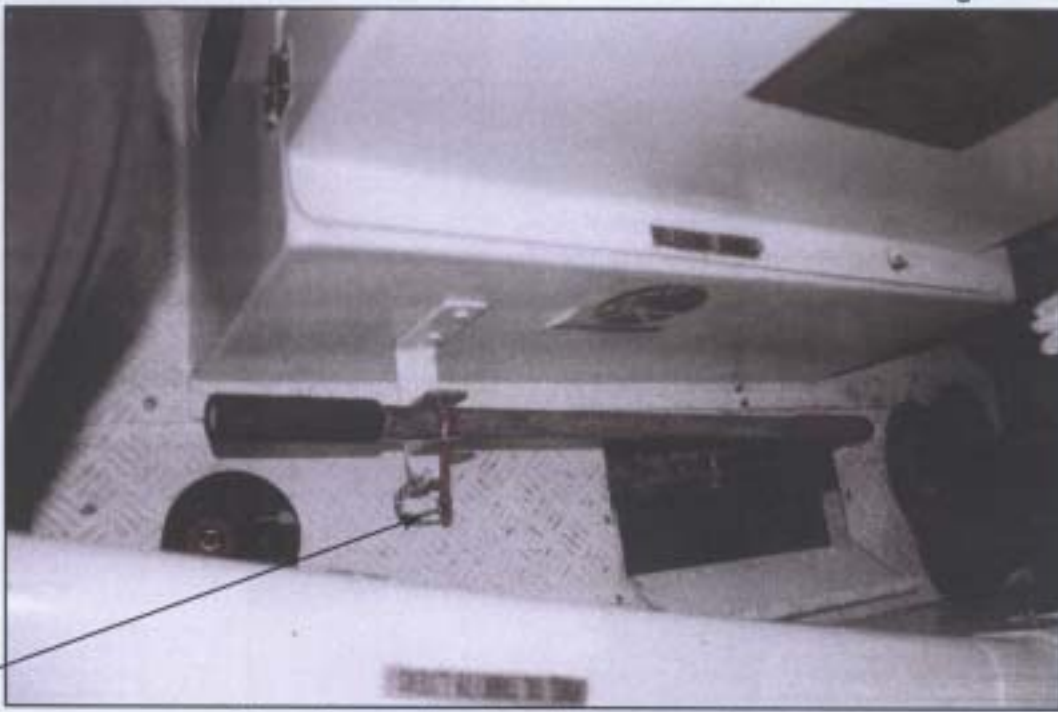
Figure 11

View of operating handle in stowed position

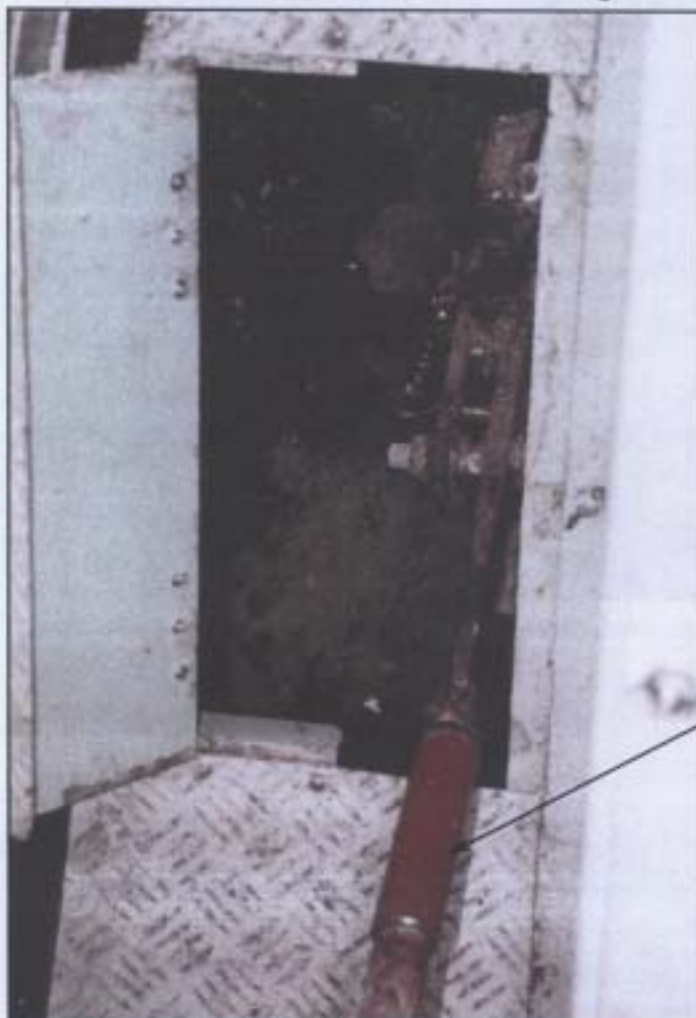
Figure 12

General view of access to release gear

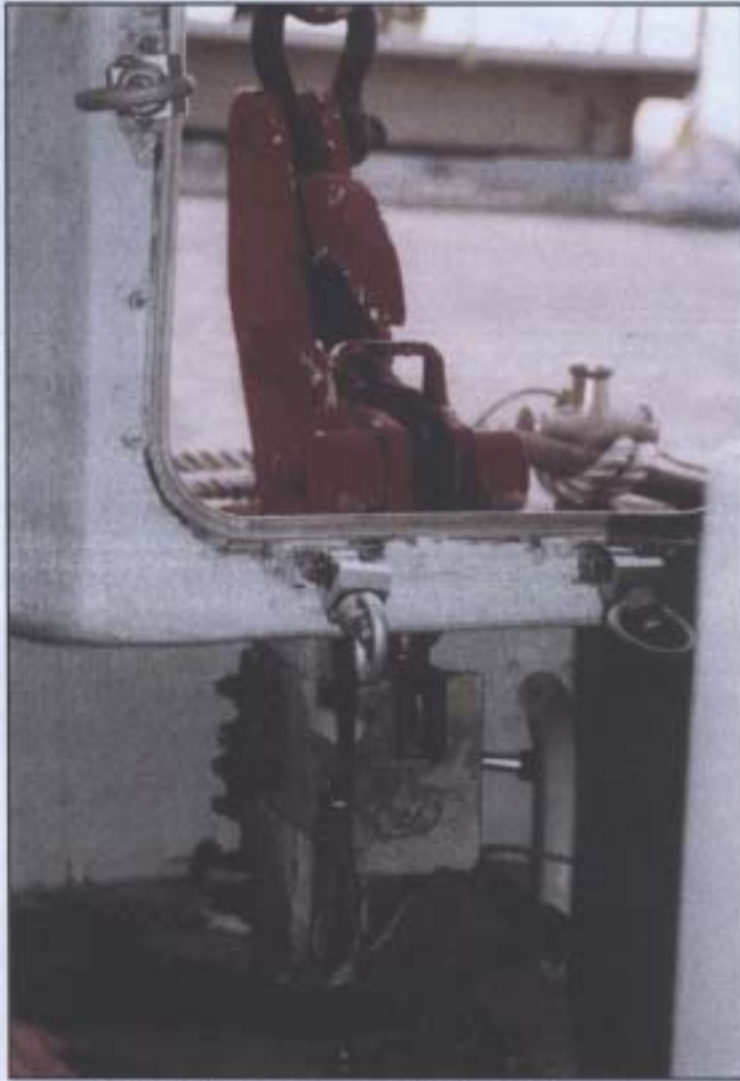
Figure 13

General view of stern hook mechanism

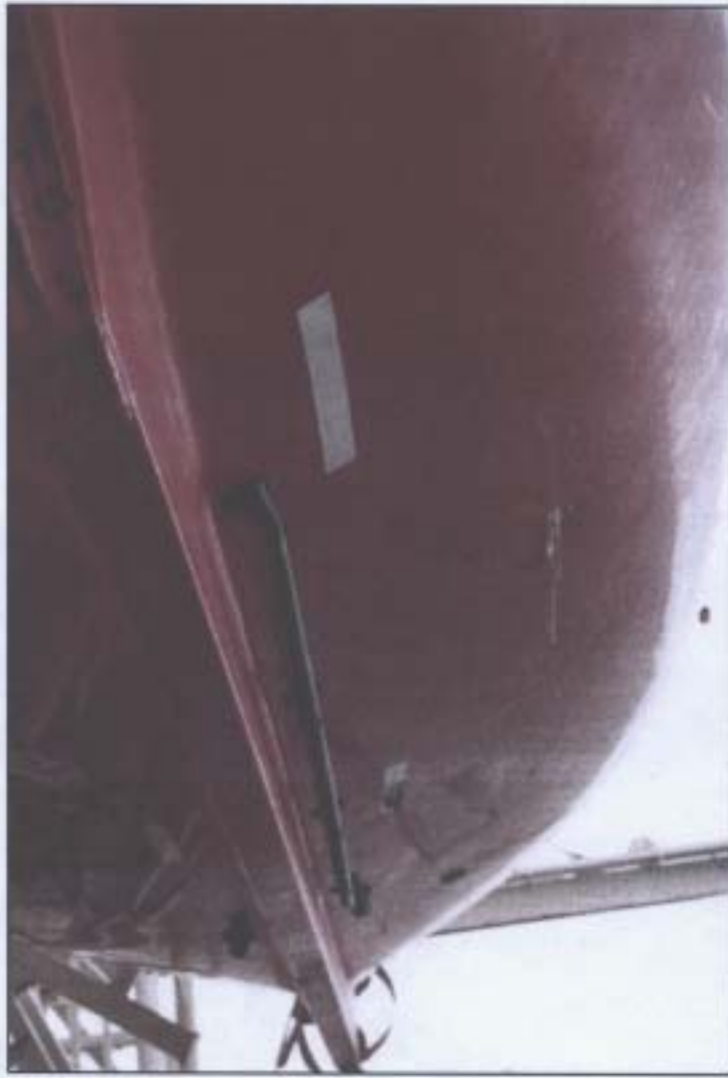
An examination of the lifeboat showed that the rudder, propeller guard ring and skeg were damaged, with scrape marks and two hull penetrations; one on the port side and one on the starboard side. Additional hull damage may become evident during detailed examination at the repair yard. Some damage was also present on the aft end of the canopy together with apparently minor damage to internal fittings.

Figure 14 - Damage to hull due to striking deck equipment during fall
