Report on the investigation of  
a fatal accident on board  
***Gemma Fidelis (GY 419)***  
9 miles east of the River Tees  
on  
23 October 2001

Marine Accident Investigation Branch  
First Floor  
Carlton House  
Carlton Place  
Southampton  
United Kingdom  
SO15 2DZ

**Report No 24/2002**  
**July 2002**

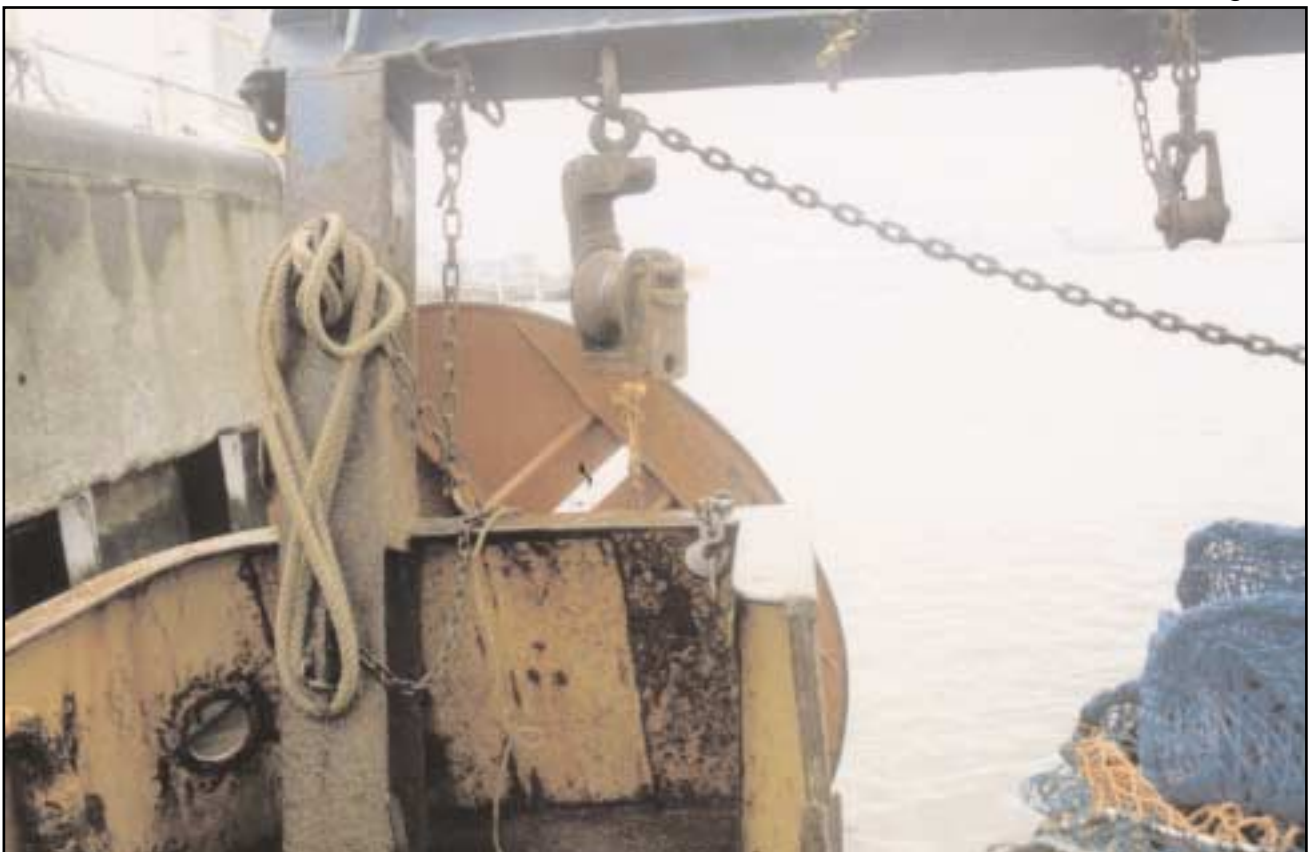
Figure 3

The warps, to which the trawl doors are connected, are led over the stern of the vessel through heavy snatch blocks which hang from both the port and starboard side of a stern gantry, at about head-height (**Figure 3**).

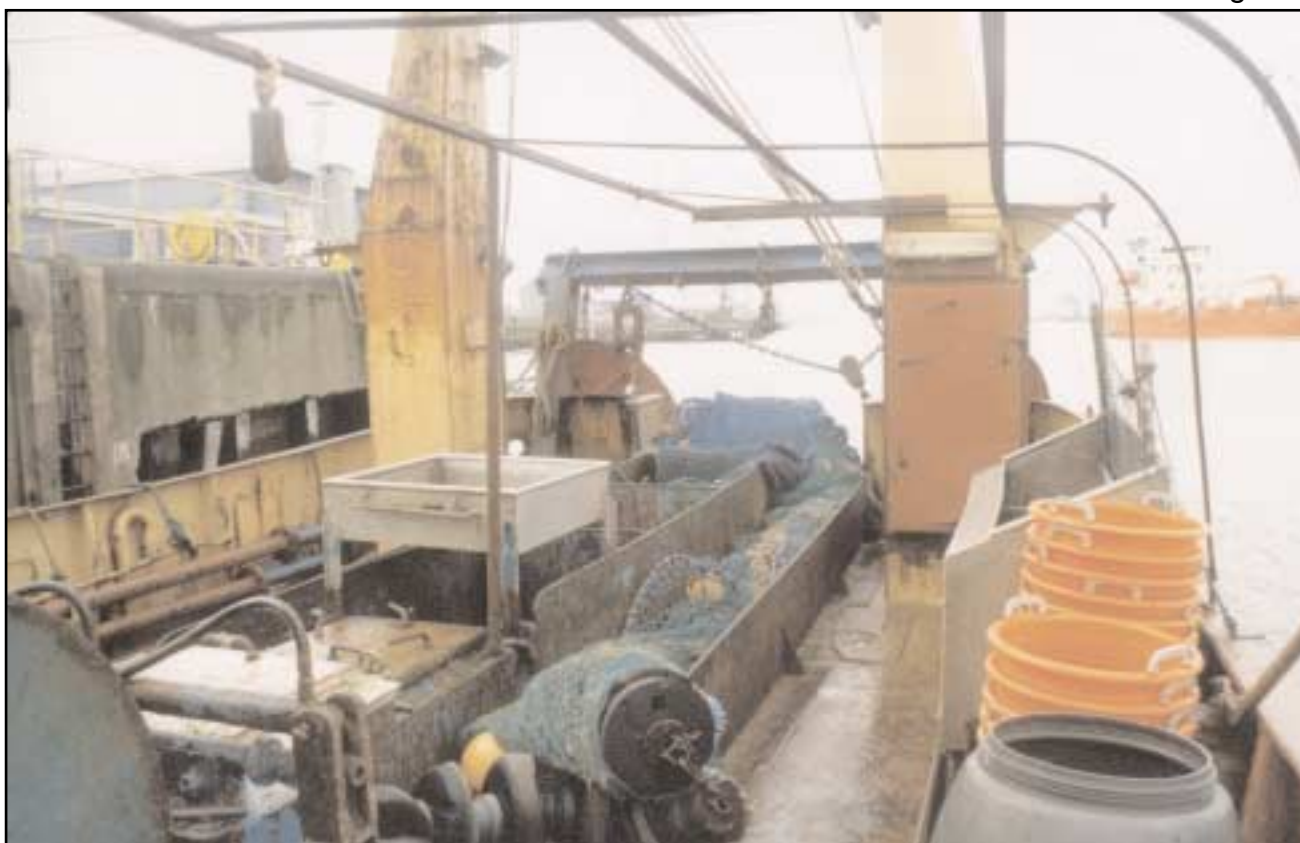
Once this operation is complete, the warp/sweep is pushed out of the block, when opened, on to the stern ramp of the vessel. This allows the trawl to be heaved on deck (**Figure 4**).

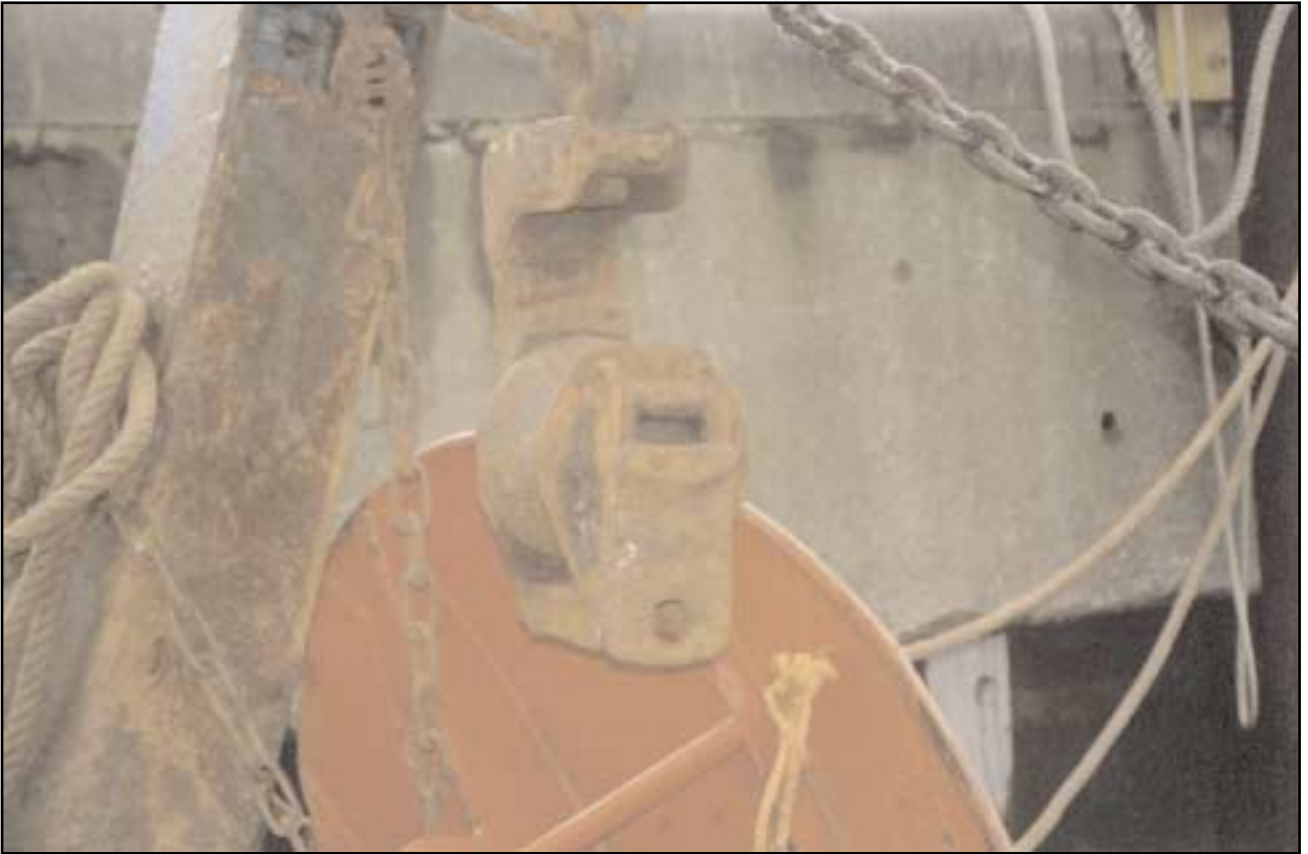
Figure 5

*In the opinion of the surveyors, the blocks sighted, stated to have been removed from Gemma Fidelis showed considerable wear consistent with the blocks being original equipment of the vessel, and also showed lack of recent maintenance, although still serviceable.*

*Further in our opinion, the distortion of the cheek plate of the starboard block although indicative of lack of maintenance or repair, was not of sufficient extent to make the block unusable or to have contributed to any accident involving the trawl wire jumping from the block.*

*Finally, in our opinion, the lack of locking pins for the hinged cheek plate of either block, and the apparent lack of recent wear or signs of recent steel to steel contact in the locking pin holes, indicate that it is most likely these blocks had been habitually used without pins, and may have been used open, that is without the hinged section of the cheek plate being closed. This is incorrect use of the snatch block and would make it possible for the wire to jump from the sheave, particularly if tension on the wire was momentarily released during movement of the vessel in open water with swell or seas causing pitching of the vessel if sufficient forward motion of the vessel was not maintained when hauling nets.*

Starboard snatch block

The condition of both trawl blocks was such that it was impossible to close them in the correct manner. Not only were the locking pins missing, but the securing lugs on the main body of the blocks were corroded to such an extent that they were also unusable.

The main reason for this was the lack of an on-board procedure for maintenance. This allowed the blocks to deteriorate to such a condition over a prolonged period of time, and would have adversely influenced any attempt to close the block by other means. An effective maintenance procedure would have enabled the snatch block to be closed correctly.

4. Ensure crews on all his vessels undergo safety awareness training provided by SFIA (Seafish), in conjunction with MCA requirements.
5. Ensure all lifting and hauling equipment on his vessels is maintained in good repair and working order.
6. Ensure:
  - all crew members are fully involved in the process of risk assessment on all of his vessels.
  - any on-board risk assessment is fully understood by the crews.
  - control measures, identified as a result of any risk assessment, are specific, take account of regulation and published guidance, and are implemented in the form of safe standard operating procedures.
