Report on the investigation of  
the loss of  
***Kirsteen Anne***  
Firth of Lorn  
31 December 2002  
with the loss of her two crew

Marine Accident Investigation Branch  
First Floor  
Carlton House  
Carlton Place  
Southampton  
United Kingdom  
SO15 2DZ

**Report No 19/2003**  
**July 2003**

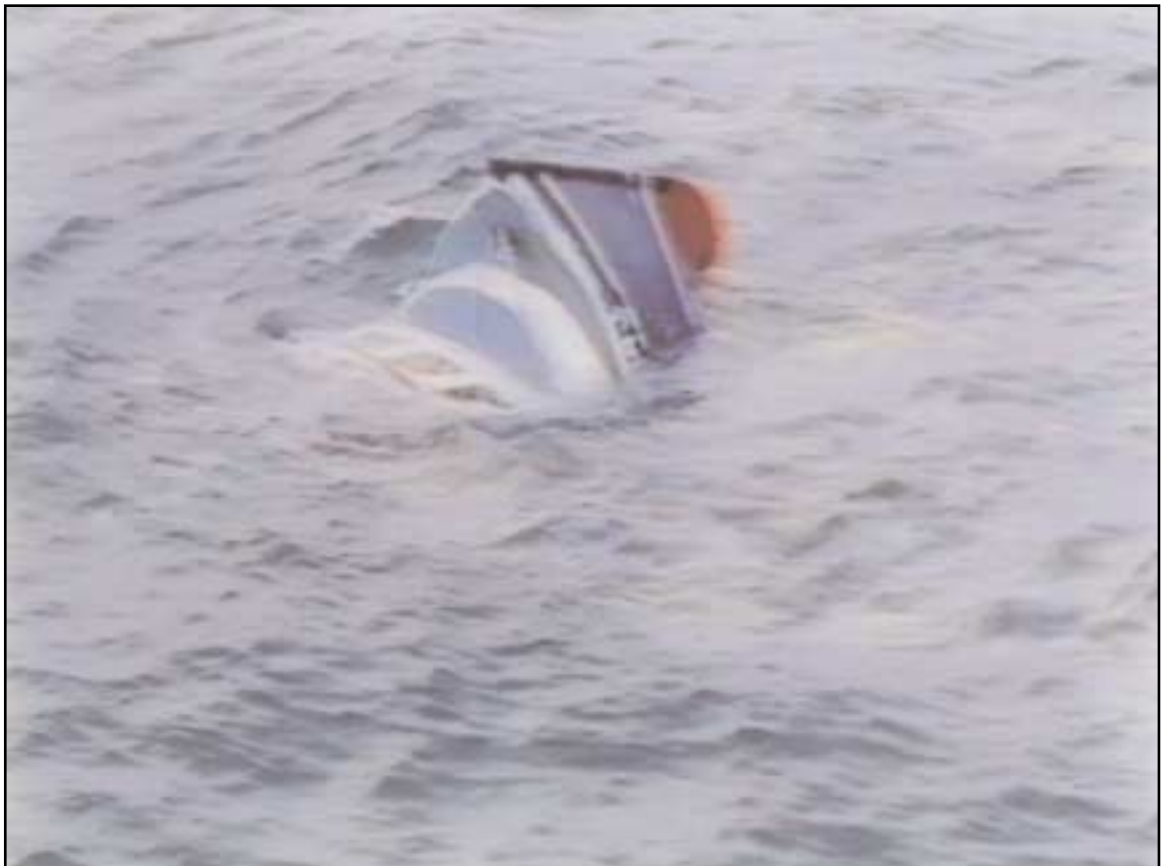
Figure 2

Photograph of *Kirsteen Anne* when found

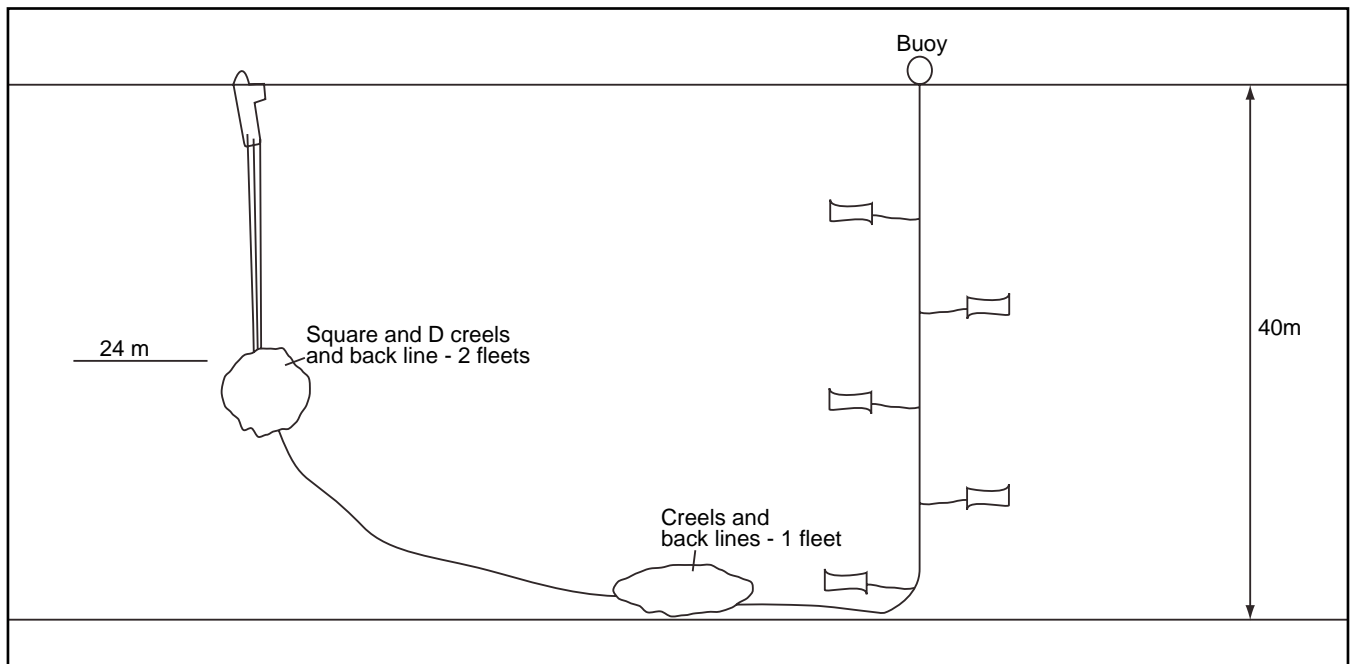
Figure 3

Diagram showing the disposition of the vessel and fleets of creels - not to scale

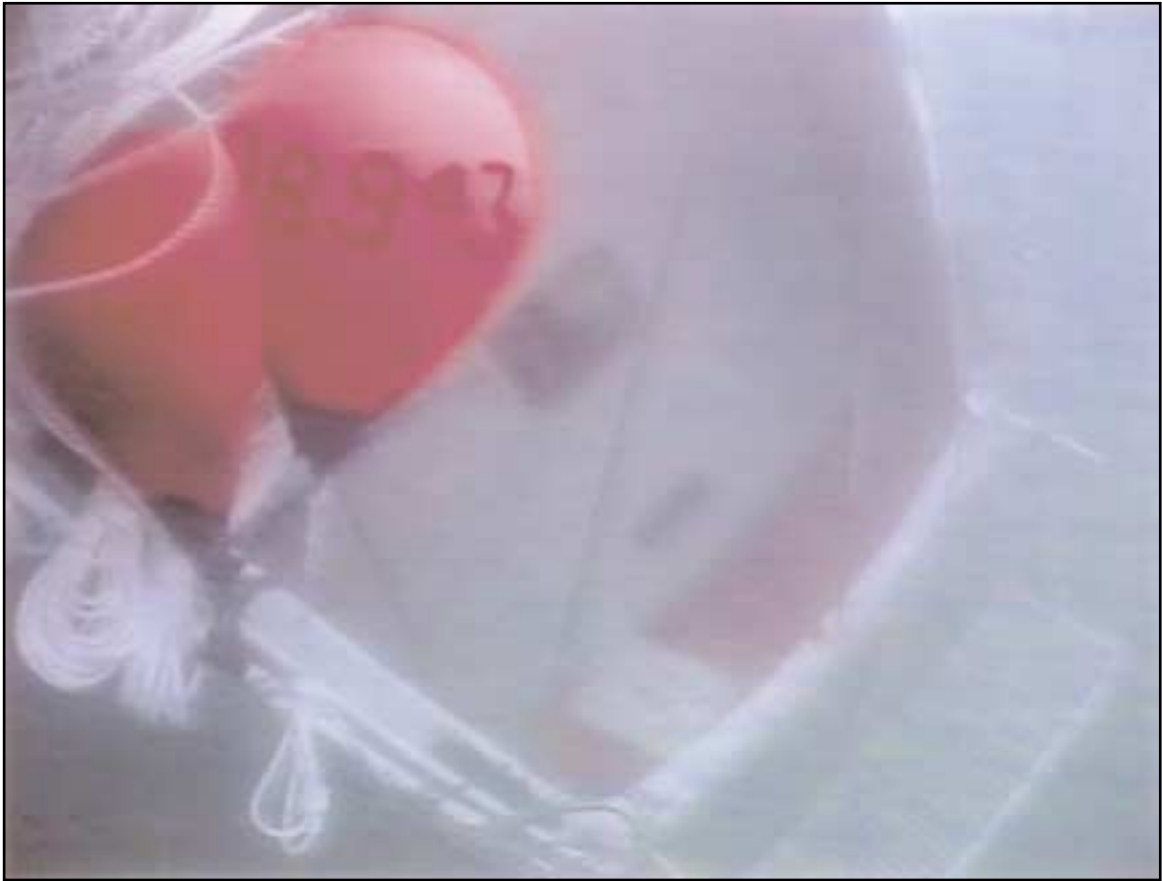
Figure 4

The Strathclyde police diving unit conducted an underwater search of *Kirsteen Anne* and her fishing gear during 1 and 2 January, and a search of the seabed on 3 January. The vessel remained partly submerged and was tethered to the seabed by the fleets of creels she had been carrying. A diagram showing the disposition of the creels in relation to the vessel and the seabed is shown at **(Figure 3)**. During the search of the vessel, the deck covers to the rudder space and bilge were found on deck on the port side of the stern transom **(Figure 4)**, and the GRP engine cover was missing.

Photograph showing deck cover on stern transom

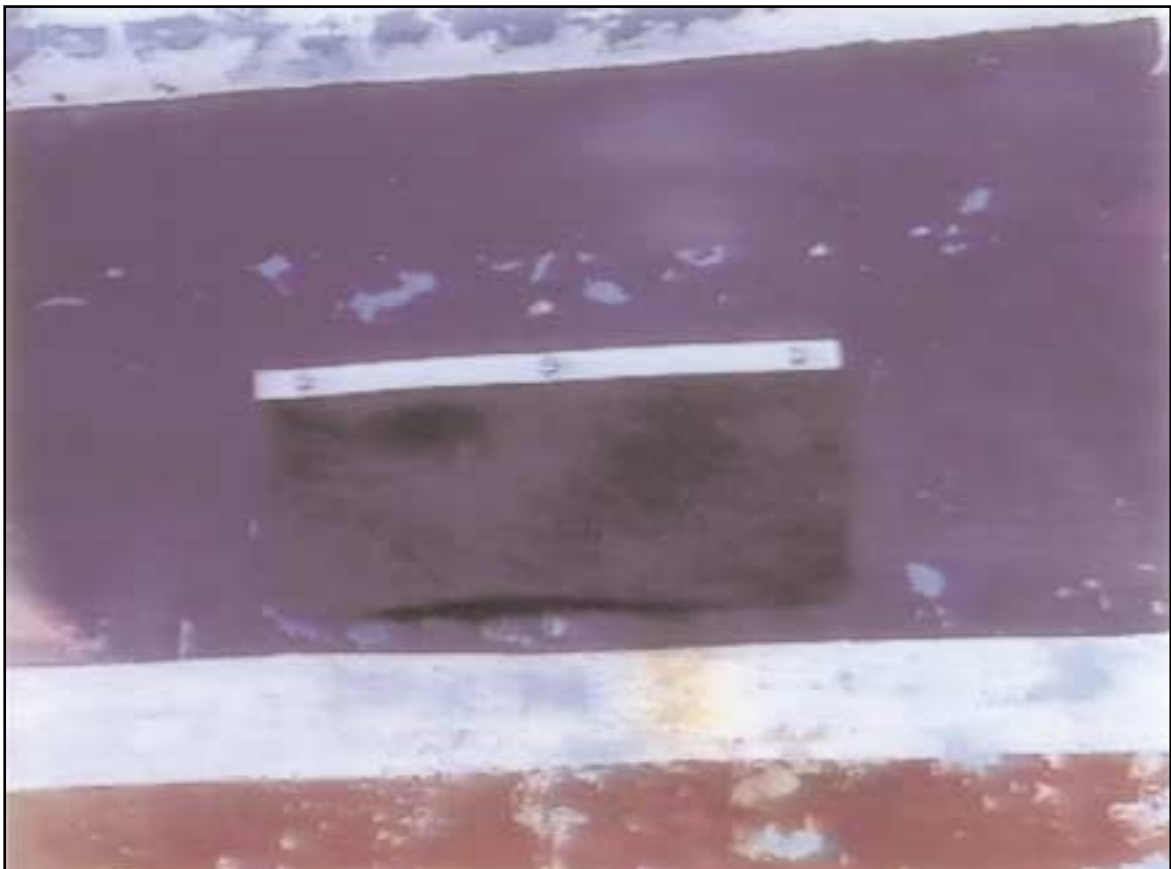
Figure 5

Photograph of freeing port with rubber flap

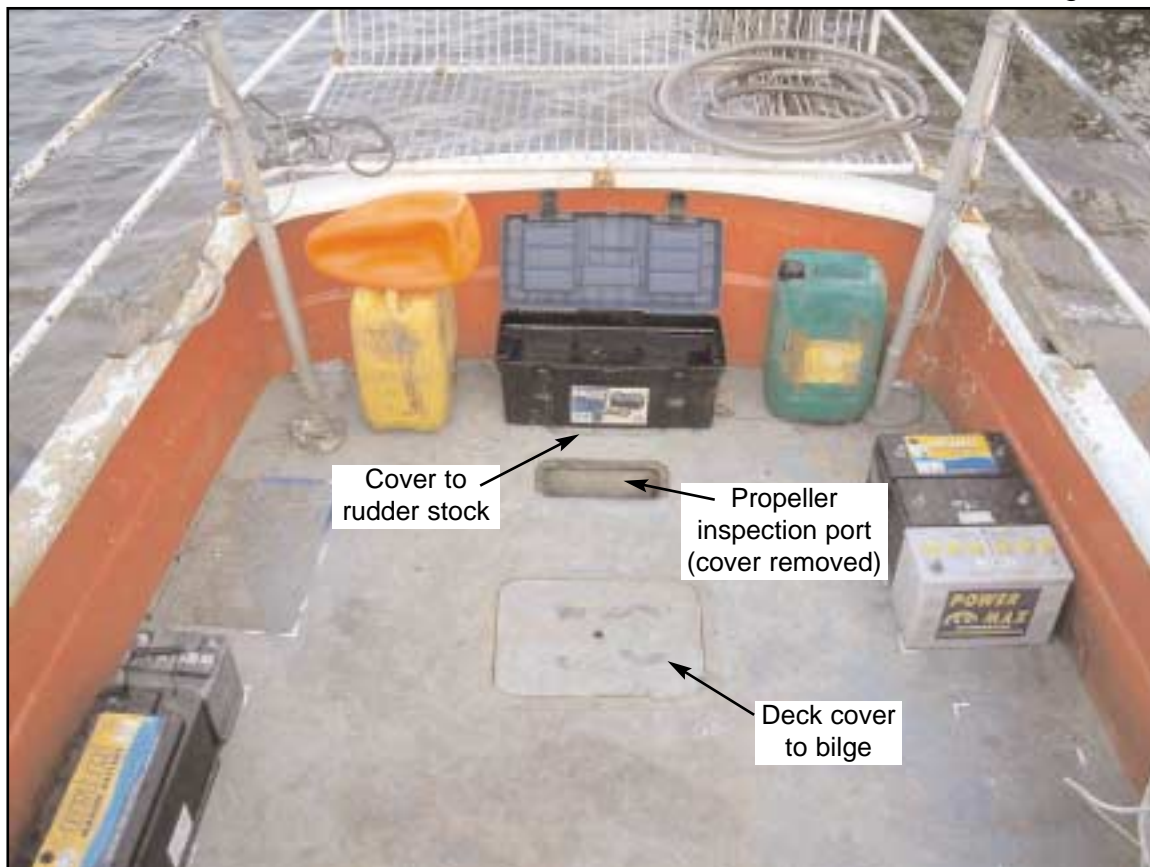
Figure 6

Although the deck was GRP and sealed around its edges, access covers to the rudder stock and bilge area on the aft deck (**Figure 6**) were not watertight. The middle of the three covers shown could be removed to allow inspection of the propeller.

Photograph showing location of deck openings

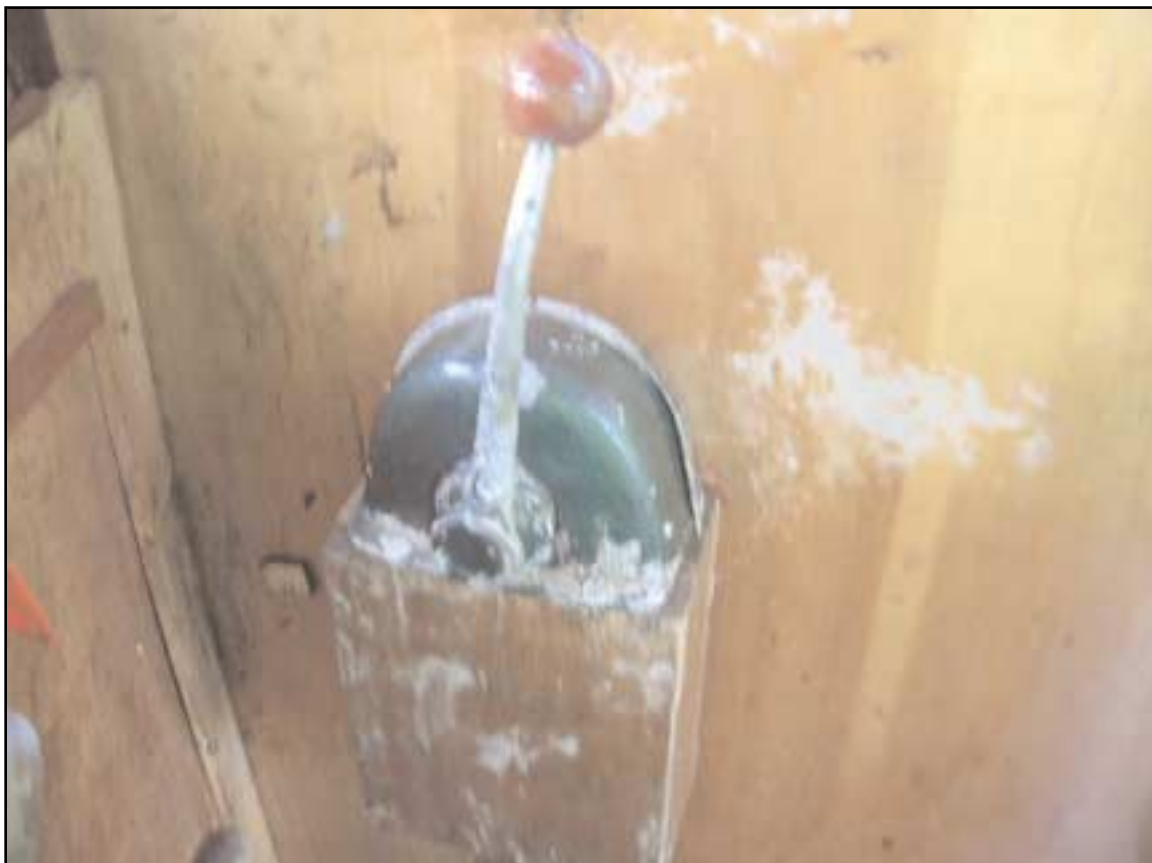
Figure 7

Photograph showing the position of the engine control lever

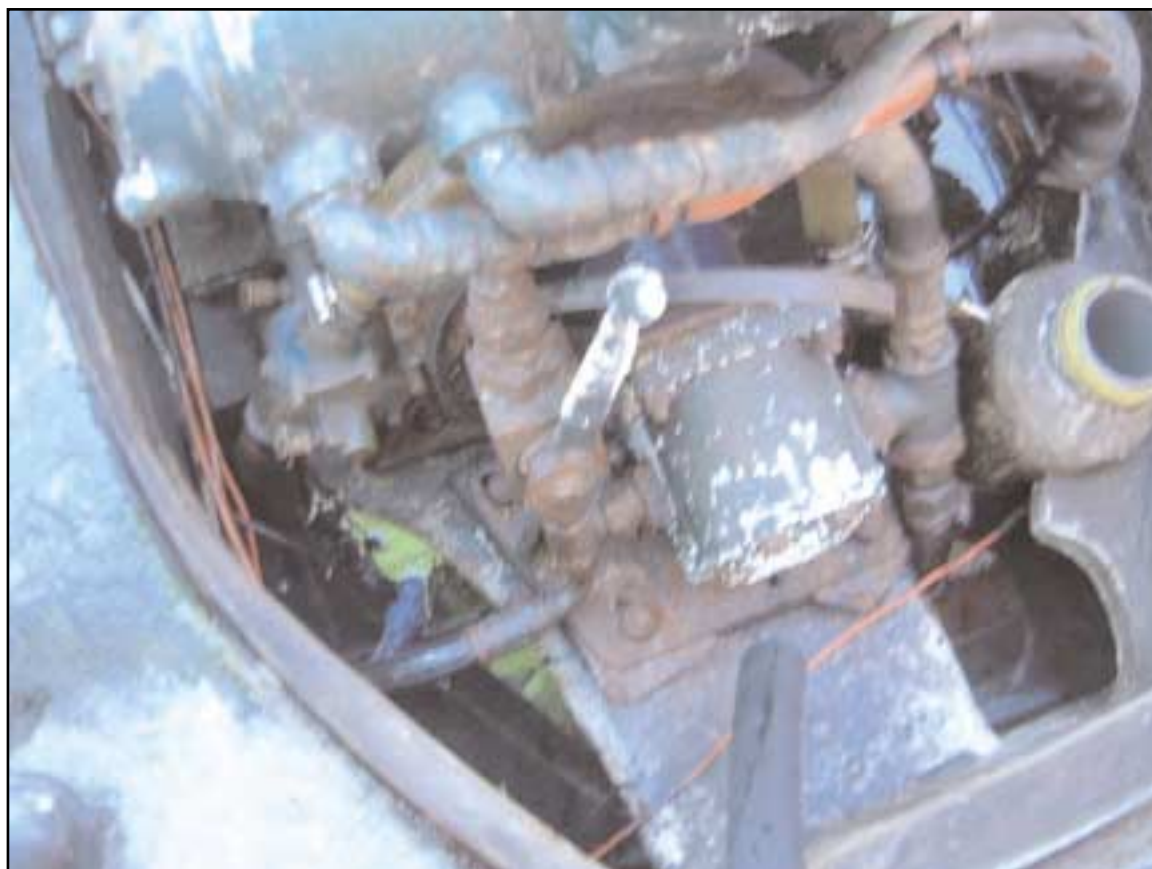
Figure 8

Photograph showing the position of the hydraulic control lever

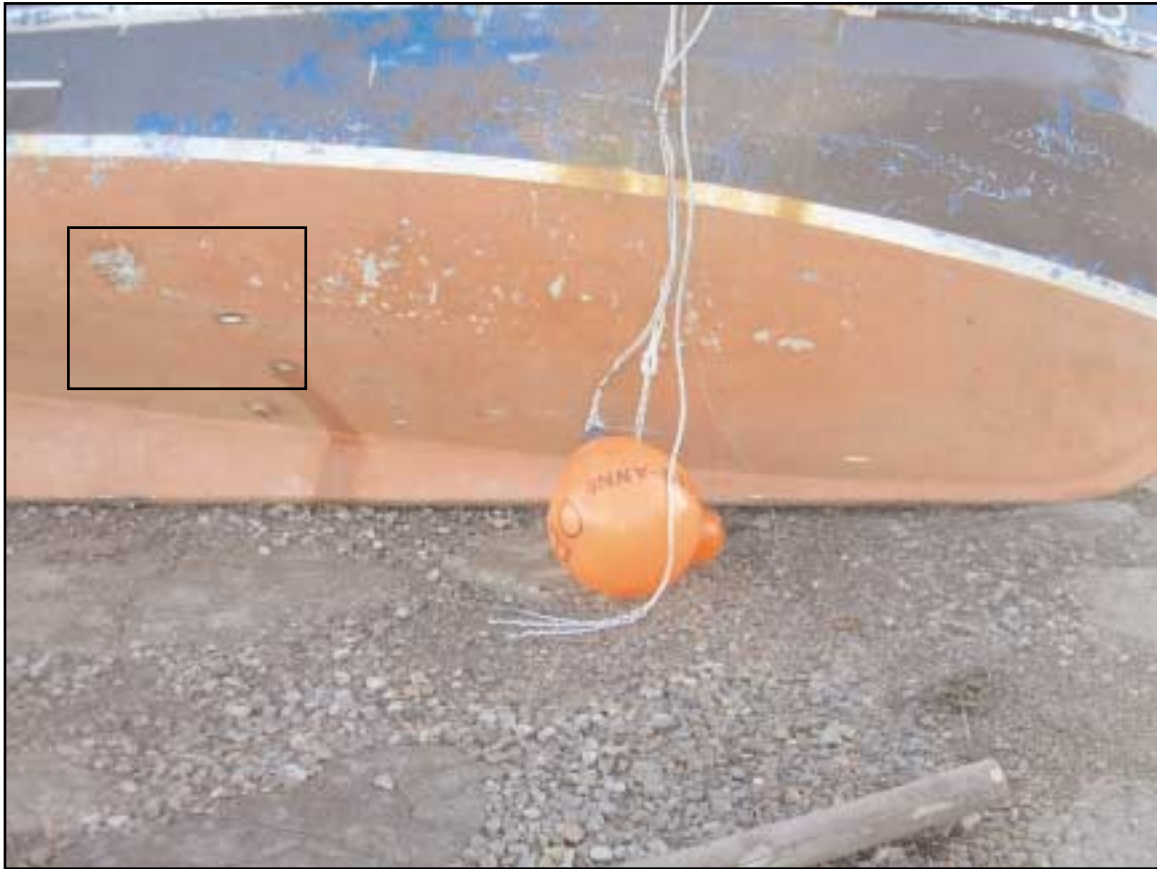
Figure 9

- Three distinct indentations were noted amidships, below the waterline on the starboard side, the lowest of which had punctured the hull (**Figure 9**).

Photograph showing the marks and puncture on the starboard side

The marks and hull puncture found on *Kirsteen Anne*'s starboard side must have been caused by contact with another object. This damage might have occurred during the vessel's recovery when it is reported there was contact between the cutter *Searcher* and *Kirsteen Anne*. There is also a possibility, however, that the puncture was caused during the recovery of the fleets south of Kerrera. The hulls of many creel boats are strengthened in the vicinity of the pot-hauler to prevent such occurrences. If the puncture to the hull was caused before capsizing, this would have increased the water ingress to the bilge.

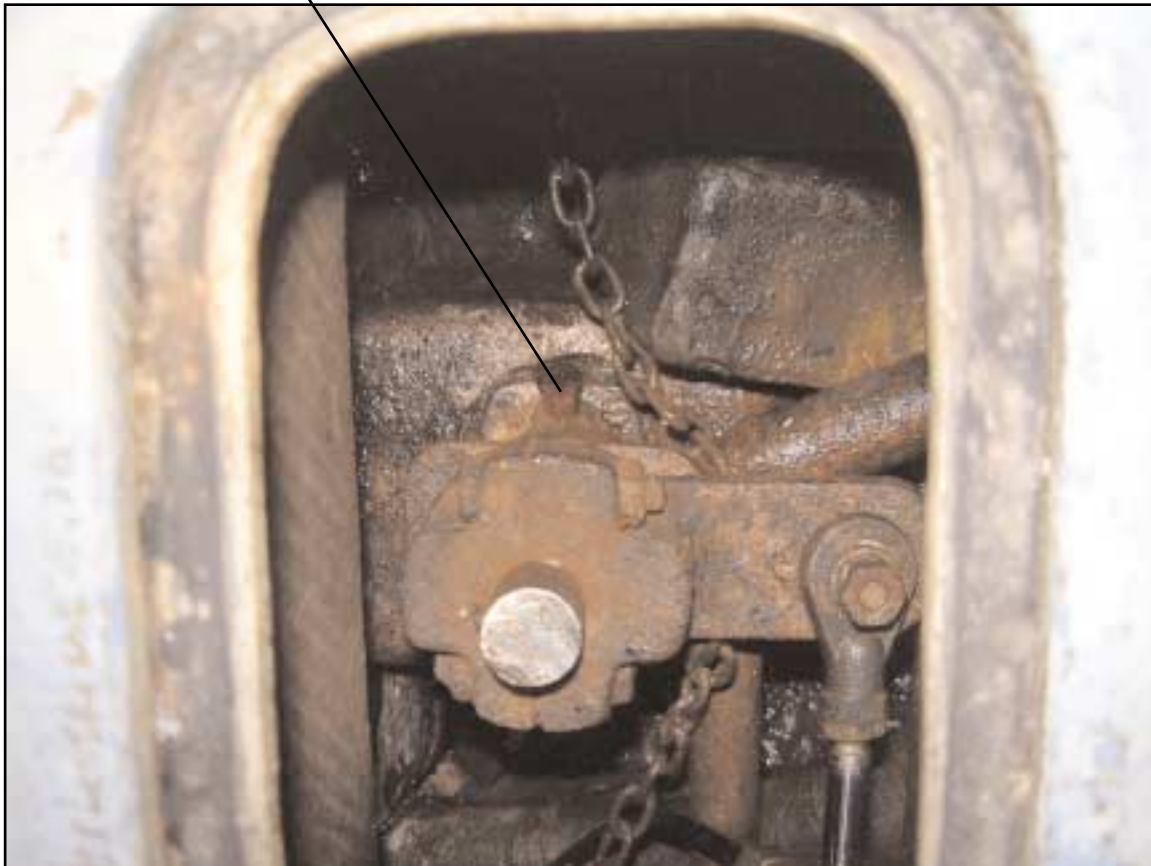
Figure 10

- On 24 December, the crew were seen pumping water via a hand-operated bilge pump at least every hour, and it is believed they fitted a wooden wedge in a hole in the rudder stock caused by a missing grease nipple to stop seawater from coming in. Crew B had also spoken to friends about the possibility of water also coming through the stern gland, but it is reported he had checked and confirmed that this was not the case.

- Eighty creels (52 D shaped, and 28 rectangular), and approximately 1200m of back lines were recovered.
- A wooden bung used in lieu of a missing grease nipple was in place on the starboard side of the rudder stock (**Figure 10**).

Photograph showing a wooden bung in the rudder stock

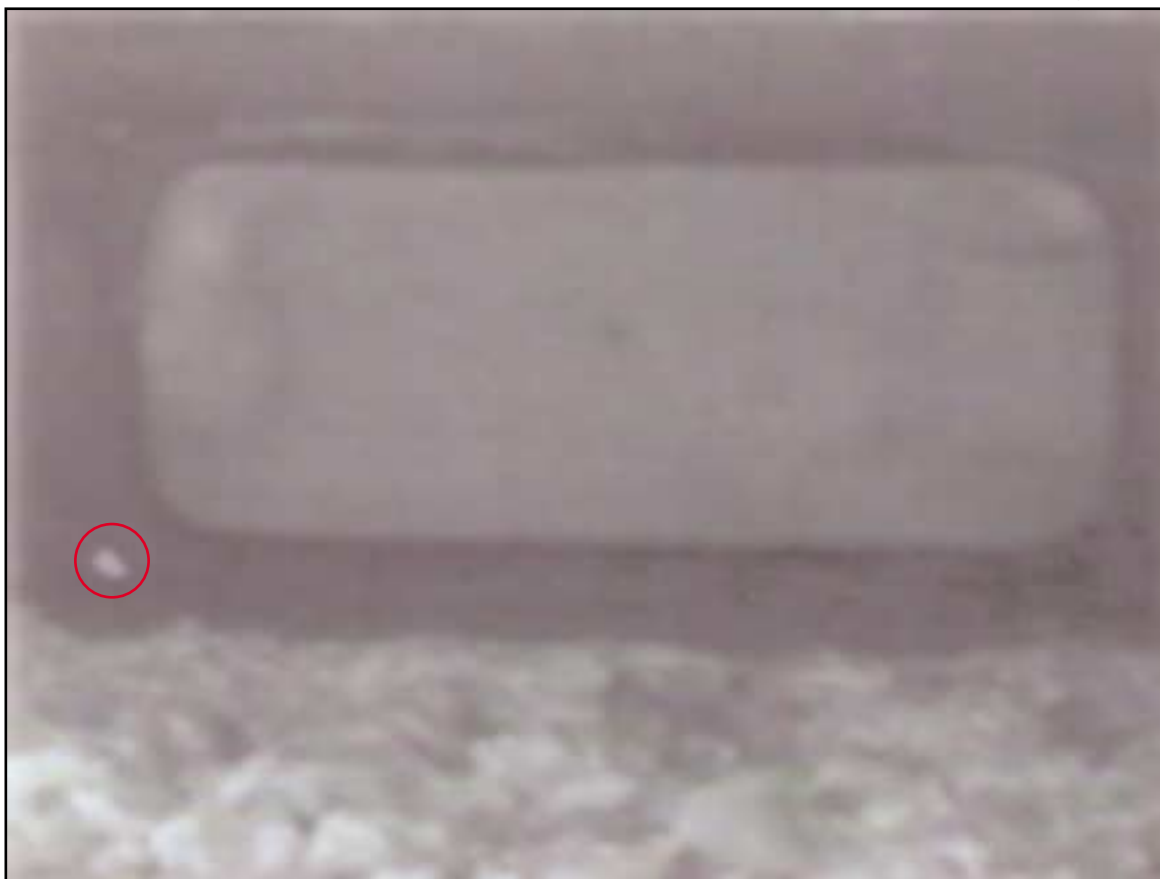
- A 75mm hole was found in the GRP between the top corner of the propeller inspection port and bilge (**Figure 11**).
- With the boat towed through the water at very slow speed in an unloaded condition, water was observed to ingress from the rim of the propeller inspection port cover. No water ingress from the rudder stock or propeller stern gland was evident.

Photograph showing hole at the top of the propeller inspection port

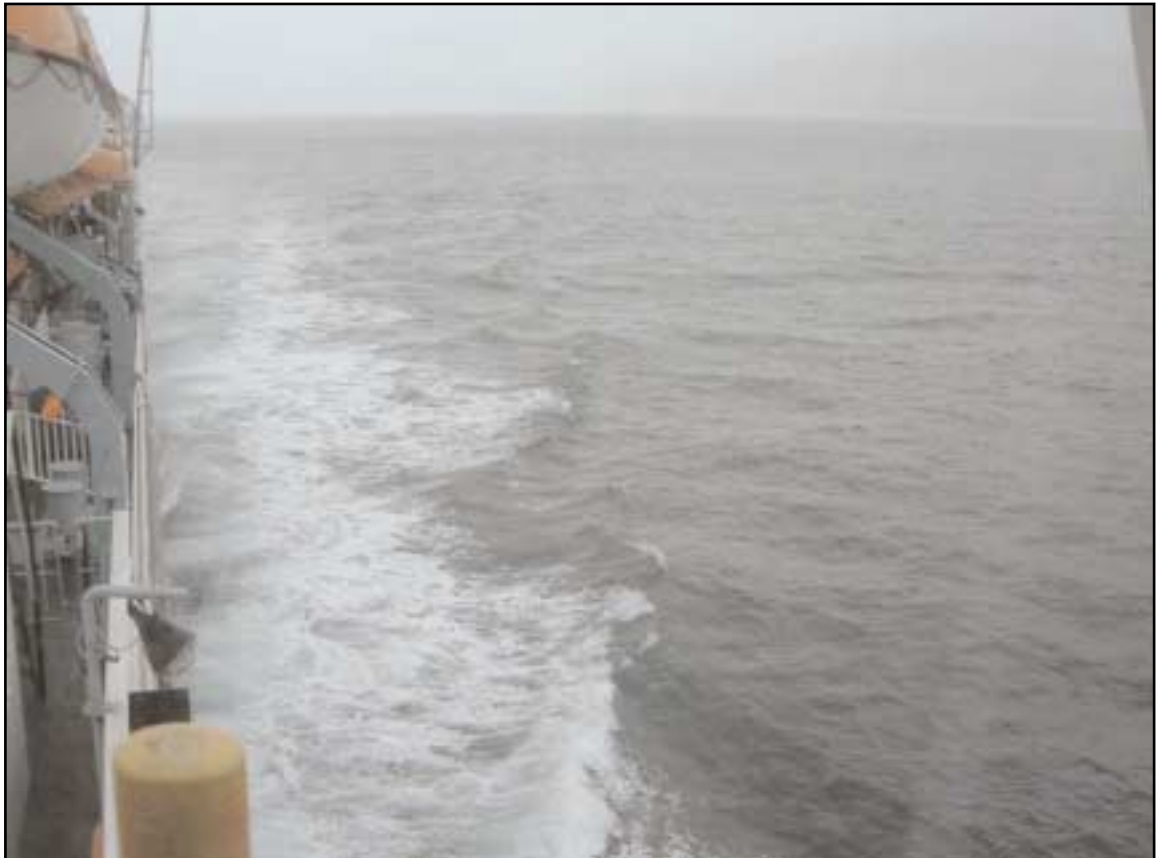
Figure 12

The vessel overtaken at a close distance by *Isle of Mull* might have been *Kirsteen Anne*, and in such situations the wake of a larger vessel can destabilise smaller ones. In this case, however, examination of the wake produced by *Isle of Mull* at 14.5 knots (**Figure 12**) shows the wake to be relatively small. It is considered such wake would have dissipated very quickly in the reported sea conditions, and therefore had only a negligible effect on vessels in close proximity.

Photograph showing the wake of mv *Isle of Mull* at 14.5 knots

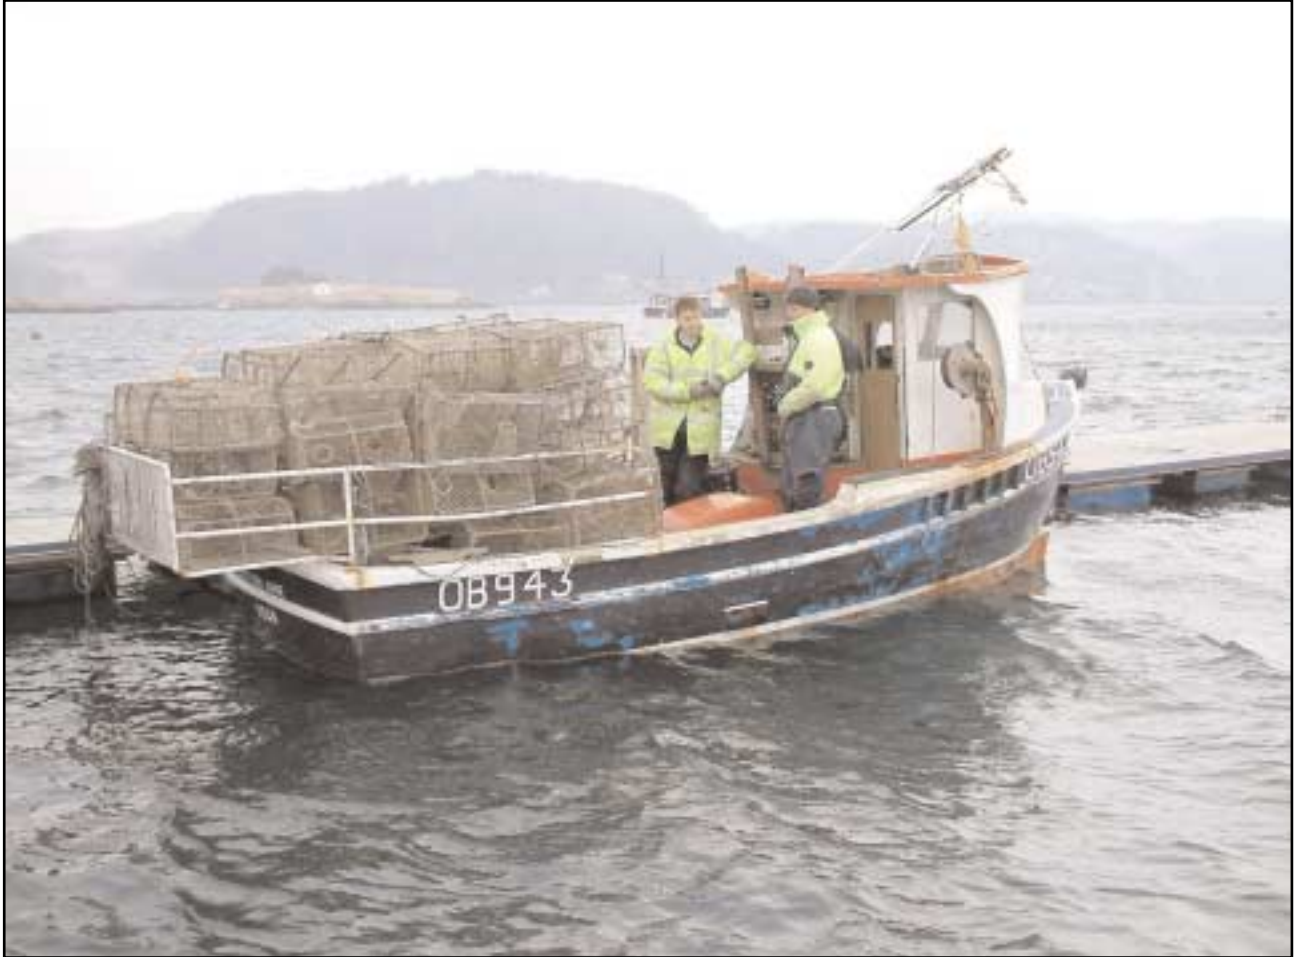
Photograph showing *Kirsteen Anne* in her estimated loaded condition

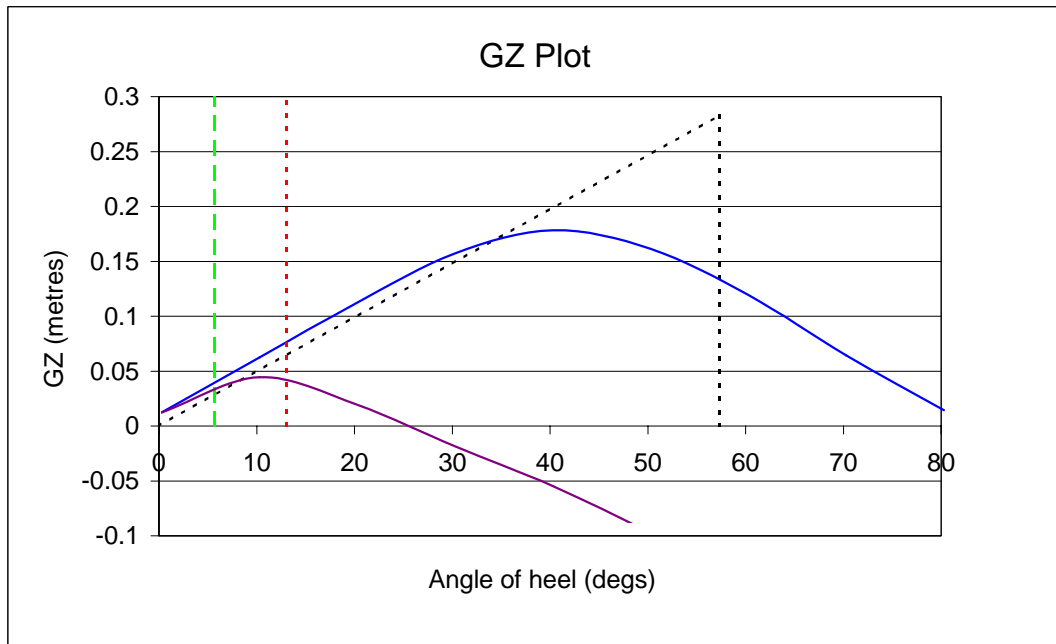
Vessel: Kirsteen Anne  
 Condition: Loaded with 75% fuel (Case 1-hull up to g'whale, Case 2-hull up to deck)  
 Water SG: 1.025  
 Longitudinal dimensions about stn 0 (+ve aft, -ve forward) Dimensions in metres  
 Vertical dimensions about baseline (USK stn 9) (+ve above) Trim by the stern positive

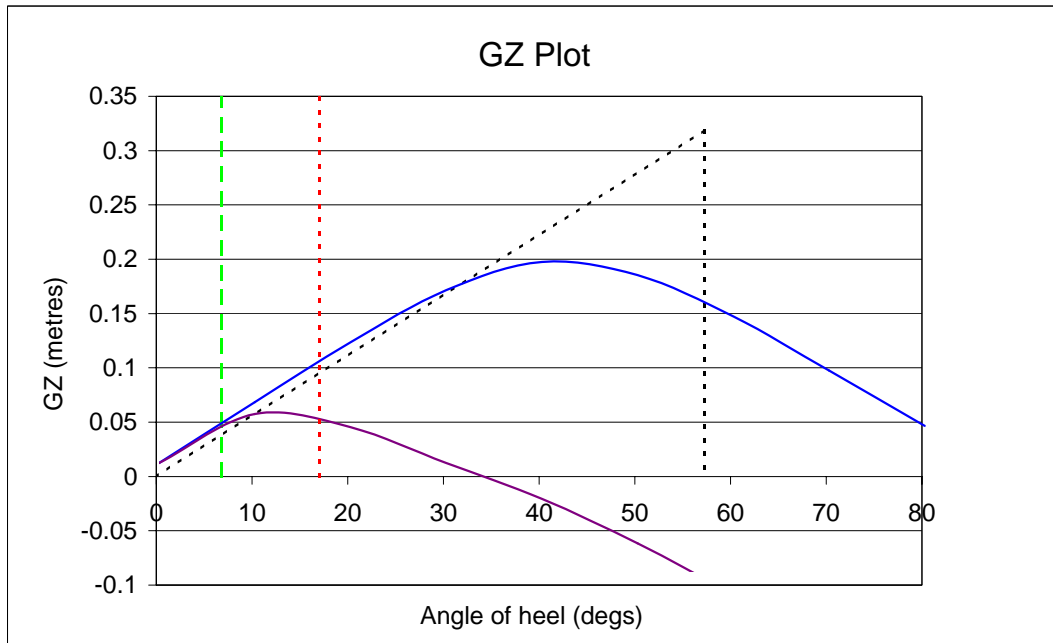
Vessel: Kirsteen Anne  
 Condition: 75% fuel, only 2 fleets of creels (Case 1-hull up to g'whale, Case 2-hull up to deck)  
 Water SG: 1.025  
 Longitudinal dimensions about stn 0 (+ve aft, -ve forward) Dimensions in metres  
 Vertical dimensions about baseline (USK stn 9) (+ve above) Trim by the stern positive

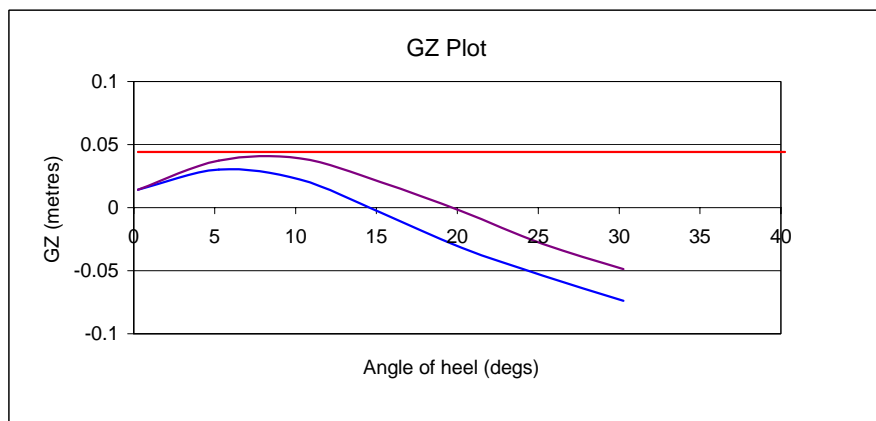
The flooding scenario demonstrates that only 0.26 tonnes of water is needed to cause marginal stability. Bearing in mind the very poor watertight integrity of the deck, coupled with the low freeboard, it is highly likely that sea water entered the hull on the day of the accident. Approximately, 0.26 tonnes equates to a 5-6 cm depth of water in the bilge.

Vessel: Kirsteen Anne  
 Condition: Partially flooded, 75% fuel (Case 1-0.5 te flooding, Case 2-0.25 te flooding)  
 Water SG: 1.025  
 Longitudinal dimensions about stn 0 (+ve aft, -ve forward) Dimensions in metres  
 Vertical dimensions about baseline (USK stn 9) (+ve above) Trim by the stern positive
