Report on the investigation of  
the cargo shift, abandonment, and grounding of

***mv Kodima***

in the  
English Channel

**Report No 1/2003  
January 2003**

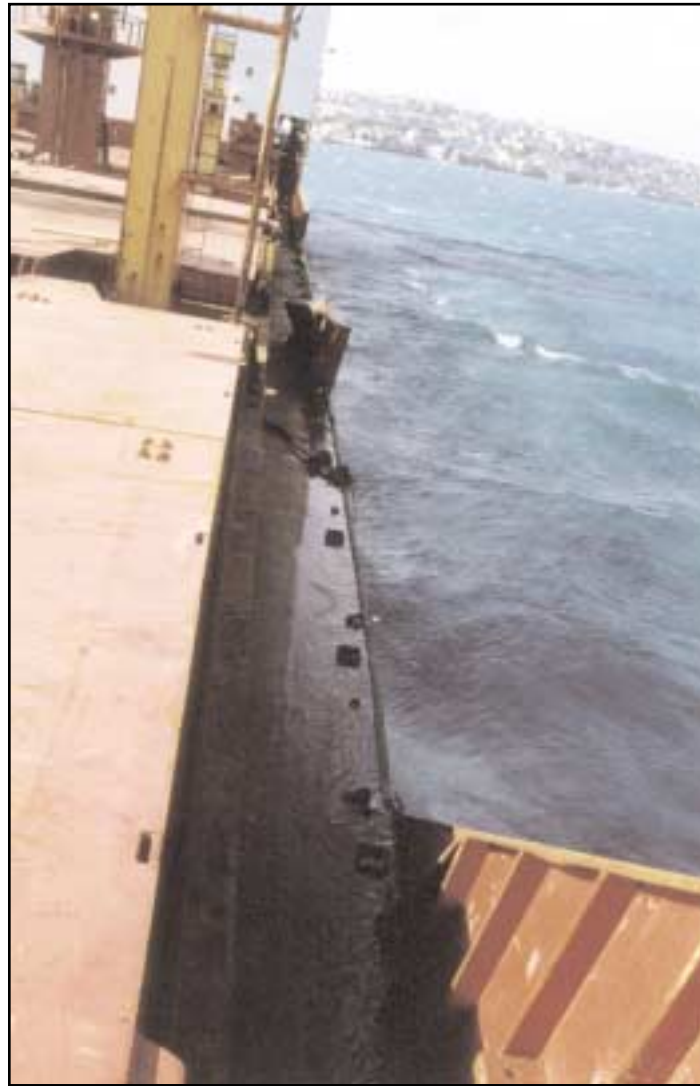
Figure 12

MAIB inspectors visited *Kodima* in Falmouth following the accident. Damage seen included the ship's side, where a large section of the port bulwark had been ripped away (**Figure 12**), deck fittings that had been sheered off, the hatch cover to hold No 3 had been lifted, and the hatch cover to hold No 4 was missing (**Figure 13**). The engine room had also been flooded after the ship had been abandoned because of its access hatch on the port aft first level superstructure deck (or poop deck) being carried away by heavy seas when the list was about 45° and the deck edge submerged. The water level had extended up to, and including, the middle levels of the engine room, as well as reaching close to the deckhead of the engine control room.

Photograph showing damage to port bulwark

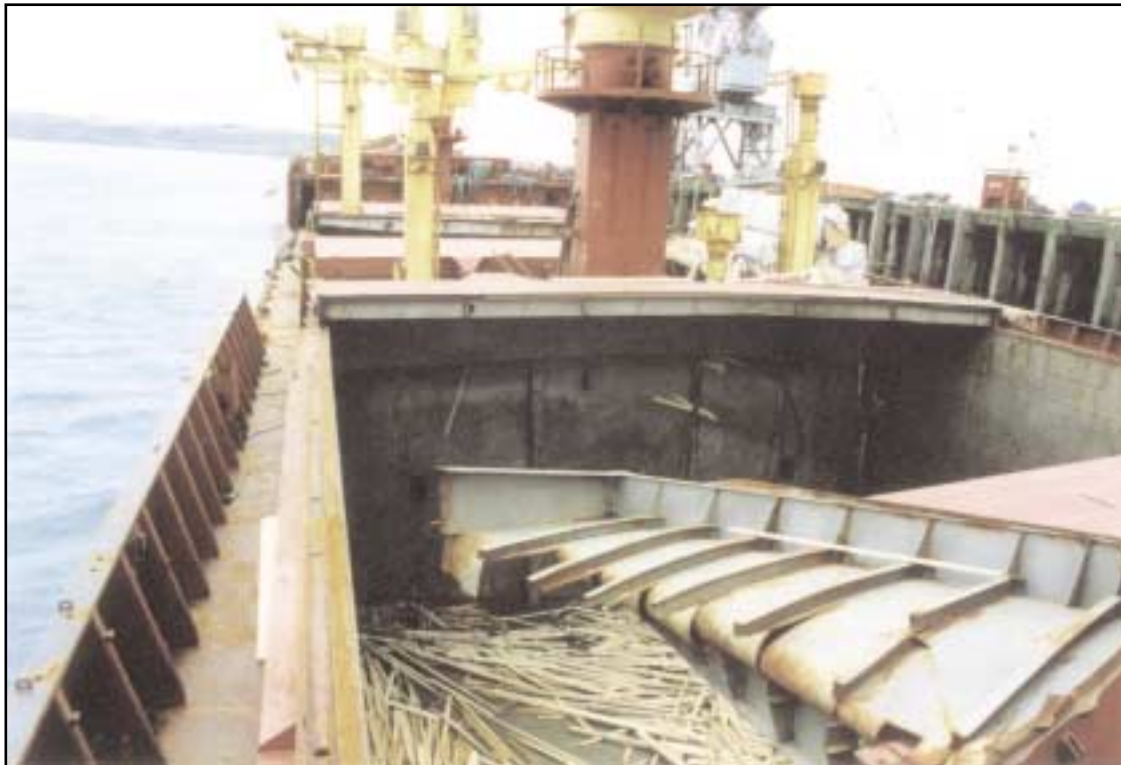
Figure 13

Photograph showing the damage to No 4 hold hatch cover

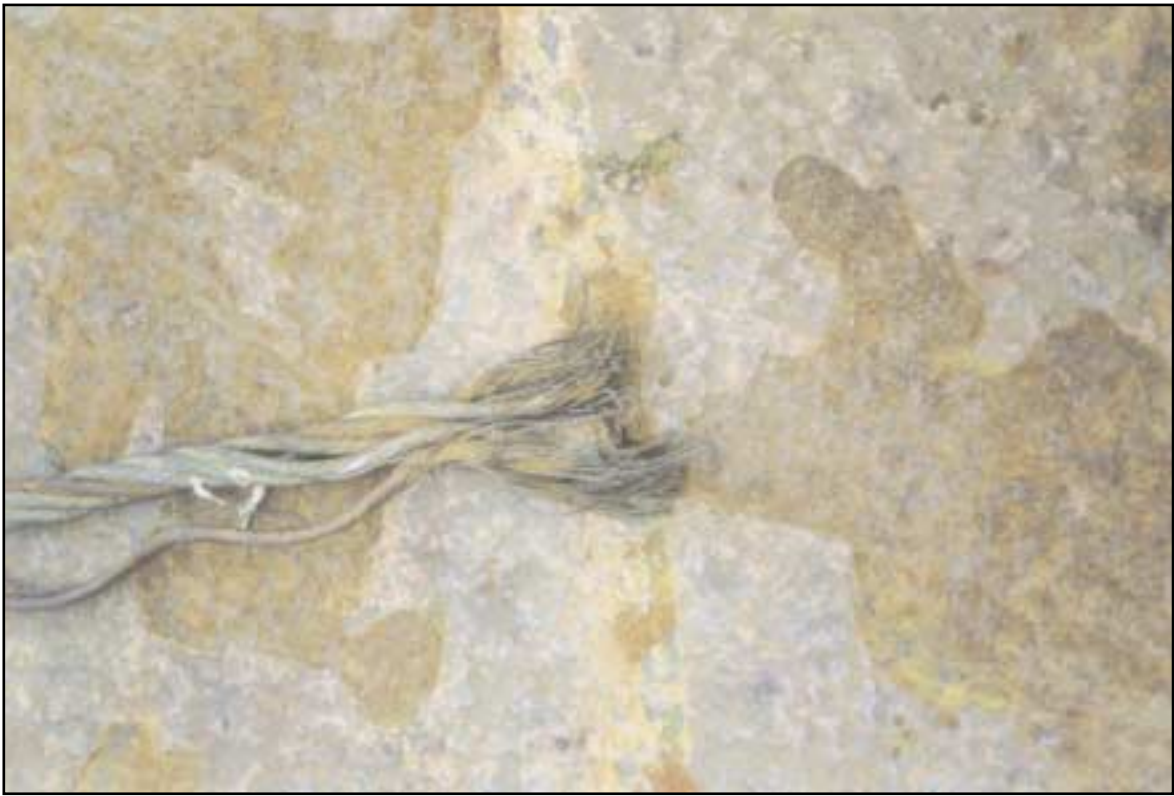
Although many of the wire lashings had been cut and moved during the salvage operation, five had a stranded appearance, indicating that they had parted (**Figure 14**). There was also some evidence that some of the lashings might have failed at the turnbuckle. All of the lashings seen appeared to be in good condition.

Photograph of stranded wire lashing

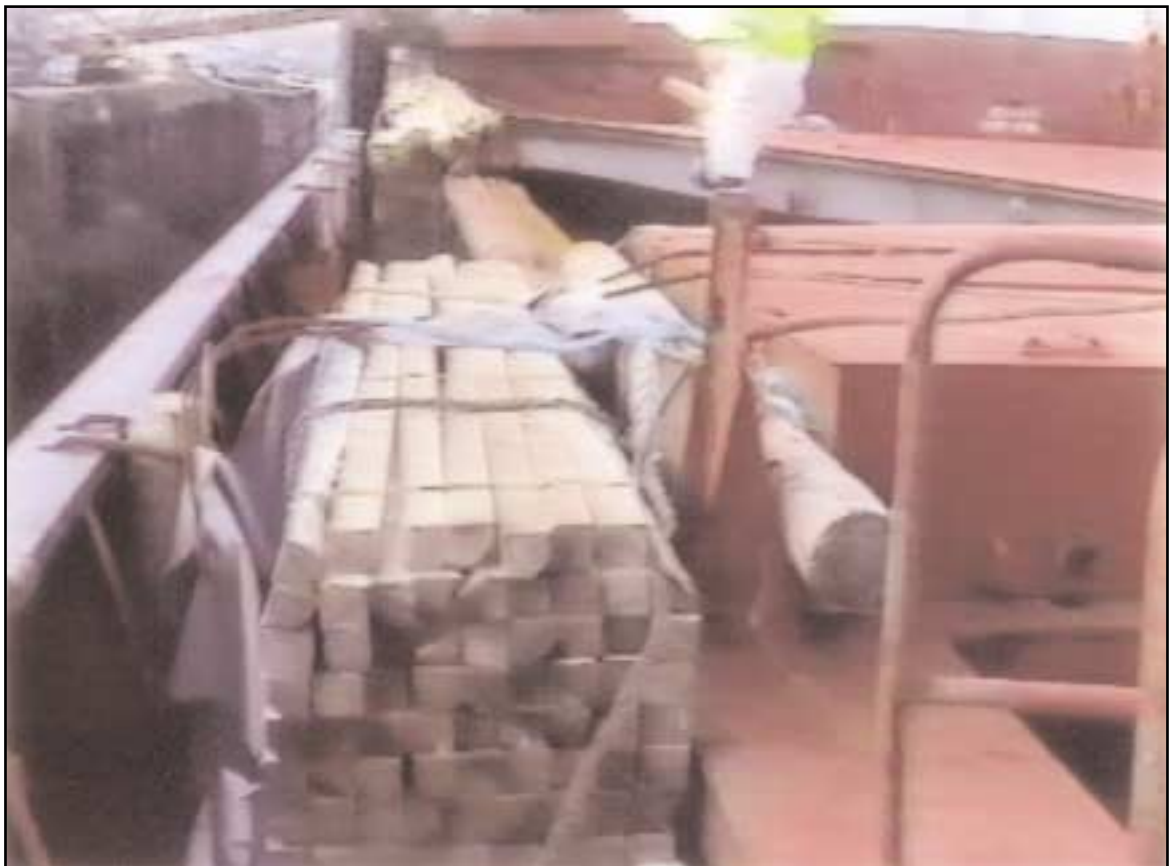
Figure 15

The achievement of a compact stow, when loading timber cargoes, is essential, but can also be extremely problematic. In this case, difficulties were caused by the difference in height between the deck and the top of the hatch covers (**Figures 6 and 15**), the presence of the wells between the hatches (**Figure 8**), the numerous obstructions in the stowage area (**Figure 15**), and the differing lengths of the timber packages. Although such difficulties made the presence of some void spaces unavoidable, appropriate measures to keep these to a minimum appear to have been taken, and there is no evidence to suggest that the stow was not compact. In particular, the repacking and placement of timber packages in the gaps between the bulwarks and hatch coamings was a prudent action to take.

Photograph showing deck obstructions and height differences
