Report on the investigation of failure of

lifeboat winch brake on

***Marine Explorer***

**Report No 2/2002**  
**January 2002**

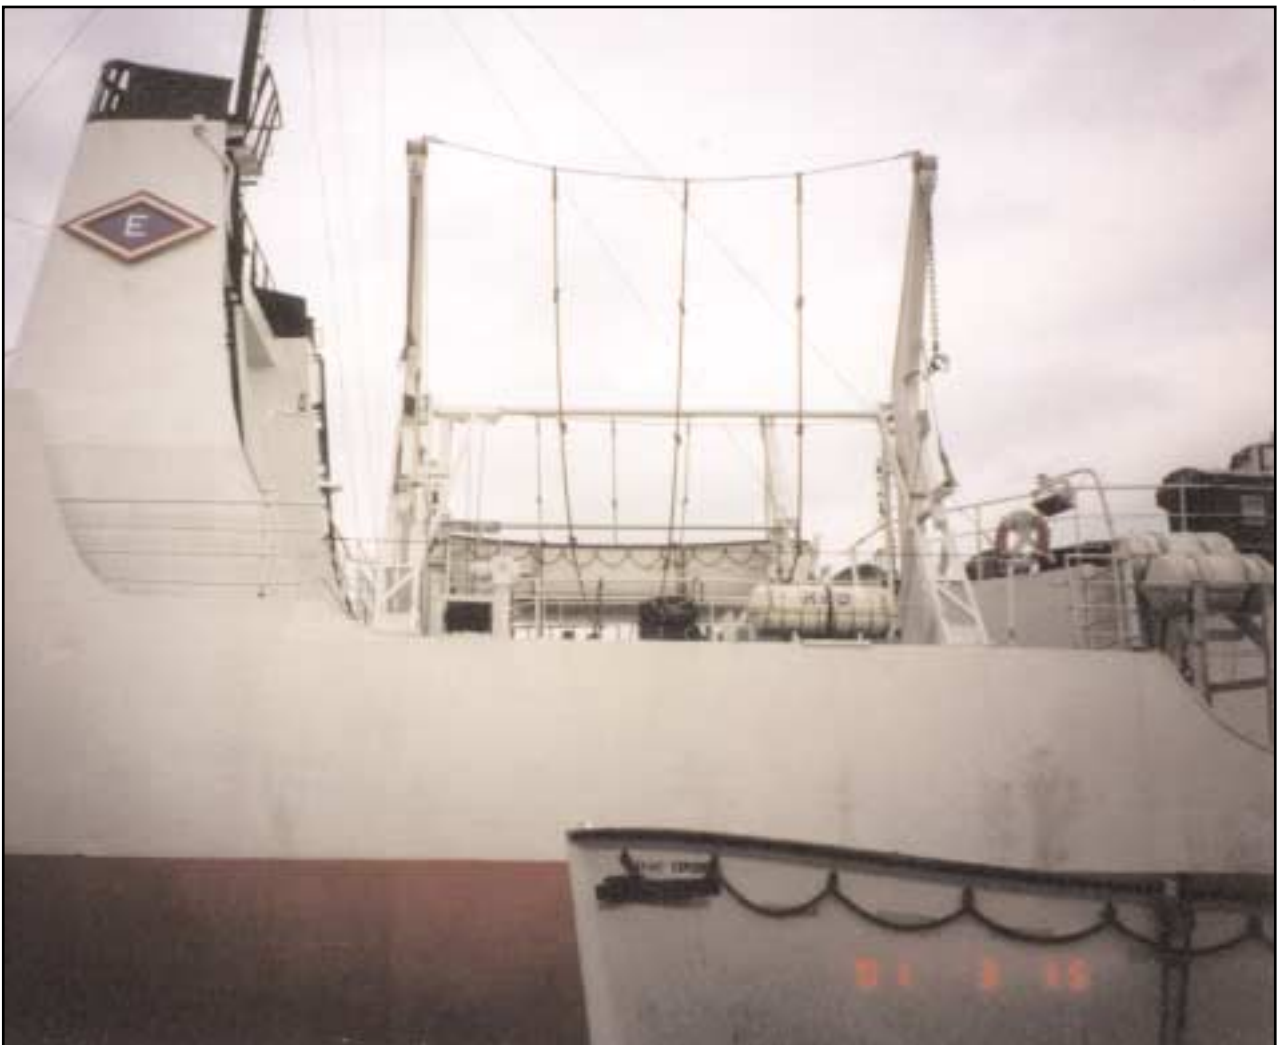
Figure 1

The inboard face of the arms on the port davit had suffered some wear in way of the mechanical stops. Welded repairs had been made to these areas shortly before this accident. Although the owners were making preparations for a load test to MCA's requirements, this test had not been performed at the time of this accident.

The port lifeboat davits

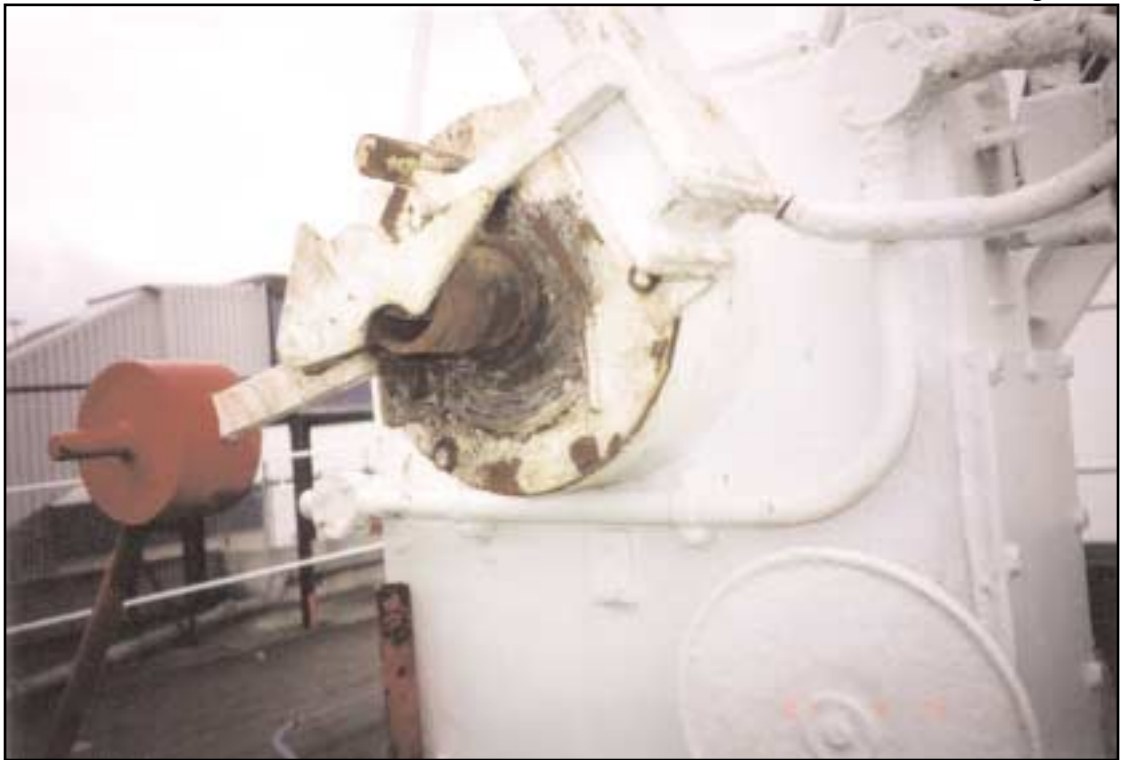
Figure 2

Before dismantling began, it was noted that the brake operating lever was resting on the external stop (**Figure 2**). The lever's securing screw was first removed which allowed the lever to be slid from its splines on the eccentric. Once the lever was clear of the splines, it was clear, from the relative position of the securing screw's slot in the eccentric, that the lever had been at the limits of its adjustment. This position corresponded to worn friction linings (**Figure 3**).

Brake housing of winch

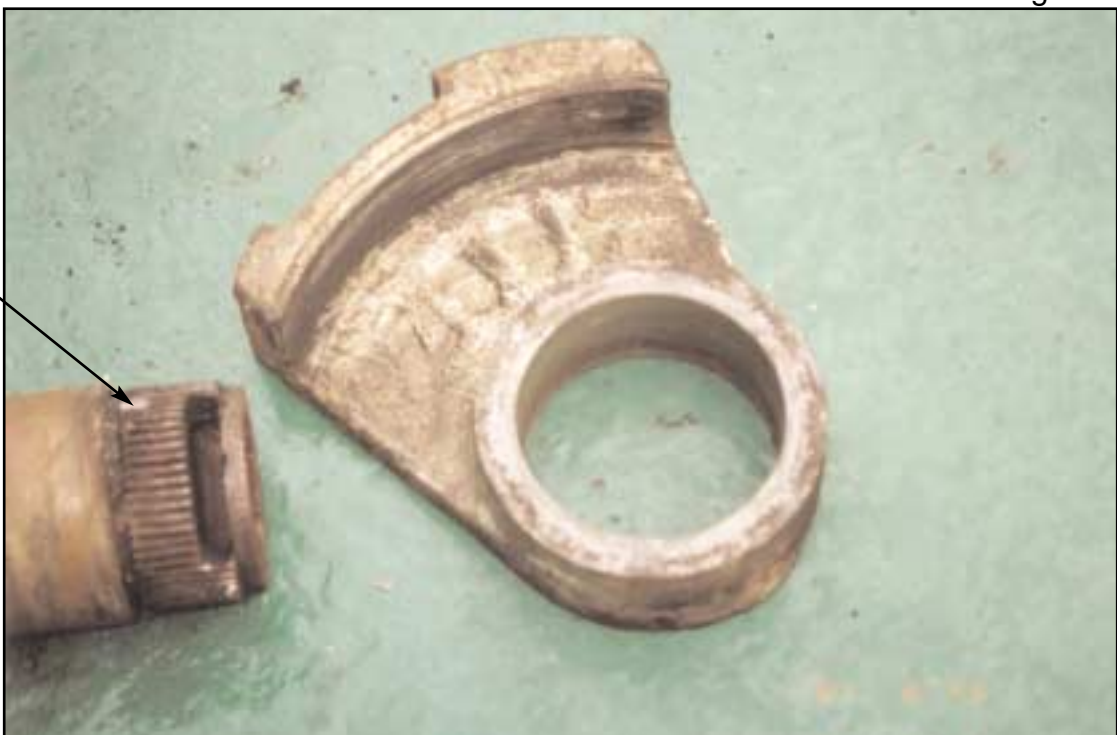
Figure 3

The eccentric was not a smooth running fit in the cover bearing and required several blows to remove. The bearing surfaces were dry and partially covered in unidentified deposits. The brake shoe was a smooth running fit on the eccentric, and the friction material was not seriously worn or contaminated (**Figure 3**).

White mark  
shows  
position of  
lever's  
adjusting  
screw

Splines of eccentric (left)  
Brake shoe, or sector (right)

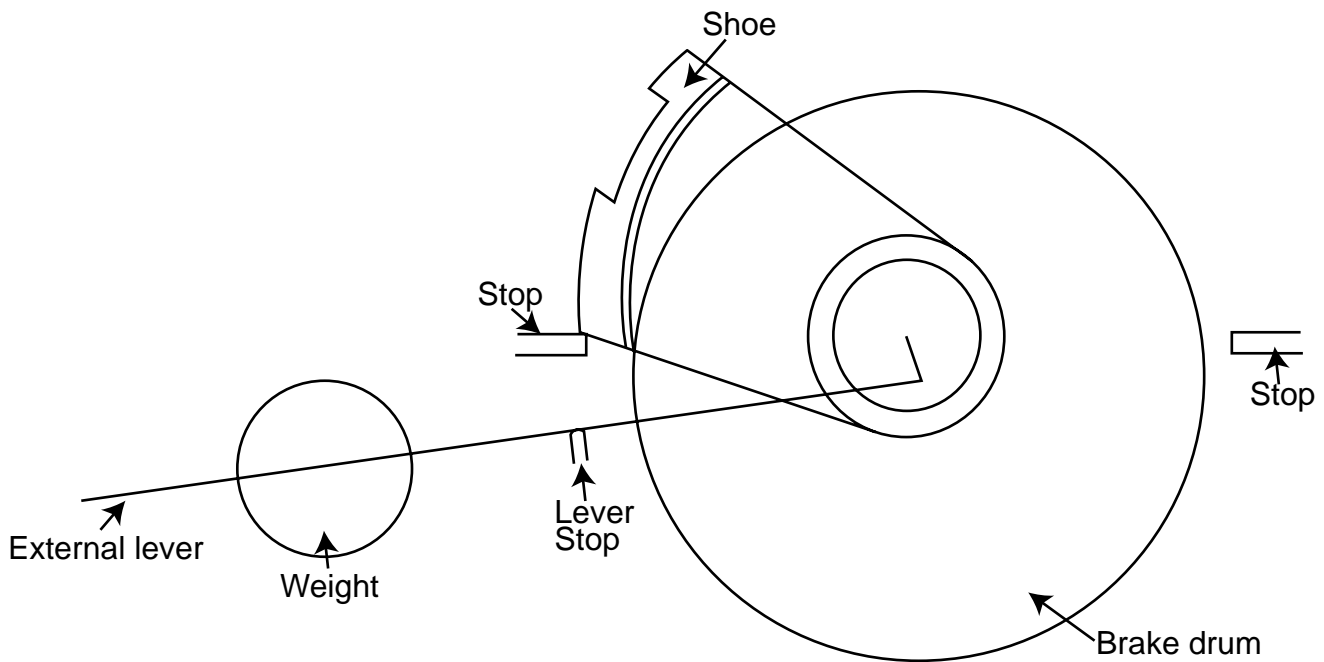
The setscrews securing the cover were removed, and the cover levered off. As this cover was being removed, the position of the brake shoe was seen as in **Figure 4**. The assembly of cover, eccentric and shoe were lifted clear and then dismantled.

Position of brake sector as found after incident

As shown by the post-accident examination, the brake shoe was not properly located by its stop pin (**Figure 4**). In the position found, there was no contact between the friction surfaces of the shoe and drum. Further, because the operating lever was in contact with its stop, the brake could offer no resistance to the drum and winch rotating, no matter how great the effort applied to the lever. This is why efforts to apply the gravity brake during the unintended descent of the lifeboat were unsuccessful.

However, when the winch's motor began to hoist the lifeboat, there was contact between the drum and the brake shoe. The friction force between them allowed the drum, now moving in the hoist direction, to accelerate the shoe away from its stop pin. This acceleration was sufficient to cause the shoe to swing over to the stop pin on the opposite side of the casing. In this position there was no contact between the shoe and the drum, and thus no means of returning the shoe to a position where it would provide effective braking (**Figure 4**).

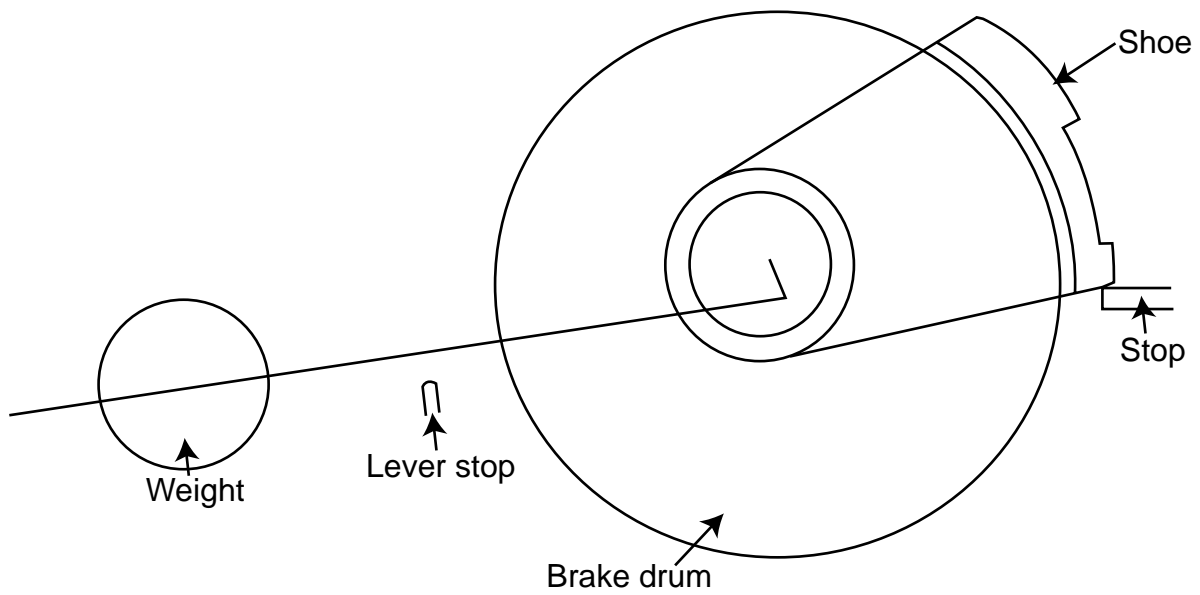
Figure 8

Brake, as assembled

Clearly, when the weight of the lifeboat was transferred from the mobile crane to the davit, the winch and its brake were able to support the lifeboat's weight. This was possible because the brake shoe was sitting on its stop pin with the lever at its extreme limit of adjustment. Any tendency of the brake drum to move in the lowering direction was resisted by the shoe and stop pin (**Figure 8**).

The owners are recommended to place winch maintenance, adjustment and repair data on board the vessel, so as to be available to ship's staff and others who may undertake work on the lifeboat winches.
